HIBISCUS PROPERTY HOLDINGS (PTY) LTD

ENGINEER'S REPORT: STRUCTURAL ASSESSMENT OF HUNTER HOUSE AT SCOTTBURGH DAY HOSPITAL, ERSKINE STREET, SCOTTBURGH

OUR REF | P 10634
DATE | 18 NOVEMBER 2021

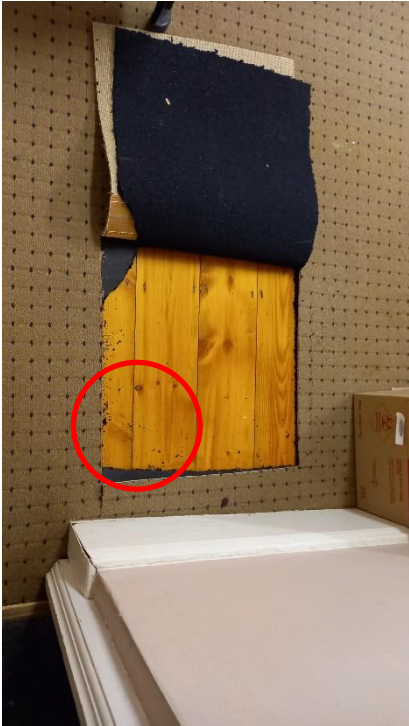
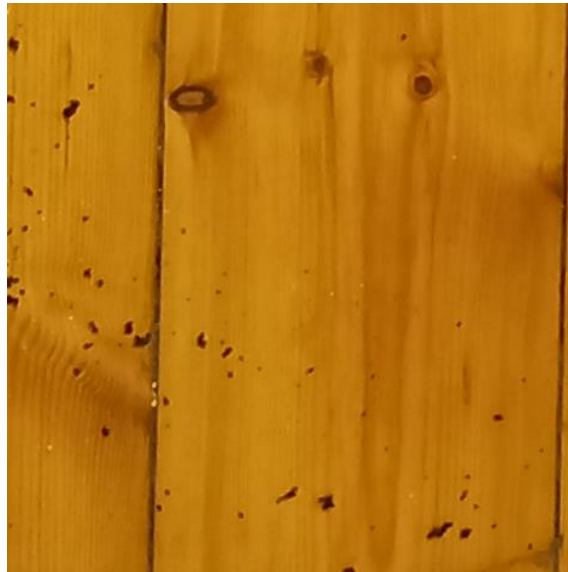
PLATE 1

- 2.3. The floors to the main house are suspended Oregon Pine timber floors supported off the walls and internal brick piers. Closer inspection of the floorboards reveals borer holes. We are of the opinion that it is extremely likely that the supporting bearer beams and timber elements are of similar state. See Plate 1

- 2.7. The timber skirtings, window and door frames and Architraves are all heavily infested with borer. The floors are carpeted above the Oregon pine and felt firm underfoot however having seen the condition of the other timber elements the true condition will only be known once all the carpets have been removed. See Plate 1

- 3.3. The timber elements within the building including window frames, doors and frames, skirtings, architraves are all infested with wood borer and will require replacement.

- 3.4. It is evident that the timber floorboards are infested with wood borer, it is extremely likely that the supporting timber elements are in a similar state. Our recommendation is to condemn the timber floors. The area is to be backfilled and compacted with a new concrete floor slab.

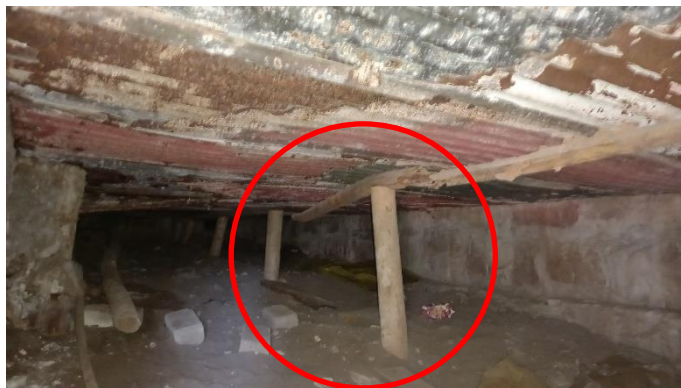
PLATE 2

- 2.4. The veranda floors are concrete deck floors created utilizing corrugate iron sheets "permanent shutters". These sheets are severely corroded and are falling apart. In the basement levels the metal sheets have been stripped away and the soffit painted. There are no apparent cracks or indications of the floors being compromised at this stage. A request to break out a section of concrete was submitted which revealed that there is no reinforcing within these concrete decks.

- 3.5. Damages to the peripheral veranda supporting structure will require replacement.
- 3.6. Concrete deck floor slabs no longer have the corrugated metal sheet as a supporting film in tension and are now self-spanning. An investigation of the concrete floors has

confirmed that there is no reinforcing within the slabs. These slabs are deemed condemned and are to be temporarily supported with props during the current site operations until such time that they are demolished.

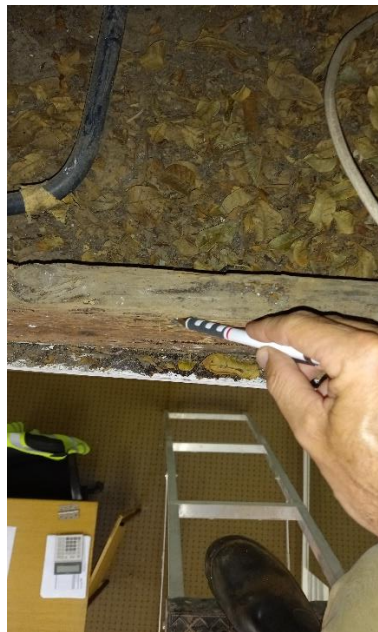
PLATE 6

- 2.5. The roof consists of Asbestos / fiber cement corrugated sheets on 75x50 SA Pine purlins on 110x38 SA Pine timber trusses. The bottom chords of the timber trusses are heavily infested with wood borer with isolated areas of infestation in the top chords and diagonals. There are many large voids between the roof sheeting and the closure profiles, this has led to an accumulation of leaves and debris getting into the roof space making it a thriving environment for insect infestation. See Plates 6 – 8.

- 3.2. The roof structure is currently stable and with constant treatment, cleaning and maintenance may last a few years. We have witnessed a high level of infestation of wood borer within the structural elements especially within the bottom chord tie beams, Purlins and battens are needing replacement, ceilings and cornices supported off the battens are showing signs of localized failure and collapse. The repairs required to revive the roof considering the current asbestos materials would result in an entirely new roof. Our recommendation is that the roof is condemned and to be replaced.

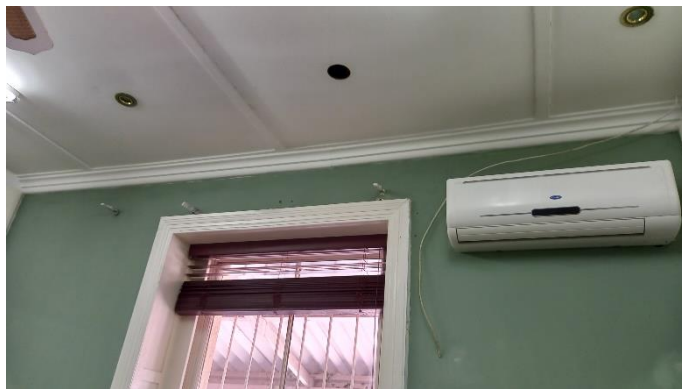
PLATE 9

- 2.6. Walking through the internal rooms within the original main house, it was seen that there are very few minor cracks in the walls but nothing to indicate any cause for concern of the structural integrity. See Plate 9

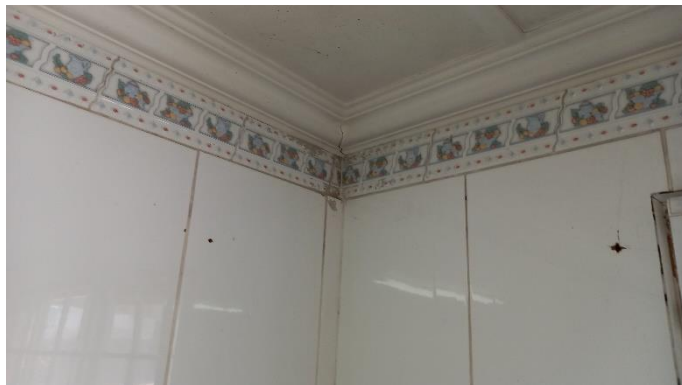
PLATE 10

- 2.8. The kitchen area is tiled floor to wall. There were no obvious indications of cracked tiles. See Plate 10
- 2.9. Bedroom 3, 4 and the common bathroom no indication of cracking occurring. The ceiling however is drooping over these areas. Quite possibly from the degradation of the supporting timber battens. See Plate 11

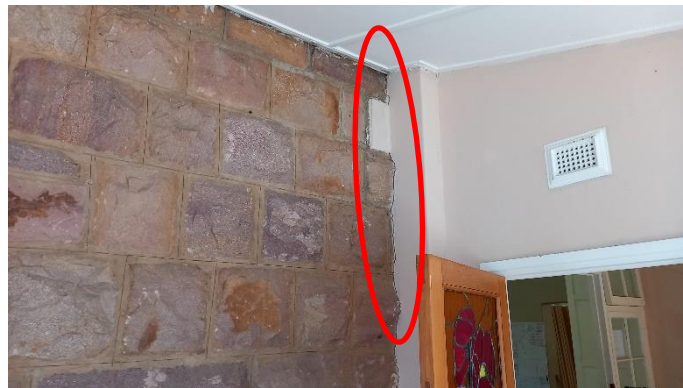
PLATE 12

- 2.10. The Entrance, Sunroom and Office area has been impacted by the recent collapse of the external support. Cracks have opened at the interface of the brick and stone wall and the wall along the window line. See Plate 12 - 14

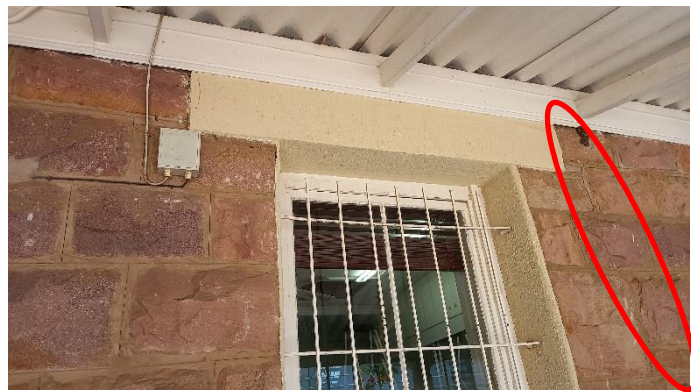
PLATE 15

- 2.11. The external walls on the Veranda have a few minor cracks that have formed. These are not visible from the inside due to the large cavity wall. See Plate 15

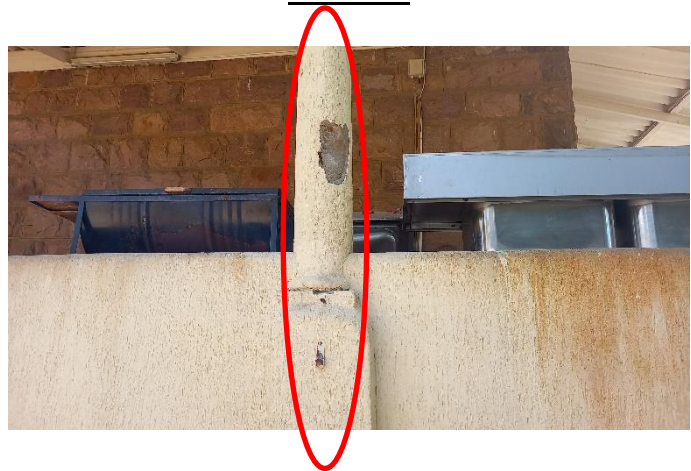
PLATE 16

- 2.12. The veranda pre-cast columns supporting the roof overhang have been damaged and are cracking severely, the low walls do not have sufficient expansion joints and are cracking at the interface with the columns. It was also noted that the floor surface slopes towards the outer low wall. The drainage points are few and of small diameter. This could lead to water ponding and unnecessary damage. See Plate 16

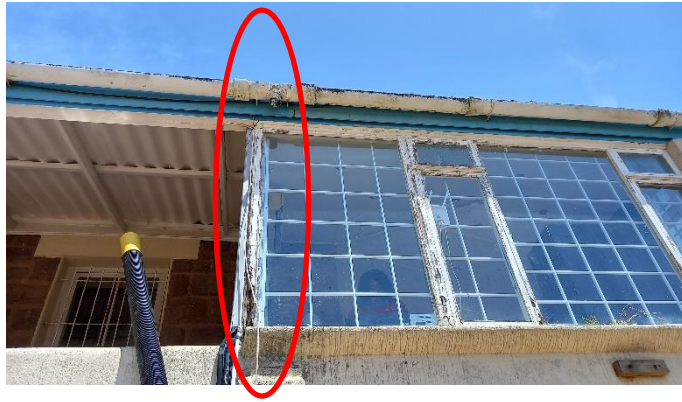
PLATE 17

- 2.13. The rainwater goods are in poor condition. The down pipes are missing or broken and thus allowing water to flow directly onto the window frames and other areas. The gutters are either broken, discontinuous or full of debris and foliage See Plate 17

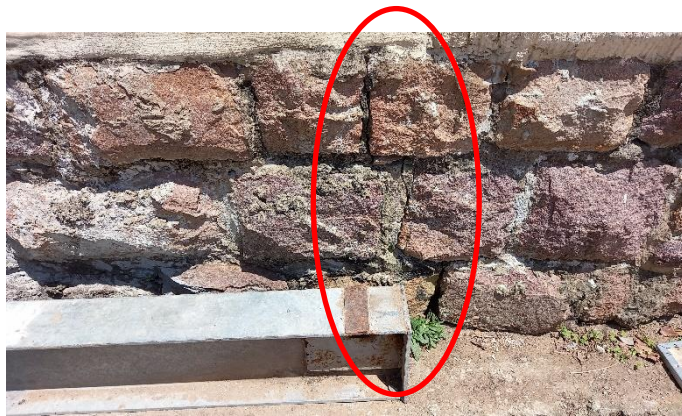
PLATE 18

- 2.14. The excavations requested to expose the foundations were not prepared however the collapsed wall at the adjacent site entrance ramp gave a good indication of what is to be found below the existing walls. It was seen that the existing foundations consist of large boulders grouted together on the loose density in-situ sand. It was seen in several locations around the building at the basement level that the boulder foundation has settled or moved and has opened large cracks where foliage has started to grow. See Plates 18 - 20

- 3.1. The building shell may seem structurally sound with no obvious indication of failure; it is however loaded with potential to fail. The foundations are believed to be the same grouted rock boulder seated within the soil. Any excavation or construction works near the building could have a very similar effect to the collapse which has recently occurred.
