## **CONCEPT DESIGN REPORT**

Project Name: Restoration of ZK Matthews House  
Alice, Eastern Cape  
Project Number: TBA

Release Date:  
Print Date: 08/11/2016  
Template Date: 01/01/2012  
Document No: RPT-0001

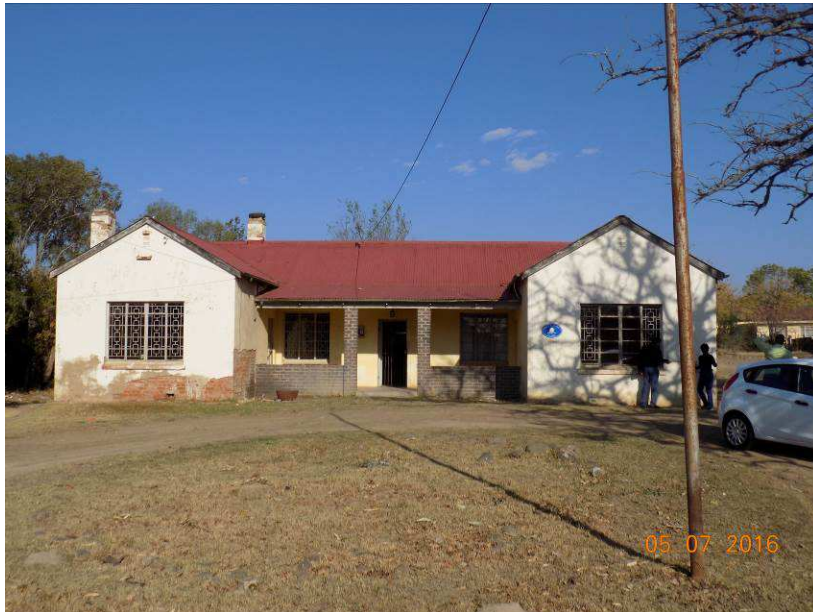
**Figure 4: North East Elevation (front of main house)**

Figure 3 presents the front of the house. It is evident that the brickwork and plaster has been compromised over the years due to limited maintenance.

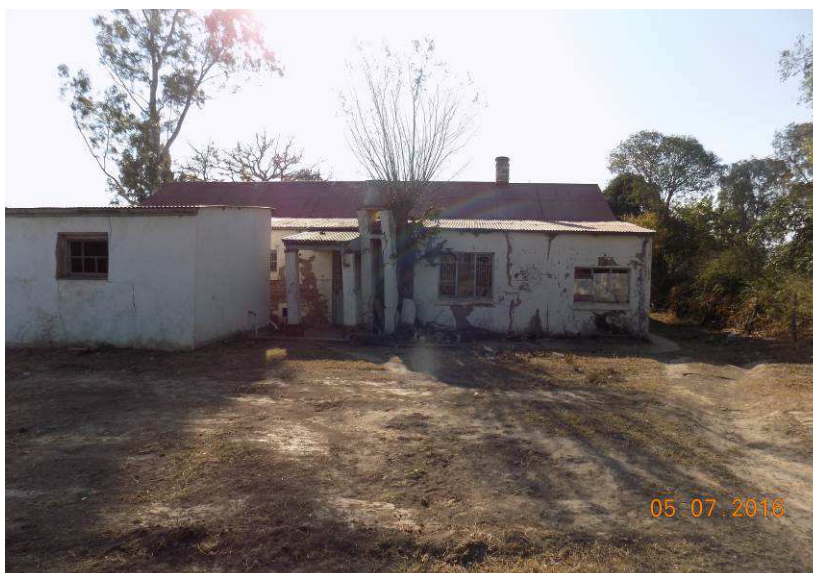
**Figure 5: South West facade (back of main house)**

Figure 5 represents the South West façade of the main house. Significant structural cracks are evident that pose a safety risk. The fascia's, gutters and rain water good are missing causing water problems around the building.

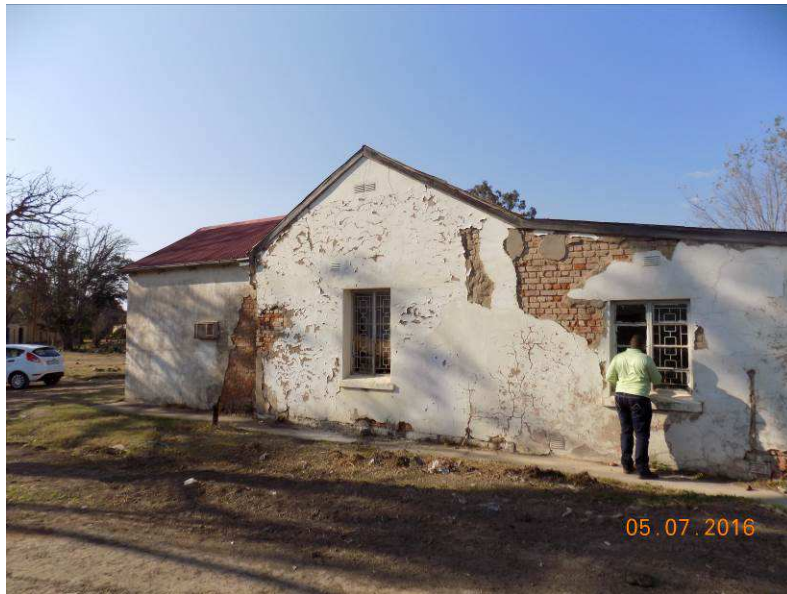
**Figure 6: North West Facade with foundations compromised**

It is assumed that the foundations are concrete strip footings. Due to large structural cracks observed it is evident that the foundations are undermined due an inadequate drainage system. The downpipes have been damaged/ removed. Water discharges onto the ground and seeps into the foundation.

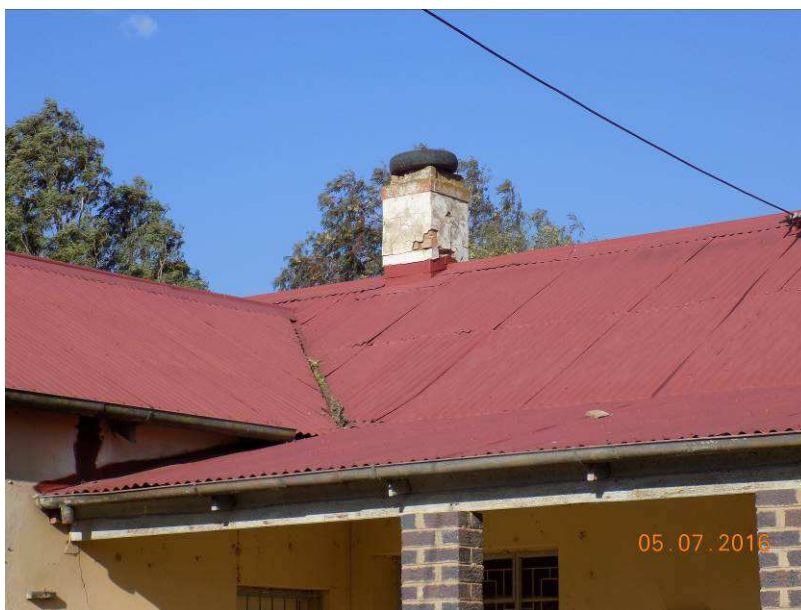
**Figure 7: Existing roof sheeting of the main house**

Figure 7 presents the roof of the main house. Visual inspection revealed that early corrosion has set in and compromising the integrity of the roof structure and water proofing of the roof. Drainage off the roof is poor due to missing gutters and downpipes.

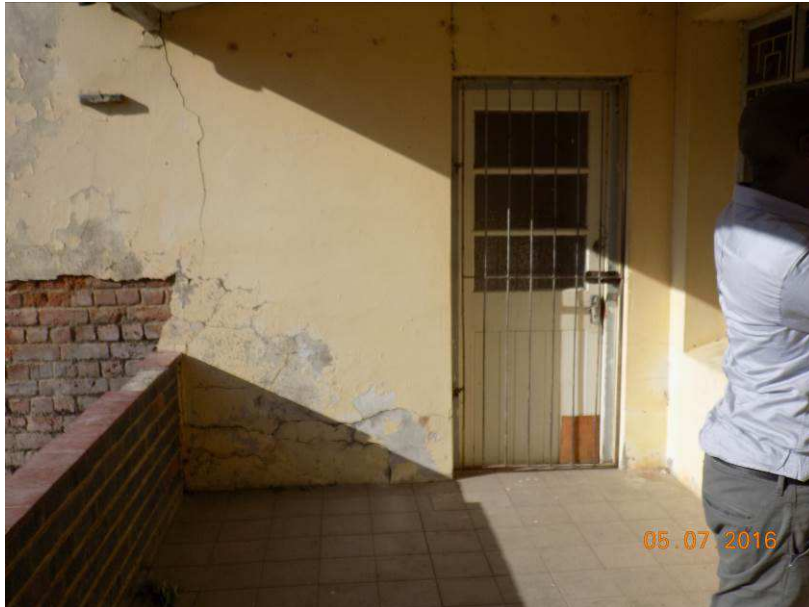
**Figure 8: Veranda space showing plaster cracks**

Figure 8 shows the veranda space in the main house. The plaster in this area is spalling and indicated structural cracks resulting in damp problems internally.

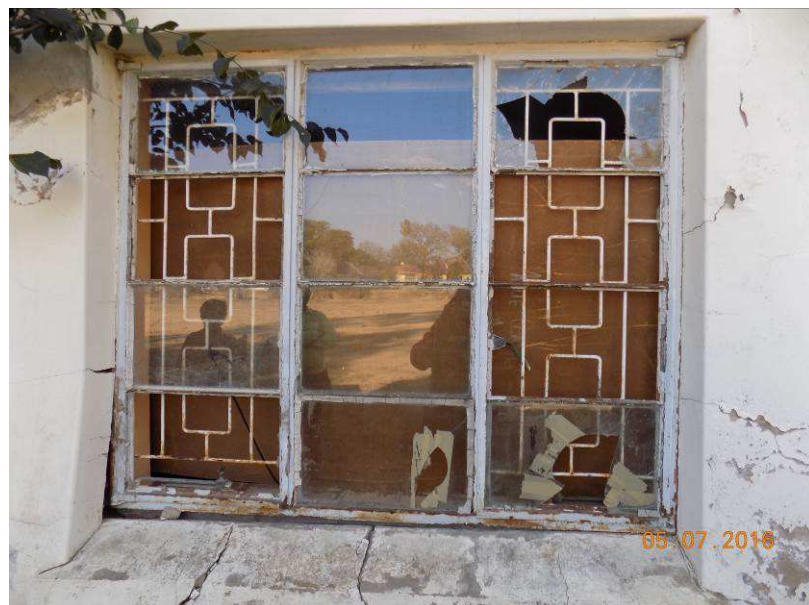
**Figure 9: Typical painted steel window**

Figure 9 shows the typical windows in the house. Window frames are galvanised steel and painted. Burglar guards are installed for additional security. There are cracks evident around the windows which indicate differential settlement.

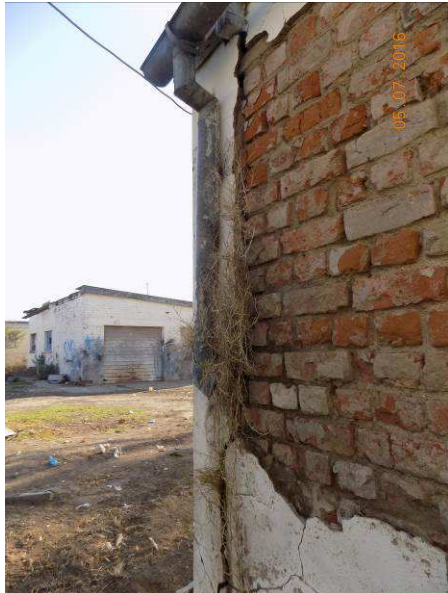
**Figure 10: Shows the cracks and exposed brickwork**

Figure 10 shows brickwork. The undermining and settlement of the foundations has led to severe cracking of the internal and external brickwork and plaster. The plaster to the brickwork is severely cracked and loose and has left the brickwork exposed in certain areas. The exposed brickwork has since been eroded and has lost its structural integrity.

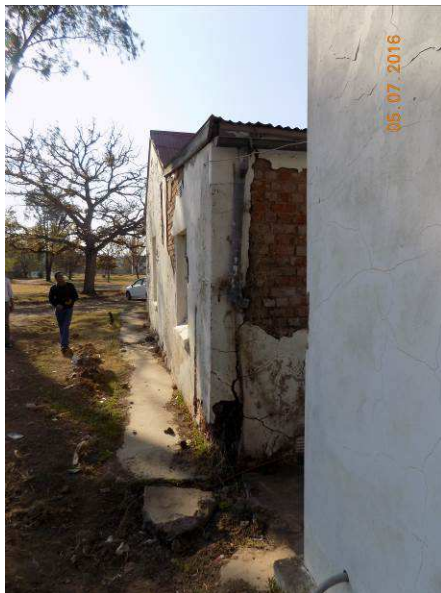
**Figure 11: North West corner severely damaged and collapsed**

Figure 11: shows the North West corner. The north-west corner of the building has been severely damaged and the brickwork at the ground level has collapsed and contributed to damp problems internally.

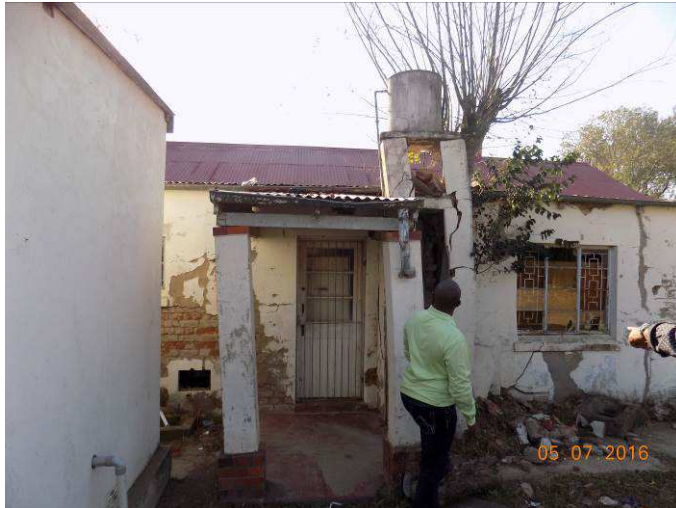
**Figure 12: South Western Facade with tree growth in wall**

Figure 12 shows the external face of brickwork on the south western wall of the main house has separated and is deemed to be unsafe. This damage is due to the roots of a tree which has grown on the face of the rear wall. The brick piers supporting the rear covered entrance is displaced by this growth and has become unstable and unsafe.

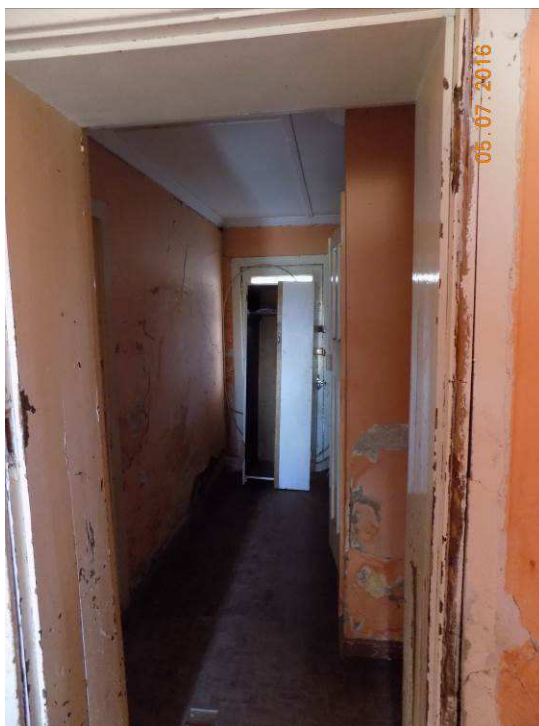
**Figure 13: Interior passage of the house**

Figure 13 shows the interior of the house.

The ceilings are in poor condition and are missing in places.

Due to inaccessibility, the roof structure could not be assessed. The brickwork joints on the chimney vents to the fireplaces have eroded. This has also become unstable and unsafe.

Interior walls indicate loose plaster, dampness, cracks and is in poor condition.

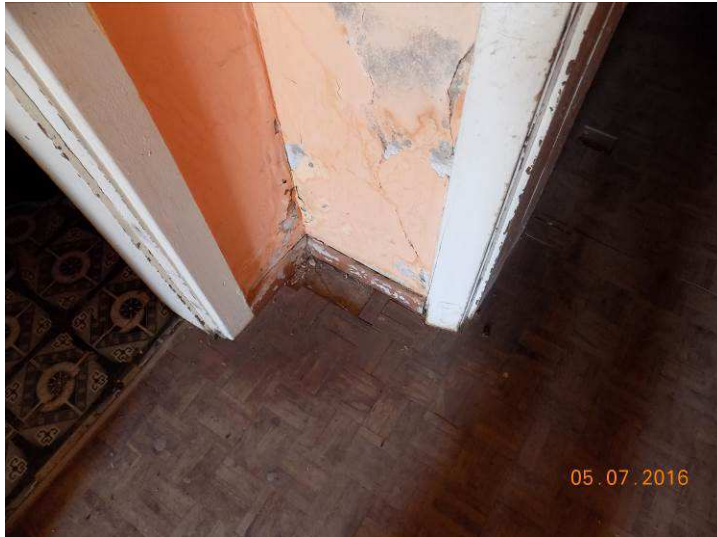
**Figure 14: Shows the existing concrete floor with parquet finish in most rooms**

Figure 14 shows the existing floor. The old timber floors have been removed in most rooms and replaced with concrete floors. Floor covering is a mix of timber parquet flooring and vinyl sheeting. The floor levels are below the existing ground line and this is creating damp problems internally

Due to damp problems, the floor shall be raised at least 100mm above natural ground line and replaced with new concrete floor slabs. This shall ensure durability and reduce long term maintenance. Floors shall be tiled with hard-wearing porcelain tiles.

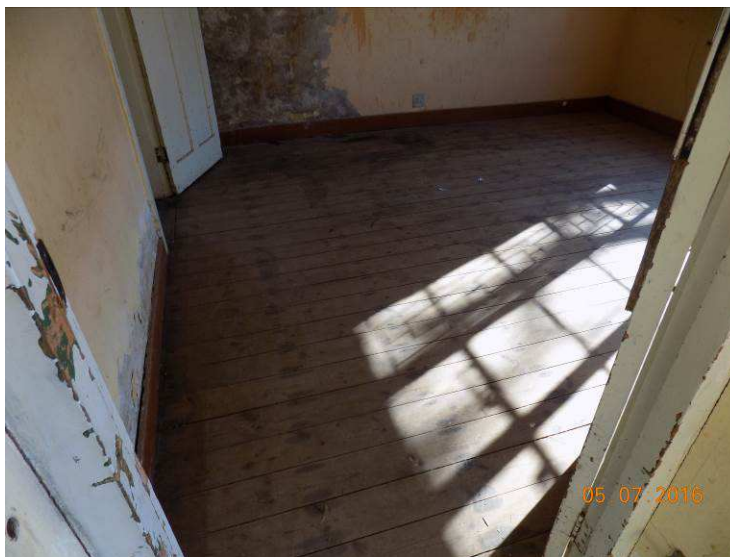
**Figure 15: Existing timber floors in two rooms**

Figure 15 shows the timber flooring. Only two rooms have timber floors. The supports to the timber floors have deteriorated over the years and are deflecting. These floors are extremely unsafe and susceptible to possible collapse.

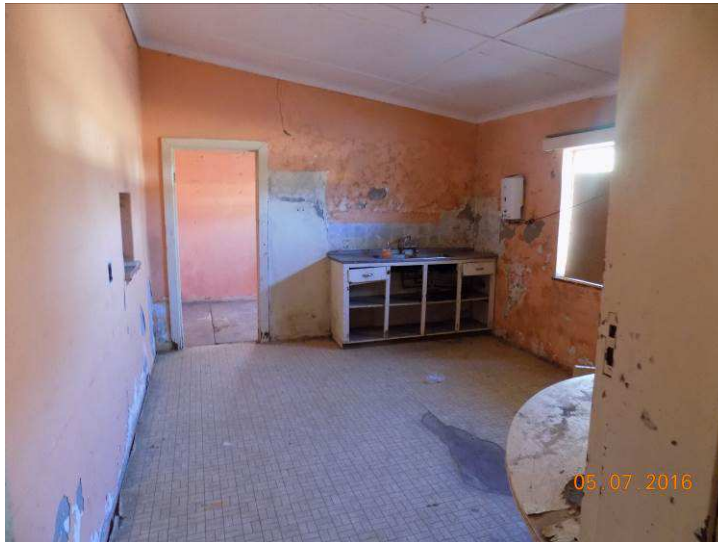
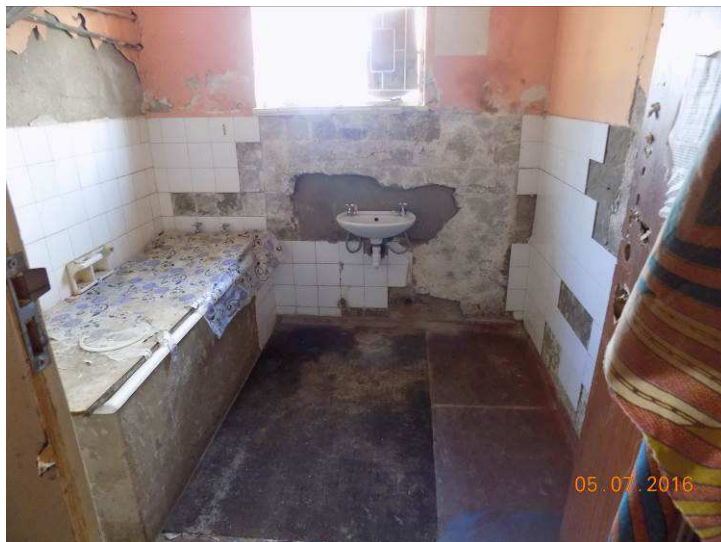
Figure 16 and 17 shows the existing kitchen

Kitchen and bathroom fixtures, cupboards, fittings and plumbing are in poor condition and will need to be replaced. Revamp of kitchen and bathroom is required

**Figure 16: Existing kitchen in very poor state**

**Figure 17: Existing bathroom needs total refurbishment**

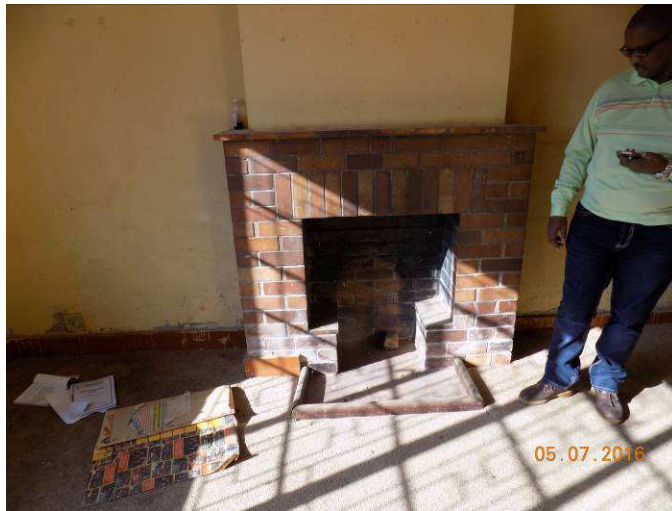
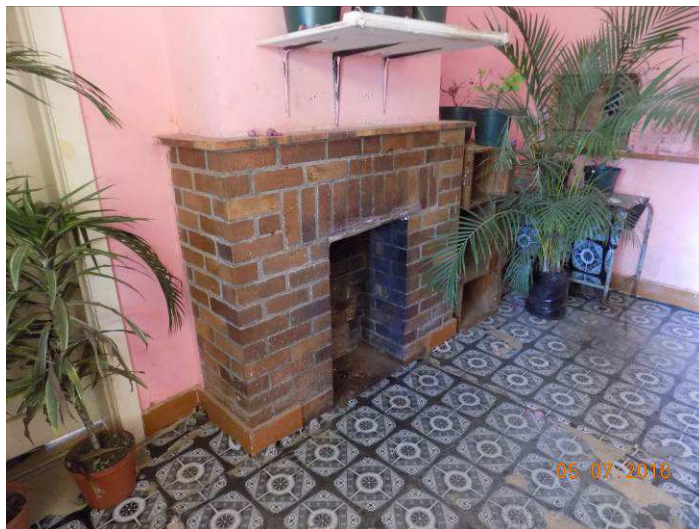
**Figure 18: Show existing fireplace**

Figure 19 and 19 shows the existing fireplaces in the house.

There are two existing face brick fireplaces internally that are in fair condition. They are of no architectural significance and can be rebuilt.

**Figure 19: Shows existing fireplace in living room**

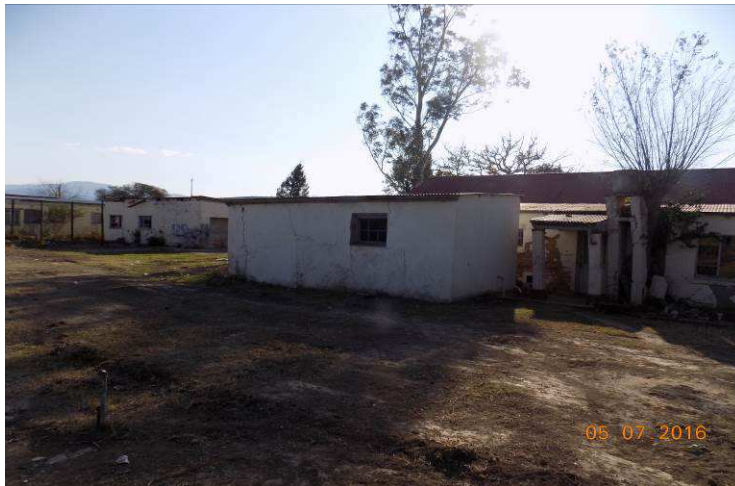
**Figure 20: Shows the existing outbuilding**

Figure 20 presents the outbuilding which is a simple lean-to structure that is in very poor condition. Window glazing is missing.

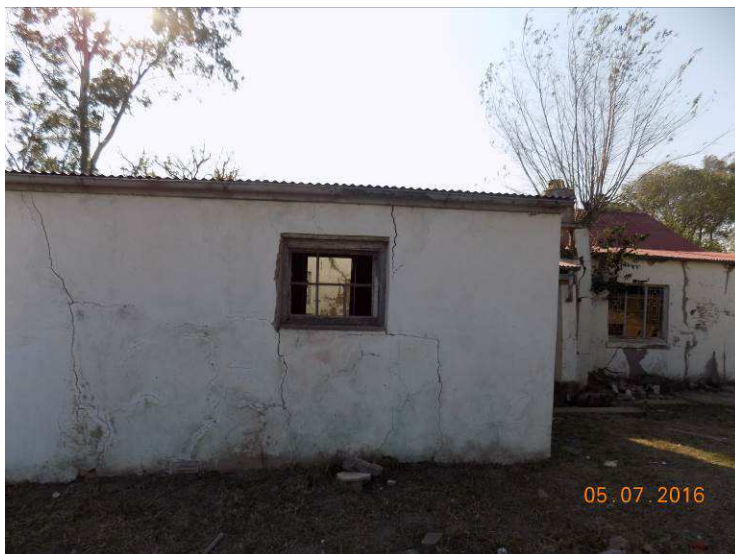
**Figure 21: Outbuilding showing compromised foundations**

Figure 21 shows the outbuilding cracks and subsidence due to foundation being undermined.

It is assumed that the foundations are concrete strip footings which have been undermined due an inadequate drainage system.

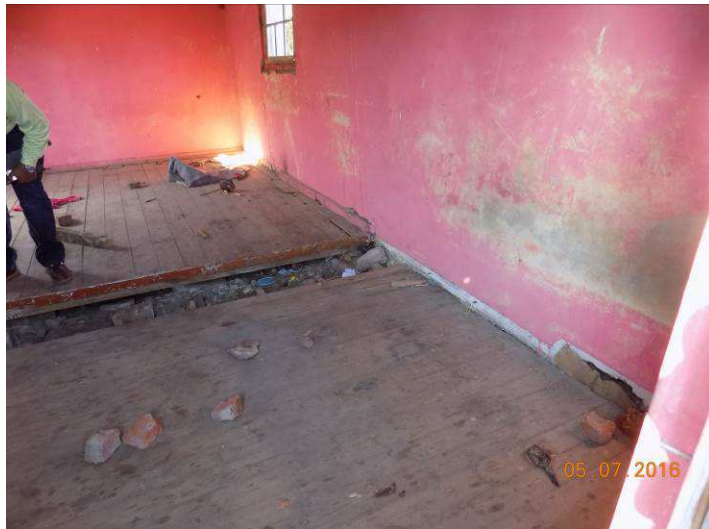
**Figure 22: Outbuilding floor collapse**

Figure 22 shows the existing floor in the outbuilding. The floors are timber. The supports have deteriorated thereby allowing excessive deflection when trafficked. Some of the timber flooring has been removed. These floors are extremely unsafe and susceptible to possible collapse.

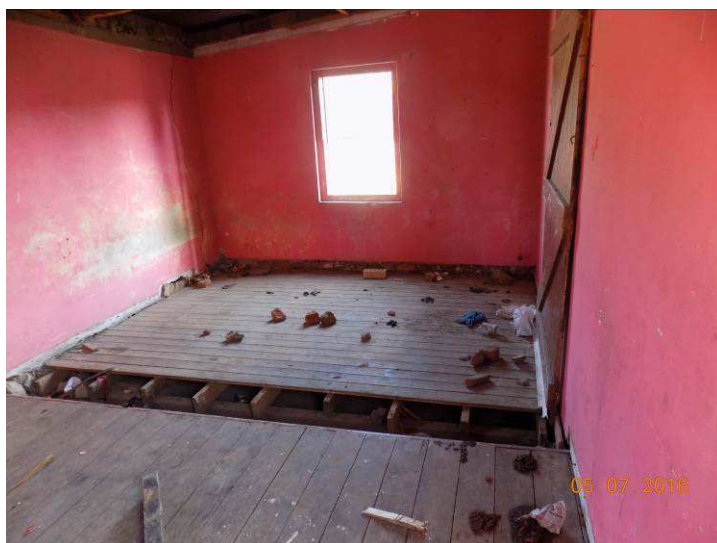
**Figure 23: shows the interior of the outbuilding**

The undermining and settlement of the foundations has led to severe cracking in the external brickwork and plaster. The integrity of the walls have been compromised.

The roof comprises of a timber rafter and purlin system. The main rafter show signs of excessive deflection which could lead to possible collapse.

The roof sheeting and rainwater goods are in poor condition and in need of replacement.

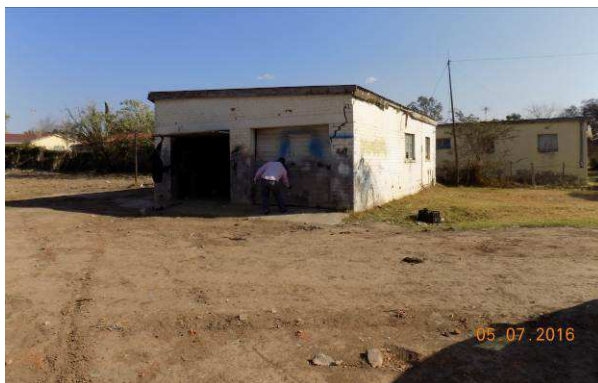
**Figure 24: shows the existing garage**

Figure 24 shows the existing garage which is in very poor condition. The building shows signs of movement as there are large cracks visible.

It is presumed that the foundations are concrete strip footings which have been undermined due an inadequate drainage system.

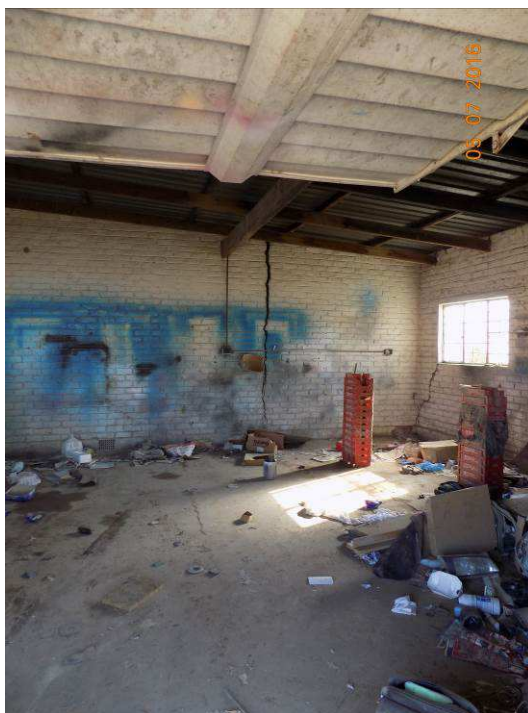
**Figure 25: Interior of garage showing large crack**

Figure 25 shows the interior of the garage. The floors of the existing garage are concrete.

The undermining and settlement of the foundations has led to severe cracking of the external brickwork and plaster. The external wall on the north eastern side has settled and rotated causing severe cracks in the adjacent brickwork. The pier supporting the beam over the garage door has settled causing severe cracking at this junction leading to possible collapse. There is a large crack centrally on the north western wall. The plaster to the brickwork is severely cracked. The integrity of the walls have been compromised and deemed unsafe.

The roof comprises of a central timber beam supporting a timber rafter and purlin system. The current construction of the roof does not conform to the statutory codes and standards. The roof sheeting is in poor condition and in need of replacement.
