CIVIL/STRUCTURAL CONDITIONAL ASSESSMENT REPORT (Final – RV02)

CONSTITUTIONAL HILL PRECINCT – RAMPARTS BUILDING AND SURROUNDING WALL

11 May 2023

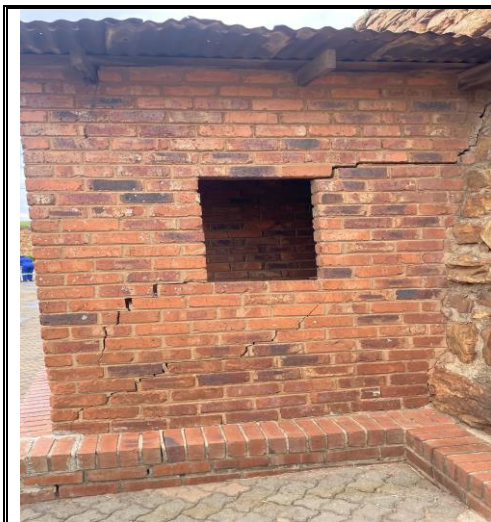
Figure 3 – Minor to severe diagonal and horizontal cracks on guard tower due to retaining wall movements

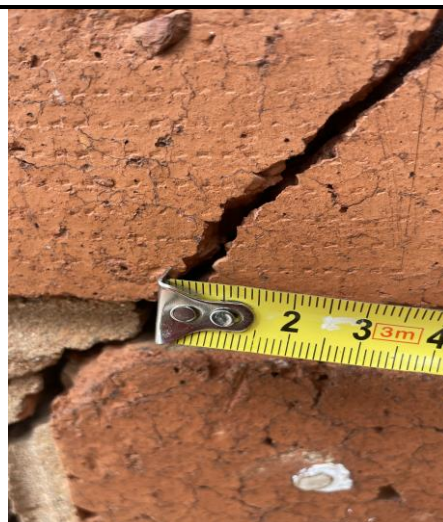
Figure 4 – Minor diagonal crack on guard tower brick (1mm – 5mm) due to retaining wall movements

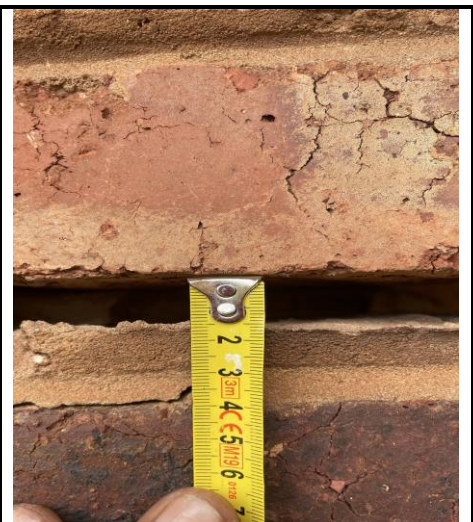
Figure 5 – Severe horizontal crack on guard tower brick (15mm – 25mm) due to retaining wall movements

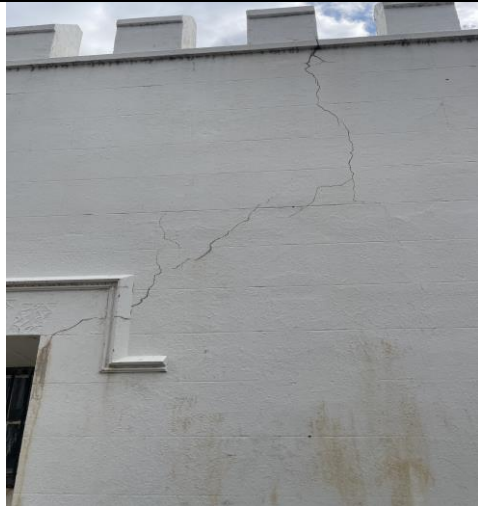
Figure 6 – Minor diagonal crack on external fabric (1mm – 5mm) of the western building

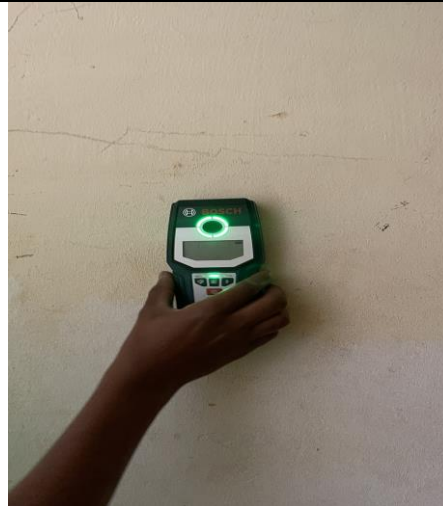
Figure 7 – Radar device indicating no brick force/brick reinforcement on retaining wall on western building

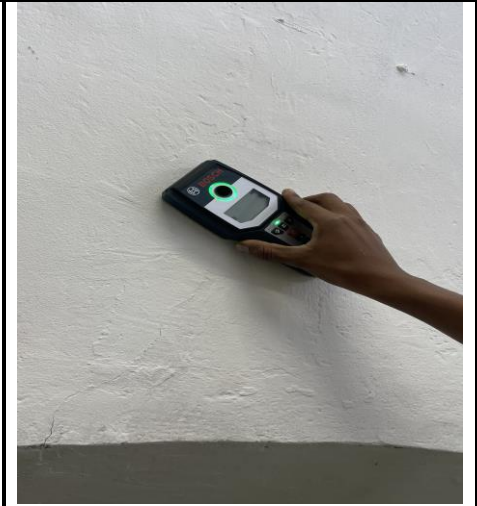
Figure 8 – Radar device indicating no brick force/brick reinforcement on external wall on western building

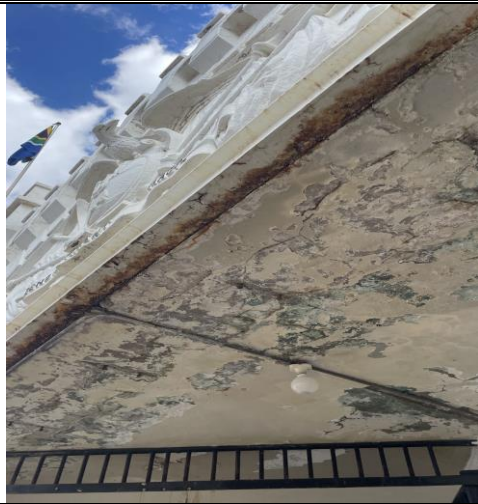
Figure 9 – Minor cracks (1mm – 5mm) on suspended slab due to water leakage at entrance of southern museum building; Surface rust on structural steel of southern museum building

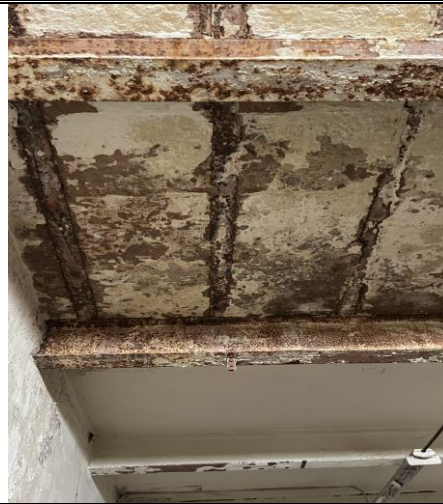
Figure 10 – Surface rust on structural steel on soffit of basement slab of southern museum building; Minor cracks on suspended slab due to water leakage of southern museum building

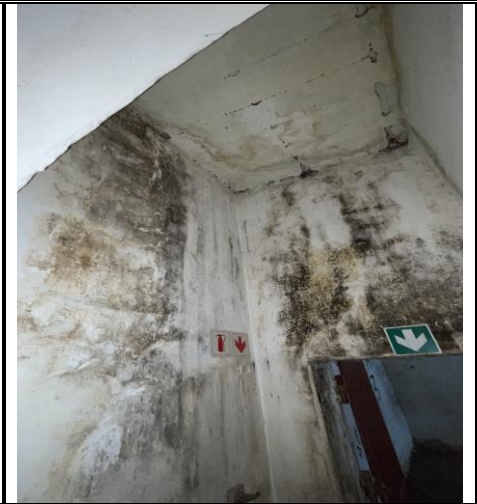
Figure 11 – Stained wall due to water leakage above slab in basement of southern museum building

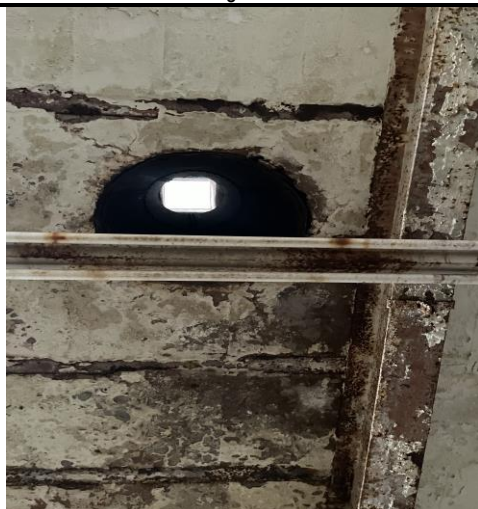
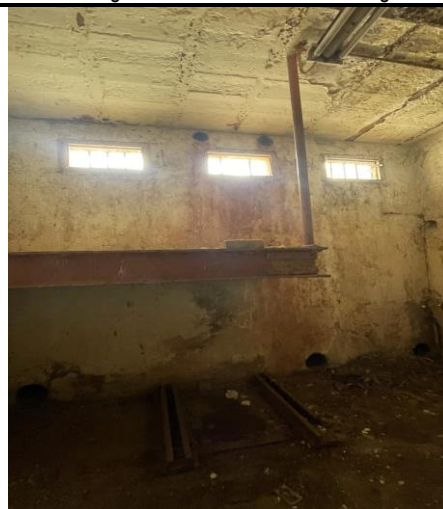
Figure 12 – 9m air shaft causing severe water leaks of southern museum building

Figure 13 – 9m air shaft causing severe water leaks of southern museum building

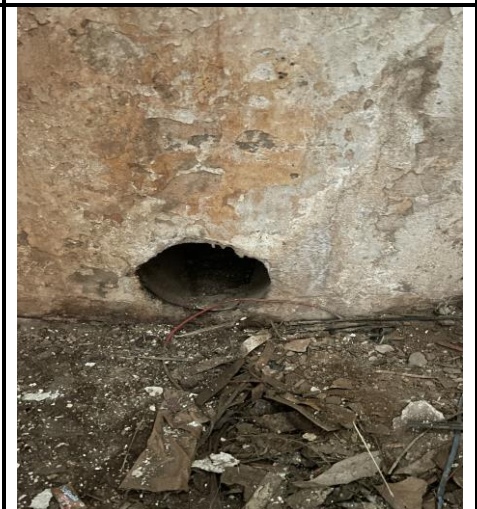
Figure 14 – Blocked stormwater pipe of southern museum building

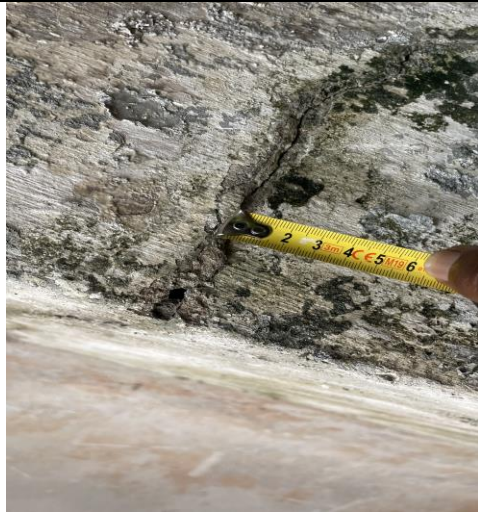
Figure 15 – Minor cracks (1mm – 5mm) on suspended slab due to water leakage of southern museum building

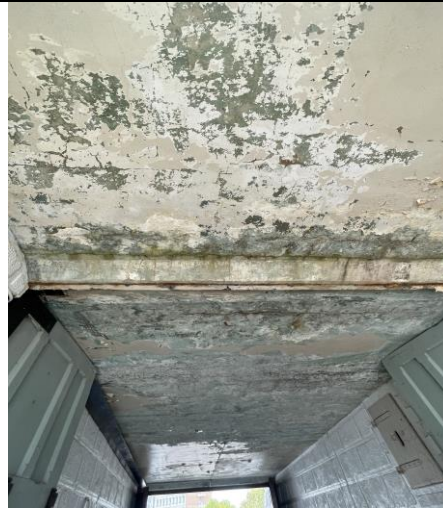
Figure 16 – Minor cracks (1mm – 5mm) on suspended slab due to water leakage of southern museum building

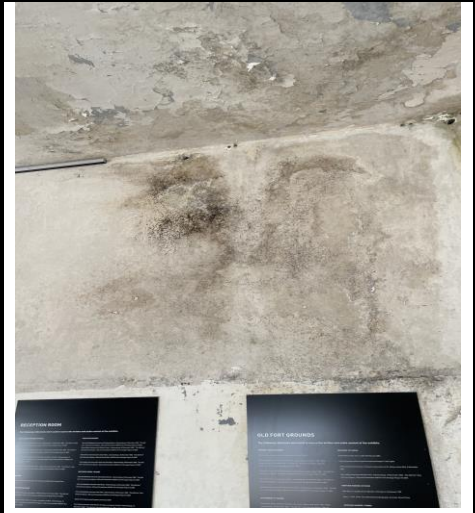
Figure 17 – Water stains on suspended slab and brick wall in museum area of southern museum building

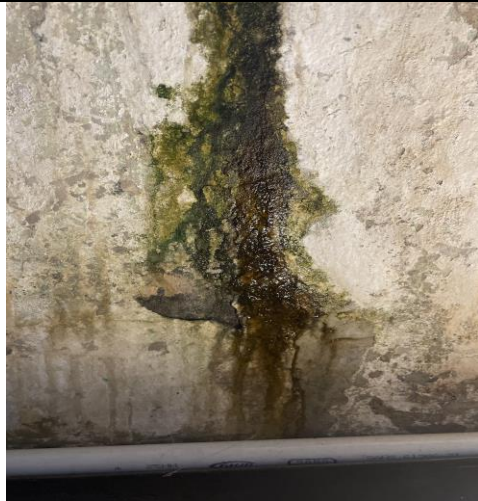
Figure 18 – Water stain on wall indicating water leakage of southern museum building

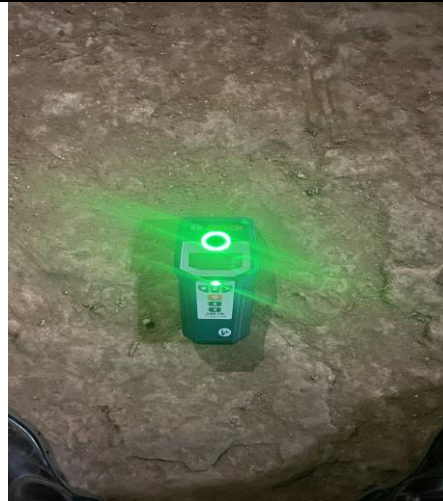
Figure 19 – Radar device indicating no brick force/brick reinforcement on surface bed of southern museum building

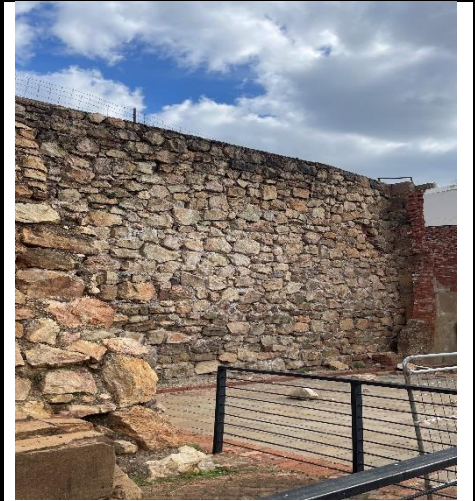
Figure 20 – Collapsing retaining wall with no visible drainage next to southern museum building

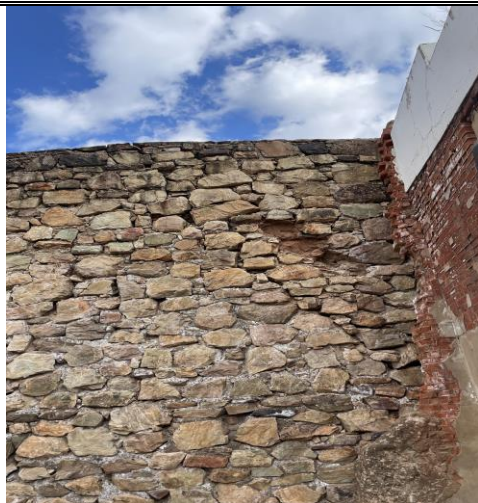
Figure 21 – Collapsing and loose retaining wall with fallen pieces of rock next to southern museum building

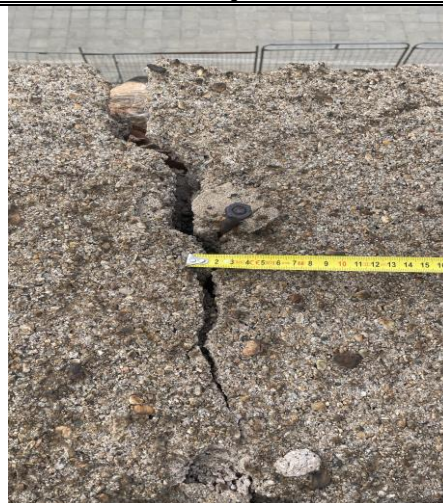
Figure 22 – Severe horizontal crack on retaining wall (15mm – 25mm) due to retaining wall movements next to southern museum building

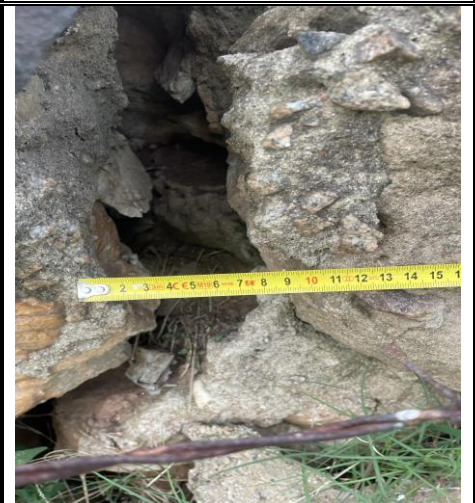
Figure 23 – Very severe crack (>25mm) on retaining wall next to southern museum building

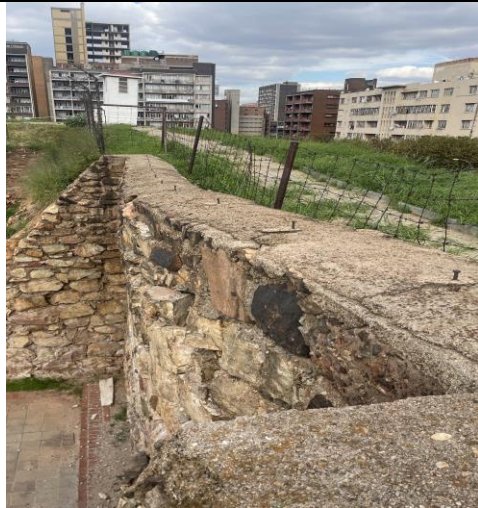
Figure 24 – Retaining wall leaning next to southern museum building

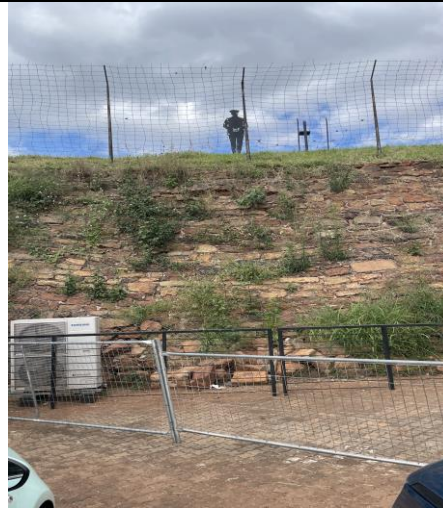
Figure 25 – Deflecting and loose retaining wall next to eastern studio building

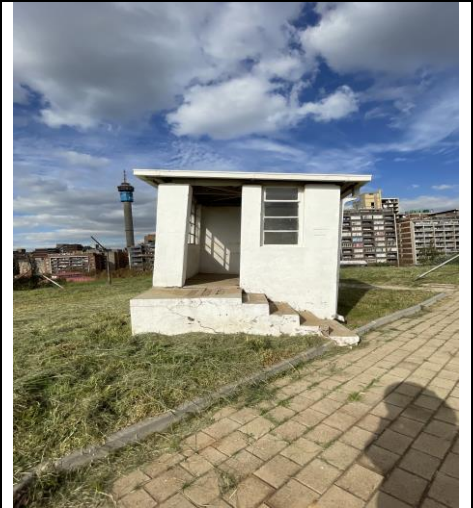
Figure 26 – Leaning guard tower 2 (north-eastern) due to settlement

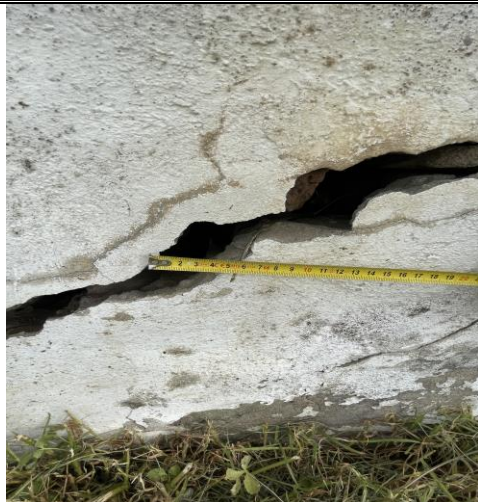
Figure 27 – Very severe crack (>25mm) on guard tower 2 (north-eastern) due to settlement

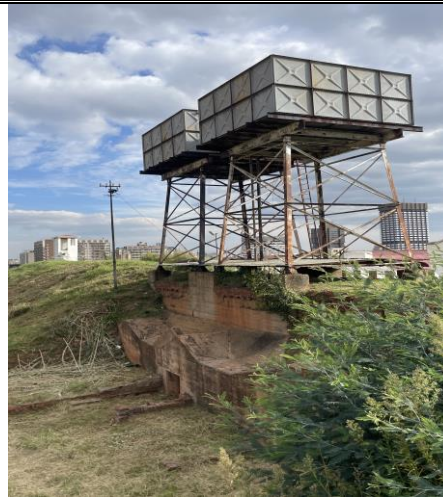
Figure 28 – Elevated water tank in good condition but with surface rust

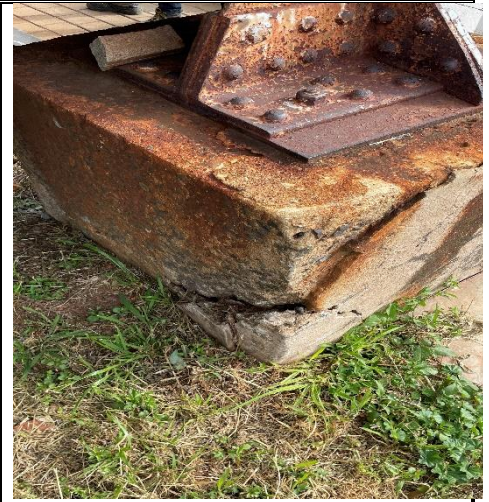
Figure 29 – Crack on suspended tank footing due to settlement ; Bolts and nuts of suspended tank in good condition but with surface rust

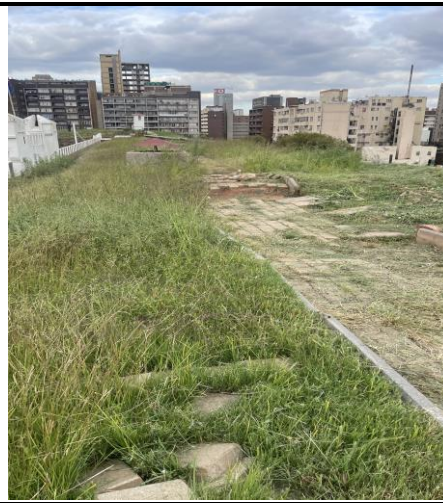
Figure 31 – Sagging, uneven and missing pavement blocks; Soil backfill and vegetation on rampart walk embankment

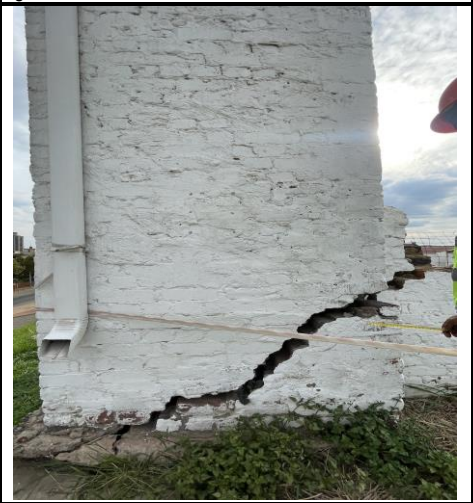
Figure 32 – Leaning guard tower 3 (north-eastern) due to settlement

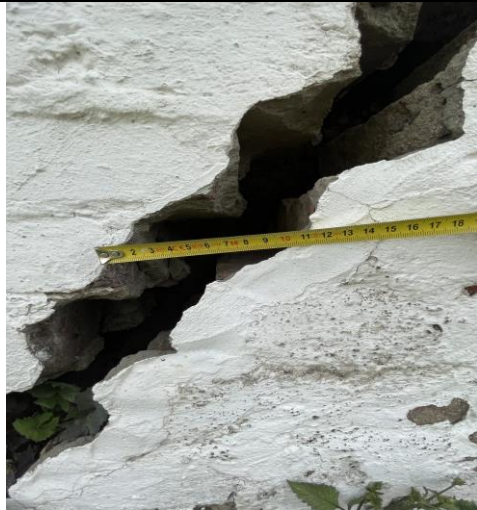
Figure 33 – Very severe crack (>25mm) on guard tower 2 (south-eastern) due to settlement

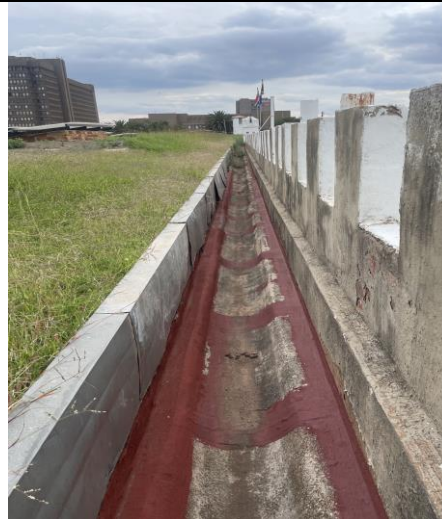
Figure 34 – Roof stormwater drainage with partial waterproofing above southern museum building ; Soil backfill and vegetation on roof top of southern museum building

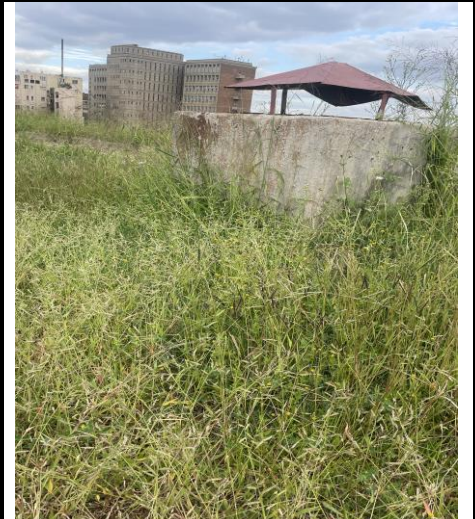
Figure 35 – Vent shaft opening causing severe leaks in basement area of southern museum building; Soil backfill and vegetation on roof top of southern museum building

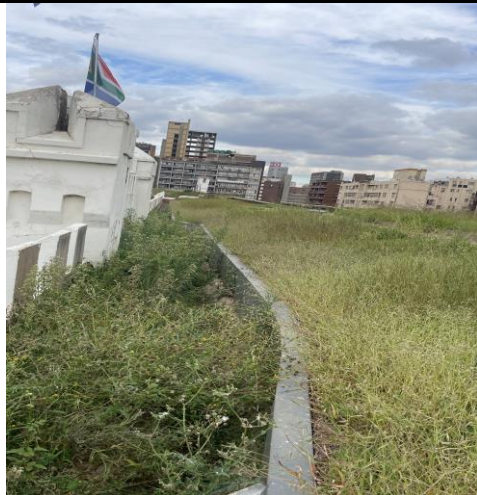
Figure 36 – Vegetation growing on roof stormwater drain channel of southern museum building

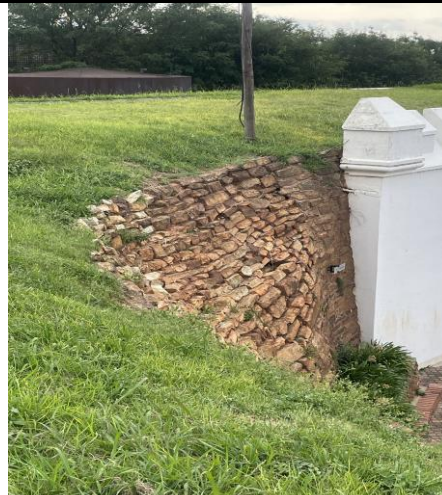
Figure 37 – Cracks on retaining wall; Loose stones on retaining wall; No drainage on retaining wall of south-western area

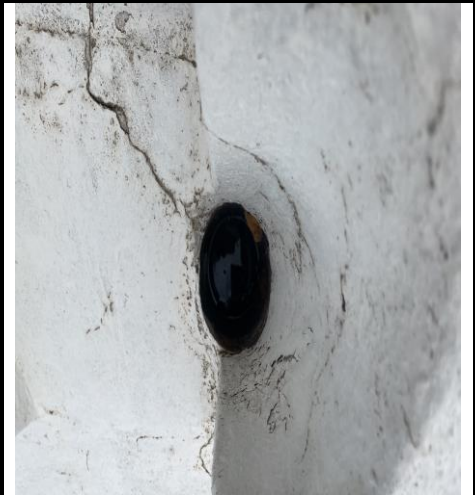
Figure 38 – Blocked drainage pipes on southern museum building
