MALE / FEMALE ABLUTIONS - FIRST FLOOR (SOUTH WING)		ROOM NAME -

P.O.BOX 37188 OVERPORT DURBAN 4067 TELE : 2097245/6 FAX : 2097247 E-MAIL :seedat@ion.co.za AHMED.SEEDAT-ARCHITECT REG no :3140(S.A.C.A.P)	PROJECT: NATAL COMMAND -DILAPIDATION REPORT	SCALE: 1/50	DRWG.No: 21126
	DRAWING TITLE: ROOM AND OFFICE DATA SHEETS	DATE: DEC 2022	PAGE.No: 1

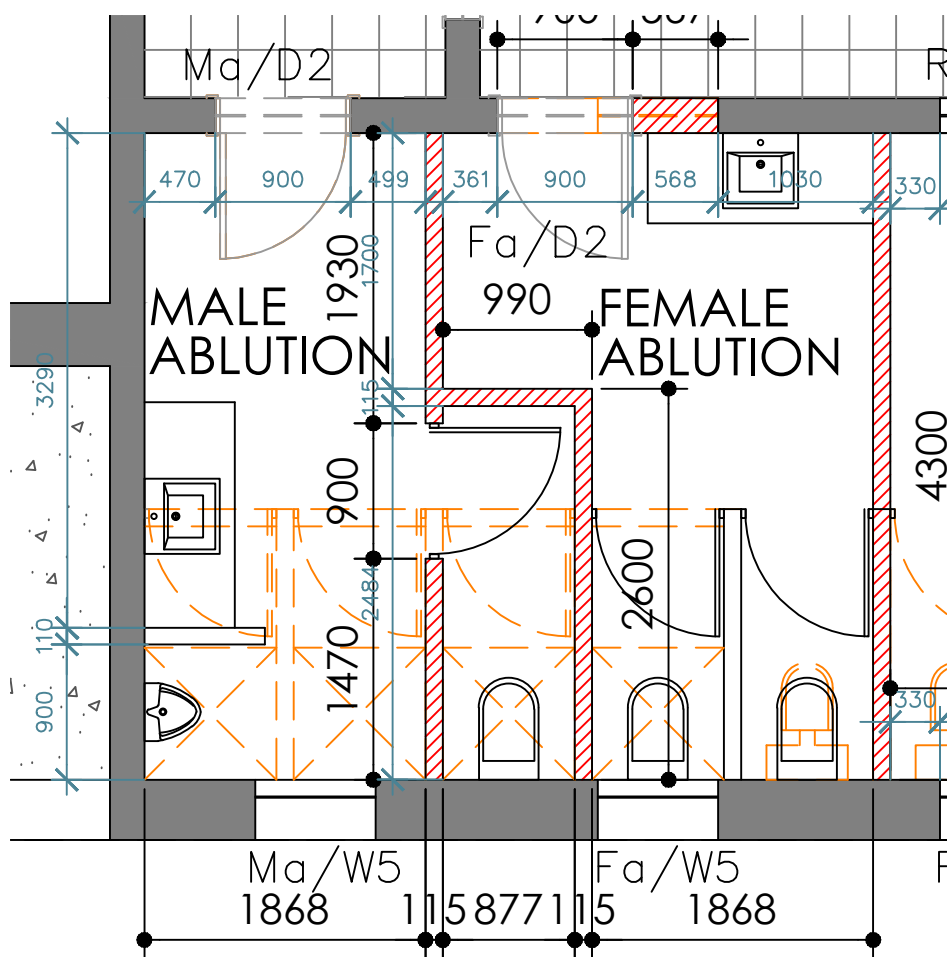
FLOOR FINISH	• ex. floor tiles to be remove in its entire , floor to be repaired and filled were required to receive new finish as per architects spec. - 17.81sqm
WALL FINISH	• Existing plaster & paint: - Walls to be scraped, treated, fill all imperfections. - Walls to receive new tile finish as per specifications - Ex. bathroom wall tiles to be removed in its entire , walls to receive new finish as per spec.
DADO RAILS	• Dado rail: Ex. dado rail to be inspected for wood rot & water damage. Replace damaged dado rails with salvaged. Sand, repair & seal as per specification.
CEILING	• 12mm plasterboard ceiling. sand down & apply plascon 2 coats high quality acrylic paint-colour as per specifications 75mm gypsum coved cornice - finish as per ceiling
WINDOW	• Existing Timber Window Frames: - Timber window frames to be inspected for wood rot and water damage. - Affected mullions to be removed and replaces to match. - All damage and broken glass to be replaced with 6mm toughened safety glass as per sans 10400 Part N or equally approved my specialist - Window hinges to be replaced with brass type hinge and secured with brass screws as per schedule Window handles: Window handles to be replaced with brass type handles to match existing and fixed with brass screws as per schedule Windowsill : - Windowsill to be inspected for damage ,and replaced were required - Affected sills to be removed and replaces to match.

DOOR	• Timber door frames to be inspected for wood rot and water damage. door frames to be repaired with salvaged and made good to match ex. Doors: Refer to door detail

WINDOW: Ma/W5
 General note:
 All window frames & casements to be fixed where damaged. Filled, sanded & sealed as per specifications.

Replace (1 off) missing window handles with brass window combination stay & fastener 300mm
 NB: fix with brass screws
 Hinges: Window hinges to be inspected, serviced or replaced if required with brass butt hinge and brass screws or equally approved

Replace (1 off) missing timber window sash and glazing to match existing replace glazing with 6mm toughened safety glass or equally approved as per SANS10400 part N

WINDOW: Fa/W5
 General note:
 All window frames & casements to be fixed where damaged. Filled, sanded & sealed as per specifications.

Fanlight:
 Replace (1 off) missing fanlight with 6mm toughened safety glass or equally approved as per sans 10400 part N fixed with timber glazing beads

Door frame : reuse ex. salvaged door frame repair all imperfections to receive new door specified
 Door:
 - replace missing door with Swartland interior deep moulded door , elegance code- EBELGHSO,
 - ironmongery as per spec.
