ROOM NO.1 - FIRST FLOOR ( NORTH WING )	ROOM NAME - NORTH WING STAIR 1	SCALE:	DRWG.No:

P.O.BOX 37188 OVERPORT DURBAN 4067 TELE : 2097245/6 FAX : 2097247 E-MAIL :seedat@ion.co.za AHMED.SEEDAT-ARCHITECT REG no :3140(S.A.C.A.P)	PROJECT: NATAL COMMAND -DILAPIDATION REPORT	1/50	21126
	DRAWING TITLE: ROOM AND OFFICE DATA SHEETS	DATE: DEC 2022	PAGE.No: 1

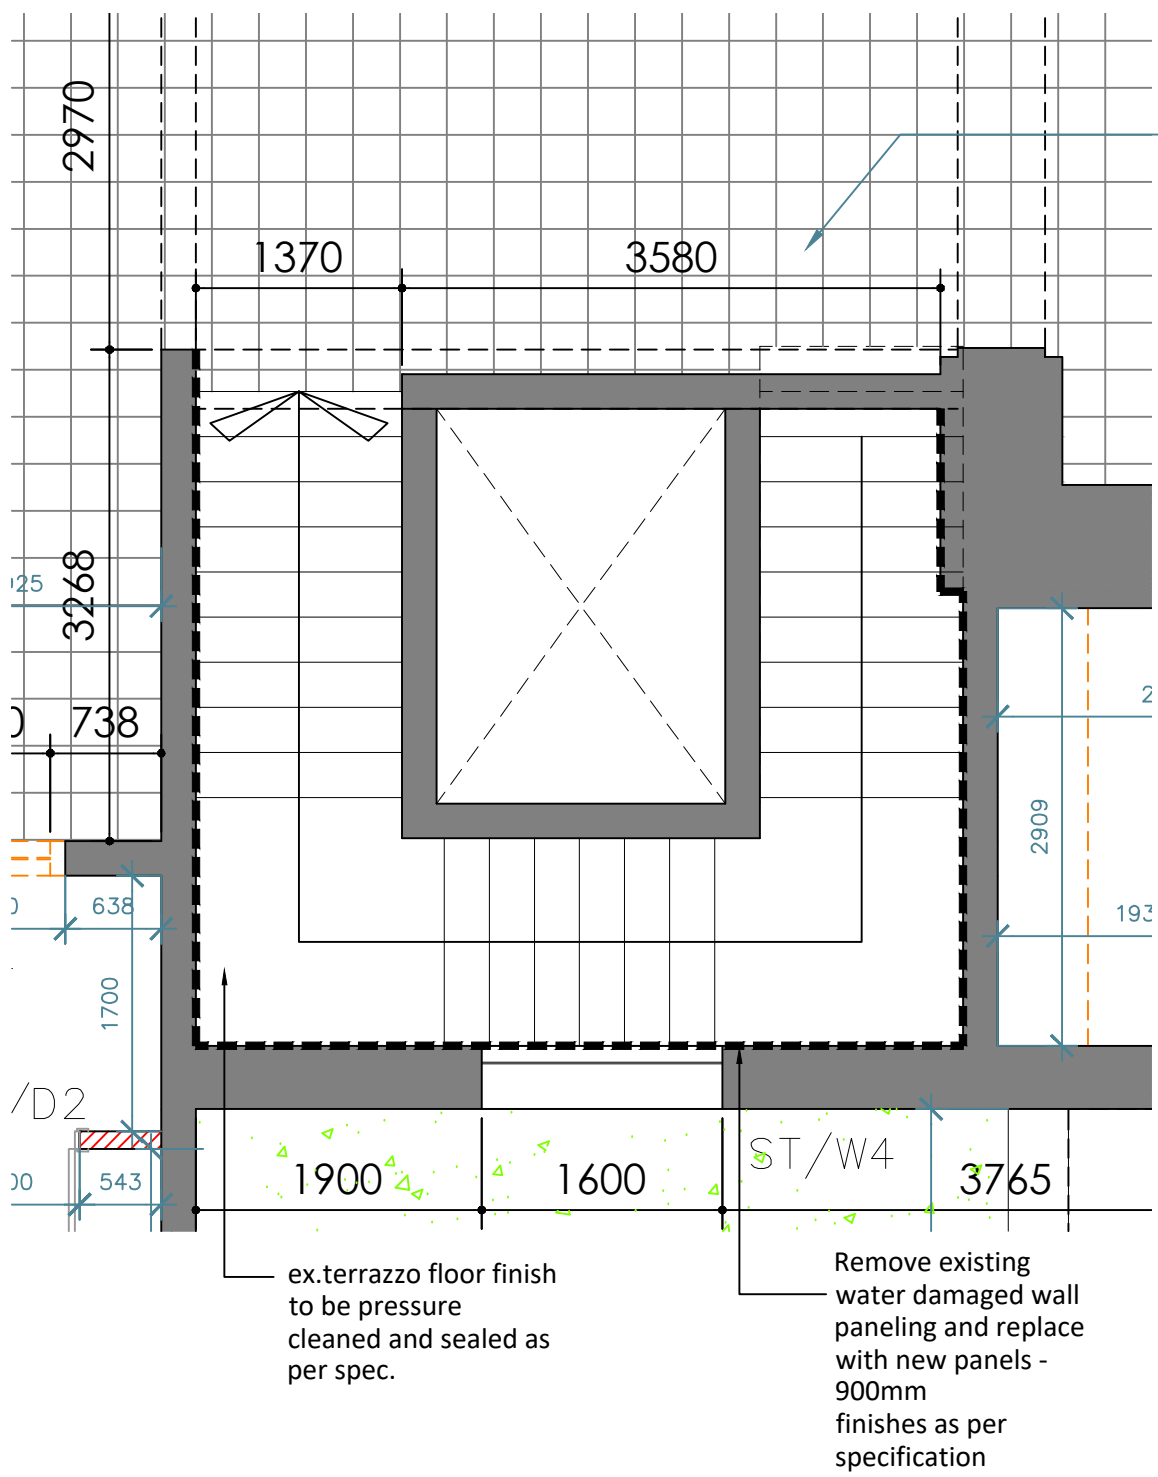
FLOOR FINISH	• ex.terrazzo floor finish to be pressure cleaned and sealed as per spec - 15.50sqm
SKIRTING	• Skirting: Ex. skirting to be inspected for wood rot & water damage. Replace damaged skirting with salvaged. Sand, repair & seal as per specification
WALL FINISH	• Existing plaster & paint: - Walls to be scraped, treated, fill all imperfections. - Walls to receive new finish as per specifications
CEILING	• 12mm plasterboard ceiling. sand down & apply plascon 2 coats high quality acrylic paint-colour as per specifications 75mm gypsum coved cornice - finish as per ceiling
WINDOW	• Existing Timber Window Frames: - Timber window frames to be inspected for wood rot and water damage. - Affected mullions to be removed and replaces to match. - All damage and broken glass to be replaced with 6mm toughened safety glass as per sans 10400 Part N or equally approved my specialist - Window hinges to be replaced with brass type hinge and secured with brass screws as per schedule Window handles: Window handles to be replaced with brass type handles to match existing and fixed with brass screws as per schedule Windowsill : - Windowsill to be inspected for damage ,and replaced were required - Affected sills to be removed and replaces to match.

DOOR	• Timber door frames to be inspected for wood rot and water damage. door frames to be repaired with salvaged and made good to match ex. Doors: Refer to door detail
