- Affected panel to be removed & replaced with solid timber veneered paneling to match.				
	- All paneling to be sanded, sealed, stained to matched existing				
CEILING •	NG • - scrape off existing flaking paint , treat and fill all imperfections to receive new finish as per spec.				
DOOR •	door frames to be repaired with salvaged and made good to match ex.				
	Doors: Refer to door detail				
ROOM NO. NORTH WING FOYER ROOM		ROOM NAME -			
<i>5</i> 8 0	P.O.BOX 37188	PROJECT:	SCALE:	DRWG.No:	
OPI OFF	OVERPORT	NATAL COMMAND -DILAPIDATION REPORT	1/50	21126	
	DURBAN 4067		1/00	21120	
	TELE : 2097245/6				
P P S S S S S S S S S S S S S S S S S S	FAX : 2097247	DRAWING TITLE:	DATE:	PAGE.No:	
	E-MAIL :seedat@ion.co.za	ROOM AND OFFICE DATA SHEETS	DEC 2022		
1 1 7 5	AHMED.SEEDAT-ARCHITECT			1	
	REG no :3140(S.A.C.A.P)			·

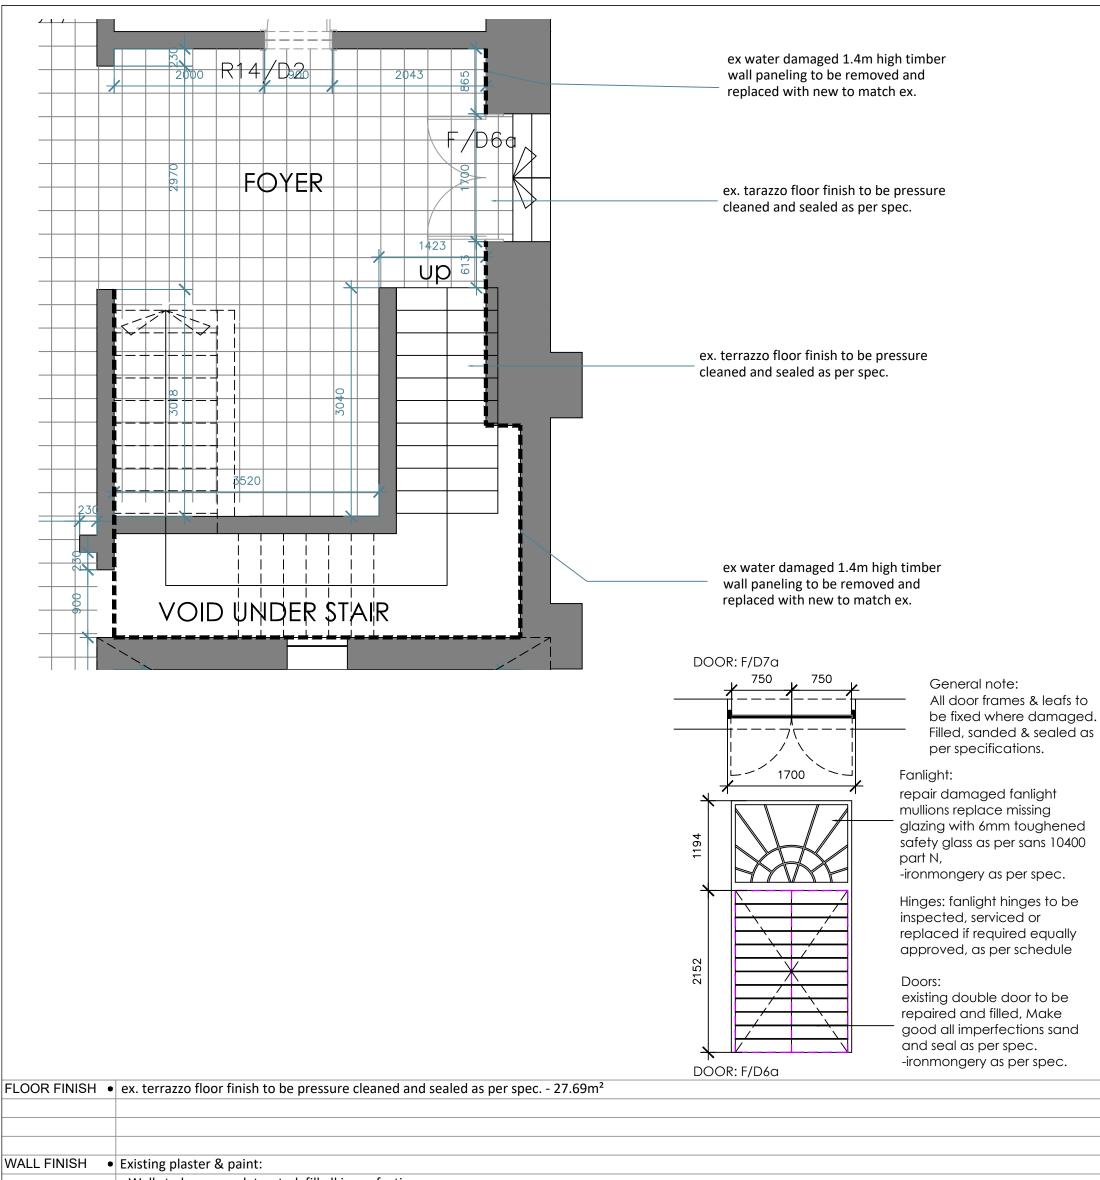
- Walls to receive new finish as per specifications				
	Timber Wall Paneling: 1.4m high				
	- All timber panels to be inspected for wood rot and water damage.

- Walls to be scraped, treated, fill all imperfections.
