**SPECIALIST REPORT ON THE DE WITTEKRANS ROCK ART SITE COMPLEX:  
DE WITTEKRANS PROJECT – MASHALA HENDRINA COAL MINE (PTY) LTD,  
LOCATED NEAR HENDRINA, MPUMALANGA PROVINCE**

**September 2023**

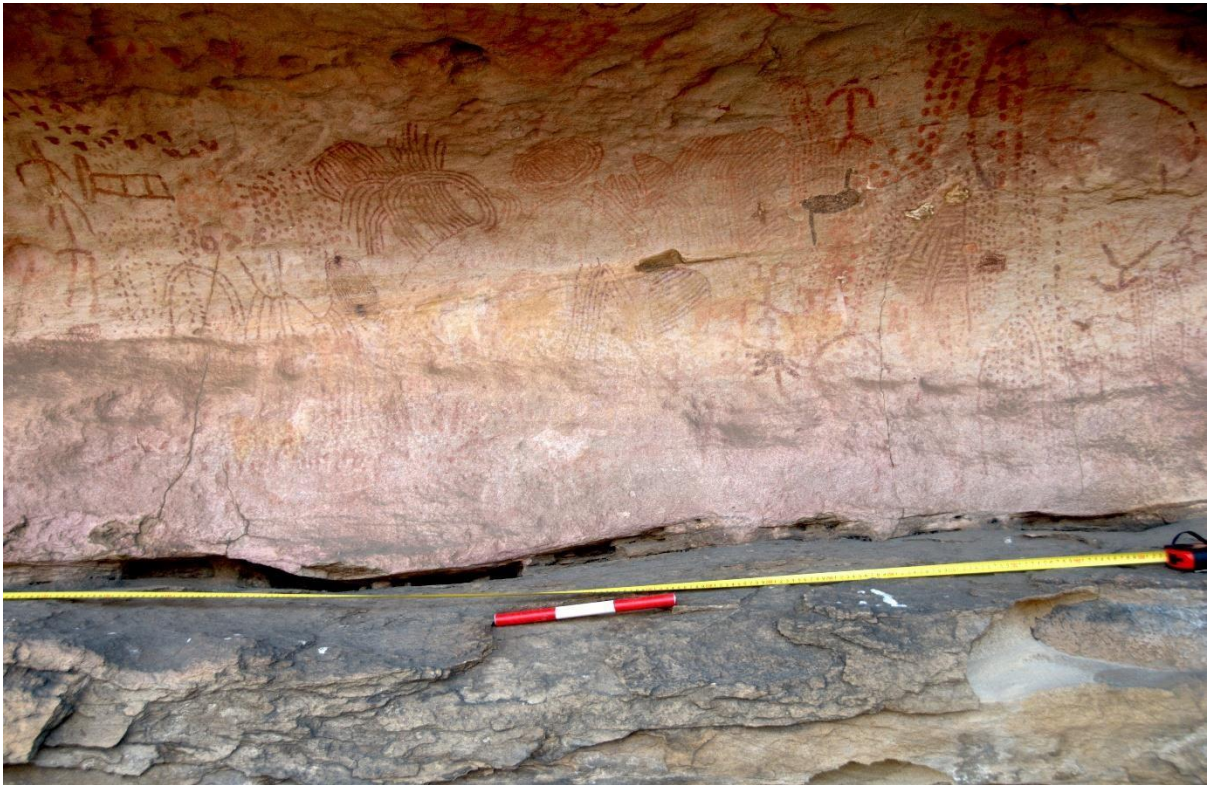
*Figure 7: Main panel at Site 9b, depicting fine-line and finger-painted 'geometric' paintings over fine-line animal figures. Dirt has accumulated on the panel, covering some of the images.*

- (iii) While cognisant of the sensitivity of the rock paintings, a cleaning procedure for the accumulated dust on the rock art panels should be devised – SAHRA can be contacted about guidelines regarding this;

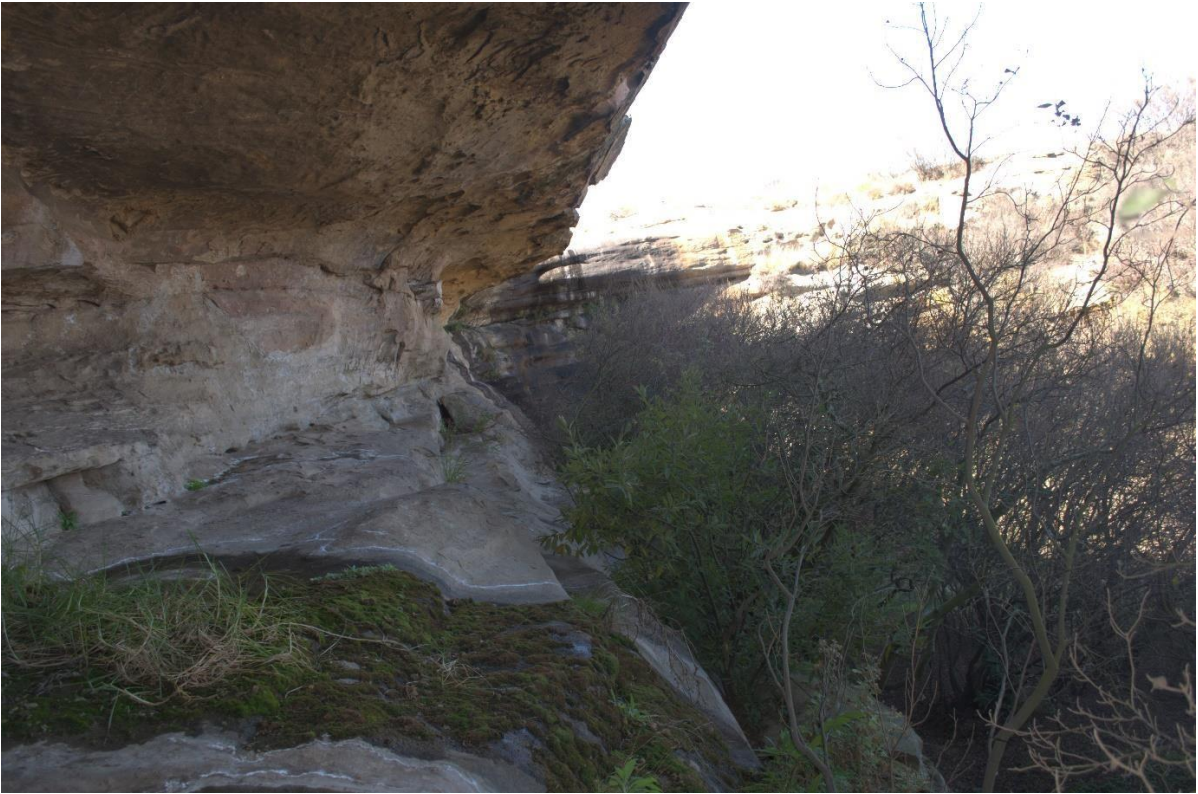
Figure 9: The Site 9d shelter. The main panel is to the left of the section covered by algae.

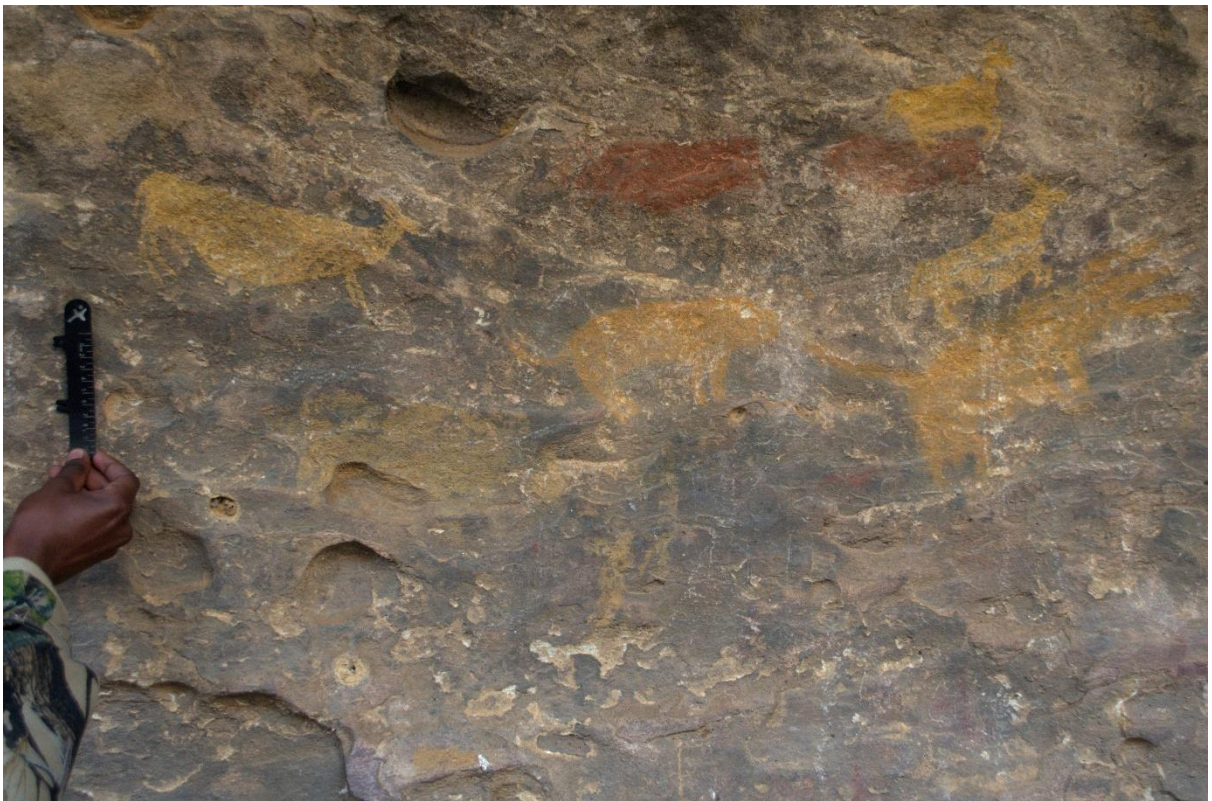
Figure 10: Left side of the panel at Site 9d, showing fine-line animal figures in a chalky pigment. Note the dust on the panel and the scratches on some of the images.

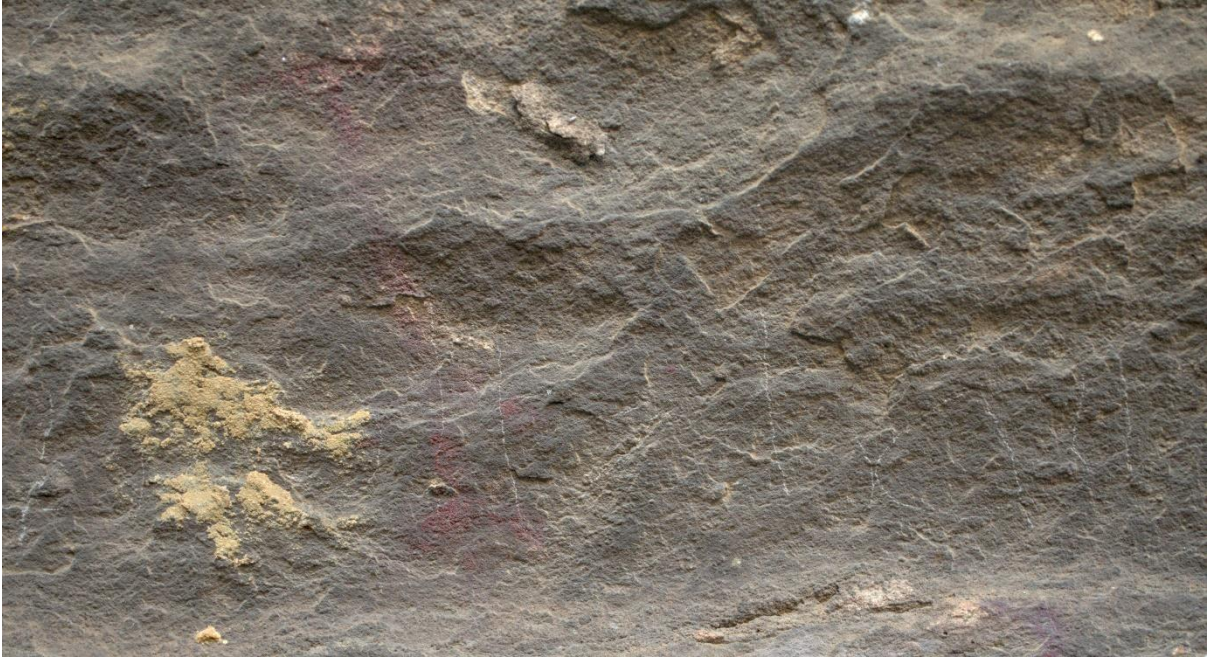
No excessive damage by human activity was observed. However, comparing the photographs of the site taken in August 2023 with older ones, it is apparent that more dust has accumulated over some of the panels, even in a considerably short period. It is almost unquestionable that the source of the dust on the rock art panels is the mine – especially the busy dirt road leading in and out of its premises. However, there may be other sources, such as foot traffic to the site. Multiple factors, including rainy weather, may lead, over time, to the dust solidifying and obscuring the images even more.

*Figure 12: Dust and graffiti on the panel of 9d, covering some of the images.*

Bird droppings cover some part of the rock face at 9d, but none of them cover any of the images. The panel at 9d is covered by dust, which appears to have solidified. There are algae on the floor of the panel, which is about a metre above ground level. To the right-most of the panel is a waterfall, which has now dried up, but possibly gets wet in rainy season.

There is graffiti on the top-right side of the shelter at 9d, and on the ceiling of 9c – the landowner confirmed on a previous visit to the site that he was aware of the markings, seemingly made by visitors to the site some years prior. When Maseko and his team recorded the site in 2018, these markings were already present, and so were they in

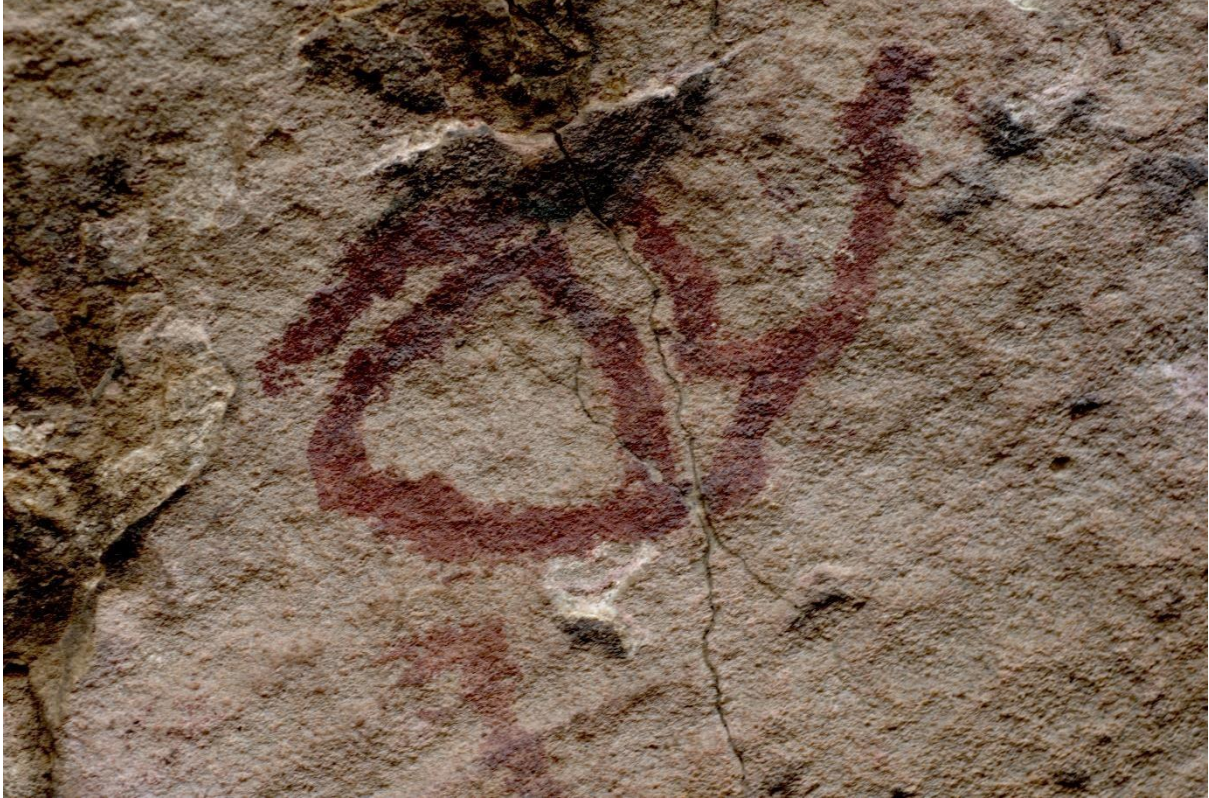
Multiple cracks on the rock surface were also observed at 9b, with many of them occurring where images are placed. More concerning here is a long vertical crack that runs across the whole panel. It is important to note here that, possibly in relation to the beliefs of the people who made the rock paintings, where images were intentionally placed on features of the rock such as cracks, hollows and depressions, this is usually discernible (such as at 9a; see Maseko 2020: 113-115). This may be one way of

*Figure 13: Cracks on the rock surface, affecting the painted images.*

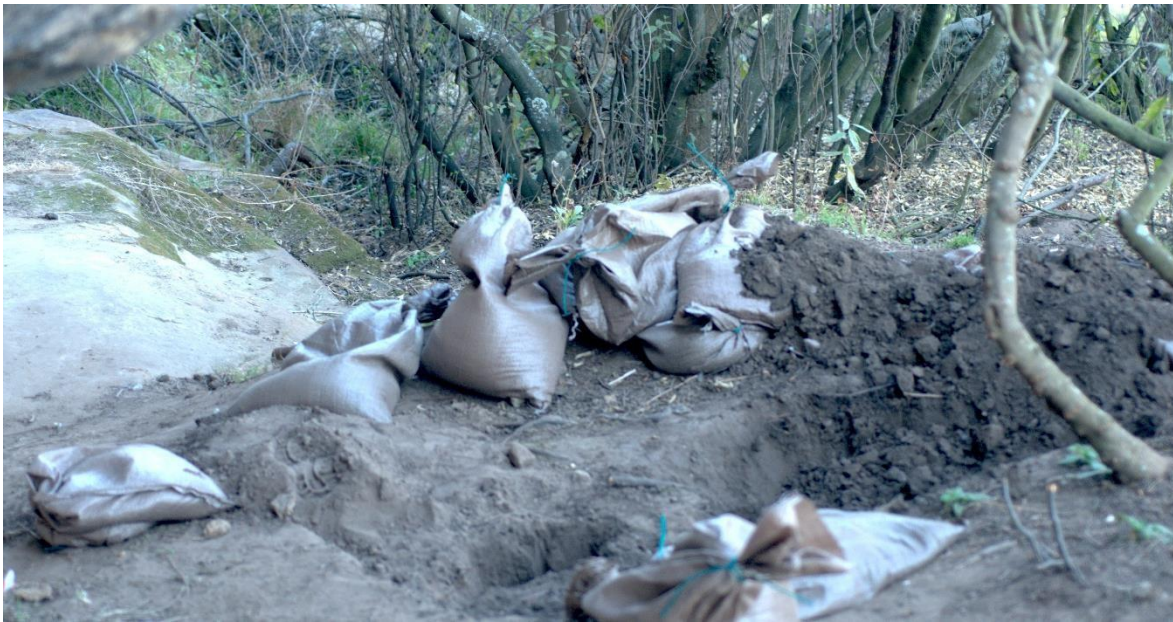
An open archaeological excavation was observed between 9c and 9d – excavated trenches were left uncovered by the sandbags and a pile of sand (possibly the spoil heap) next to it. On 27 August 2023, the landowner—Vincent Schulze—expressed concern that the excavated pit may have been disturbed by trespassers who were curious what the excavation team had been doing there in previous weeks.

*Figure 14: Possibly disturbed excavation or left without backfill.*

The potential impact of there being an excavation at the site should be considered as an additional factor that may lead to the accumulation of dust on the rock art panels. As such, it should be ensured that buckets are sieved away from the rock art panels, perhaps down at the nearby river. Excavated sections should be backfilled at the end of the excavation season.

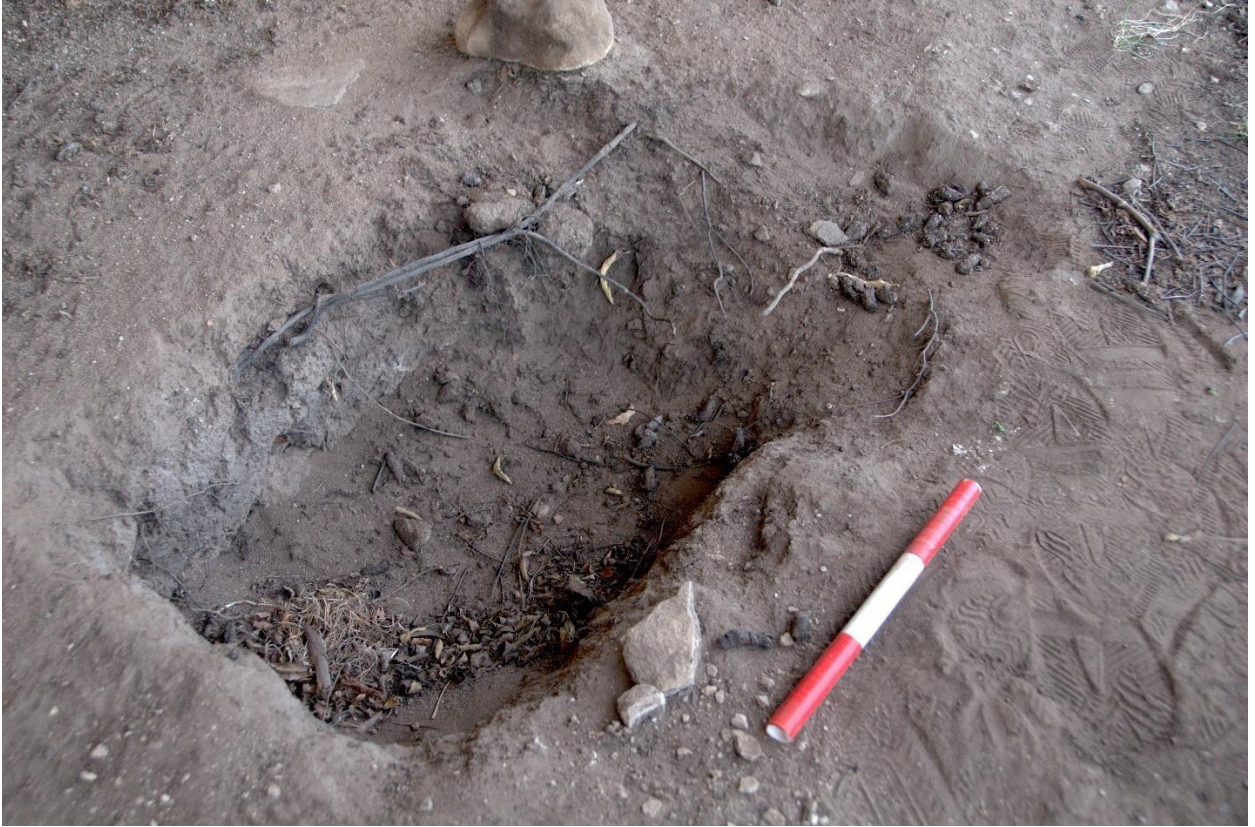
There is rectangular hole in the ground at 9a, in the middle of the panel, suggesting that a shovel-test excavation was done (see image in **Appendix 2**).

*Figure 18: Possible shovel-test excavation at Site 9a.*

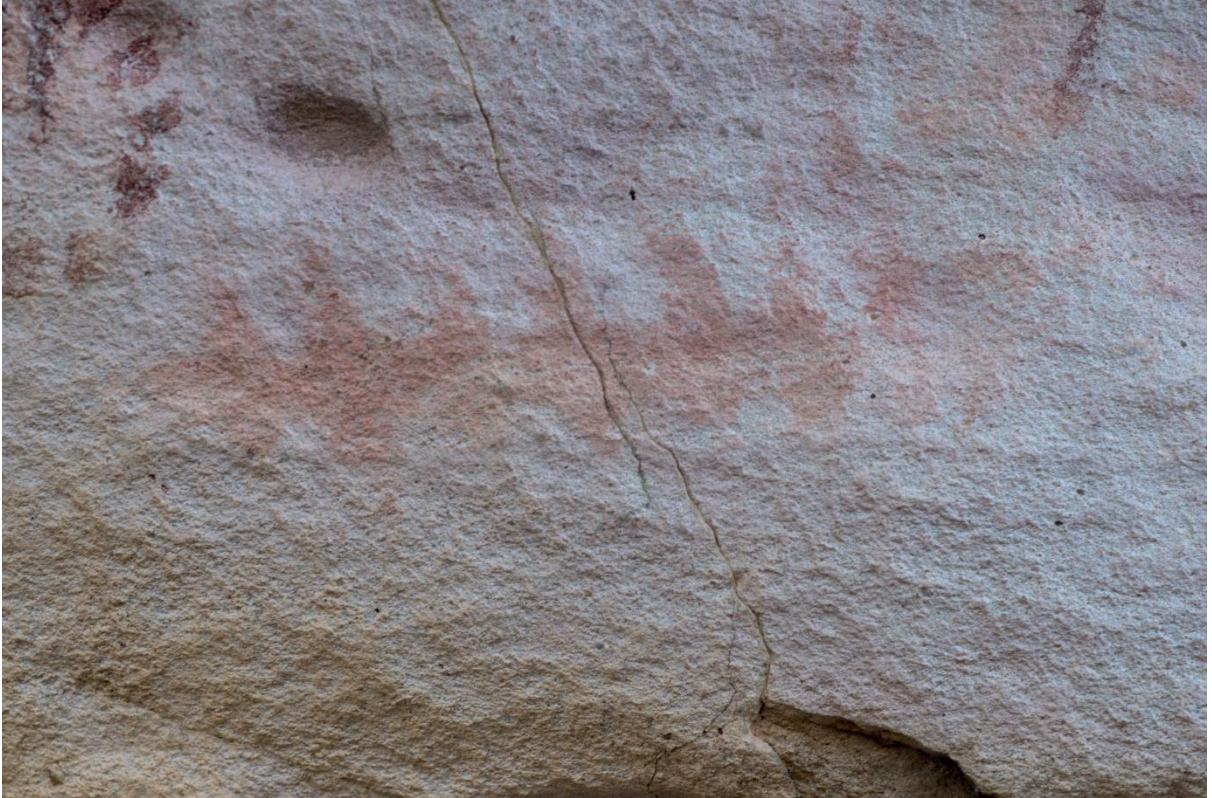
*Figure 24: Orange and dark red 'geometric', finger-painted images on a crack rock surface.*
