ROOM NO. SOUTH WING FOYER	ROOM NAME -	SCALE:	DRWG.No:
P.O.BOX 37188 OVERPORT DURBAN 4067 TELE : 2097245/6 FAX : 2097247 E-MAIL :seedat@ion.co.za AHMED.SEEDAT-ARCHITECT REG no :3140(S.A.C.A.P)	PROJECT: NATAL COMMAND -DILAPIDATION REPORT	1/50	21126
	DRAWING TITLE: ROOM AND OFFICE DATA SHEETS	DATE: DEC 2022	PAGE.No: 1

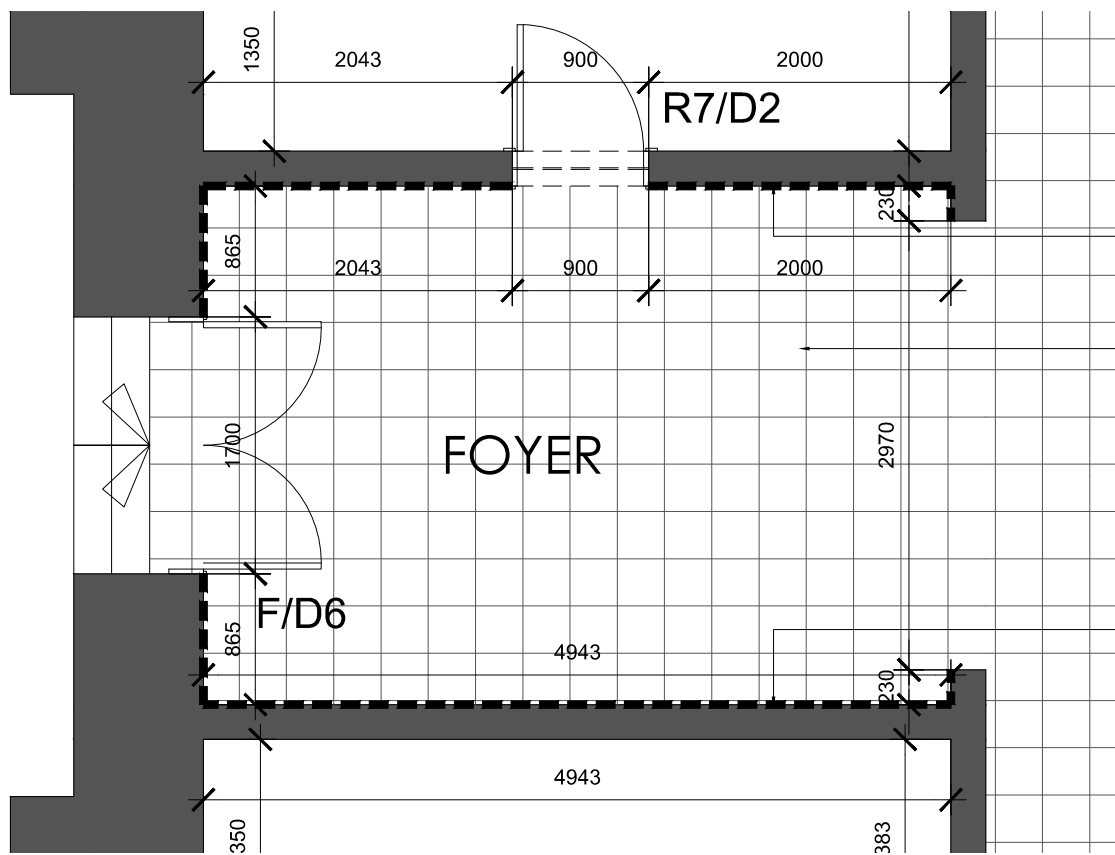
ex water damaged 1.4m high timber wall paneling to be removed and replaced with new to match ex.

ex. quarry floor tile to be pressure cleaned and sealed as per spec.

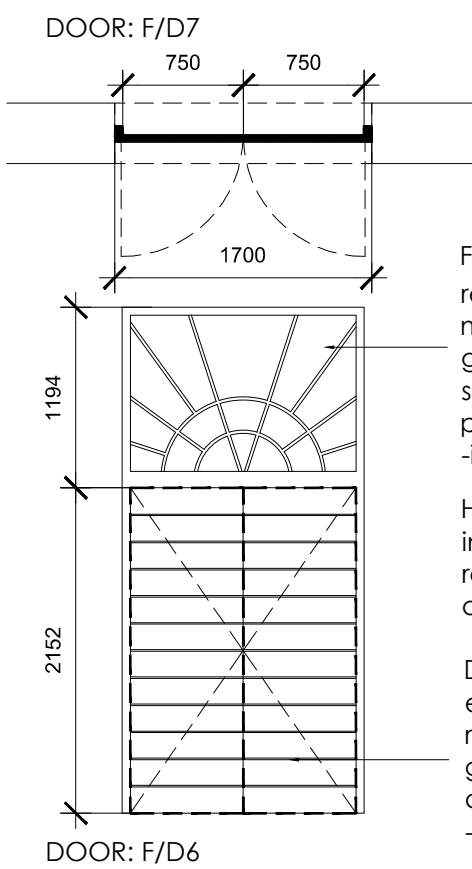
Fanlight:
repair damaged fanlight mullions replace missing glazing with 6mm toughened safety glass as per sans 10400 part N, -ironmongery as per spec.

Hinges: fanlight hinges to be inspected, serviced or replaced if required equally approved, as per schedule

Doors:
existing double door to be repaired and filled, Make good all imperfections sand and seal as per spec. -ironmongery as per spec.
