Ref: 8118/ub/grb/05.12.2018.

05 December 2018

**RE: INSPECTION OF TIMBER ROOF CONSTRUCTION OVER THE METHODIST  
CHURCH BUILDING AT MUSGRAVE ROAD, DURBAN.**

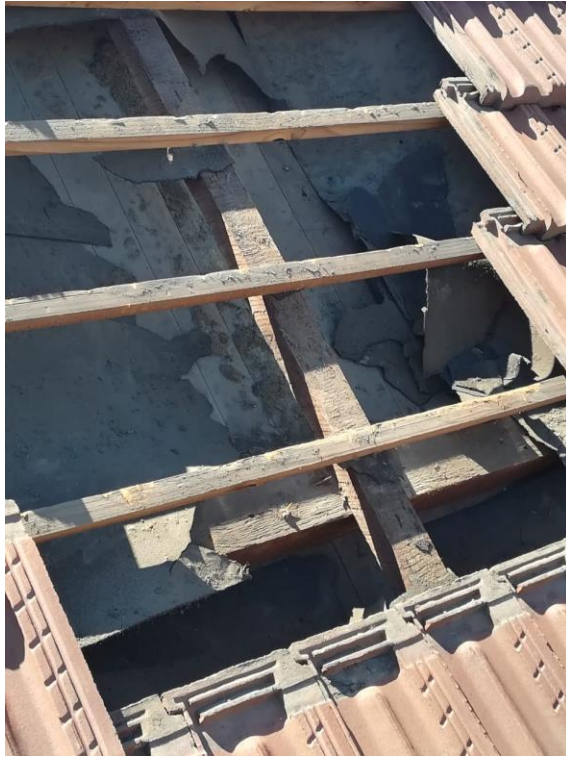
**Figure 1- PORTION OF EXPOSED ROOF**

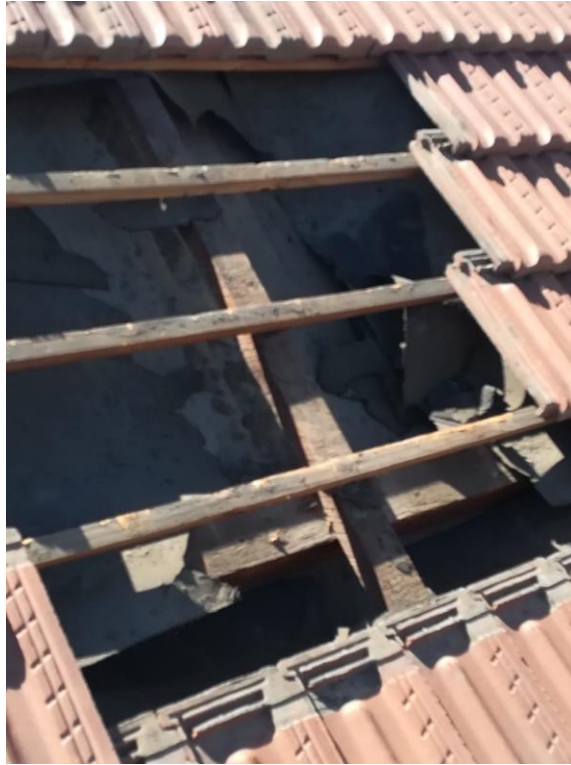
The 38mm x 38mm tiling battens have been damaged by rot and have become brittle. It was observed that there is significant vertical deflection of the weakened battens.

**Figure 2- DEFLECTING BATTENS**

All the existing secondary timber above the primary truss including the tongue and grooved boards must be replaced in their entirety.

The secondary timber must be replaced with treated SA Pine timber. It is recommended that the primary trusses also receive treatment in the form of a brush on insecticide like Timber-life's CTX108 or equivalent.

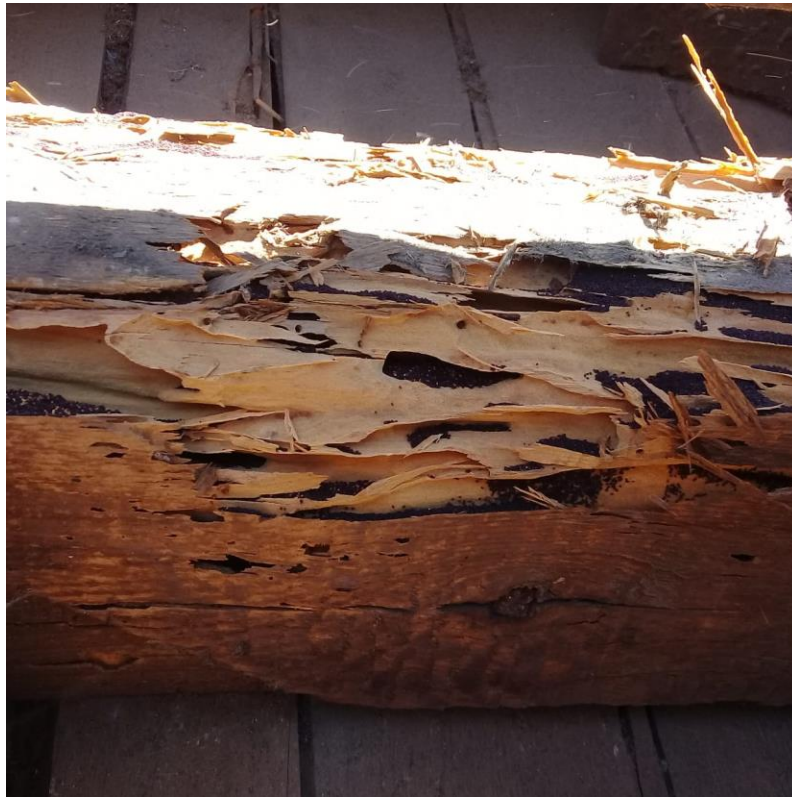
The 76mm x 38mm rafters and 90mm x 150mm bearers have been severely damaged by wood borer. In instances the damage is so severe that the timber disintegrates with the slightest hand pressure.

**Figure 3- WOOD BORER DAMAGE ON 90 x 150 BEARER**

Due to the fact that the original Oregon Pine is a stronger material than SA Pine. The replacement rafters and bearers will have to be slightly deeper and wider than the existing Oregon Pine timber sections. As a result of this the roof height will be raised by 108mm. The size of the new SA Pine Rafters will be 76mm x 76mm Grade S5 and the size of the new bearers will 76mm x 220mm grade S5.

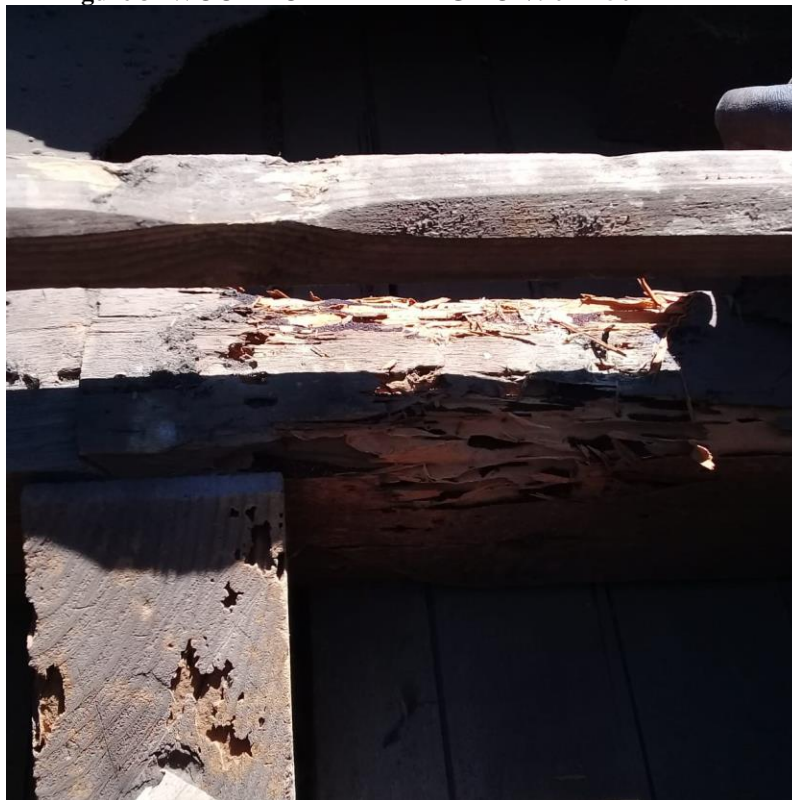
**Figure 4- WOOD BORER DAMAGE ON BEARER AND RAFTER**

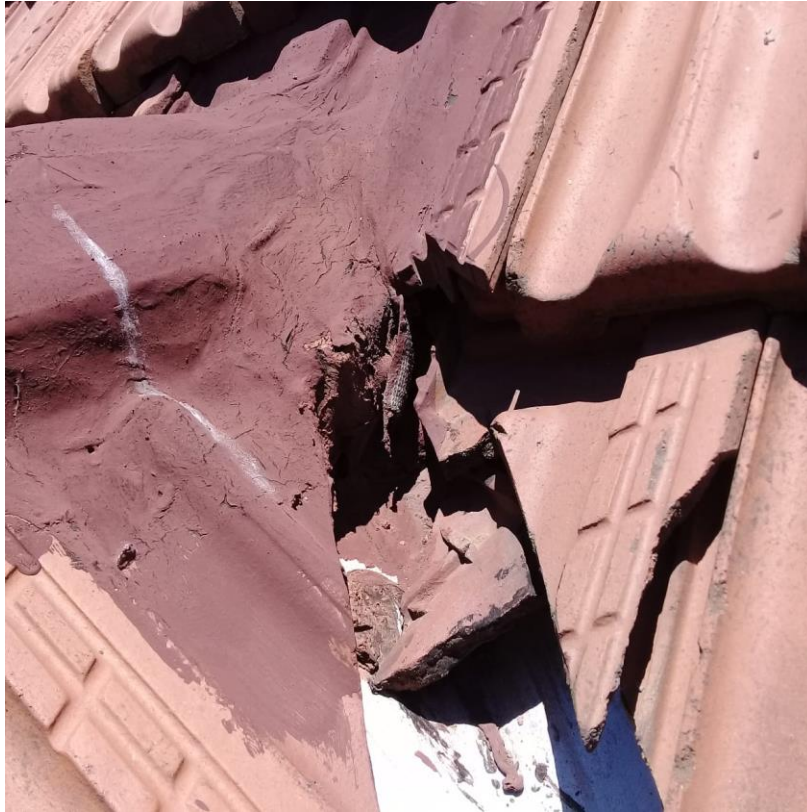
It was observed that an acrylic waterproofing membrane has been used at the valley intersections and the ridge tile closest to the parapets. It appears that there are some broken tiles beneath the membrane that could be a possible point for storm water ingress.

**Figure 5- BROKEN TILES ON VALLEY**

The valley linings and headwall flashing along the parapets must be refurbished when the remedial works are being carried out.
