HALL- NORTH WING

ROOM NAME -
PROJECT:
NATAL COMMAND -DILAPIDATION REPORT

DRAWING TITLE:
ROOM AND OFFICE DATA SHEETS

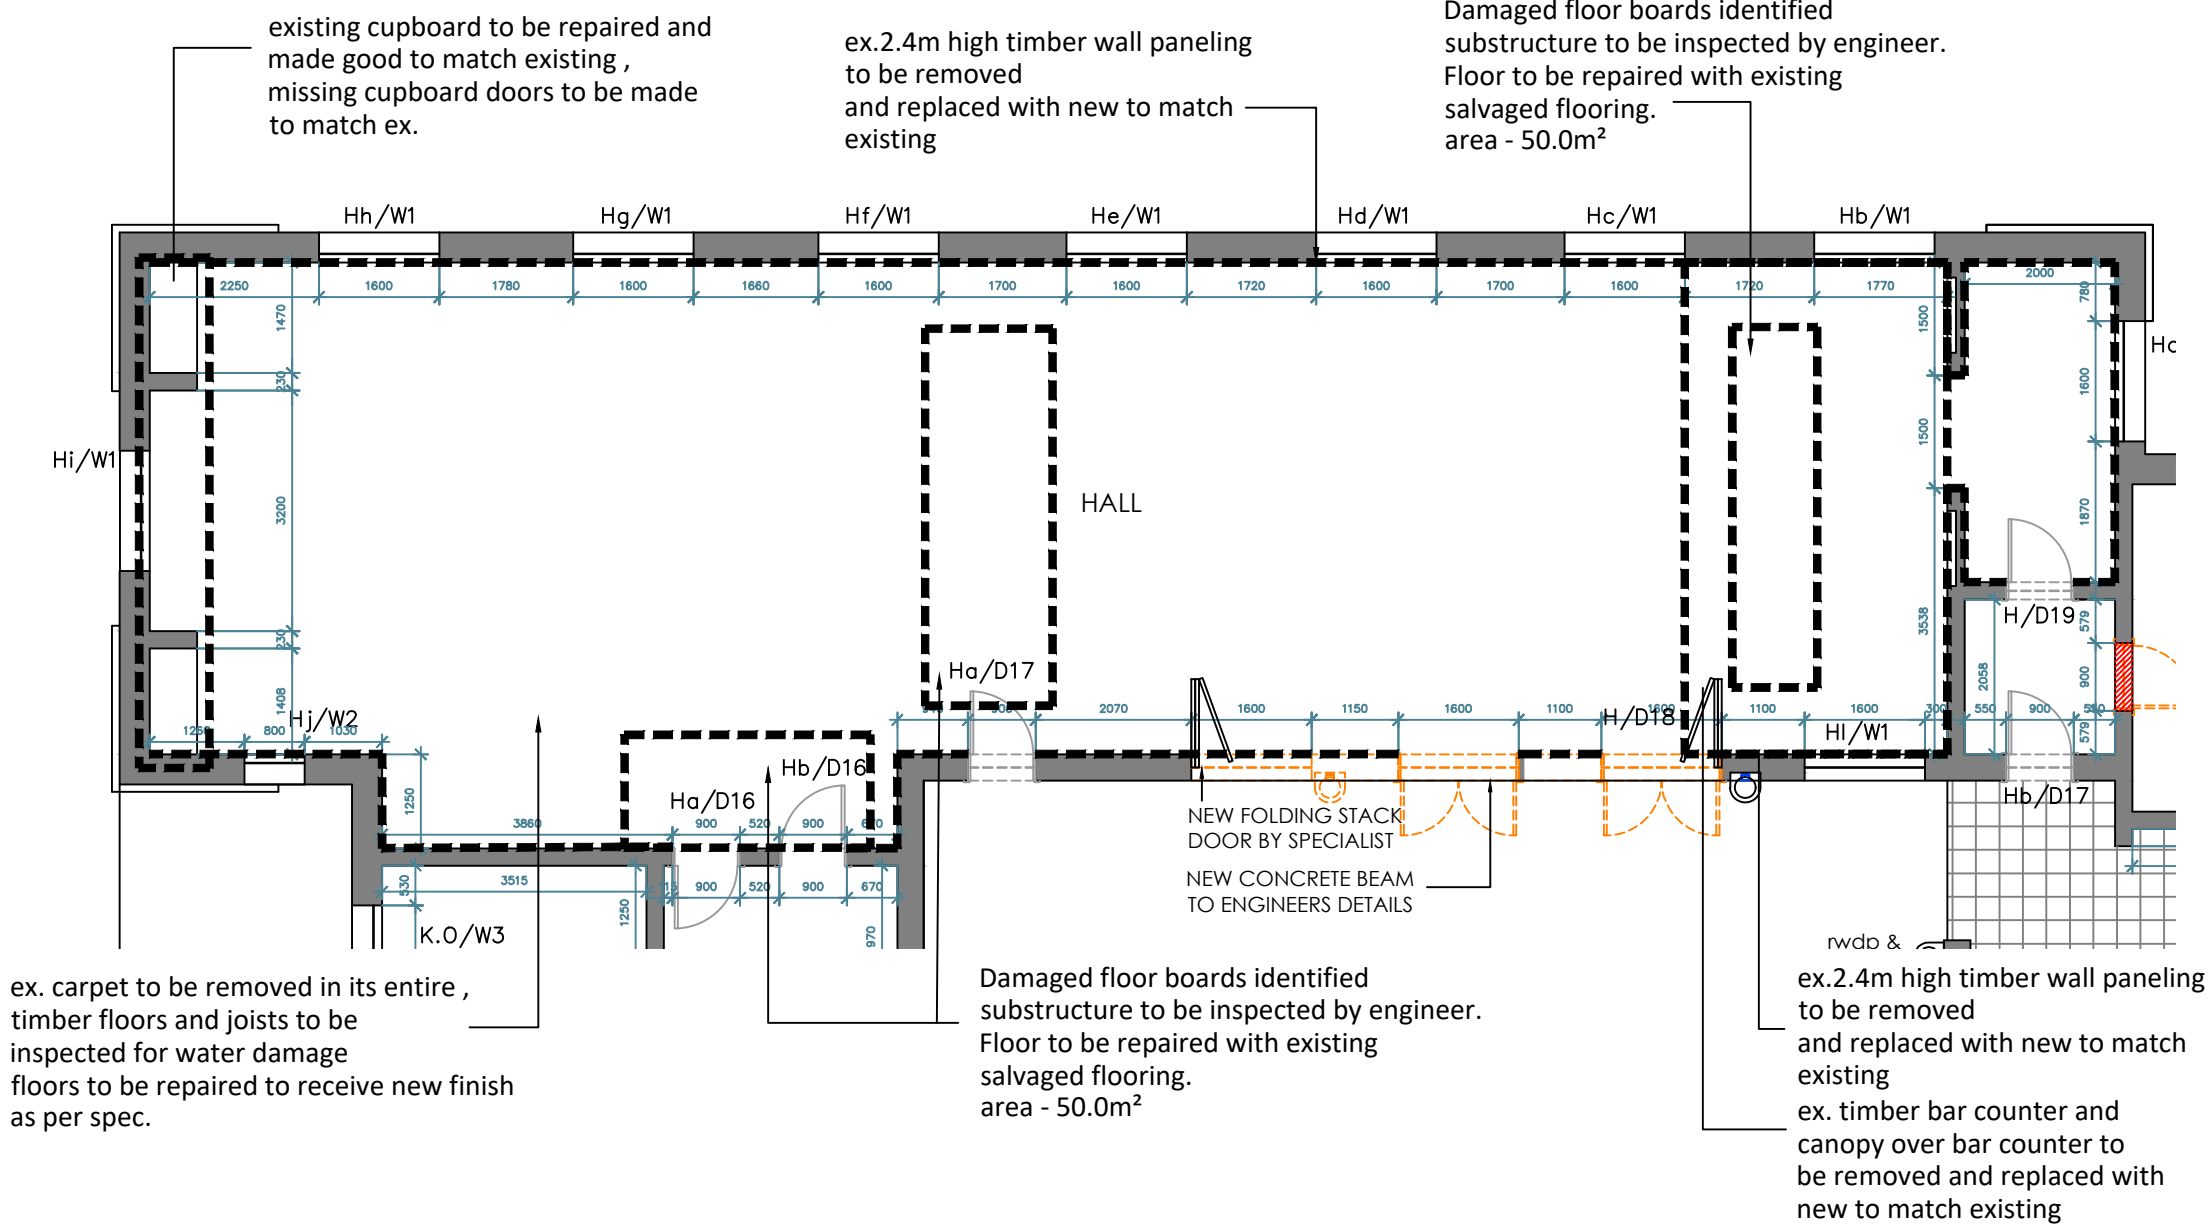
FLOOR FINISH	<ul style="list-style-type: none"> remove and repair damaged timber floor boards, inspect timber joist for wood rot repair if required as per engineers spec. - 50.0m² Floors: ex. timber floors to be sanded & made good to receive new floor finish as per specifications - 179.40m²
SKIRTING	<ul style="list-style-type: none"> Skirting: Ex. skirting to be inspected for wood rot & water damage. Replace damaged skirting with salvaged. Sand, repair & seal as per specification
WALL FINISH	<ul style="list-style-type: none"> Existing plaster & paint: <ul style="list-style-type: none"> - Walls to be scraped, treated, fill all imperfections. - Walls to receive new finish as per specifications Timber Wall Paneling: 2.4m high <ul style="list-style-type: none"> - All timber panels to be removed and replaced with new to match existing
DADO RAILS	<ul style="list-style-type: none"> Dado rail: Ex. dado rail to be inspected for wood rot & water damage. Replace damaged dado rails with salvaged. Sand, repair & seal as per specification.

CEILING	<ul style="list-style-type: none"> - scrape off existing flaking paint, treat and fill all imperfections to receive new finish as per spec.
WINDOW	<ul style="list-style-type: none"> Existing Timber Window Frames: <ul style="list-style-type: none"> - Timber window frames to be inspected for wood rot and water damage. - Affected mullions to be removed and replaces to match. - All damage and broken glass to be replaced with 6mm toughened safety glass as per sans 10400 Part N or equally approved my specialist - Window hinges to be replaced with brass type hinge and secured with brass screws as per schedule Window handles: <ul style="list-style-type: none"> Window handles to be replaced with brass type handles to match existing and fixed with brass screws as per schedule Windowsill: <ul style="list-style-type: none"> - Windowsill to be inspected for damage, and replaced were required - Affected sills to be removed and replaces to match.

DOOR	<ul style="list-style-type: none"> Timber door frames to be inspected for wood rot and water damage. door frames to be repaired with salvaged and made good to match ex. Doors: Refer to door detail
