# **DU TOIT FARMSTEAD**

Portion 7 of the farm Steenkoolspruit 18-IS, Mpumalanga Province.

**Architectural Historical Assessment**

**Issue Date:** 3 December 2012

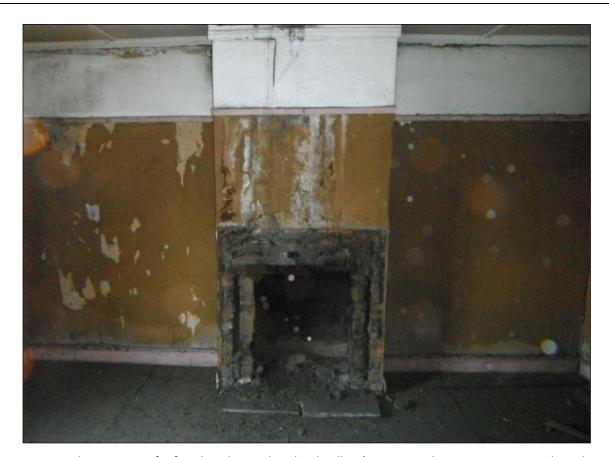
Figure 7 – The remains of a fireplace located in the dwelling's sitting or living room. It is evident that the fireplace was removed at an unknown time.

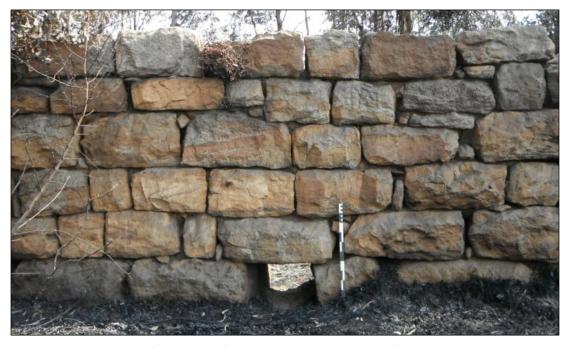
Figure 13 – General view of a section of the eastern wall with one of the drainage openings visible.

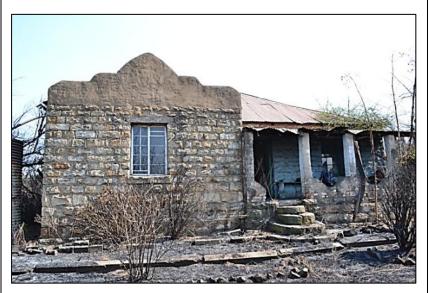
The building contains details but they tend to be unrefined such as the handling of the sandstone stairs in front of the main entrance, the lack of attention to quoining at the corners, around windows and doors and the manner in which the front gable has been executed.

Figure 14. The facade of the dwelling is the most exceptional feature of the building with its folk gable addition and later additions of plastered brick verandah columns.

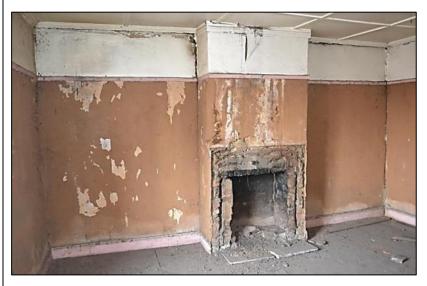
Figure 18. Remains of clay plastering in the principal lounge. The mantelpiece has been removed.

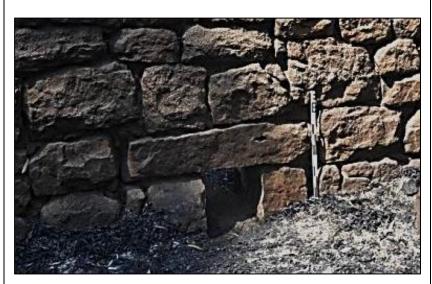
Figure 19. Water drain along the lower wall of the kraal with narrow stone lintel.

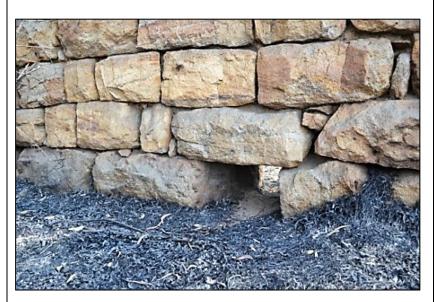
Figure 20. Water drain along the lower elevation wall with crude large stone lintel.

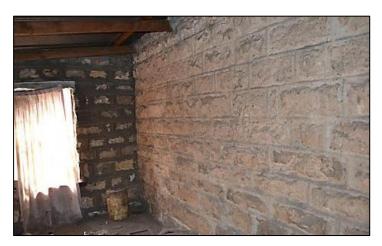
8.	Were the additions and extensions done in sympathy with the original design?	Rating
	Building 1: The dwelling was extended and added-onto several times with different degrees of success.	not sympathetic

Figure 21. Original back wall of the dwelling with later additions closing the back stoep that used to be an open space.

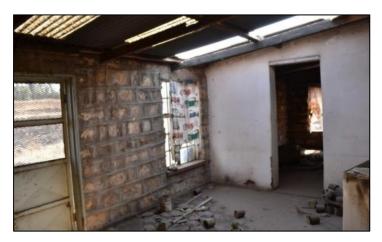
Figure 22. Closing of the open stoep at the back of the dwelling. The stoepkamer was closed with plastered brick walling.

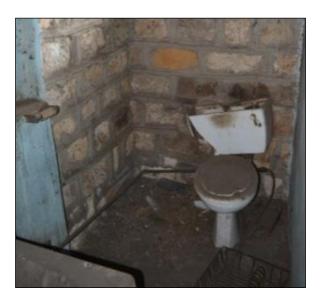
Figure 23. Crude addition and closing of the privy that was added on the back stoep of the original dwelling.
