HERITAGE STATEMENT: "GYM"

The document is supplementary to the application for a permit made by Robben Island Museum and the Department of Public Works to the South African Heritage Resources Agency in terms section 27 of the National Heritage Resources Act, 25 of 1999.

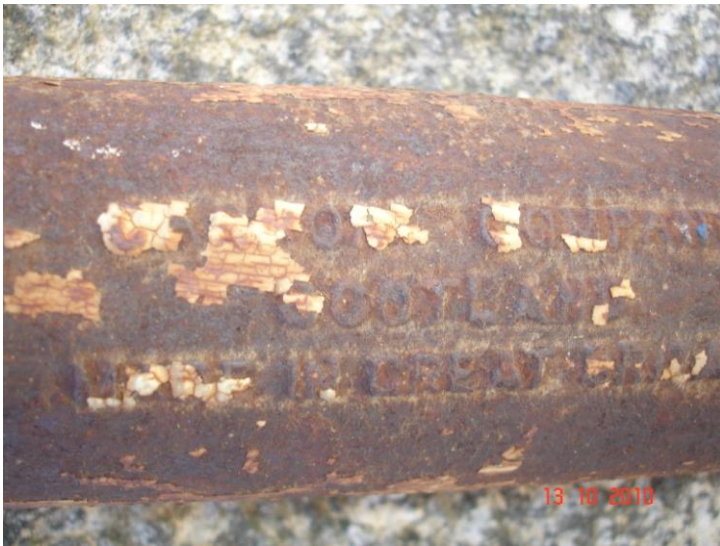
The cast iron guttering and down pipes are very significant. No other such feature is known of on the island at present. The northern face guttering and NW down pipe are in good condition. The name of the manufacturer is cast into the down pipes and is most visible on the NW side. The guttering is late Victorian in style and was cast by the Carron Company in Falkirk, Scotland. The company started casting iron in 1760 and was well known for its cast iron balustrades and baths towards the end of the 1800's. During WWII the company manufactured arms and ammunition. The exigencies of war saw iron and steel used for munitions and it is very unlikely that the gutters and downpipes were cast during WWII. Some earlier Victorian structures, notably a billiards and recreation building, existed on the site in 1894. The gutters and pipes may have been salvaged by the Union Defence Force when these structures were demolished during the war.

Detailing on cast iron down pipe: "CARRON COMPANY, SCOTLAND, MADE IN GREAT BRITAIN"

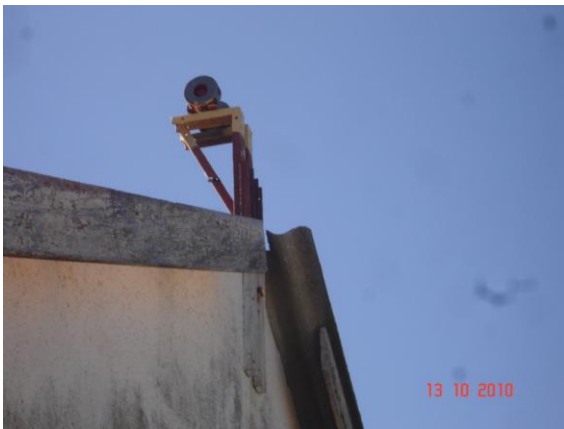
Siren

A siren perched on the Western side is also significant as it indicates the wartime use of the structure.

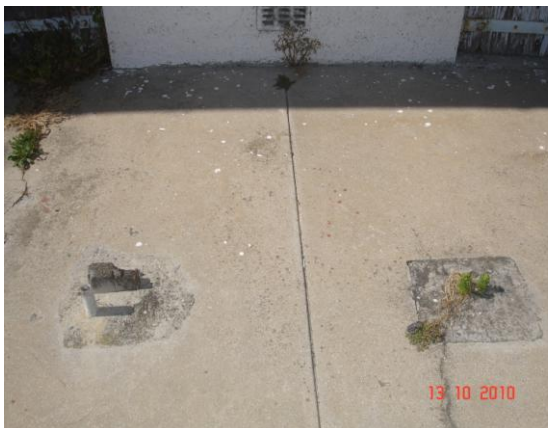
Situated to NW of residency next to school. Square building with 5 large wooden barn/ garage doors. Four of which have been blocked up from the inside, steep pitched asbestos roof. Cast iron guttering and downpipes still evident. Remains of newel posts on concrete ramp on northern side opposite each door approximately one meter from building.

Remains of verandah posts on the ramp front facade.
