**PROPOSED NEW KZN MUSEUM AT 94-96 JABU NDLOVU STREET,  
PIETERMARITZBURG, LOT 2822, BURGER STREET**

**ADDENDUM TO REPORT : VISUAL AND CONDITIONAL ASSESSMENT REPORT FOR  
SUBMISSION TO THE 'NATIONAL HERITAGE COUNCIL – SOUTH AFRICA' –  
STRUCTURAL INTERGITY OF THE EXISTING STRUCTURAL AND BUILDING  
ELEMENTS (Reference: MAP AFRICA Report : 200-405 Visual And Conditional Assessment Report  
For Submission To National Heritage Council-South Africa, Dated, 2021.05.31)**

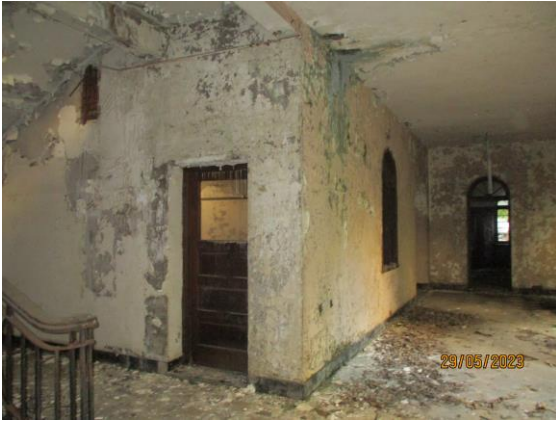
**Photo 1 : Showing internal moisture damage.**

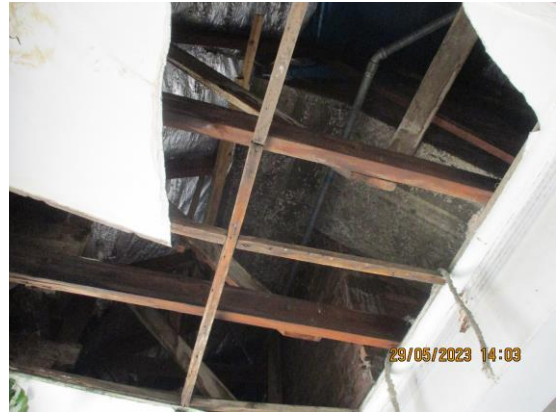
**Photo 2 : Showing moisture damage to timber roof trusses and ceilings.**

6. We strongly recommend that **ALL** structural timber (ie. timber roof trusses, suspended timber floors, timber staircases) and roof coverings be removed and discarded off site and new infrastructure be constructed as per Architect's specifications and details.

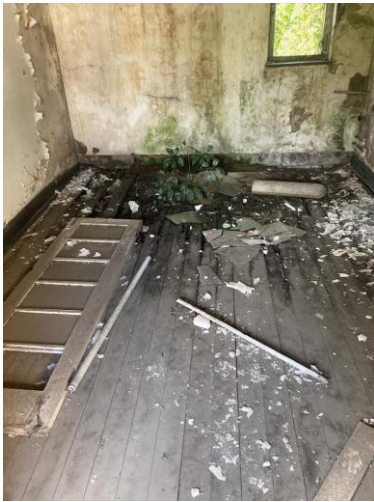
**Photo 3 : Showing severe moisture damage to suspended timber floors.**

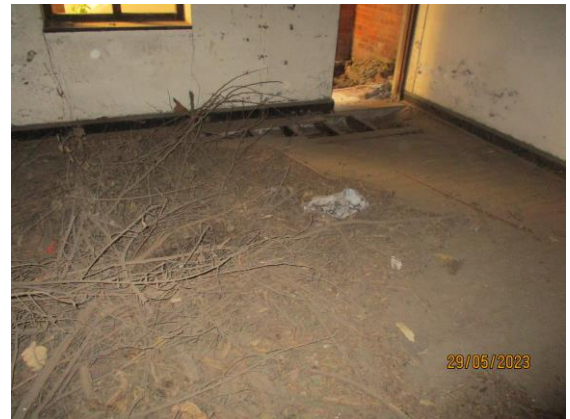
**Photo 4 : Showing internal vegetation growth.**

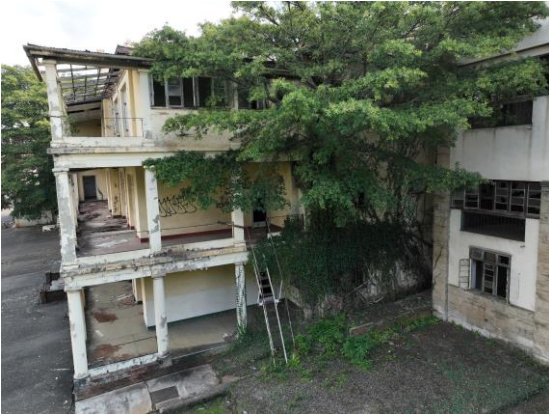
**Photo 5 : Showing major external vegetation growth.**

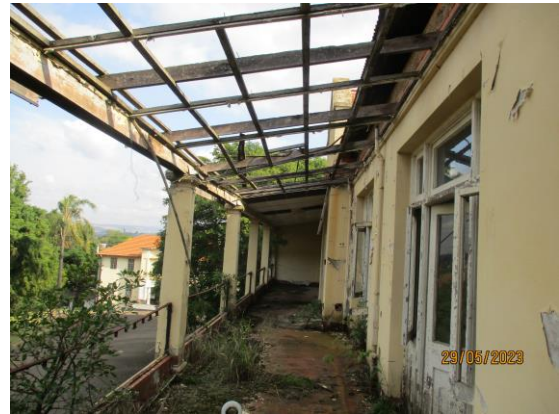
**Photo 6 : Showing severely damage timber roof structure.**

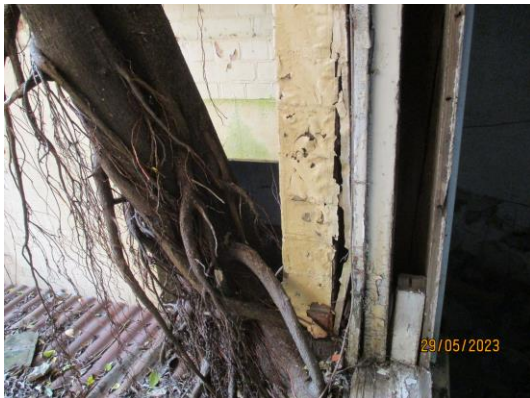
**Photo 7 : Showing major vegetation growth affecting brickwork.**

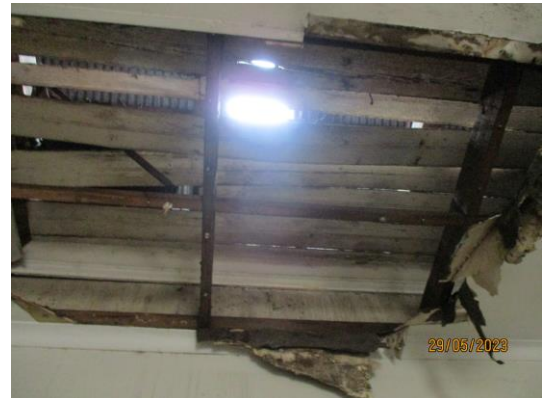
**Photo 8 : Showing damage to suspended timber floors as well as roof covering.**

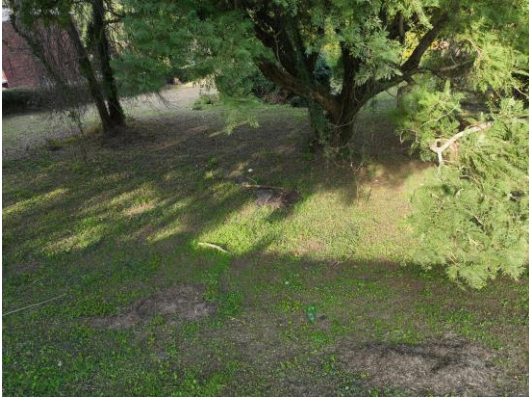
**Photo 9 : Showing overflow of sewer discharge at sewer manhole located at the bottom of earth bank.**

7. All external works are to be attended to under the Scope of Works detailed and designed by the Civil Engineer and Architect.
8. We trust that the above meets with your immediate requirements. Please do not hesitate to contact the writer or in his absence Mr. P. Narainsamy should you have any queries.

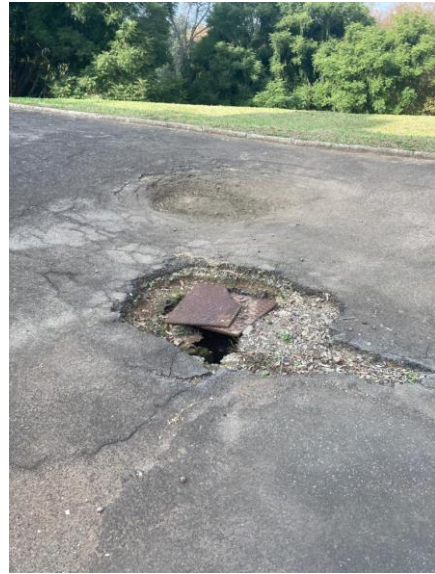
**Photo 10 : Showing extensive damage to asphalt + subbase material around existing manhole.**

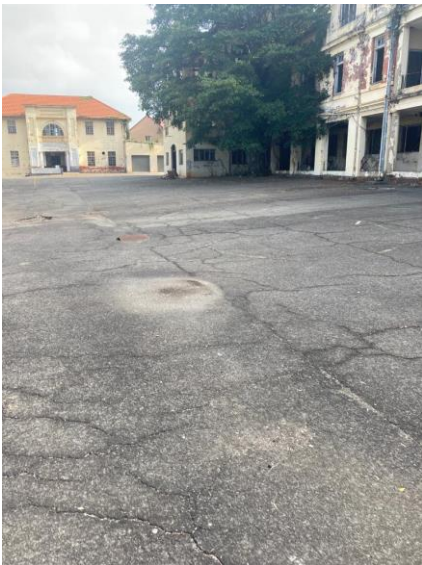
**Photo 11 : Showing deterioration and 'crocodile cracking' to asphalt surfacing.**

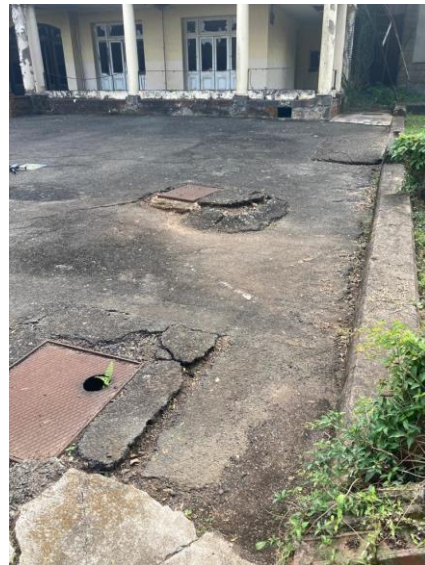
**Photo 12 : showing heave + settlement between manholes.**
