THE EXISTING OLD ST. ANNE'S HOSPITAL

VISUAL AND CONDITIONAL ASSESSMENT REPORT FOR SUBMISSION TO THE 'NATIONAL HERITAGE COUNCIL – SOUTH AFRICA'

STRUCTURAL INTEGRITY OF THE EXISTING STRUCTURAL AND BUILDING ELEMENTS

MAY 2021

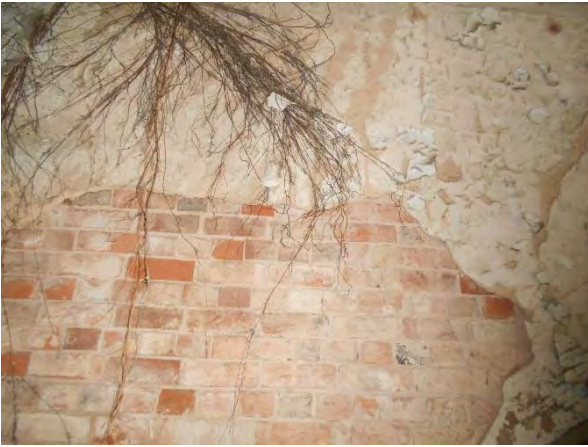
- 3.1.3 Severe delamination of plaster on the internal walls were noted – this is as a result of moisture ingress to the building.
- 3.1.4 Severe damage to the timber support structure for the suspended timber floor at first floor level was noted - this is as a result of constant moisture ingress to the building which has now compromised the structural stability of the timber support structure.

Photograph 1 : Showing severe delamination of plaster to internal walls.

- 4.3 All plaster and structural cracks must be repaired in accordance with the Structural Engineer's specification and details.
- 4.4 All moisture damage to existing elements must be investigated further and all repairs to be carried out in accordance with the Heritage Architect's and Structural Engineer's details.

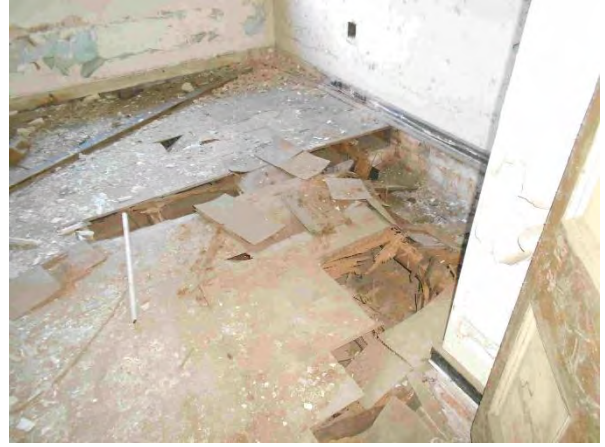
- 3.1.2 Severe damage to the internal timber suspended floors were noted – this is as a result of constant moisture ingress to the building which has now compromised the structural stability of the timber support structure.

Photograph 2 : Showing severe damage to existing suspended timber floors.

- 4.8 In our opinion, all suspended timber floors and staircases are structurally unstable and are to be demolished and replaced with new to Architects and Structural Engineers details and specifications. We recommend further investigation regarding the existing suspended timber floor slabs and foundations - a contractor must be appointed to expose floor coverings in order for the Structural Engineer to carry out further site investigations.

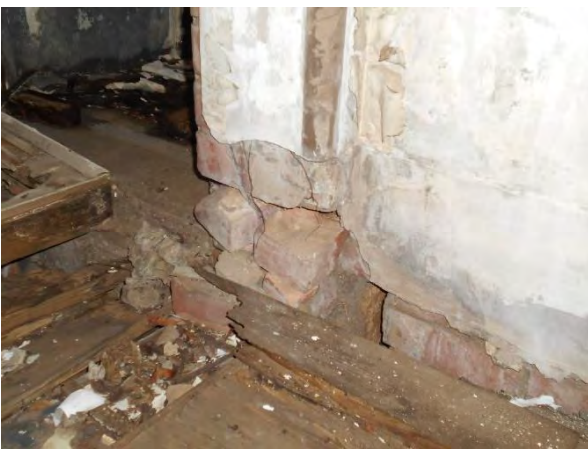
- 3.1.9 Damaged and loose brickwork below concrete column at first floor level was noted – this is as a result of the lack of maintenance to the building and deterioration of building elements.

Photograph 3 : Showing damaged and loose brickwork below existing concrete column at first floor level.

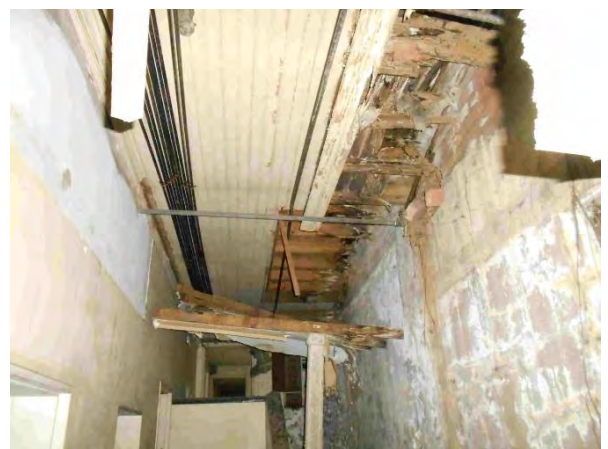
Photograph 4 : Showing severe damage to existing timber support structure at first floor level.

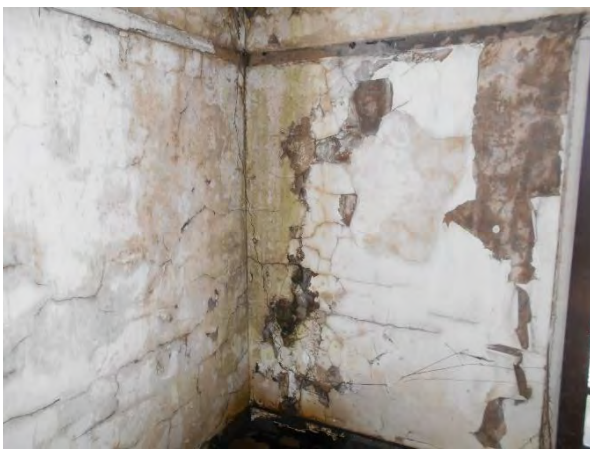
- 3.2.1 Severe moisture damage to the internal walls were noted - this is as a result of moisture ingress to the building.
- 3.2.2 Severe structural cracks to the internal walls were noted - this appears to be as a result of slight movement of the structural elements as well as the lack of maintenance to the building.

Photograph 5 : Showing severe moisture damage and cracks to the existing internal walls.

All cracked masonry walls must be repaired as per the attached brickwork / blockwork stitching repair details and specifications (Annexure B).

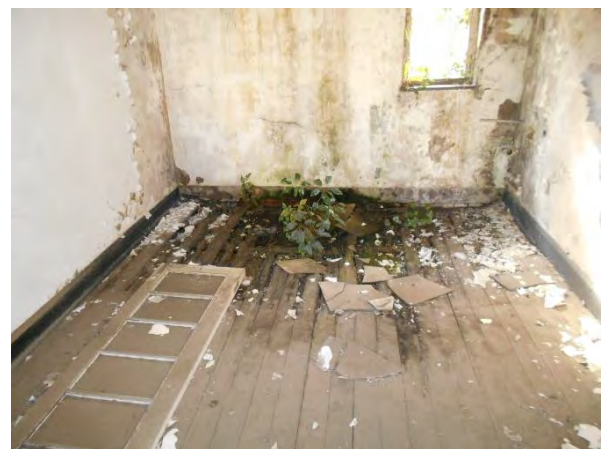
- 3.2.3 Severe moisture damage to the internal timber suspended floors were noted – this is as a result of constant moisture ingress to the building which has now compromised the structural stability of the timber support structure.

Photograph 6 : Showing severe moisture damage to the existing internal timber floors.

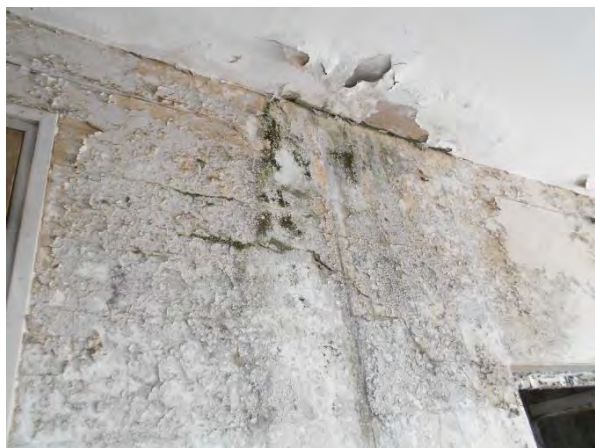
- 3.2.7 Severe moisture damage at the concrete slab and masonry wall interface above the balcony walkway at various locations were noted - this is as a result of constant moisture ingress to the building.

Photograph 7 : Showing severe moisture damage at the existing concrete slab and masonry wall interface.

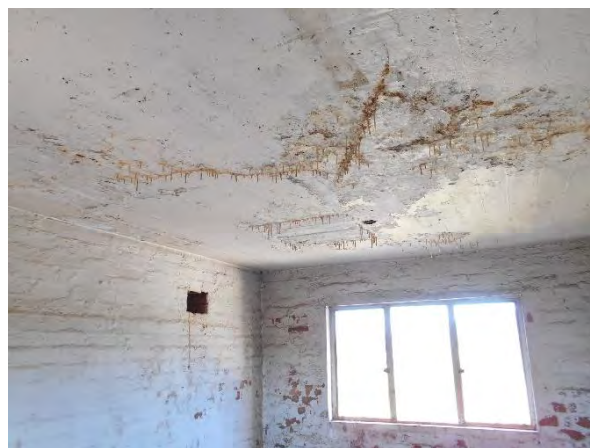
- 3.2.9 Severe ‘leaching’ of the suspended concrete slab within the existing mechanical lift shaft room was noted - this is as result of the constant moisture ingress through the existing deteriorated waterproofing membrane.

Photograph 8 : Showing severe 'leaching' of the existing concrete suspended slab in the mechanical lift shaft room.

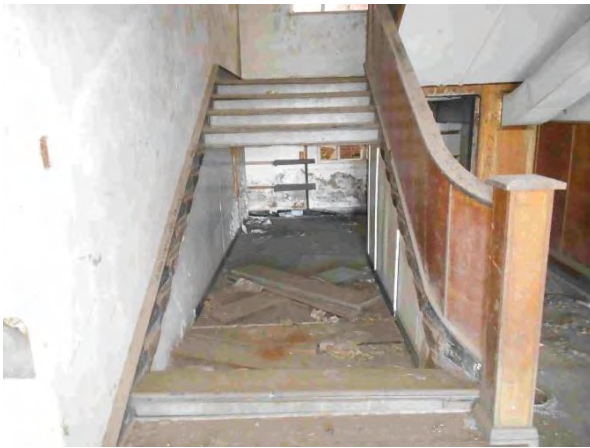
- 3.3.5 Collapse of the timber treads and first floor landing on the internal timber staircase was noted. - this is as a result of constant moisture ingress to the building which has now compromised the structural stability of the timber support structure.

Photograph 9 : Showing the collapsed treads of the internal timber staircase.

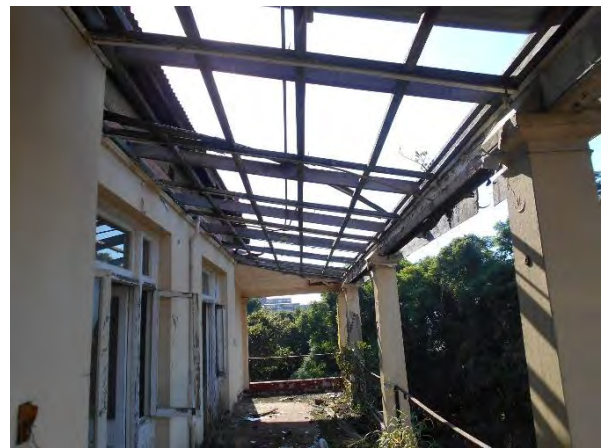
Photograph 10 : Showing severe damage to the existing timber balcony roof structure.

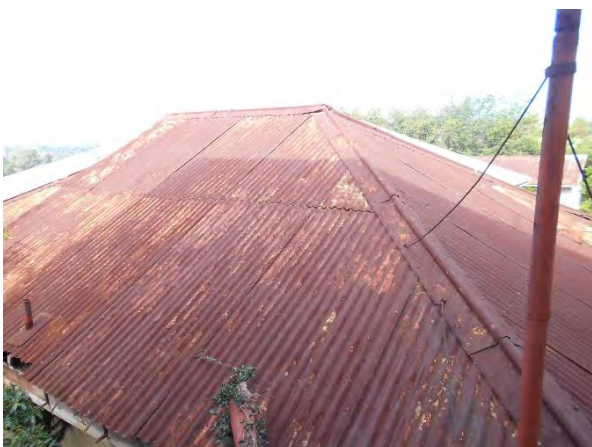
Photograph 11 : Showing the existing deteriorated and corroded metal roof

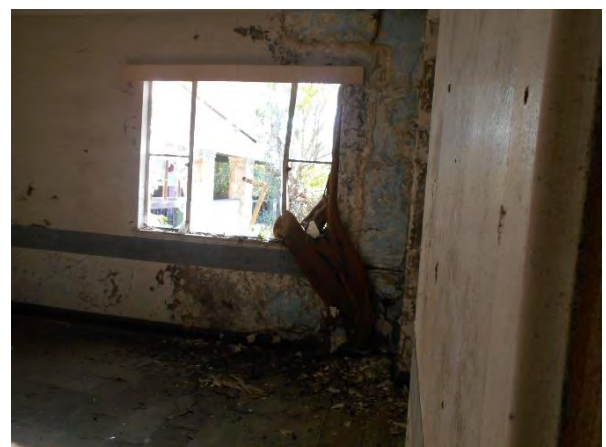
- 3.3.6 Severe vegetation growth internally and externally was noted – this is as a result of the lack of maintenance to the building.

Photograph 12 : Showing severe vegetation growth internal of the building.

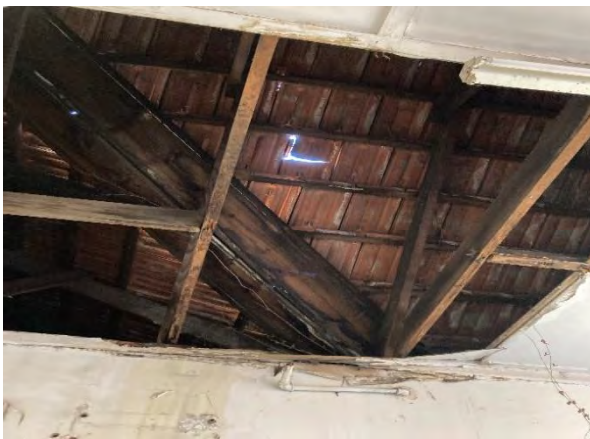
- 3.4.4 Damaged and displaced clay roof tiles were noted - this is as a result of movement of the building elements as well as the lack of maintenance to the building.

- 3.4.5 Moisture damage to timber roof elements were noted (i.e., timber valley gutter, roof trusses, etc) - this is as a result of the damaged clay roof tiles allowing constant moisture ingress to the roof area.

Photograph 13 : Showing damaged and displaced roof tiles as well as moisture damaged timber roof elements.

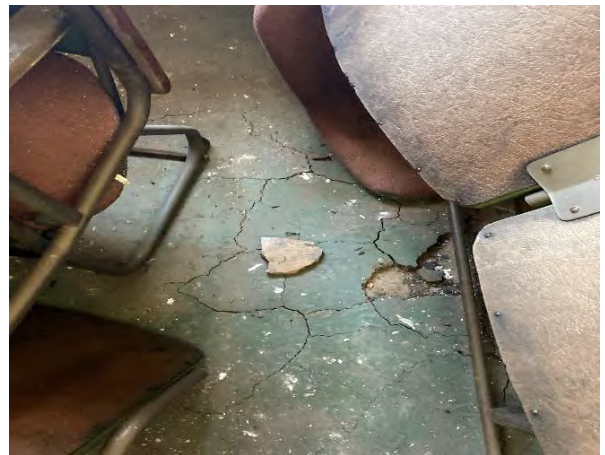
- 3.4.3 Severe deterioration of the screed on the suspended concrete floors was noted - this is as a result of movement of the structural elements as well as the lack of maintenance to the building.

Photograph 14 : Showing severe damage to the existing screed on the suspended concrete slab.

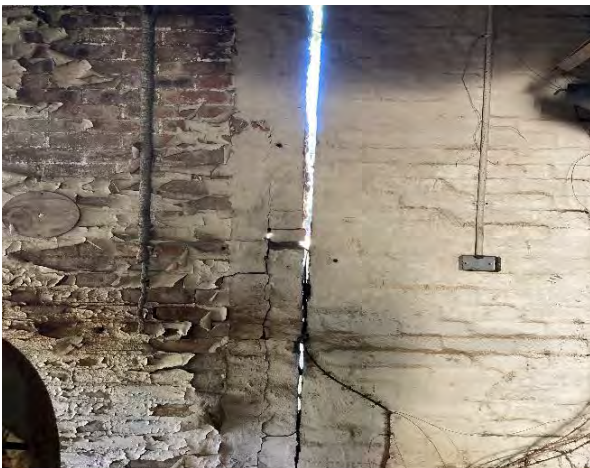
- 3.4.6 Severe separation of the existing construction joint on external walls was noted – appears to be at the interface of the building extension - this is as a result of settlement of the building.
- 3.4.7 Structural cracks on the internal face of the existing walls in various locations were noted - this is as a result of slight movement of the building elements as well as the lack of maintenance to the building
- 3.4.8 Delamination of the existing external plaster in various locations were noted – this as a result of moisture ingress beneath damaged plaster.
- 3.4.9 Corroded roof sheets were noted – this is as a result of the deterioration of building materials as well as the lack of maintenance.
- 3.4.10 Moisture damage to the existing timber roof structure was noted - this is as a result of the damaged metal roof sheeting allowing constant moisture ingress to the roof area.

Photograph 15 : Showing separation of walls at the construction joint.

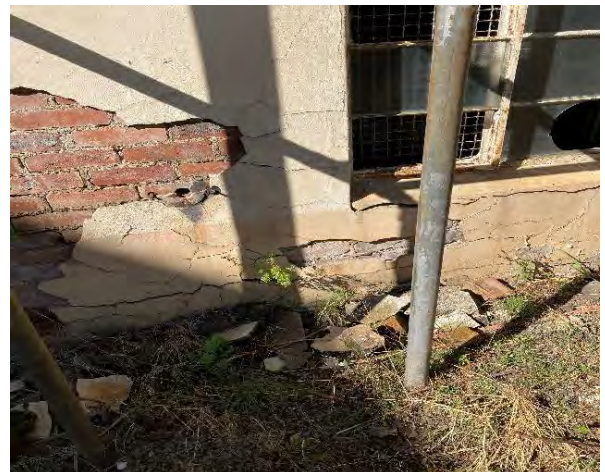
Photograph 16 : Showing delamination of the existing external plaster.

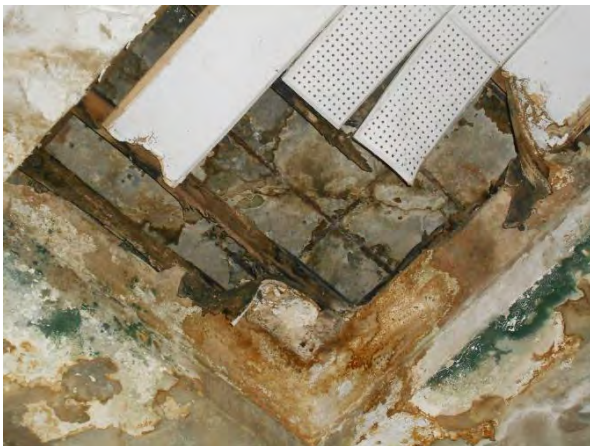
- 3.5.1 Severe spalling to the existing suspended concrete slab in various areas were noted - this is as a result of constant moisture ingress into the concrete slab as well as the lack of maintenance to the building.

Photograph 17 : Showing severe spalling to the existing suspended concrete slab.

- 4.5 All new waterproofing to be carried out in accordance with the Architect and Structural Engineer's specification and details.
- 4.6 The repairs to concrete elements must be carried in accordance with Structural Engineer's specifications and details.

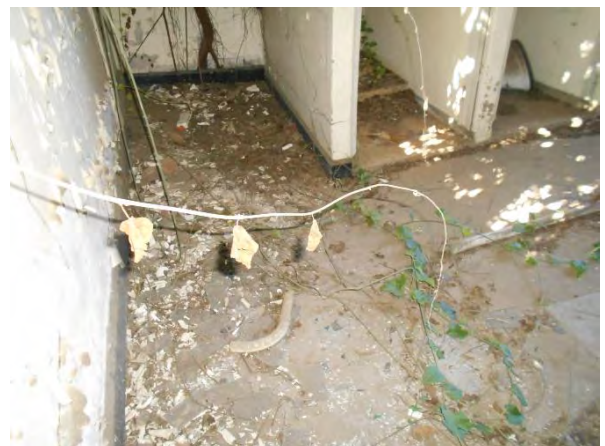
- 3.5.4 Severe vegetation growth internally and externally was noted - this is as a result of the lack of maintenance to the building.
- 3.5.5 Severe settlement of the existing surface bed within the chapel ablution was noted – this is as a result of movement of the building materials as well as lack of maintenance

Photograph 18 : Showing severe settlement of the existing surface bed slab in the ablutions.

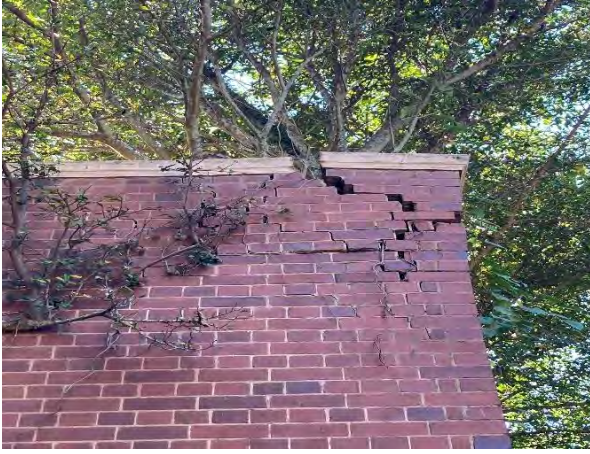
- 3.5.6 Severe structural damage to the existing parapet walls at various locations were noted – this is as a result of the lack of maintenance of the vegetation growth.

Photograph 19 : Showing severe structural damage to the existing parapet wall.

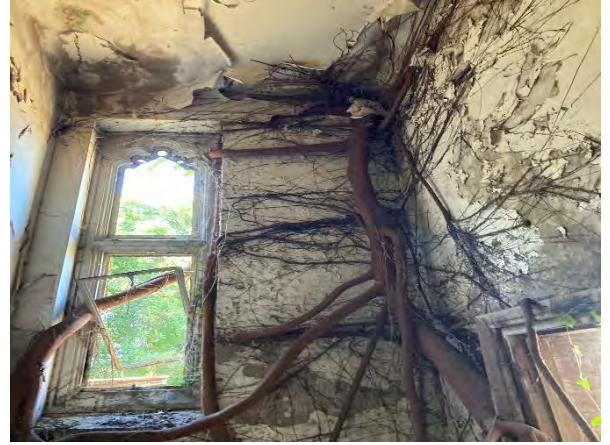
Photograph 20 : Showing severe vegetation growth internal of the building.

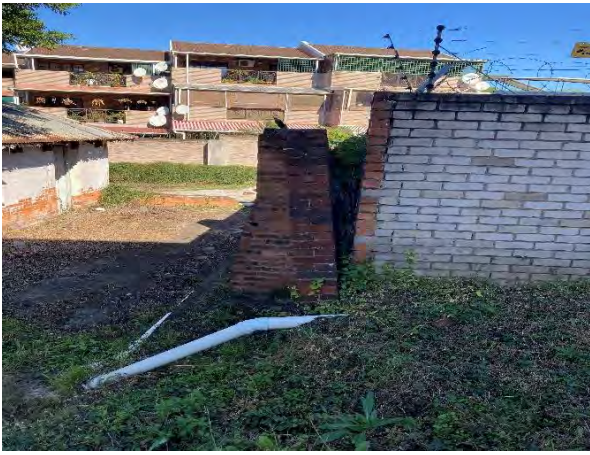
- 3.6.1 Leaning / rotating of the existing masonry boundary wall South West facing was noted.
- 3.6.2 Settlement cracks on the existing access ramp located within the vicinity of Block G was noted.
- 3.6.3 Damaged and silted 'cut-off' drain at the main entrance driveway was noted.
- 3.6.4 Damaged / missing rain water goods were noted on all buildings.
- 3.6.5 Silted stormwater gully's were noted around the buildings.
- 3.6.6 Severely damaged premix around existing manholes in various locations were noted.
- 3.6.7 Severe 'crocodile cracking' of the existing premix layer in various locations were noted.
- 3.6.8 Settlement of the existing premix in various locations were noted.
- 3.6.9 Severe dense vegetation growth in various locations of the existing precinct was noted.

The above defects and damages to the existing external works are as a result of the lack of maintenance as well as deterioration and dilapidation of the existing building materials.

Photograph 21 : Showing the existing masonry boundary wall leaning / rotating.

- 4.11 We recommend that a Civil Engineer be appointed to investigate and further assess the existing status and functionality of the existing external works.

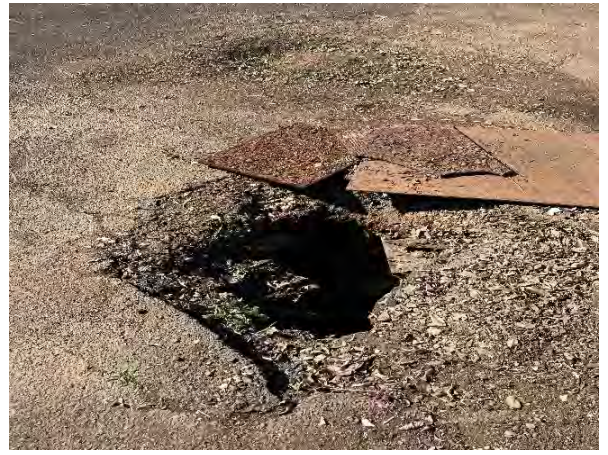
Photograph 22 : Showing severe damage to the premix and sub base layers around existing manholes.

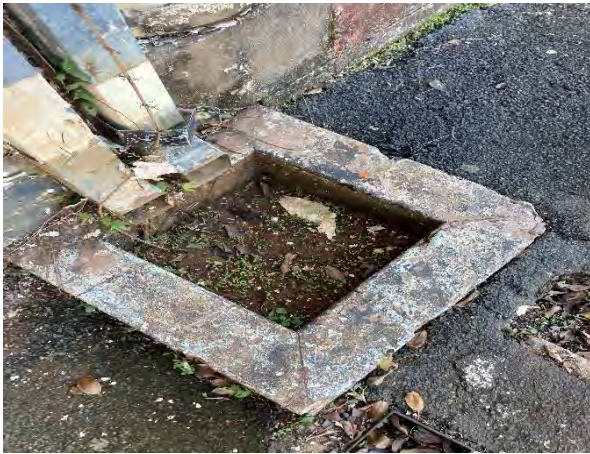
Photograph 23 : Showing existing silted stormwater gully.

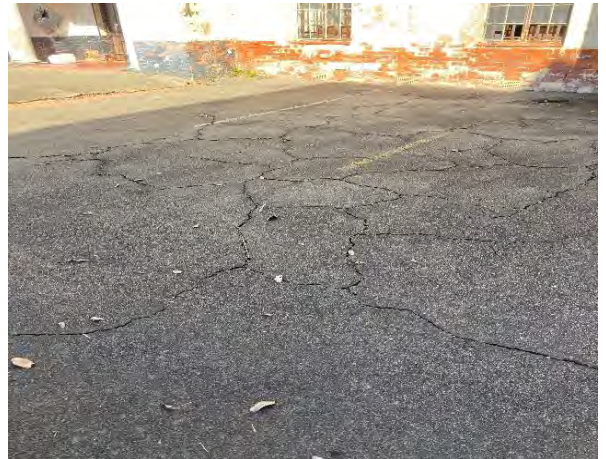
Photograph 24 : Showing severe 'crocodile cracking' of the existing premix layer.
