**UNIVERSITY OF THE WESTERN CAPE/ROBBEN ISLAND MUSEUM
AFRICAN PROGRAMME IN MUSEUM AND HERITAGE STUDIES 3013
HERITAGE MANAGEMENT-SITES**

MANAGEMENT PLAN FOR THE LEPER'S GRAVEYARD AT ROBBEN ISLAND

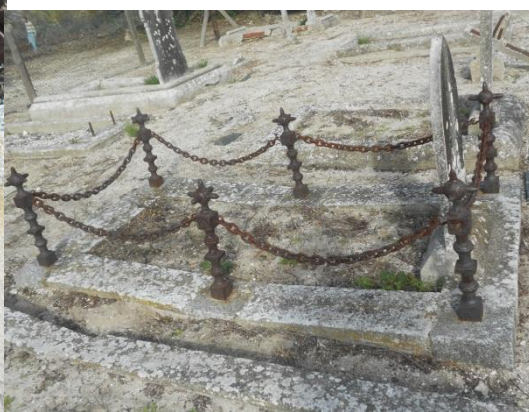
General view of a few graves

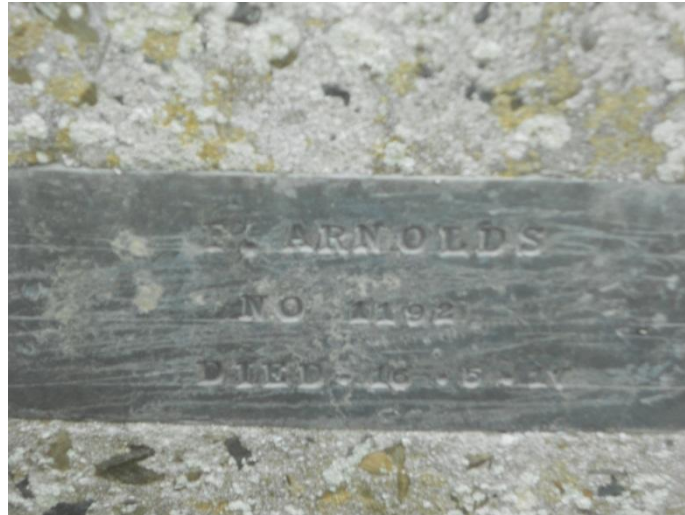
The deceased's details written on copper plates, attached to a concrete base

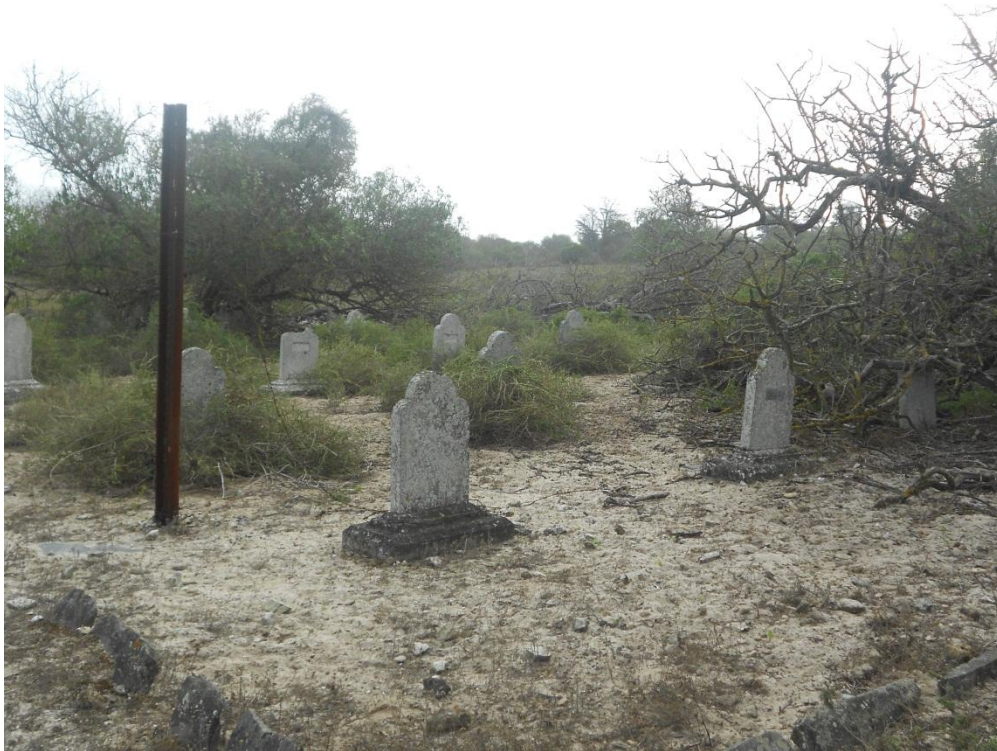
Vegetation. High risk-Alien vegetation has overgrown a large portion of the site. The risk from the growth of vegetation is very high. Inside the fenced area, there is a glasslike plant that has overgrown a large section of the North-west corner, while a number of graves show evidence of vegetation inside the plinth. However, the biggest risk caused by vegetation is on the graves outside the fenced area on all

sides except the eastern side. Here huge trees have overgrown the area. In many places, dense and thick shrubs have completely covered the graves. Some big trees were seen to be falling on some graves. The damage to the graves caused by tree trunks is massive. In many areas, the trunks have totally uprooted the graves. The biggest danger is that where there is dense vegetation some graves maybe be lost.

graves overgrown by vegetation

Management- The problem of alien vegetation at the leper graveyard needs to be addressed as a matter of urgency

- III. Another project should be initiated to restore graves that have been disturbed by vegetation and to record graves that were hidden by vegetation.

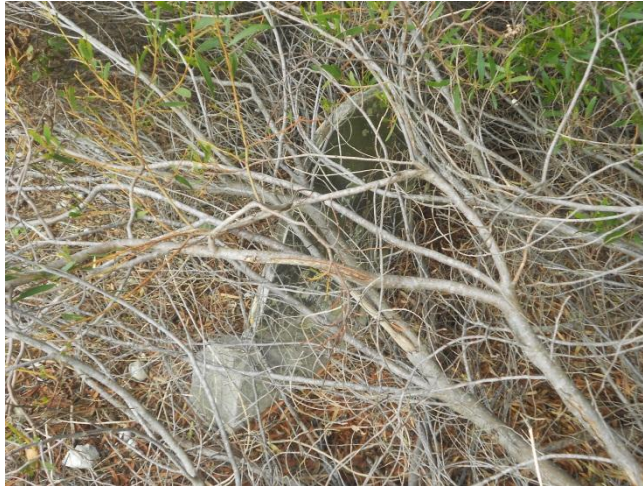
grave totally

overgrown with vegetation

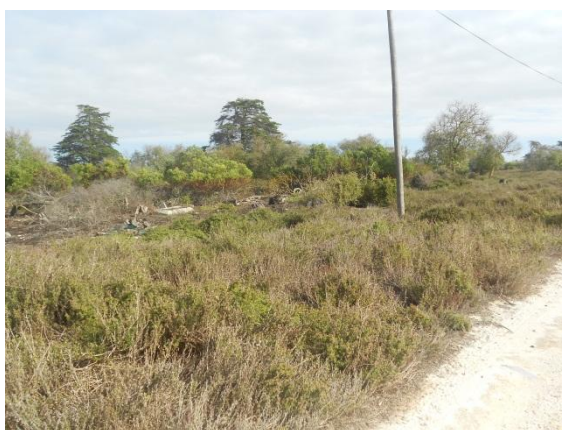
1. **Risk due to Developments -Medium to High risk-**the developments such as the construction of the road on the Northern part of the graveyard and the maximum security prison were done too close to the graveyards. Some graves were observed just a few centimetres from the road on the Northern part of the graveyard. These developments put the site at risk of extinction

Developments pose a risk to the graveyard. Here electricity poles built right in the middle of graves. Note the closeness of the road to the graves

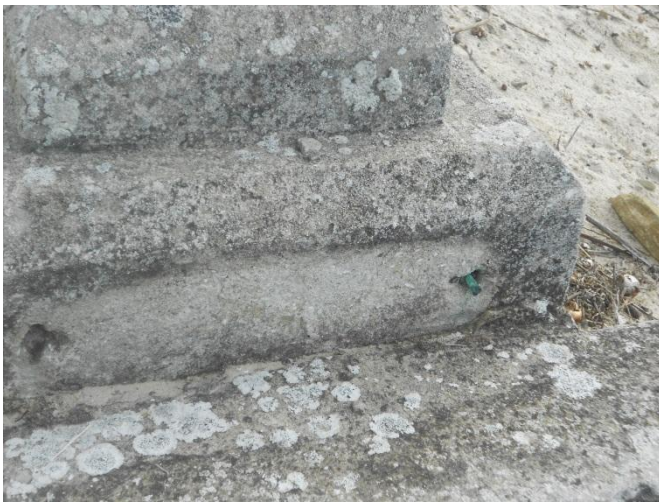
2. Theft of copper plates covering the bases-Medium to high risk. In a significant number of instances, the surveyor observed that some copper plates covering the concrete bases were missing. All factors indicate that the copper was stolen. A larger number of bases still have the copper plates intact but these are at risk of been stolen.

Place showing were the copper plate should have been

Management- increase security or even routine patrols on the site.

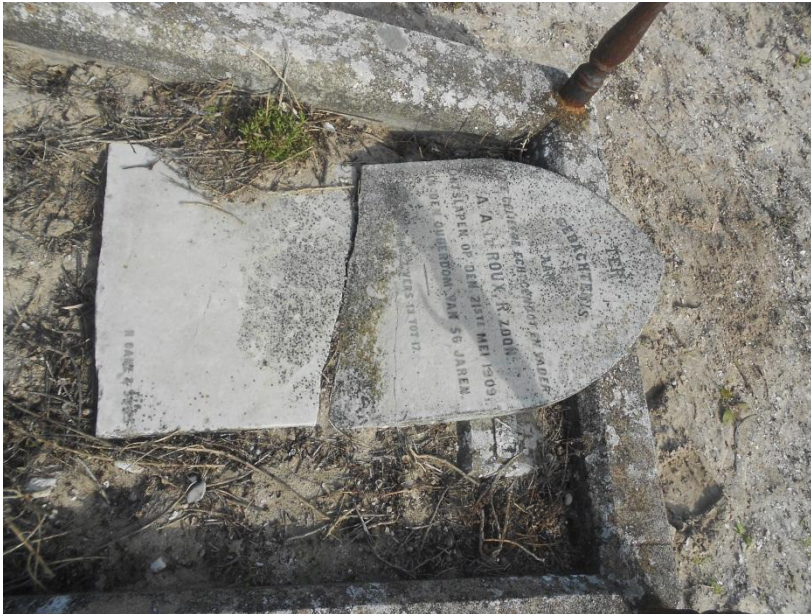
3. Risk As a result of natural factors- As reflected in the table on description, most of the graves were constructed before 1920. Due to weathering, some of the components of the graves e.g. plinths, headstones and bases have broken. This poses a threat to the continued existence of the graves.

Broken marble headstone

Management-The most important aspect of managing this risk is to restore the ones that are already broken using the *minimalist approach*. For example the broken pieces could be recast in concrete similar to the original.

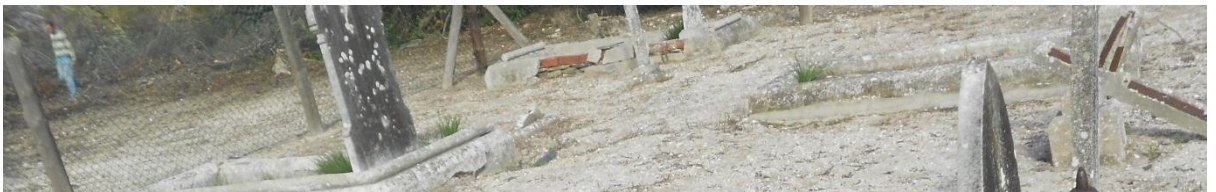
Broken Cross Headstone far right and top left broken plinth with red burnt pan bricks inside

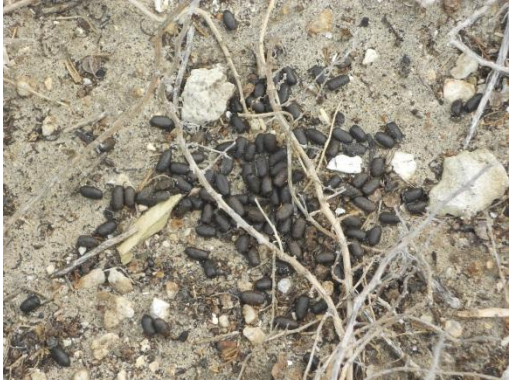
- 4. Animals**-evidence was seen that animals frequent the graveyards. In the fenced area evidence of this was seen through the animal droppings below. At present this does not seem to be a pressing problem, however, if the animals colonise the site it will be a bigger problem.

Animal droppings

Management-identify factors on the site that attract animals and remove them, e.g. vegetation which animals may want to eat, possible breeding grounds etc.

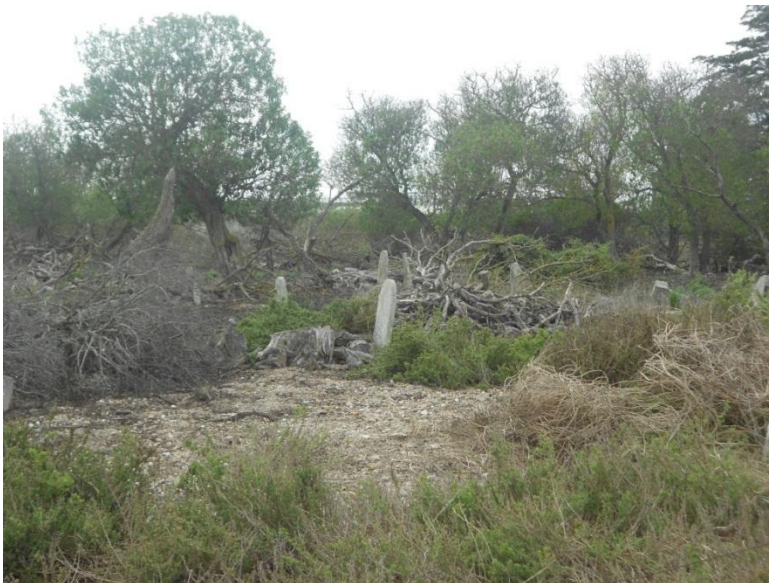
Easily flammable dry

wood surround the site

The site is surrounded by dry wood which puts the site at risk of fire breaking out. The extent of the damage that fire can cause on this site is significant. (am not sure how fire would affect the marble and concrete specifically)
