REPORT BY EDWARD MATENGA AUGUST 2004

APPENDIX I

BLUE STONE QUARRY WALL CONDITION SURVEY REPORT

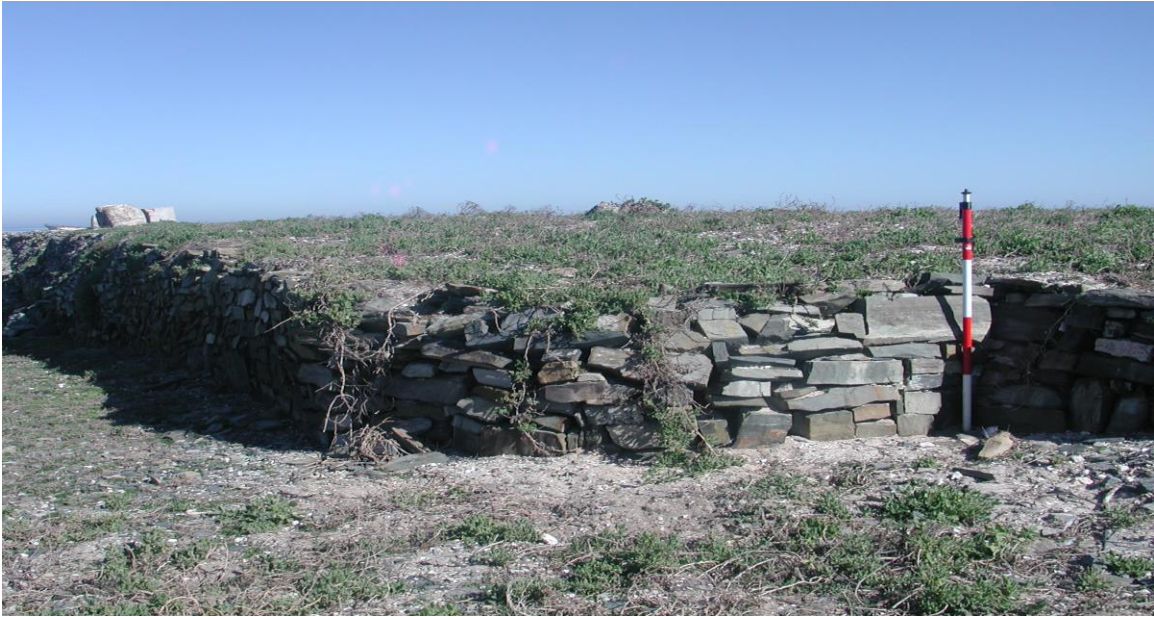
Intersection of walls 1 and 2

The northern end of the structure, it has wall 2 butting on to it on its southern end. It is a low wall with a maximum height of 0.8 m and appears stable as it retains some compacted soils. The collapse along it separates façade 1a from 1b and is a result of a very deliberate effort in moving the top blocks.

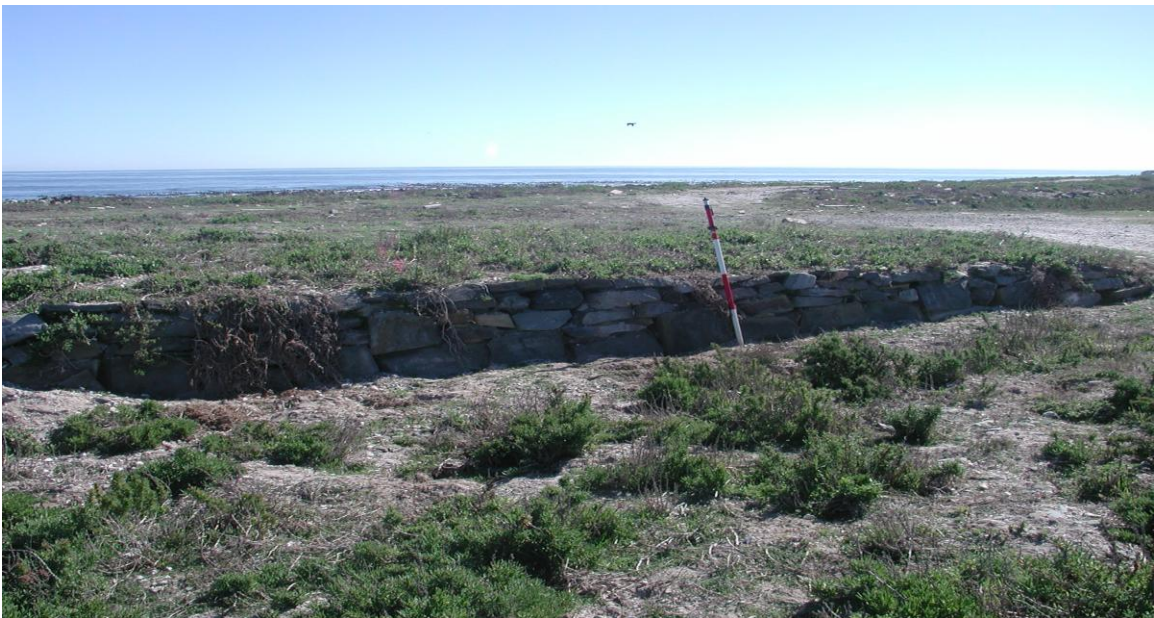
Façade 1a

It is 7.5 m long with a maximum height of 0.45 m. It is separated from façade 1b by a 0.5m long collapse of the top blocks.

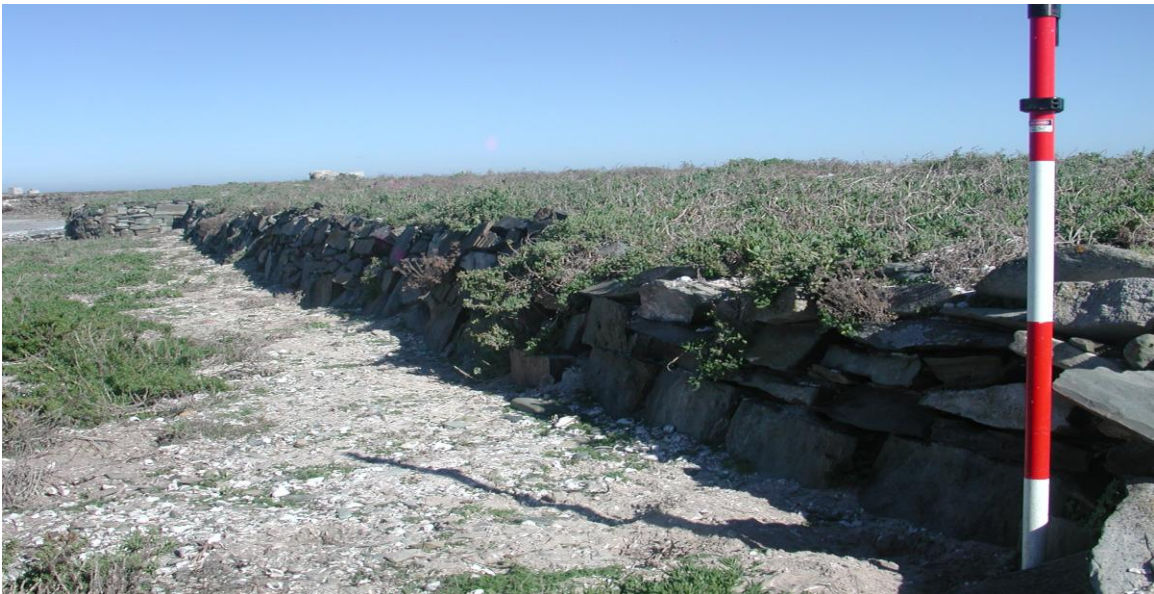
Façade 1b

It stretches for 20.5 m attaining a maximum height of 0.8m at the intersection with wall 2. It has a bottom void (0.4 m x 0.4 m) halfway along its length.

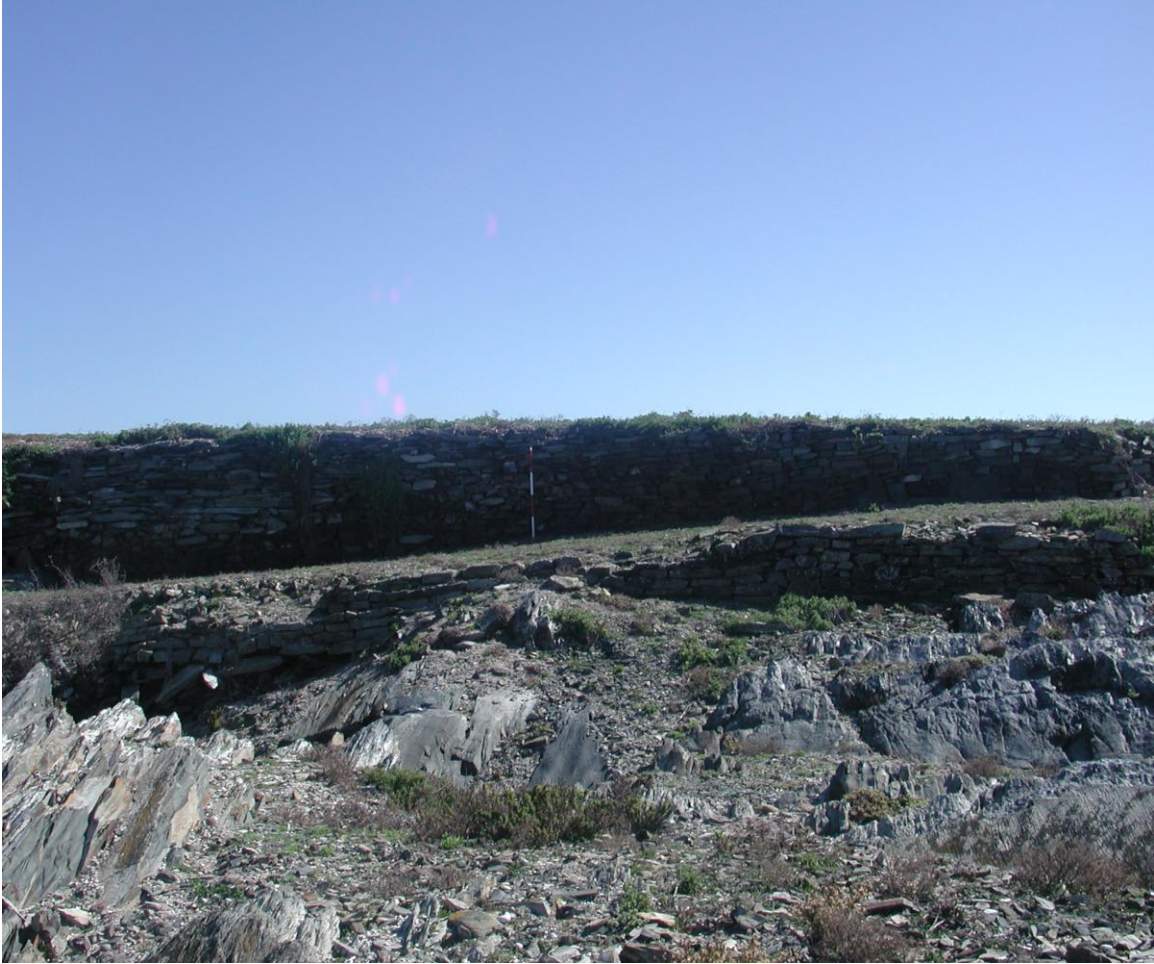
Façade 2a

It curves into façade 1b at the northern end. There is a bottom bulge towards the collapse that separates it from façade 2b. It is 20 m long and 1.85 m high.

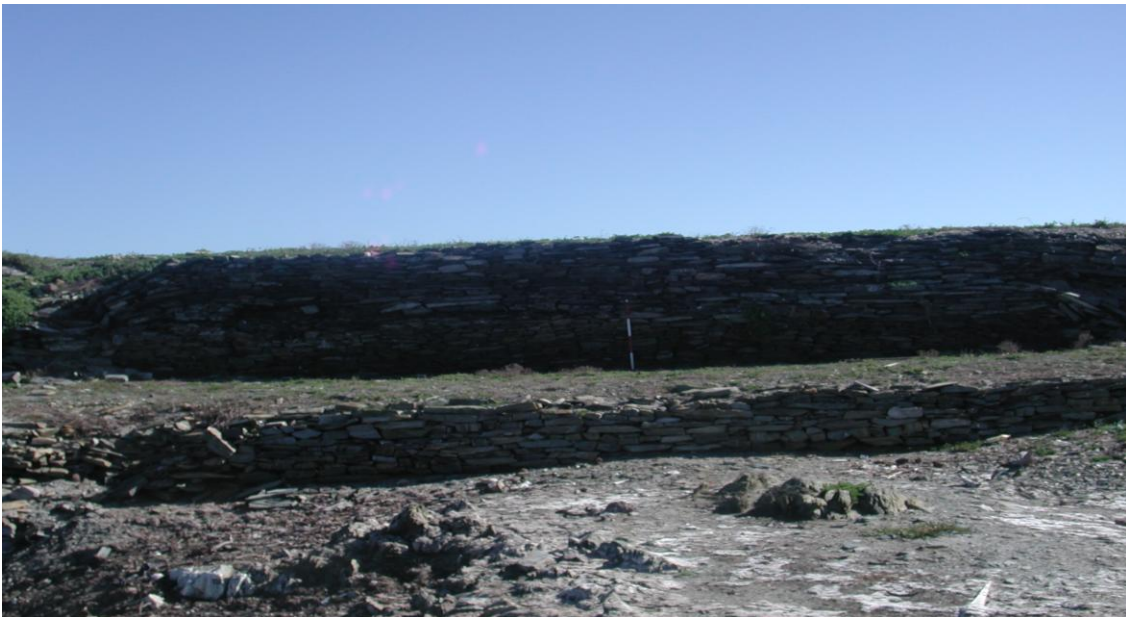
Façade 2b

It is separated from façade 2a by a 2.5 m long collapse. It is at this collapsed portion that the wall starts to have a lower wall (1.45m high) upon which the upper part sits like a terrace and tapering off. It is 12 m long and 2.15 m high.

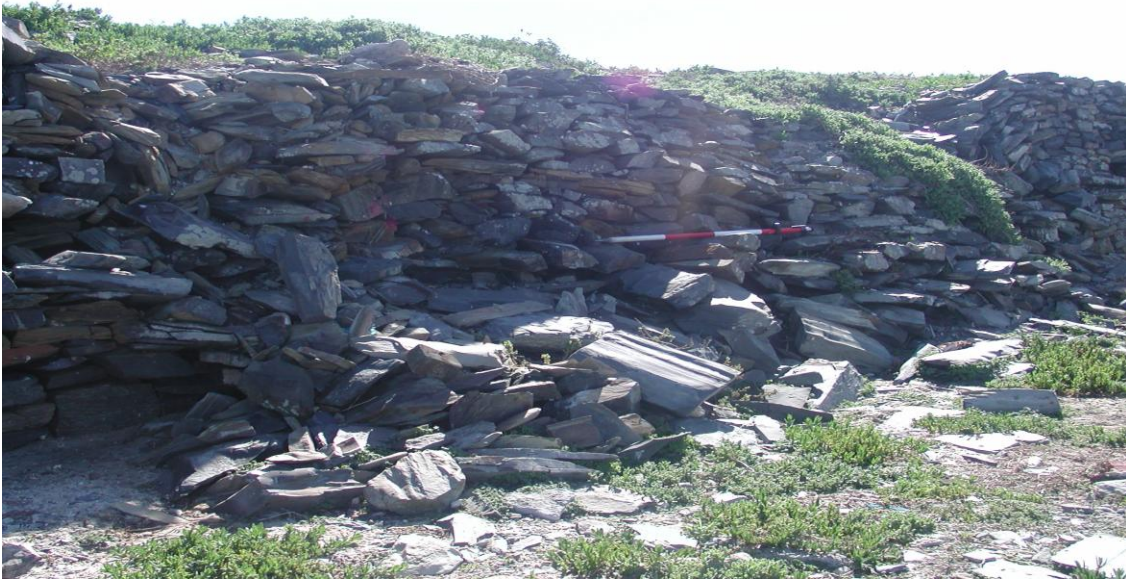
Collapse between facade 2b and 2c.

Extends for a length of 7m, the lower part of the façade collapsed forcing the upper part to sink. Result of a bottom bulge that burst.

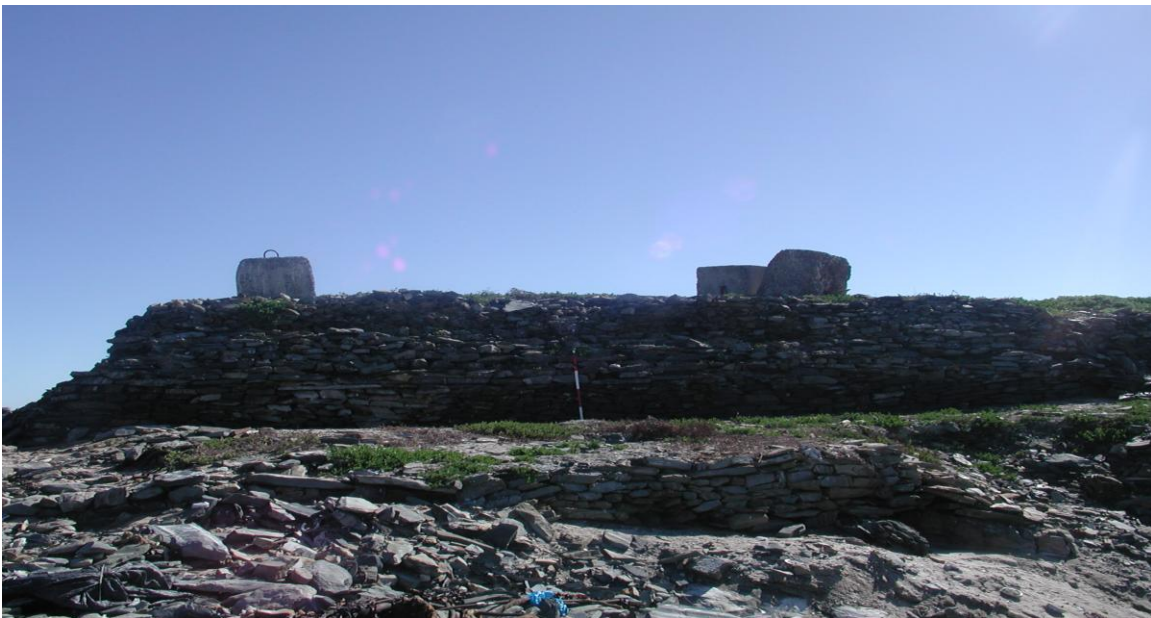
Fig. 22. Façade 2c

It is 13.5 m long and 2 m high. This is the portion that ends with the section of total collapse. Visitors should not climb over the wall, as it is unstable.

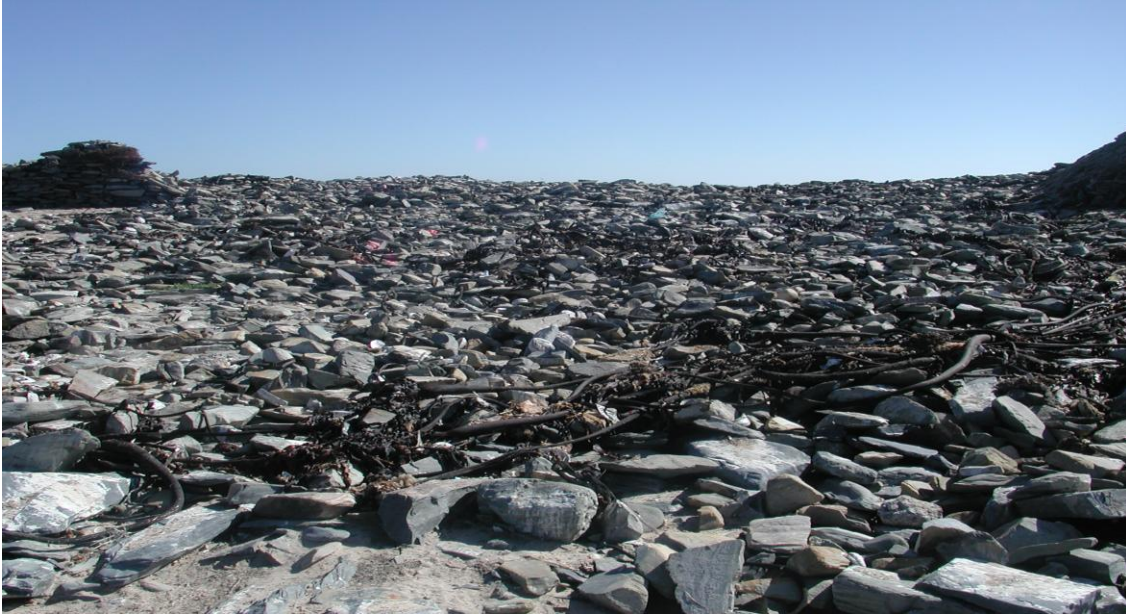
The section that was breached by the waves, between façade 2c and 2d

The breach is 15 m long and its rubble has been swept and spread towards the quarry pit.

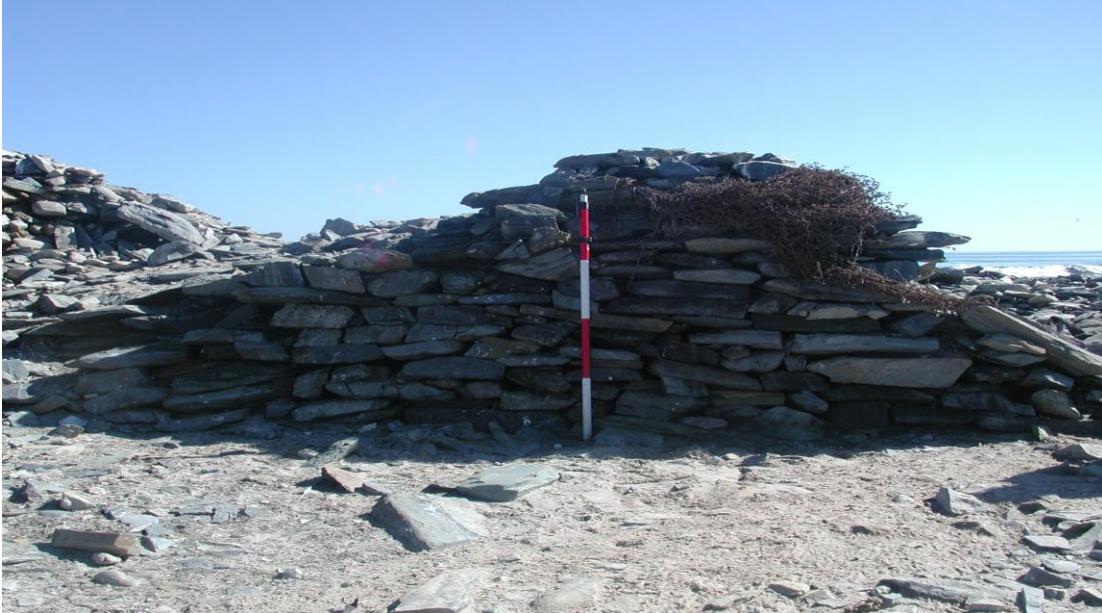
Façade 2d

It has a backward lean. Stone are sliding down at the end breach. It is 4 m long and 1.8 m high.

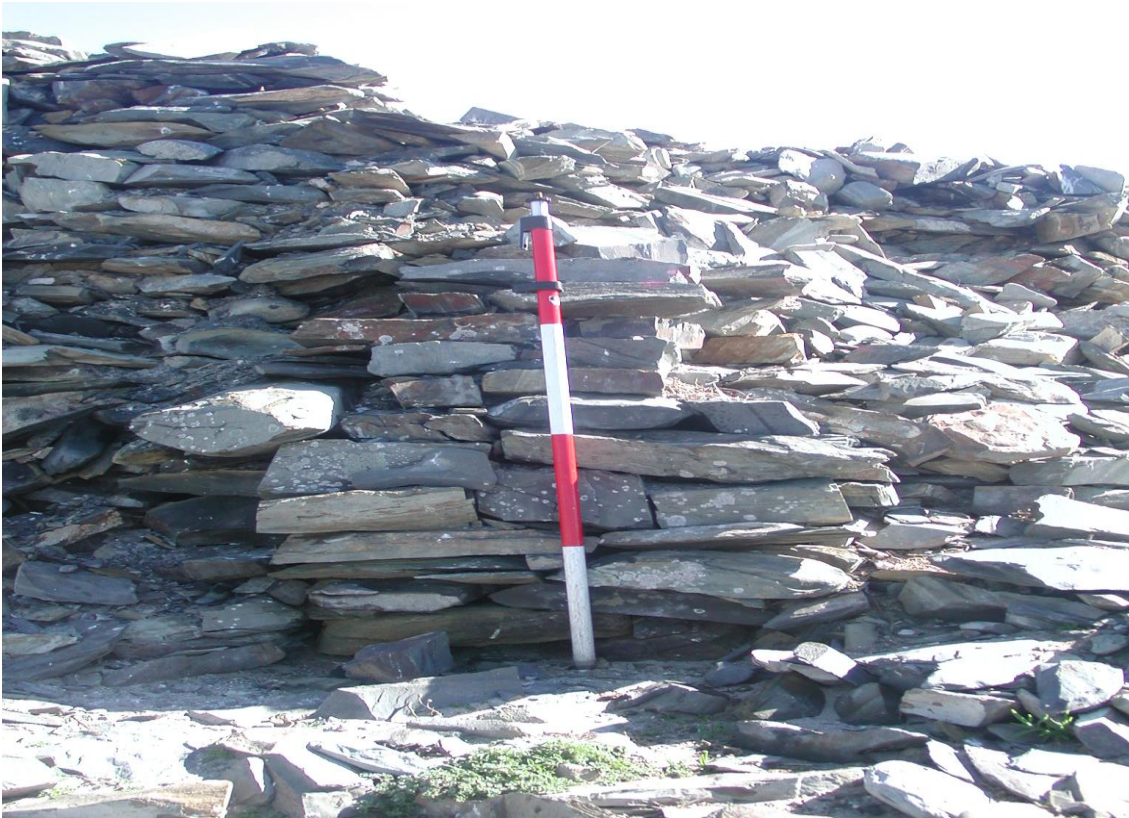
Façade 2e

It is 0.6 m long and 1.4 m high. Its top courses are leaning backwards, assuming a much more stable position.

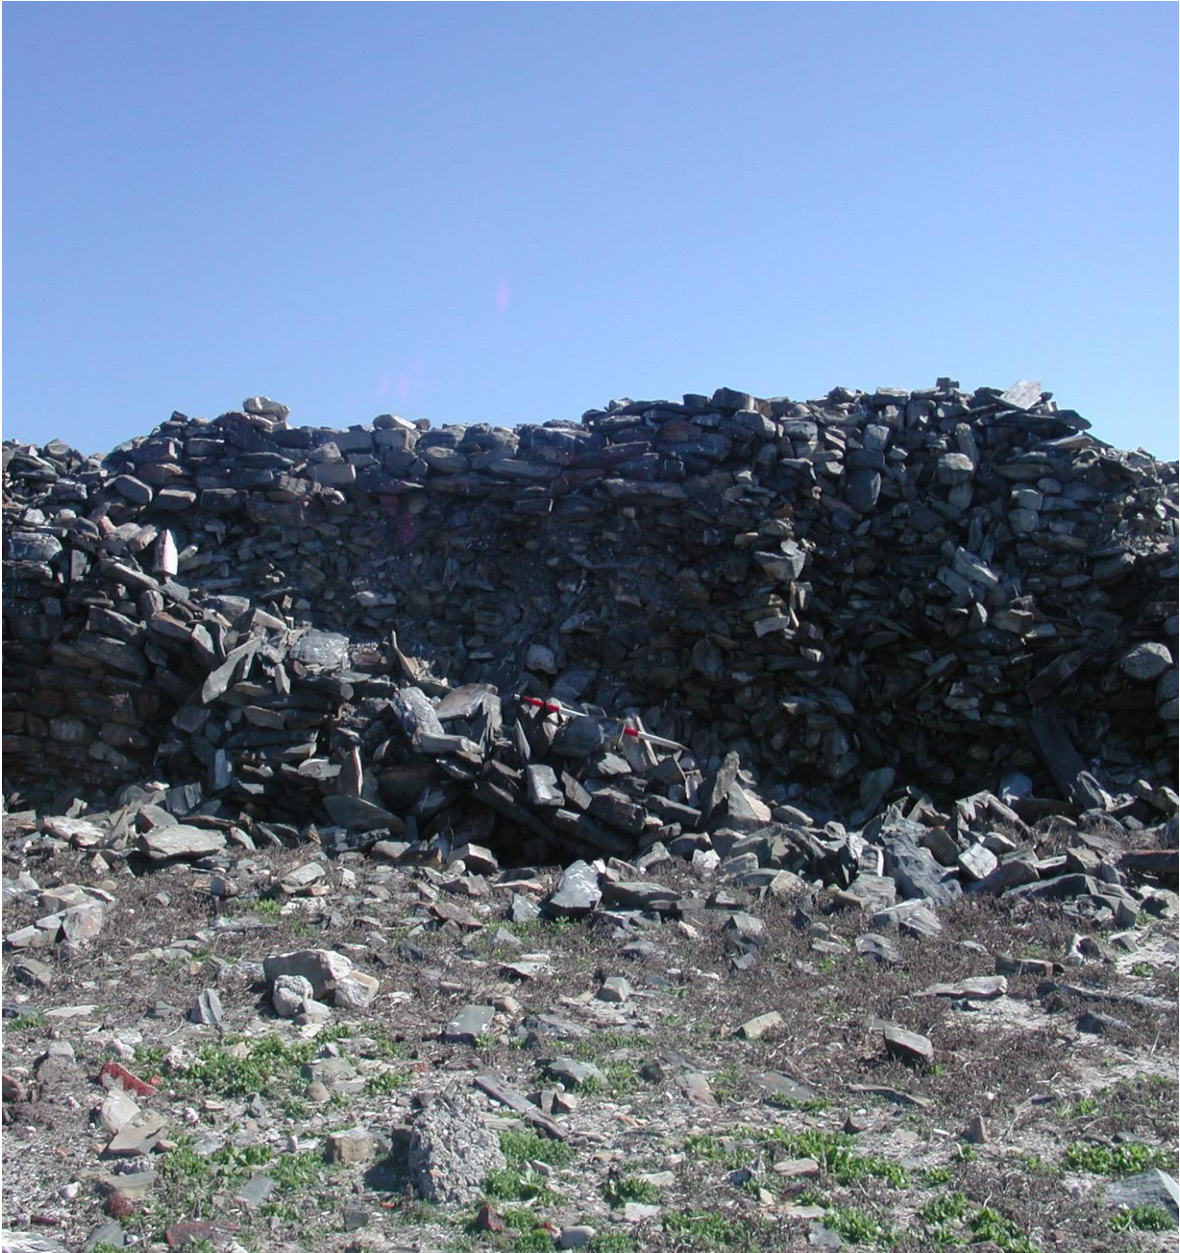
Collapse between façade 2e and 2f

The 8m long collapse that separates facades 2e and 2f has some hanging blocks.

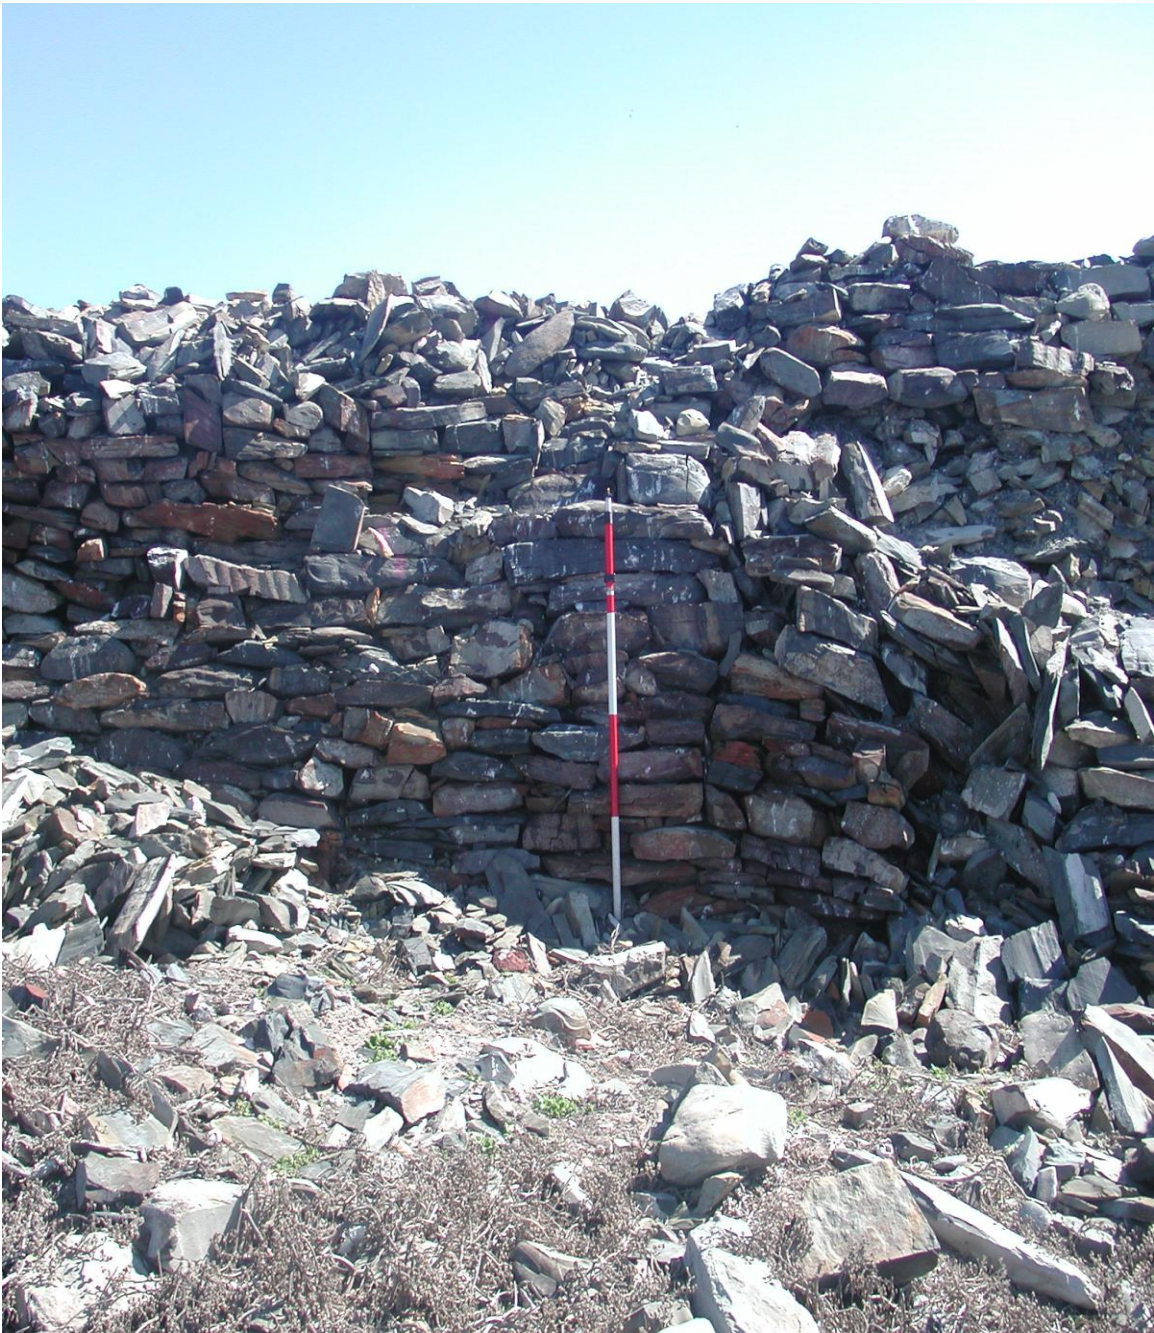
Façade 2f

It is 5.5 m long rising to a maximum height of 2 m. It leans backwards from the bottom up to halfway through its height. From here it tapers inwards.

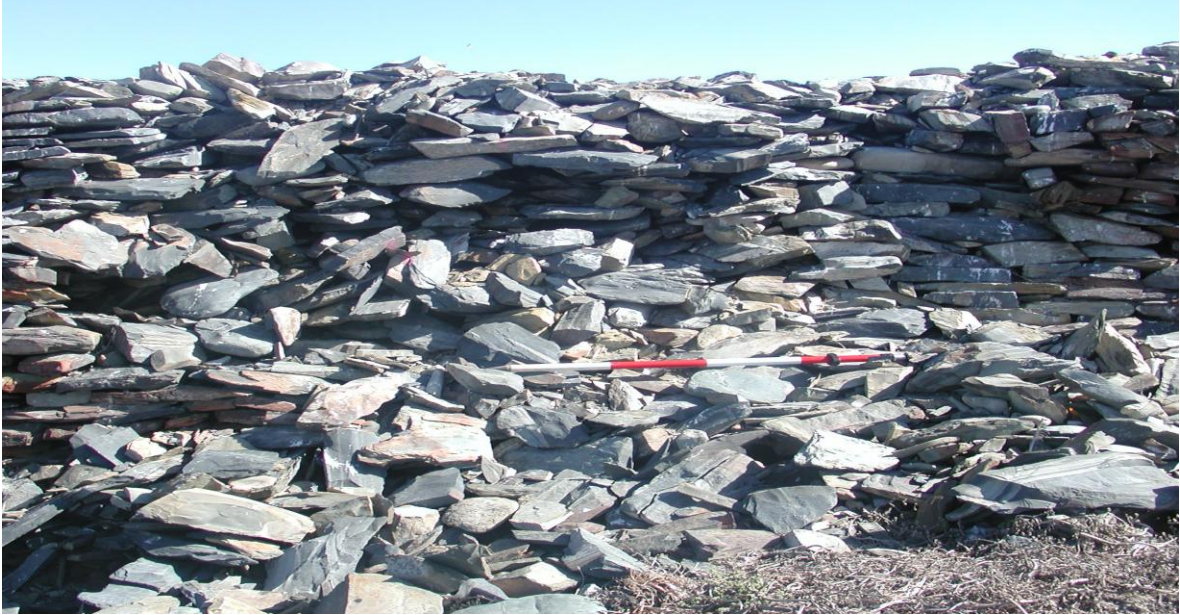
A 2m long collapse of the top blocks separates façade 2f from 2g.

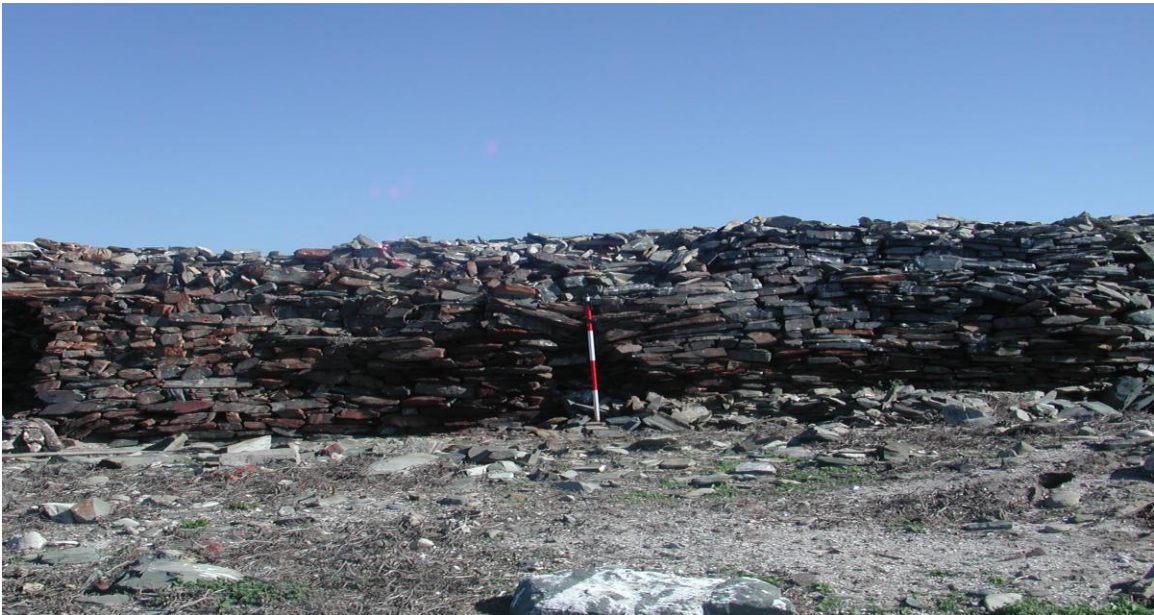
Façade 2g

It has a mid bulge near the collapse that separates it from façade 2f. Another bottom to mid bulge 5 m from this end has resulted in a void (0.5 m long x 0.6 m high). This may cause further collapse of the blocks that are directly above it. The façade stretches for 9 m and attains a maximum height of 2.1m.

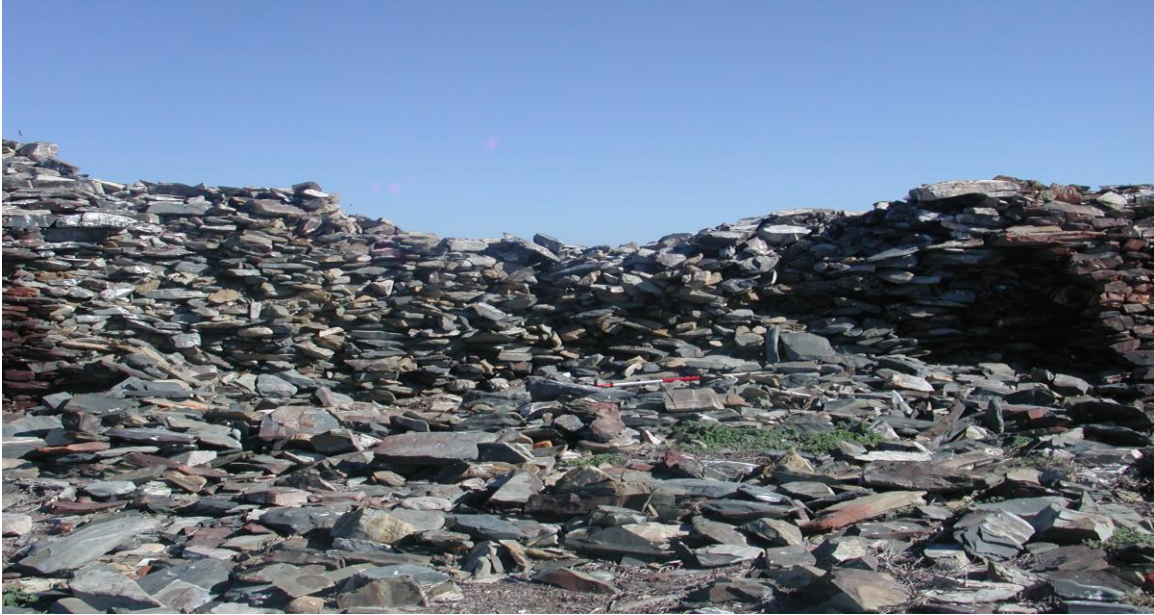
A 6m long collapse separates façade 2g from 2h.

This is an extensive collapse of the façade going down to the bottom blocks.

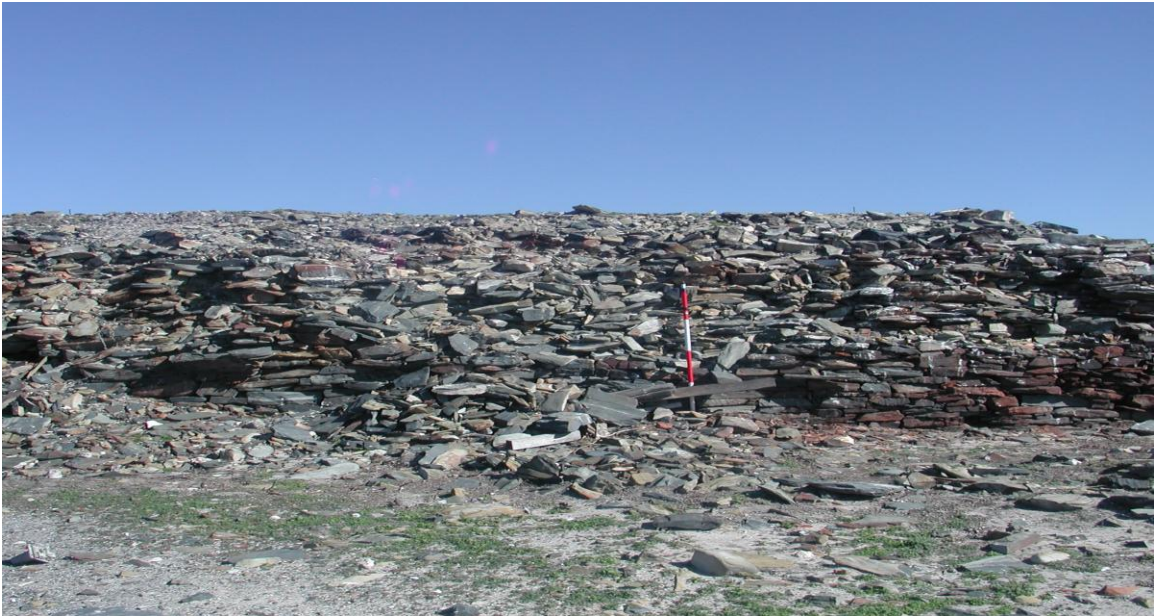
Façade 2h

It is 8.5m long and 2.15m high. Most of its top façade blocks are collapsed for three-quarters of its length.

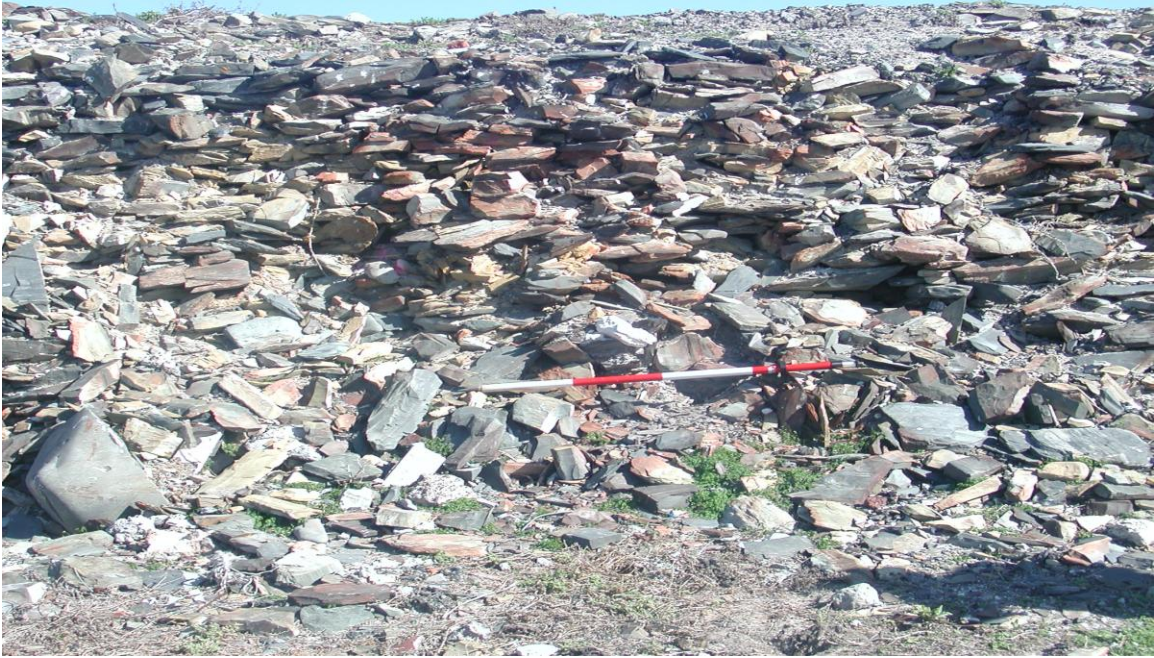
FA 4 m long collapse separates façade 2h from 2i.

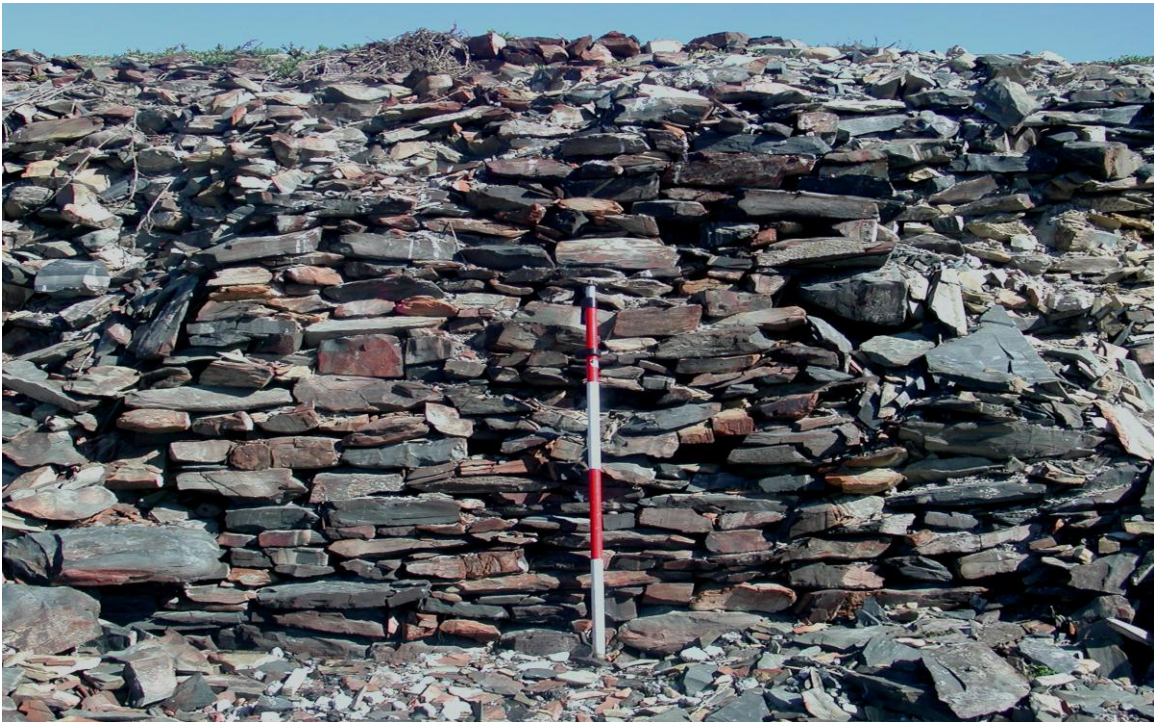
Façade 2i

It is 3m long and 2m high.

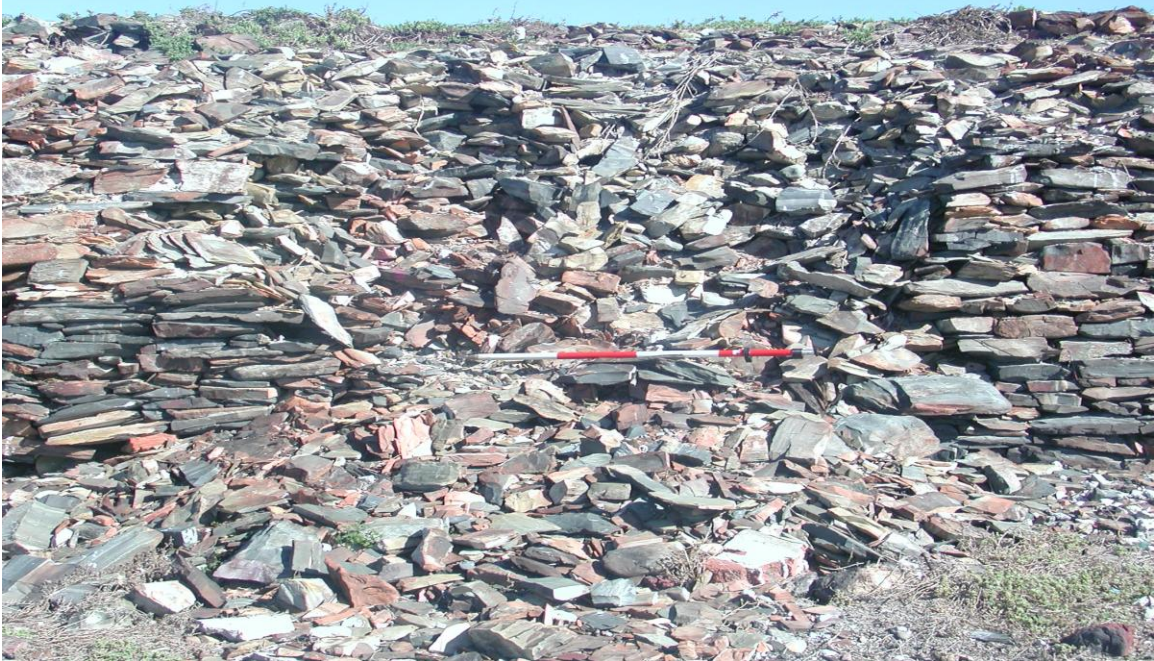
A 2.5 m long collapse separates façade 2j from 2i.

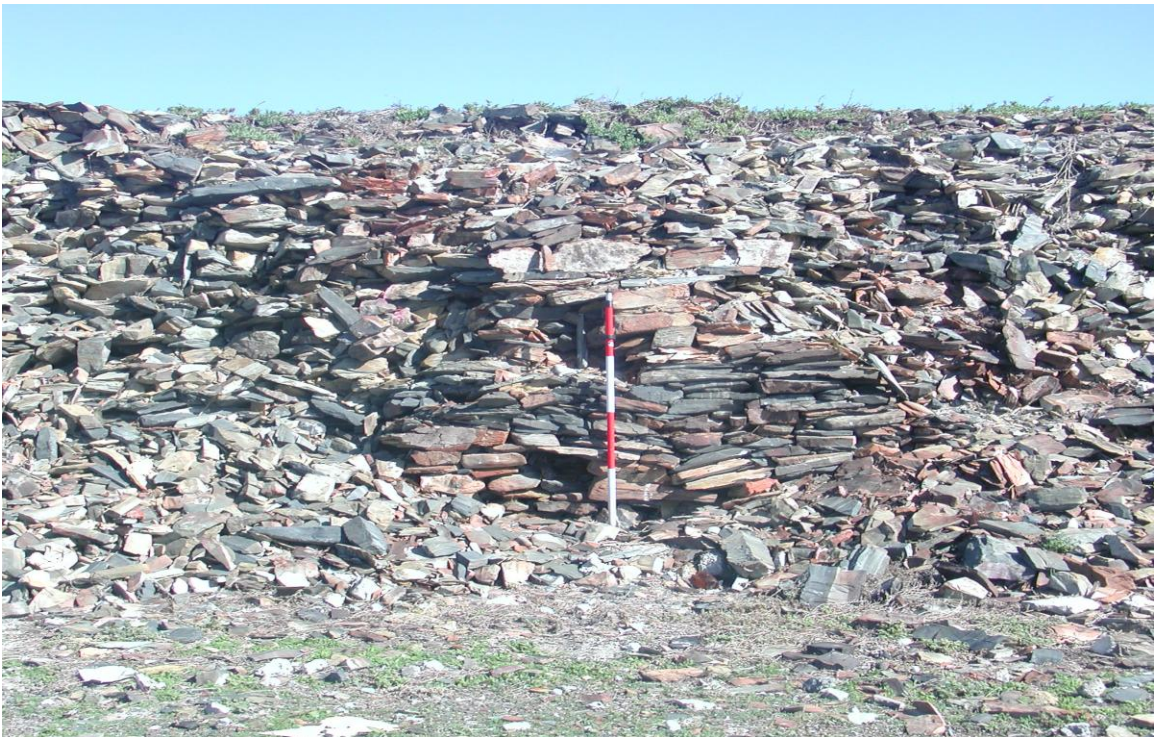
Façade 2j

It leans backwards at the point with a bottom void (0.2m long x 0.1m high) towards the right end. It is 2.5m long and 2.1m high.

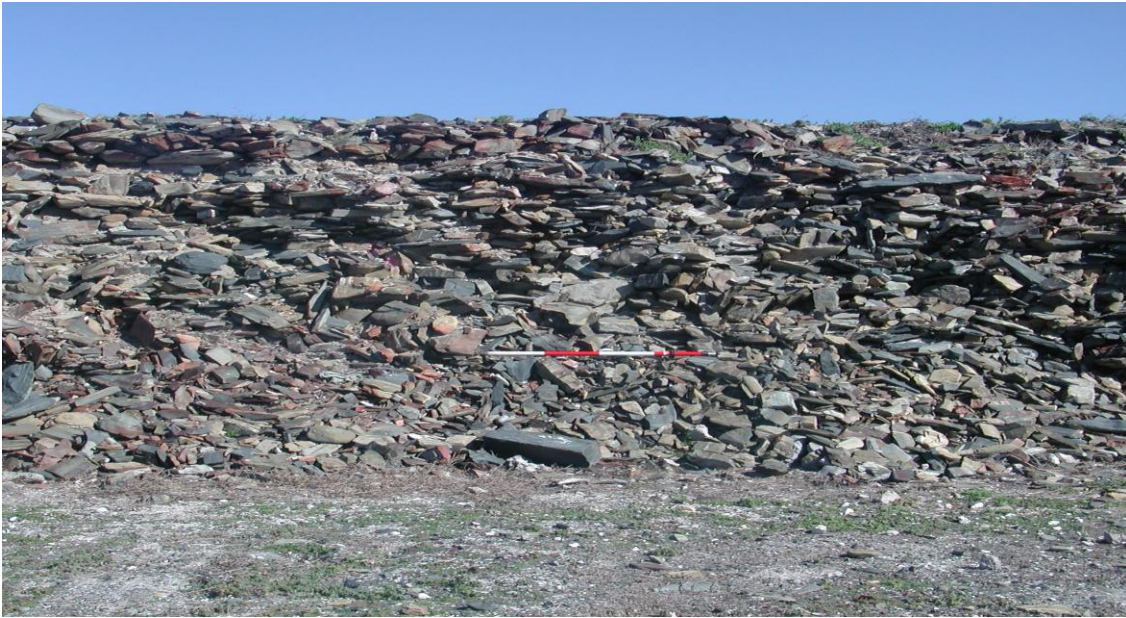
A 5.5m long collapse separates façade 2j from 2k.

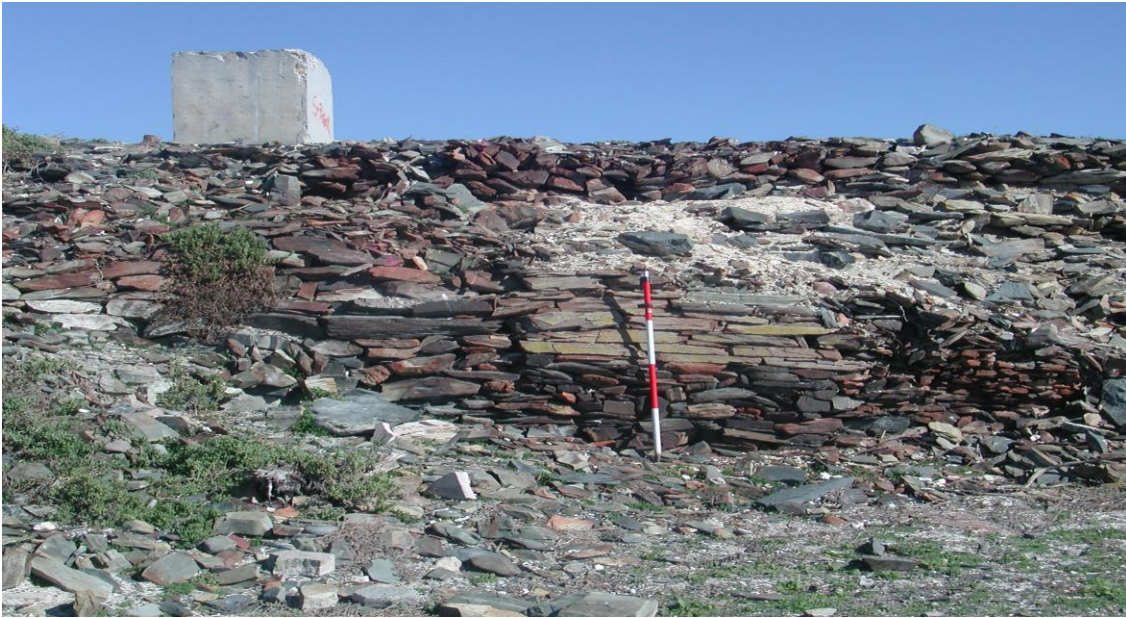
Façade 2k

This is the last standing façade of the wall 2 at the southern end. The top face blocks have collapsed. It is 7 m long and the standing façade rises to 1.5 m.

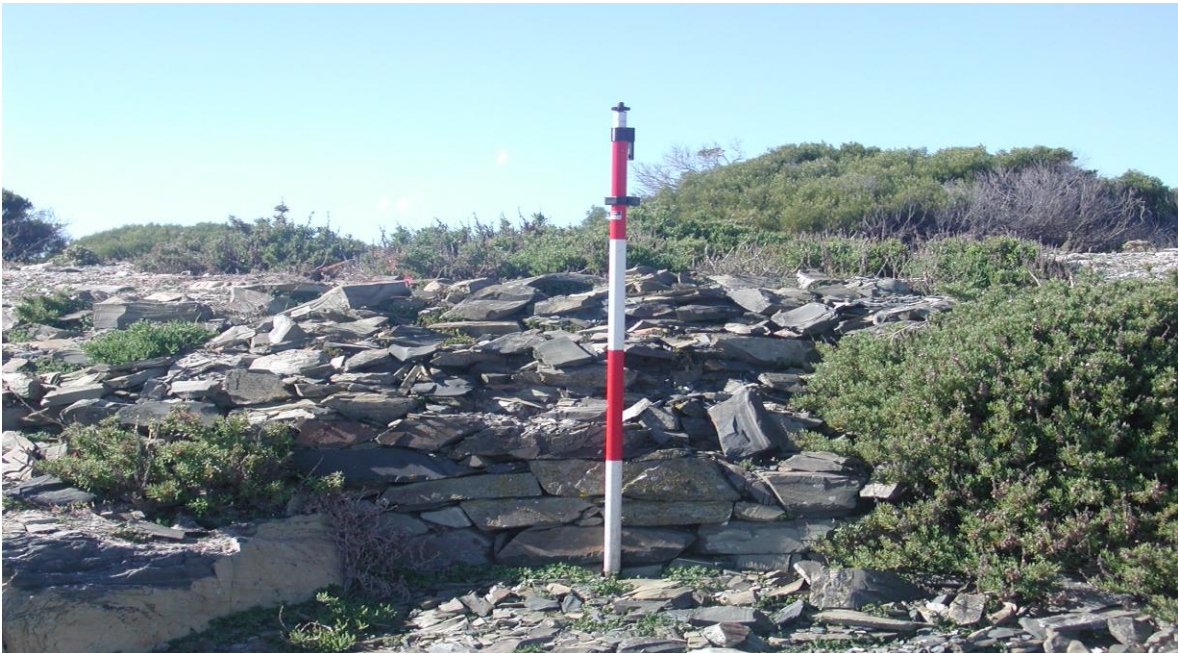
Facade 5a

It ends against a rock over which it used to pass at the northern end. The southern end is totally collapsed. The same rock forms the eastern edge of the main quarry pit. It is 1.5 m long and 0.3 m high.

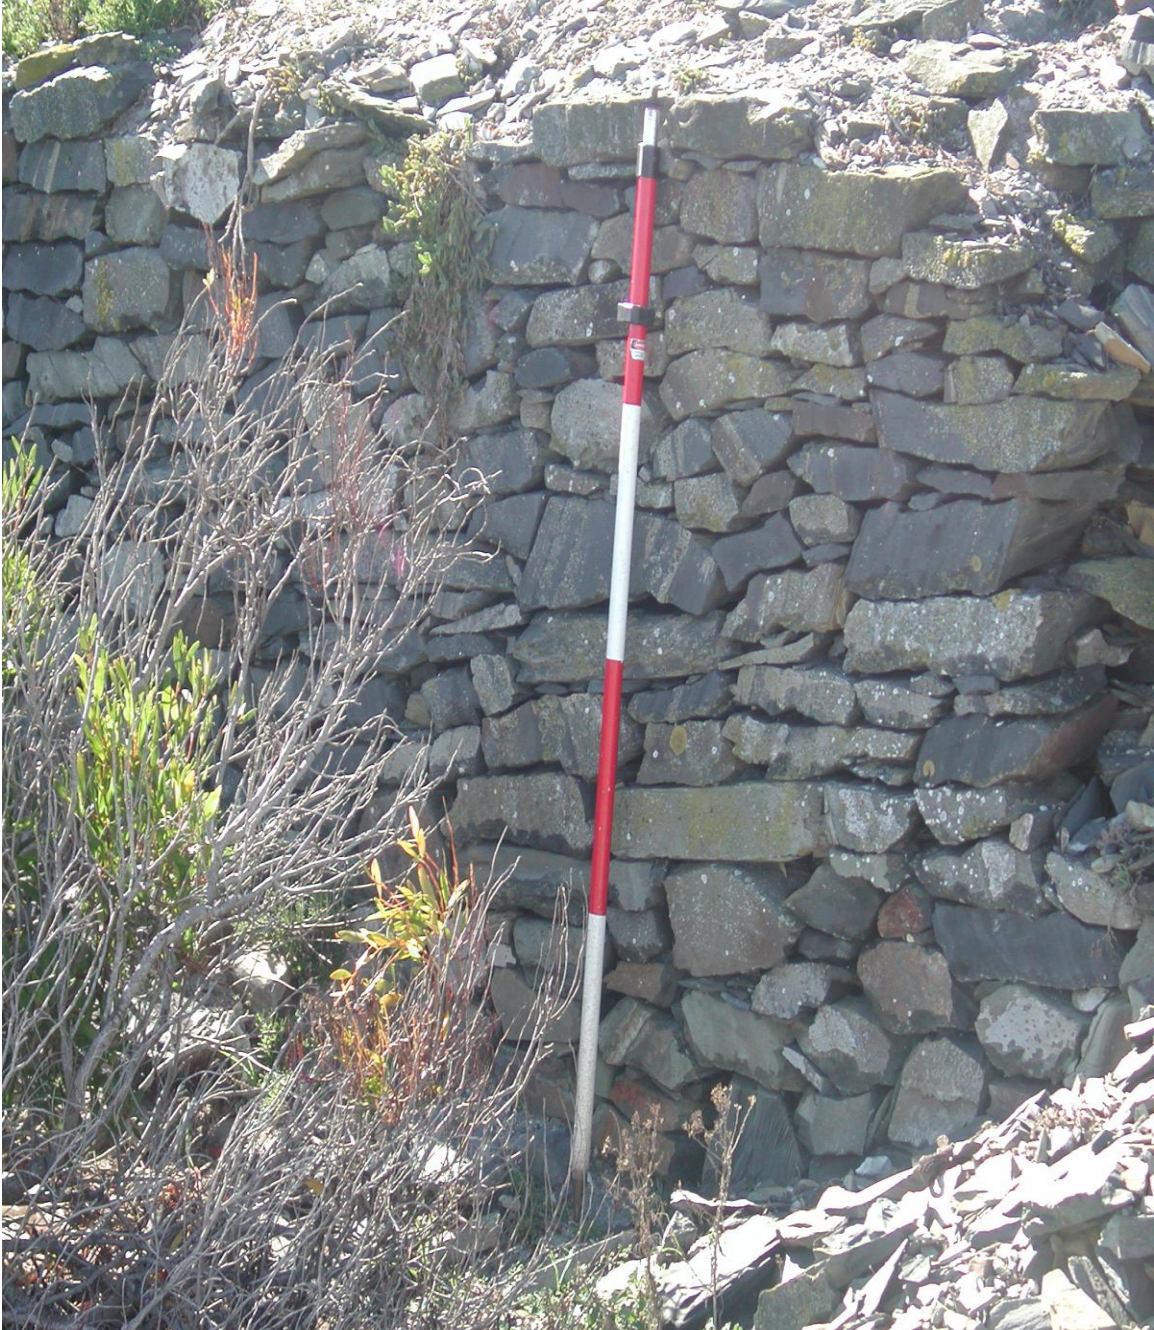
Façade 5b

It stretches for about 8m into the shrubs that grow to its northern end. It also ends against the same rock as façade 5a to its south. It is 1.5m high.

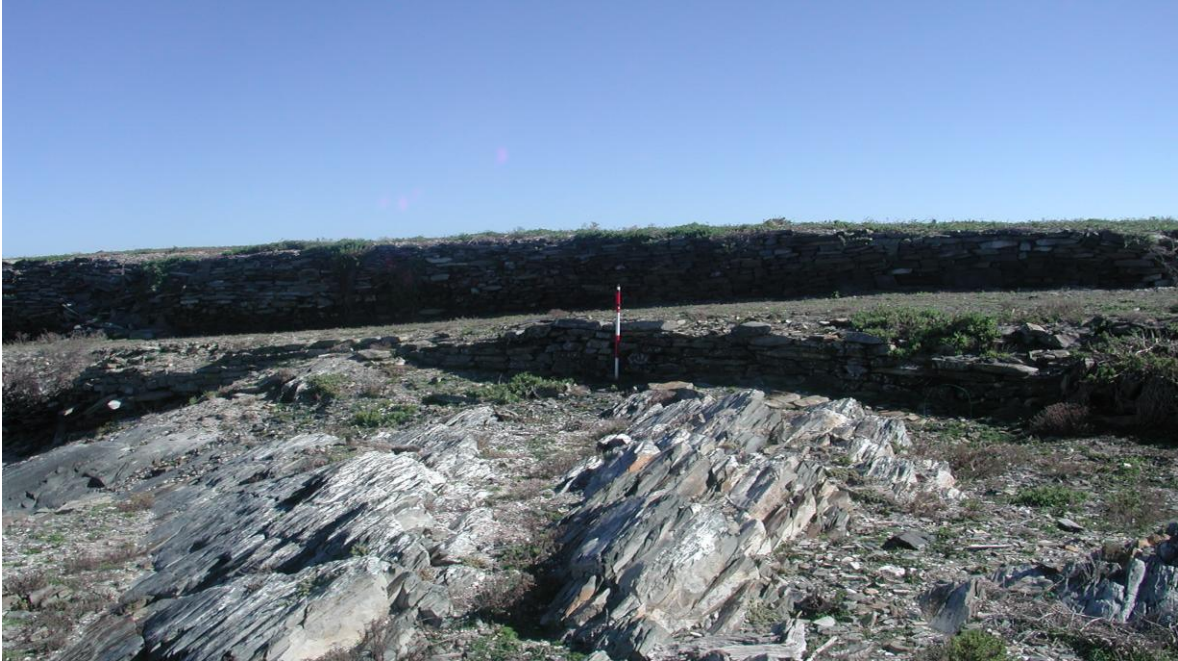
Façade 6a, it is 13 m long and 0.55 m high.

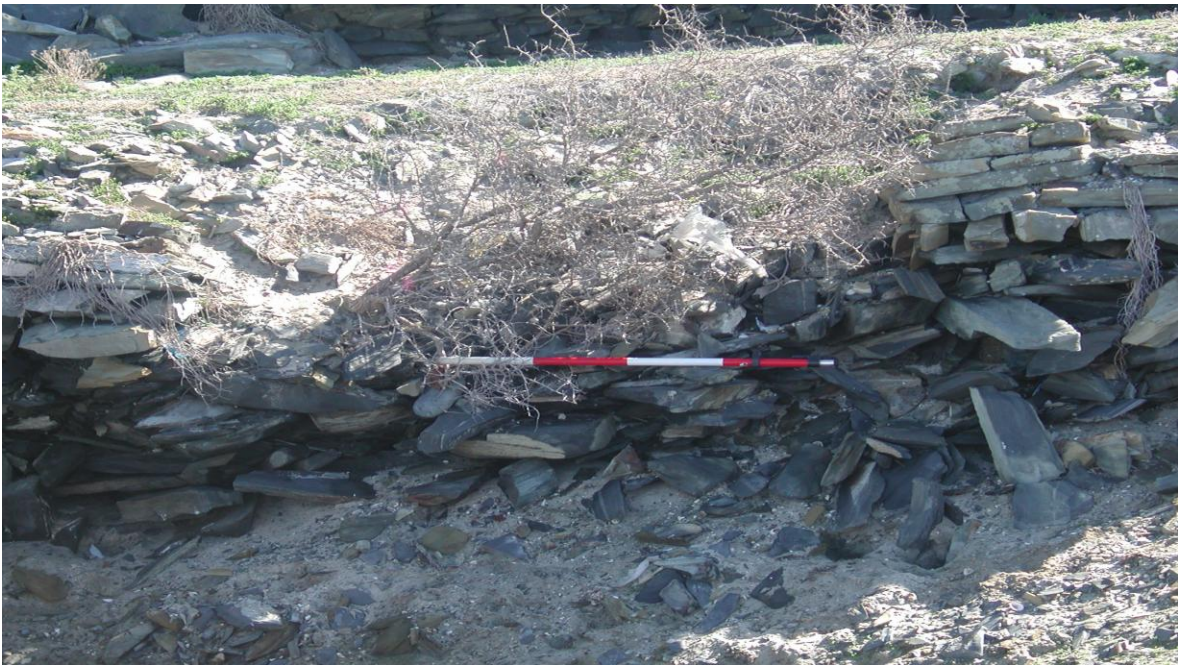
A 2.5m long collapse separates façade 6a from 6b.

A path over it into the pit was causing erosion.
