REPORT BY EDWARD MATENGA AUGUST 2004

APPENDIX I

BLUE STONE QUARRY WALL CONDITION SURVEY REPORT

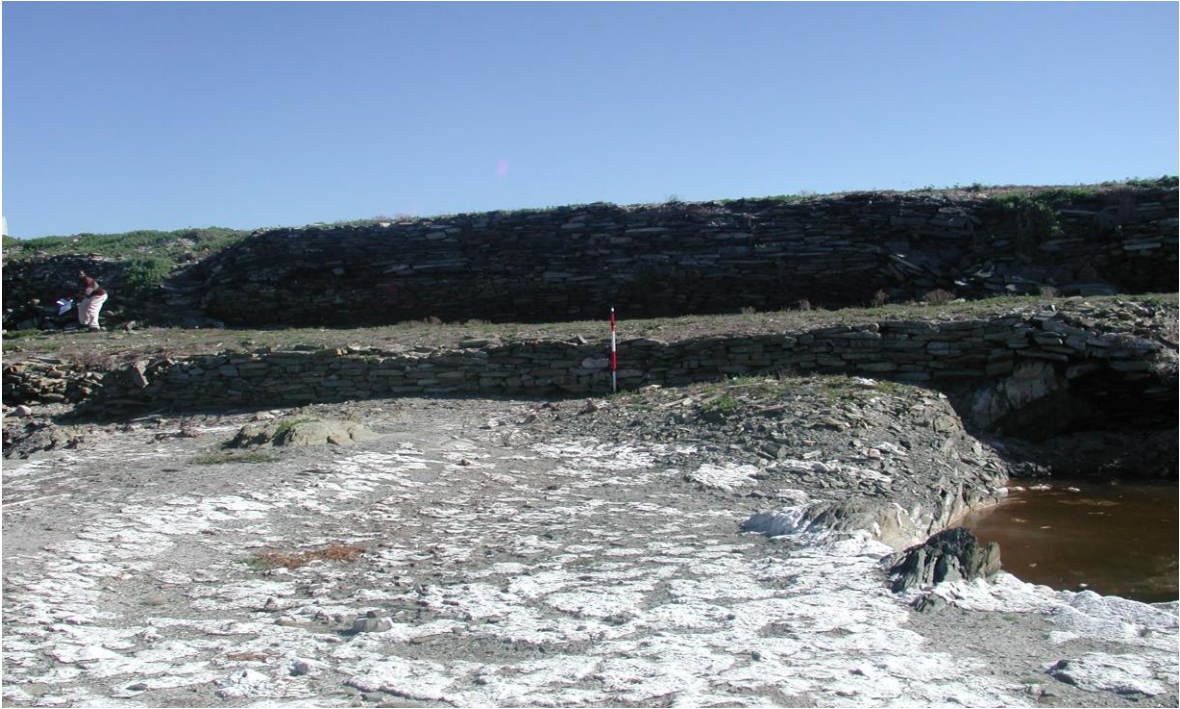
Façade 6 b. It is 13m long and 0.7m high.

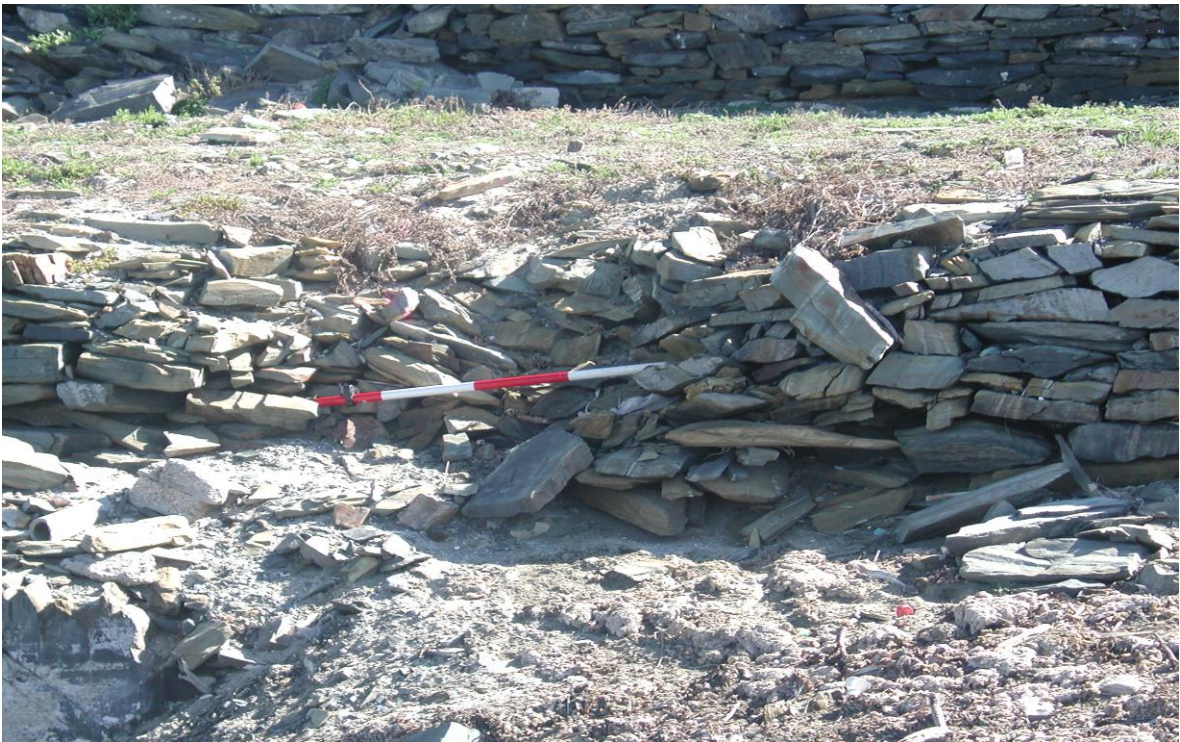
A 1.5 m long collapse separates façade 6b from 6c.

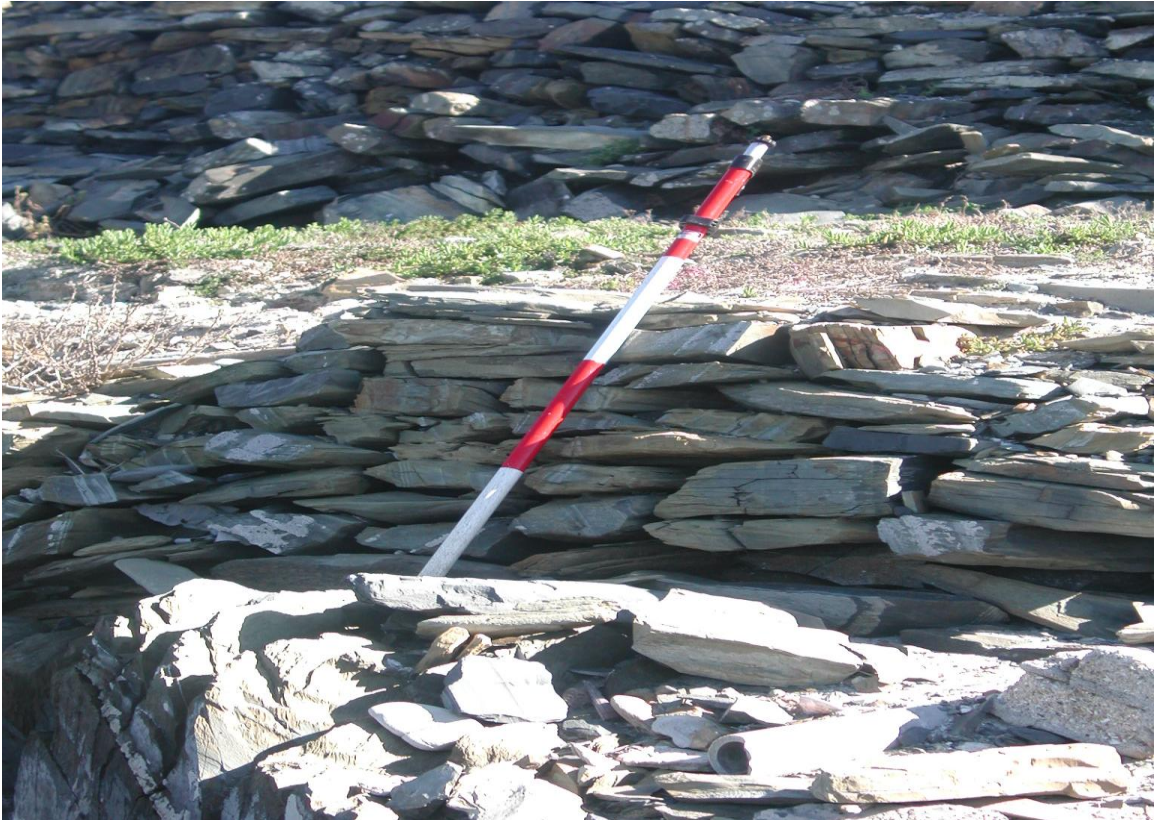
Façade 6c, It is 2m long and 0.5m high. It overlooks the main pit. Blocks between it and façade 6d are continuously sliding.

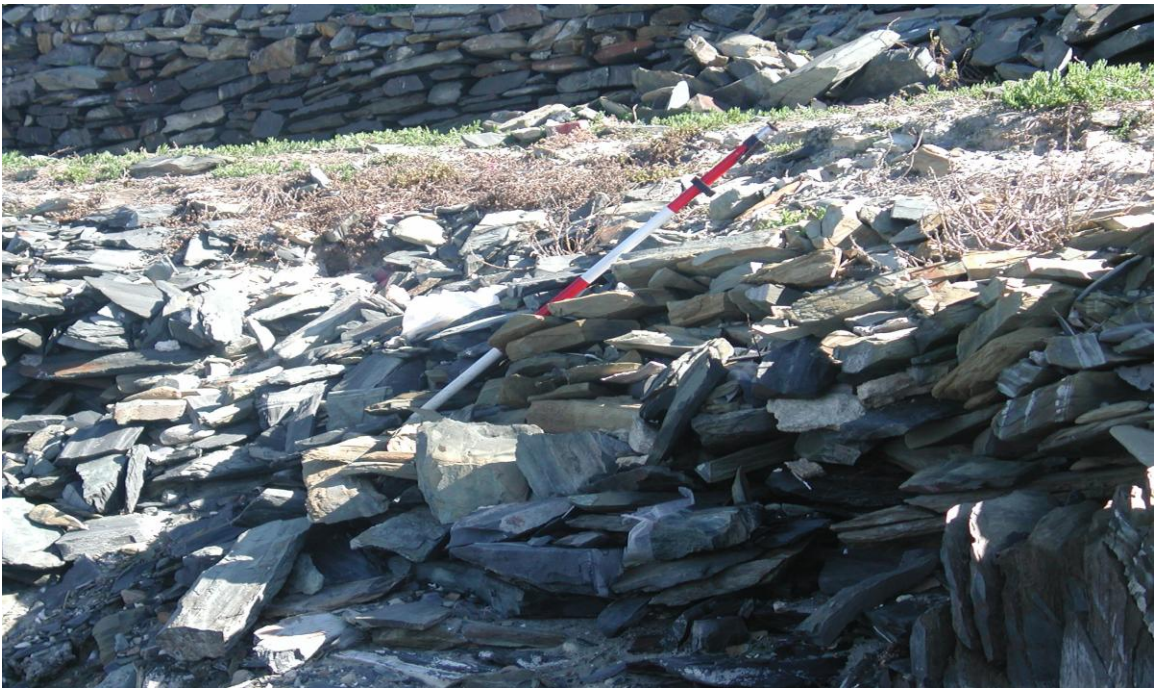
A 3m long collapse separates façade 6c and 6d.

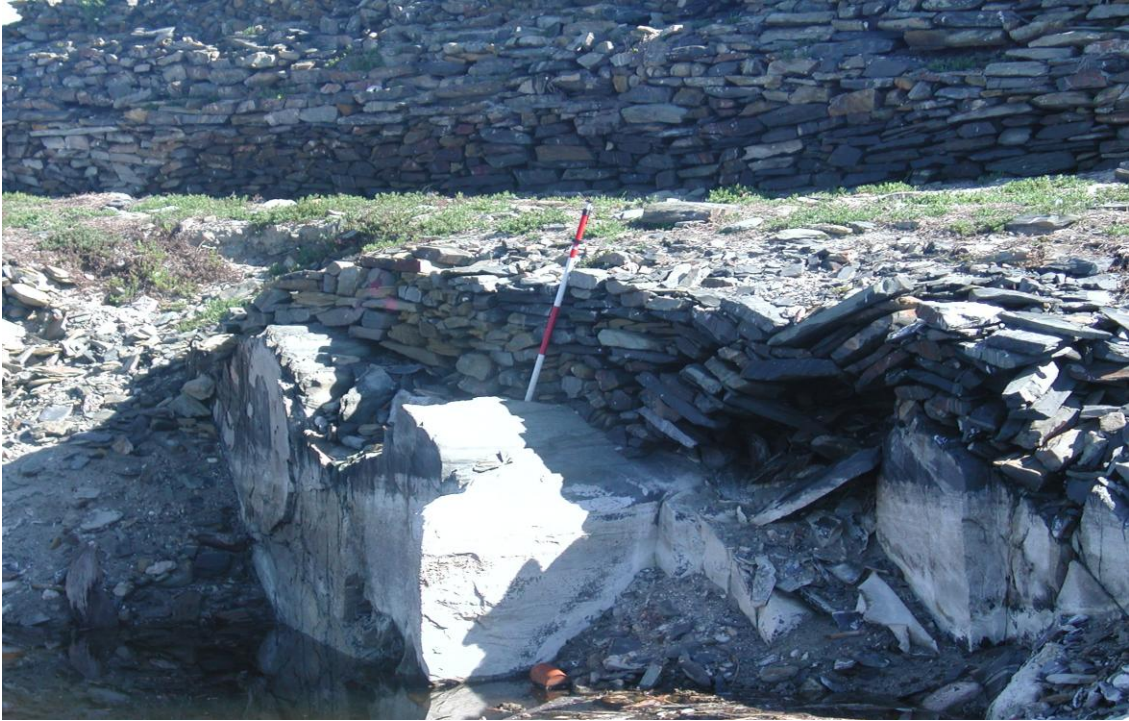
Façade 6d
It is 5 m long and 0.5 m high.

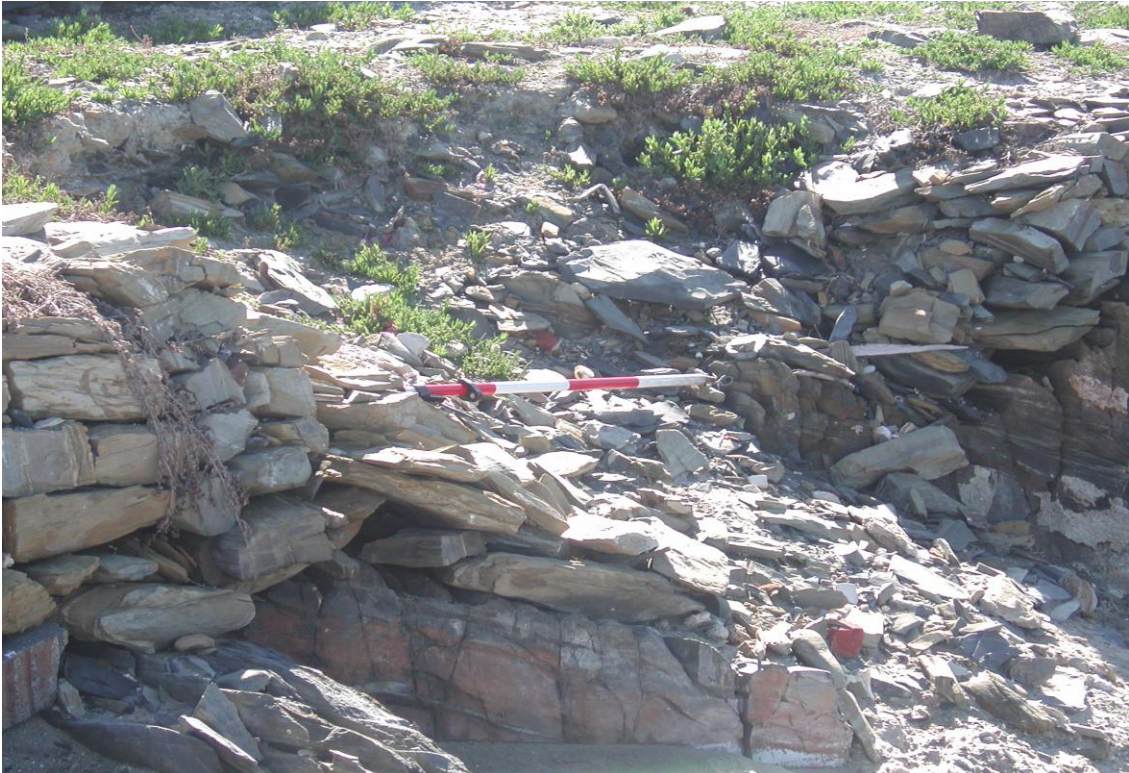
A 2.5m long collapse separates façade 6d from 6e.

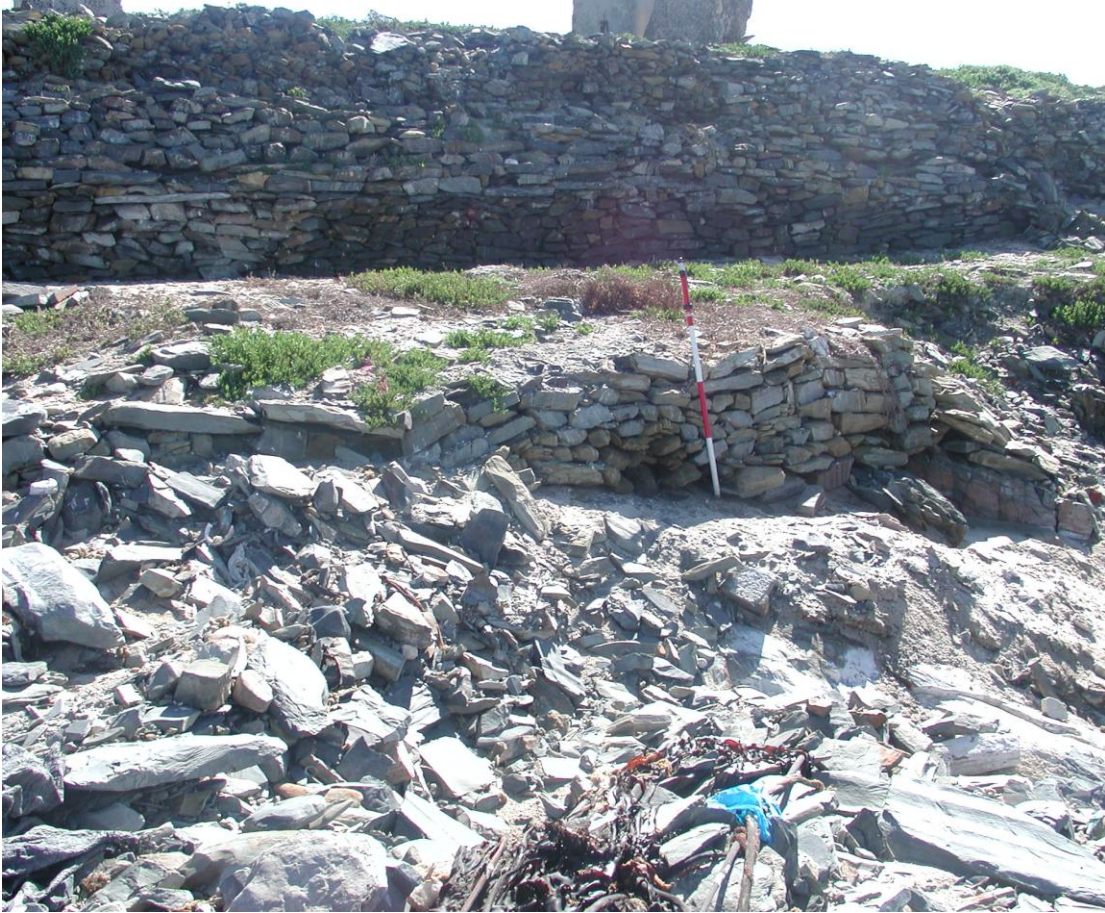
Façade 6e

It is 7m long and 0.75m high. The rubble from the total collapse is concealing its southern end that now has a few blocks remaining.
