**RE: SUBMISSION OF RISK ASSESSMENT REPORT FOR
LP/30/5/1/3/1/311EM**

**ENVIRONMENTAL RISK ASSESSMENT REPORT
IN APPLICATION FOR CLOSURE OF BORROW PITS
ALONG ROAD D3180 (MODJADJI-MOKWAKWAILA-
BAMBENI-NKOMO)
MOPANI DISTRICT MUNICIPALITY**

Date: 17 February 2009

LP/30/5/1/3/1/311 EM

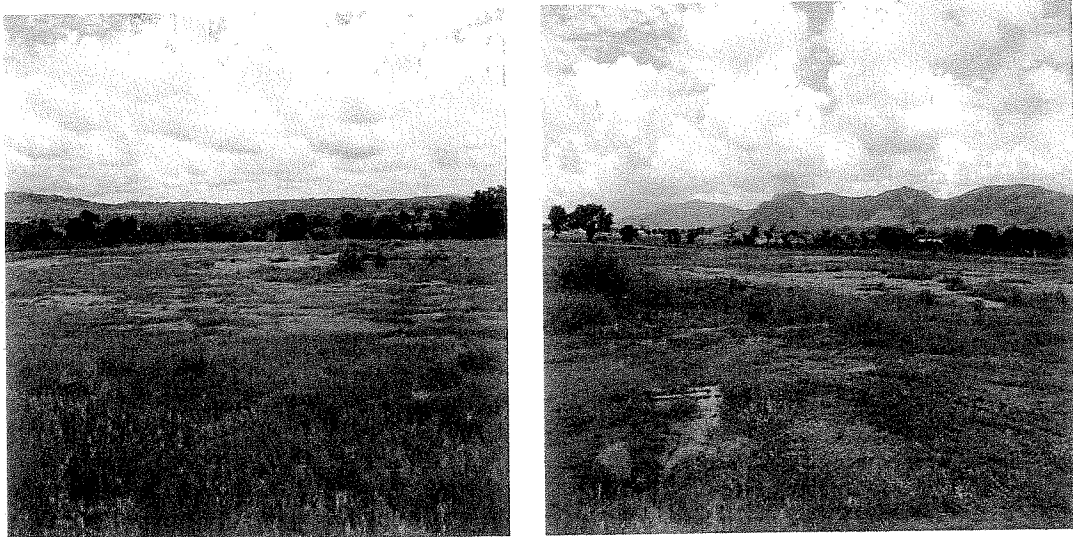
Plate 1: Borrow pit number 1 located at km3 LHS of the road D3180. The picture indicates the condition of the borrow pits after appropriate rehabilitation in accordance with the Environmental Management Plan.

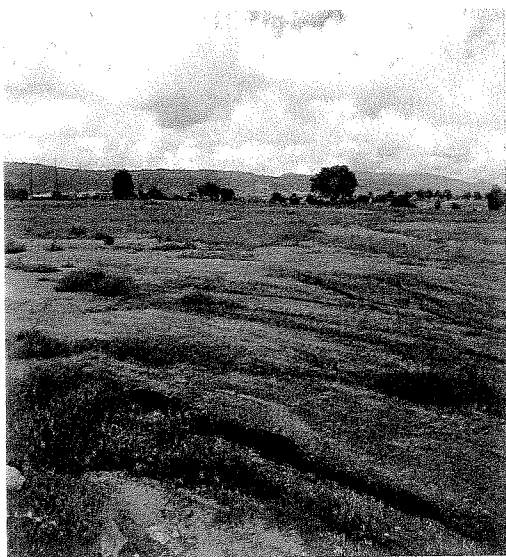
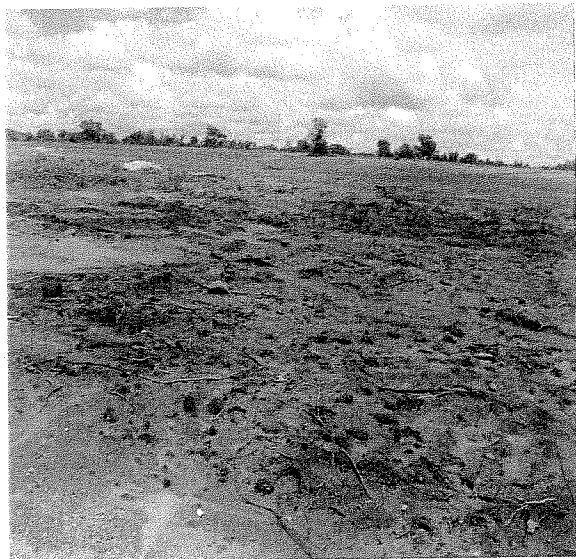
Plate 2: borrow pit number 2 located at km8.5 RHS of the road. The cleared vegetation over the area may result in serious soil erosion.

The cleared vegetation did not include any endangered species and a minimum biomass was selected for clearance in order to reduce susceptibility to soil erosion. Vegetation clearing can also influence drainage patterns which can

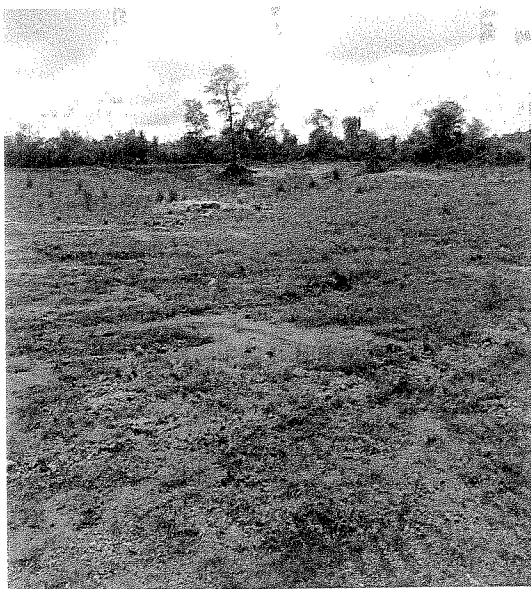
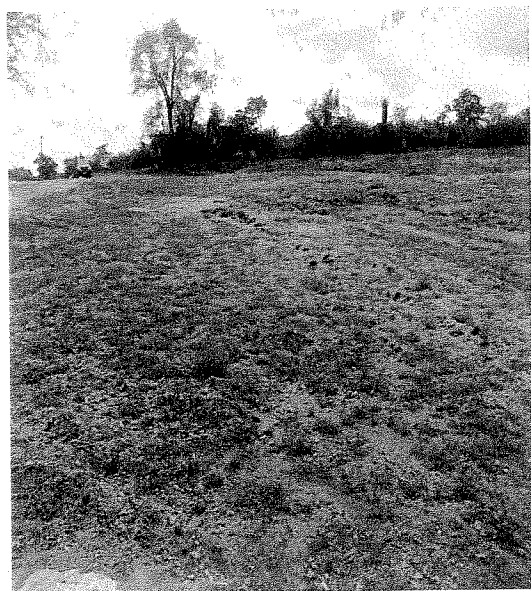
Plate 3: borrow pit number 3 located at km11.5 RHS of the road. The borrow pit is well rehabilitated. No threat is foreseen to the environment, villages and domestic animals.

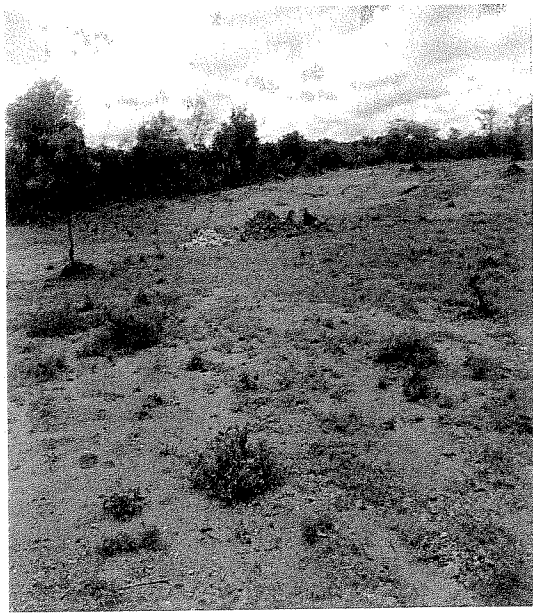
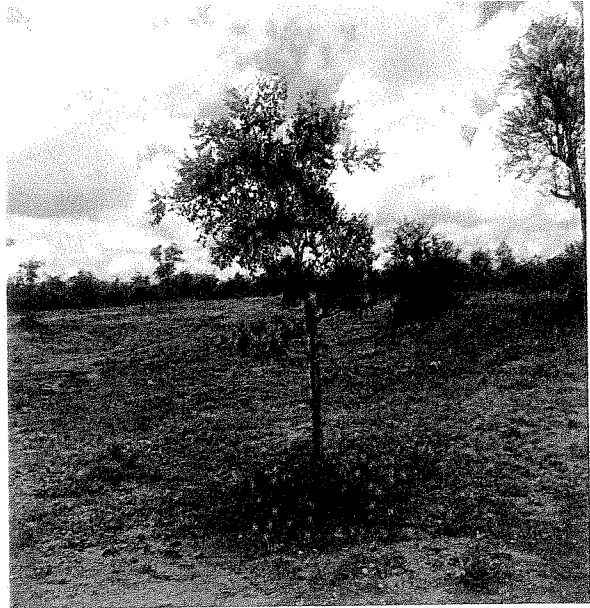
Plate 4: The borrow pit has been rehabilitated (bpt4-km17). The incomplete section waits the spoiling of more material to achieve the require slope.

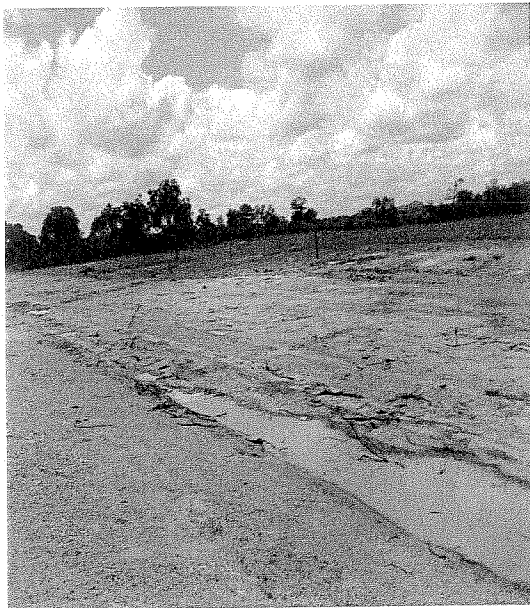
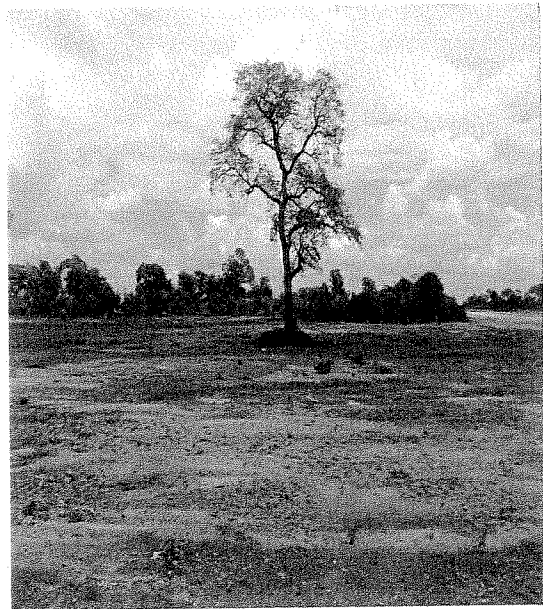
Plate 5: borrow pit number 5 located at km21 has been well rehabilitated as we can see running water on a side drain of the road.

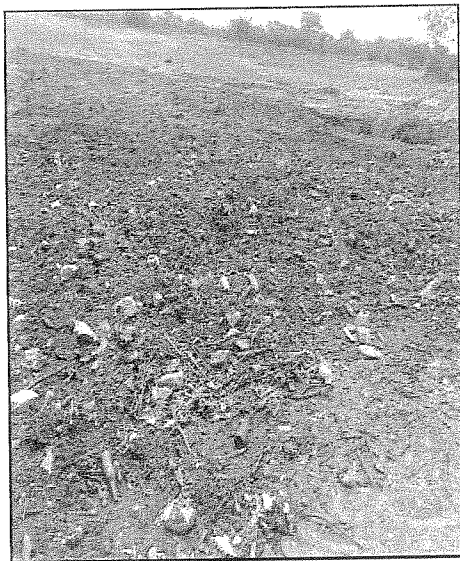
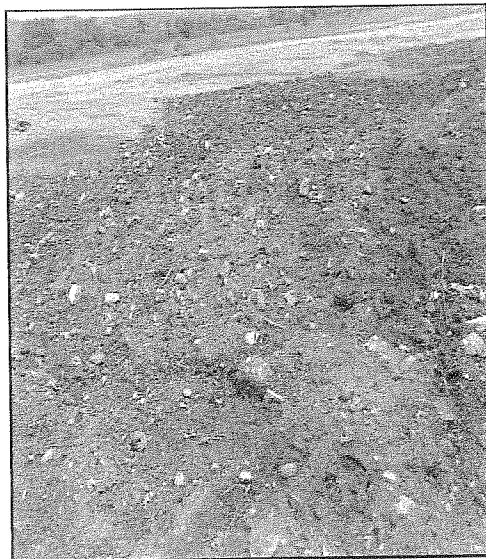
Illegal dumping is an environmental problem across the country; however, some members of the public tend to take advantage of dumping within an excavated site such as these borrow pits. See pictures below:

The potential impact on the local communities and animals can be mitigated by making sure that the site is stable and double checking that no further excavations take place after the rehabilitation has been done.

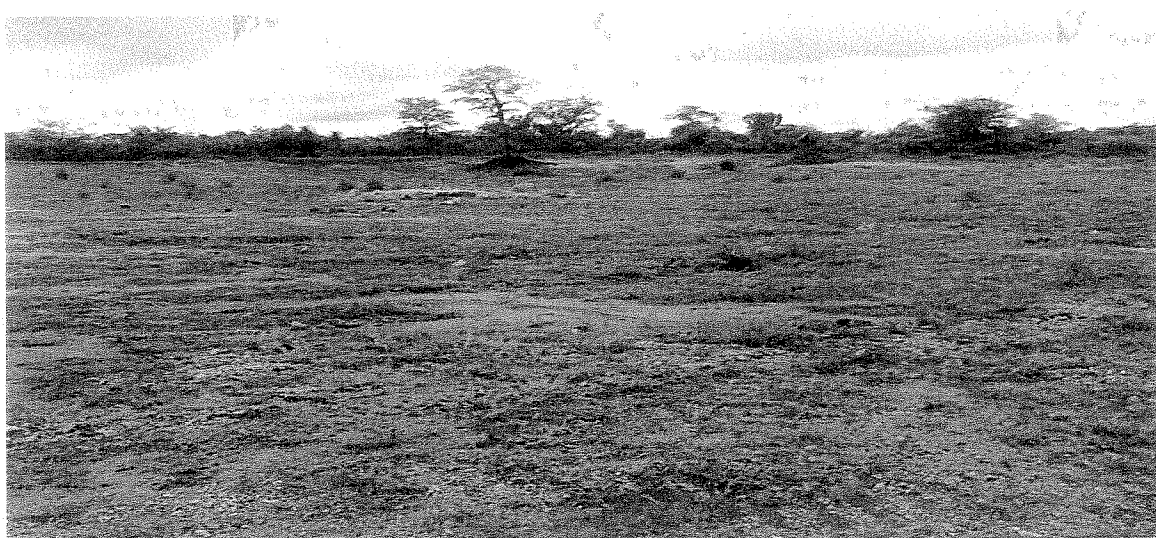
If rehabilitation is to take place in areas that are classified as grasslands, there is no need for the introduction of seedlings. Note that the natural vegetation has already started growing on site after rehabilitation was done.

The picture above illustrates the growth of vegetation on rehabilitated area.
