Structural Integrity of Existing Roofs at
St Augustines Hospital Heart Care
Centre, Cnr JB Mark and Clark Road,
Durban

**Report to Netcare Limited on the Structural Integrity of Existing Roofs
at St Augustines Hospital Heart Care Centre, Cnr JB Mark and Clark
Road, Durban**

22 April 2013

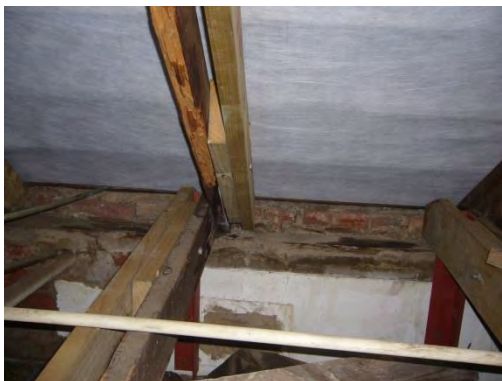
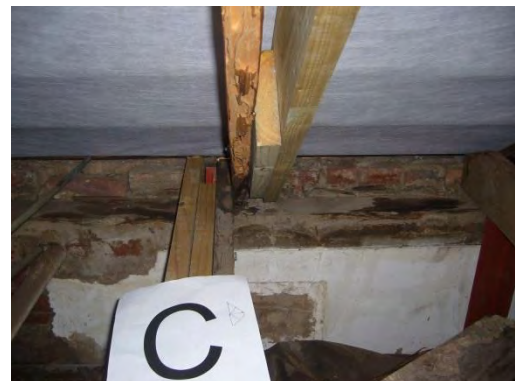
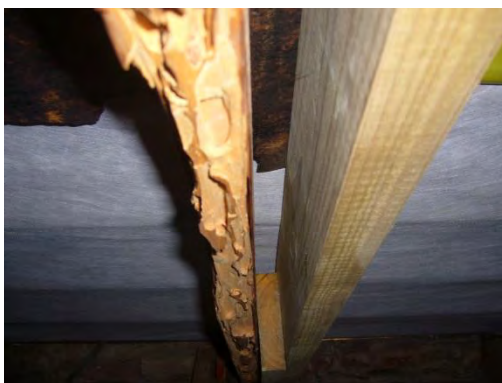
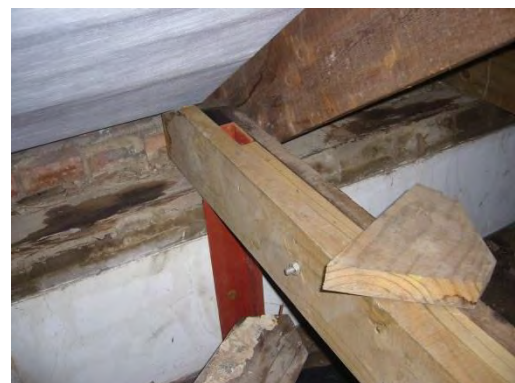
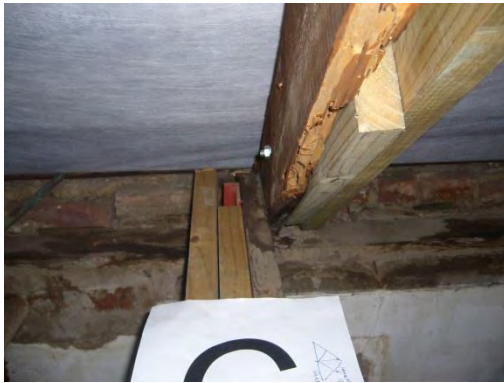
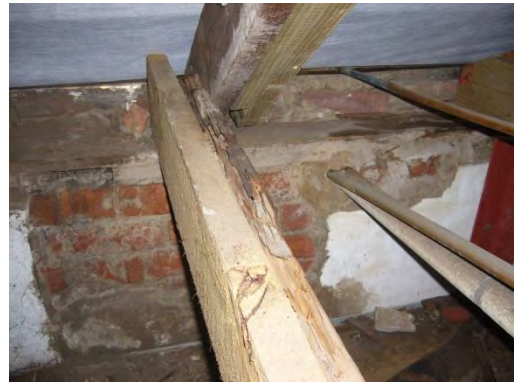
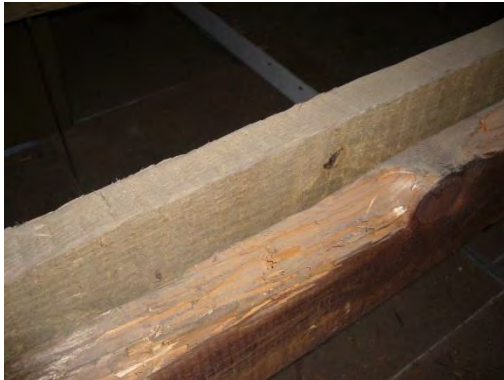
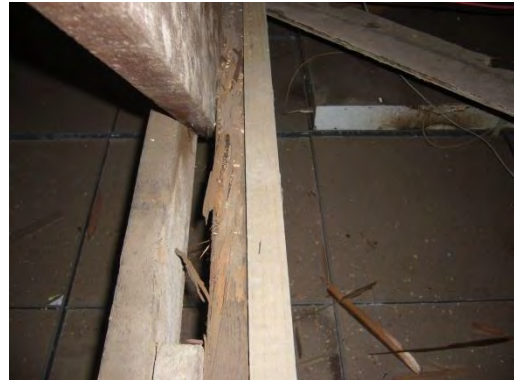
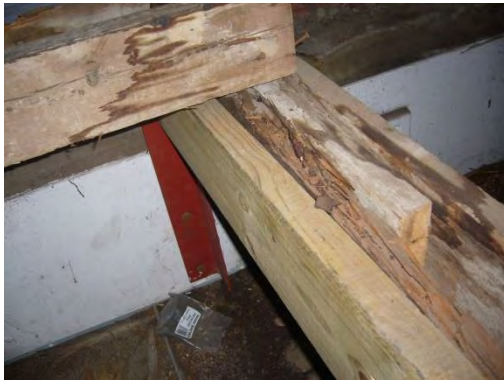
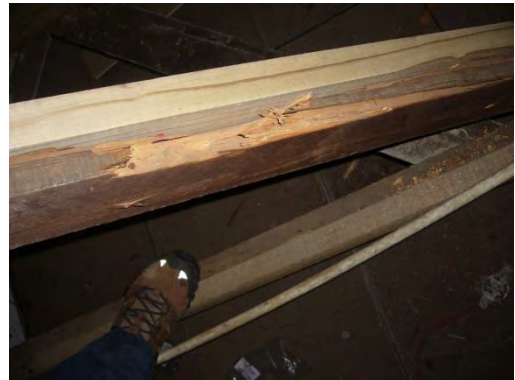
4.1 Area C – North Facing

This section of the building faces Clark Road. According to the hospital's Technical Services Supervisor, remedial work was undertaken on this portion during 2012. This remedial work consisted of attempting to strengthen those existing trusses that had been severely affected by wood borer by fixing new timber members to the bottom chords and sloping members of existing trusses.

The inspection revealed extensive damage to the existing roof trusses due to wood borer infestation. There are numerous timbers in this area, including those where strengthening was carried out, that only comprise of the outer skin of timber, with the inside being virtually hollow. Due to the extent of the damage to existing timbers, it is questionable as to whether the strengthening carried out has had any meaningful benefits.

Due to the extent of damage, the structural integrity of this portion of the roof has been severely compromised. Ongoing wood borer activity is evidenced by the wood borer frass on the ceiling. Any further damage to the roof trusses raises the risk of collapse of this section of roof.

Due to the nature and extent of wood borer damage noted during the investigation of the Heart Care Centre roof, the existing roof timbers are considered to be damaged beyond repair. It is thus recommended that all the timber trusses to the entire roof structure be replaced with new trusses.

Installation of a new roof can be undertaken in phases in order to limit the disruption to the occupants of the building. It is recommended that the first phase should be the area facing Clark Road, as it is the most severely damaged area.

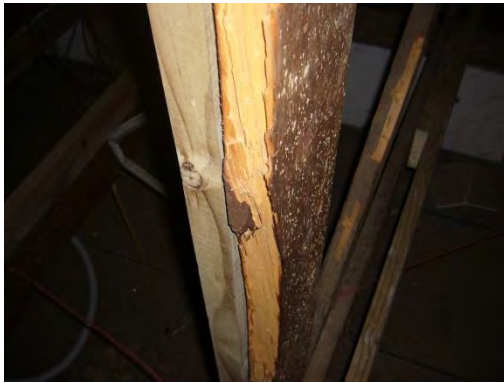
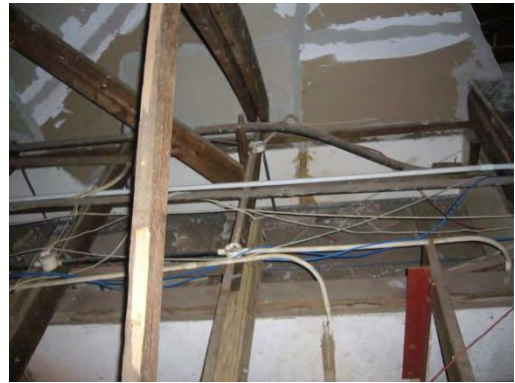
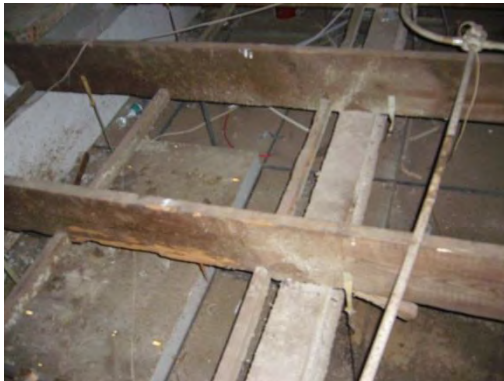
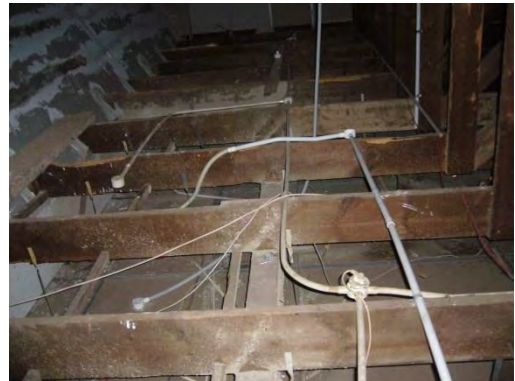
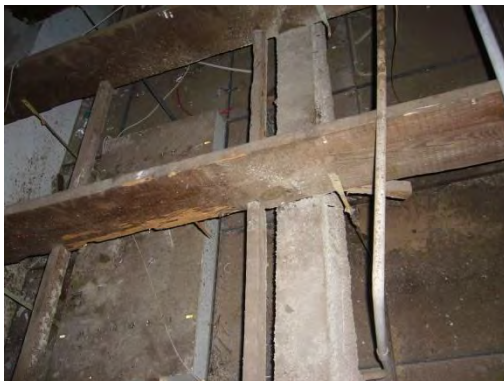
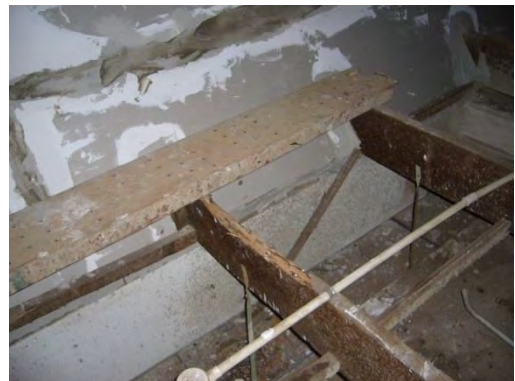
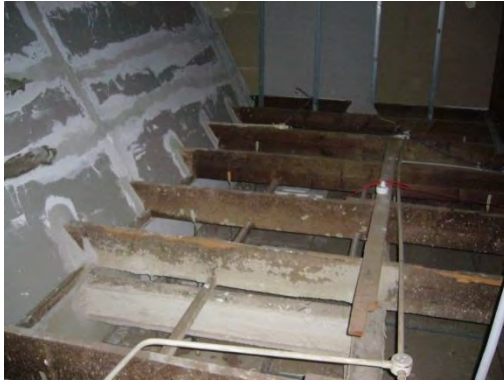
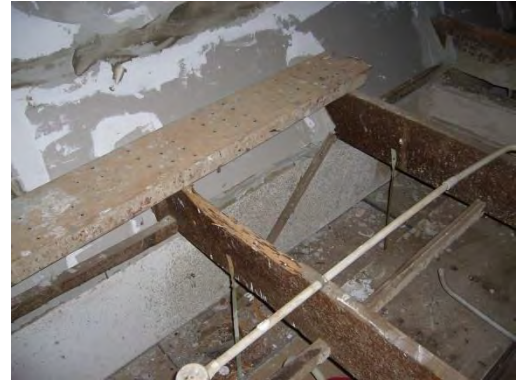
4.2 Area B – West Facing

This section of the building faces J.B Mark Road. Sections of this roof have also been strengthened as per the roof area referred to in section 4.1. The condition of these trusses are also poor with abundant evidence of active wood borer. Many of the bottom chords of the trusses are infested with borer.

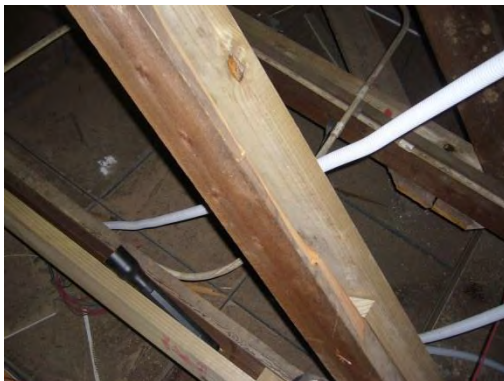
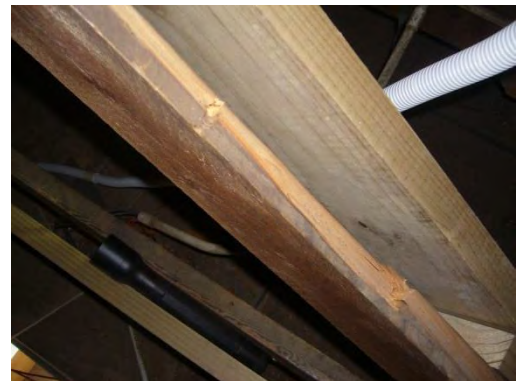
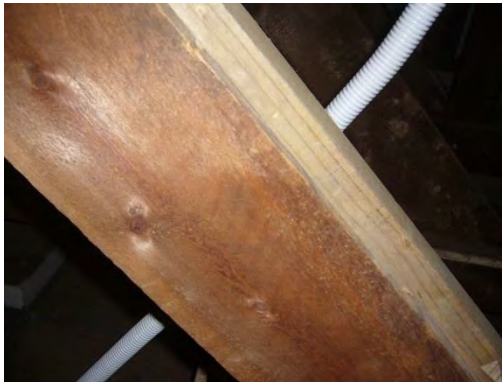
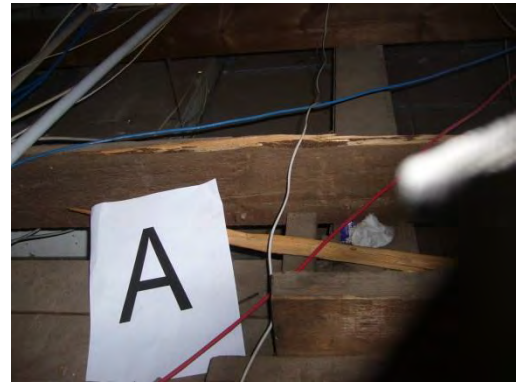
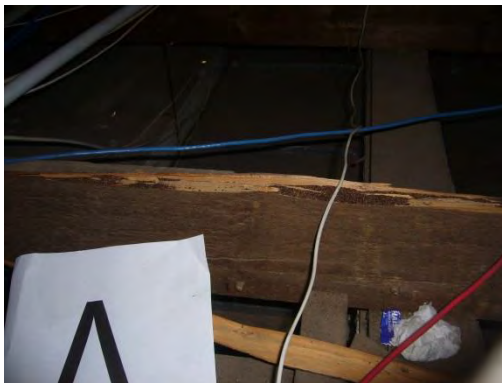
4.3 Area A – South Facing

This existing timbers in this area appear to have been treated in the past by injection method. The date of this treatment is unknown.

A visual inspection is misleading in so far as the outer surfaces of the truss appears to be unaffected by wood borer. However in a number of instances where the outer surface was hammered away exposing the underlying timber, the inside was found to be porous and riddled with wood borer tunnels. The network of tunnels inside the wood is not necessarily visible from the outside.
