# O.R. TAMBO HOMESTEAD

## STRUCTURAL IMPACT ASSESSMENT REPORT OF EXISTING STRUCTURES

FEBRUARY 2013

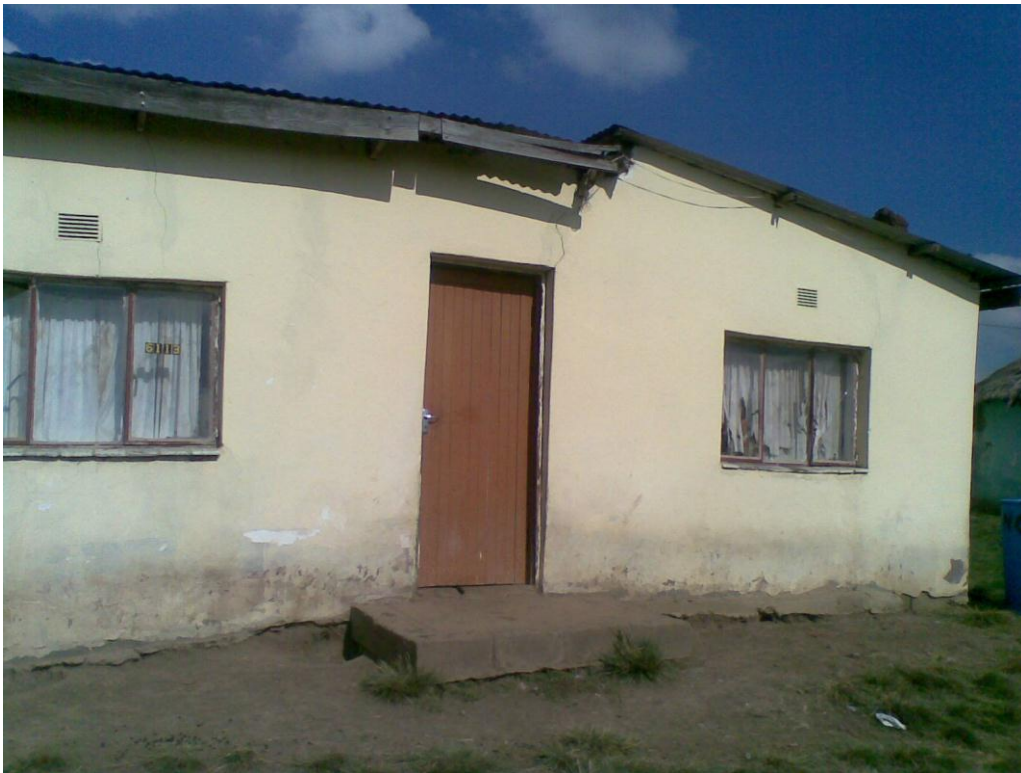
This view, the front elevation, clearly shows that the roof timber has rotted. The window and door frames are in poor condition. The walls have cracks above the windows and door. There are also indications of rising damp. The top part of the wall on the right hand side is leaning to the right. The walls are of concrete blocks as can be seen in the exposed portions.

The roof system definitely requires replacement. This means removal of all sheets, purlins and rafters. Replace the system with new rafters and purlins designed to present day codes of practice, but to use similar lines as were used in the original. The sheets should be replaced with the same profile. There should be no ceiling as there never was one. The fascia boards were also of timber and should be replaced. All the timber should be termite proofed and the external portions painted to the Architect's specification.

All rotted timber should be replaced, such as the door frame.

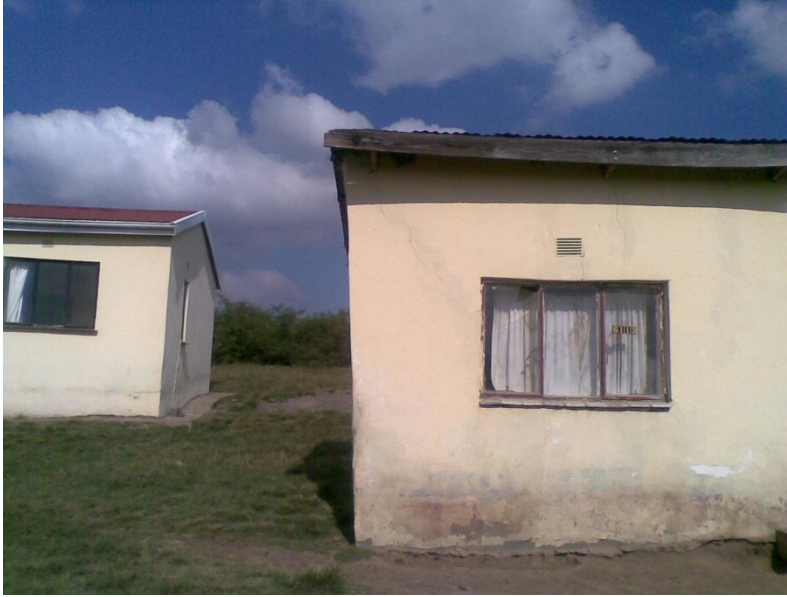
This photograph shows the left hand side of the front elevation. The wall on the left is leaning towards the left and has resulted in the formation of the crack in the front wall.

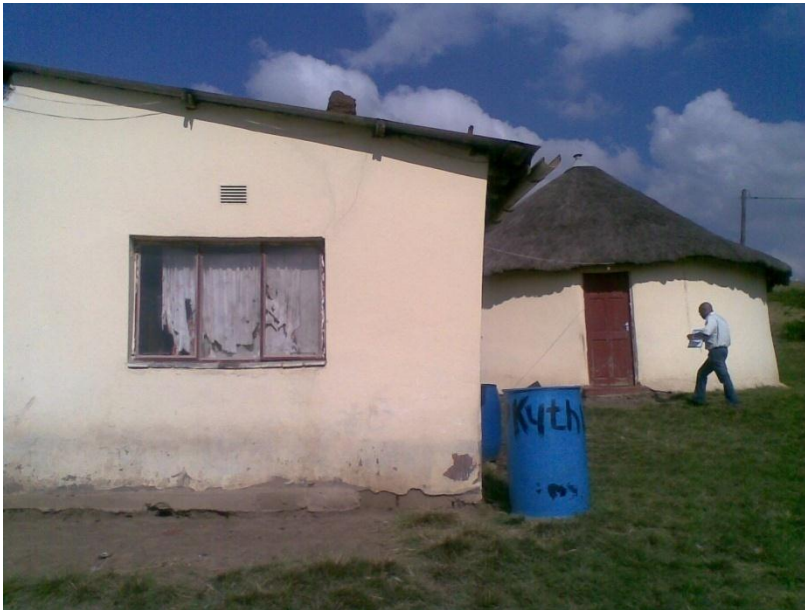
This photograph shows the right hand side of the front elevation. The right side wall is leaning outwards such that it has caused a tension crack in the front wall.

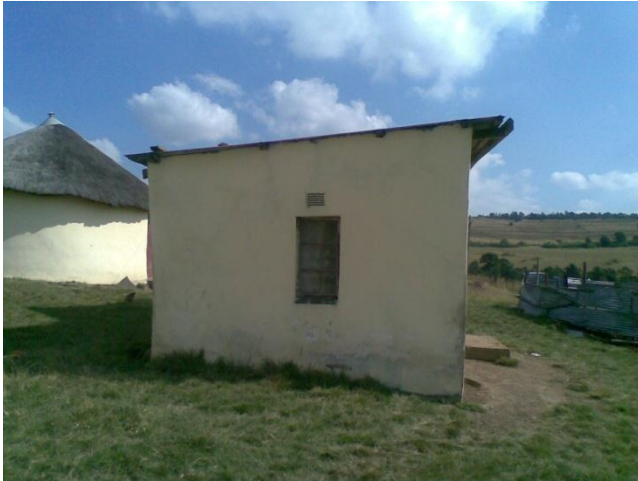
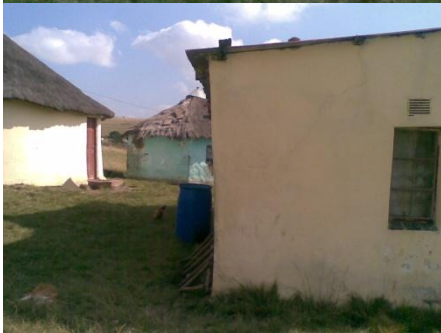
This is the left side elevation. The back wall leaning outwards can be clearly seen.

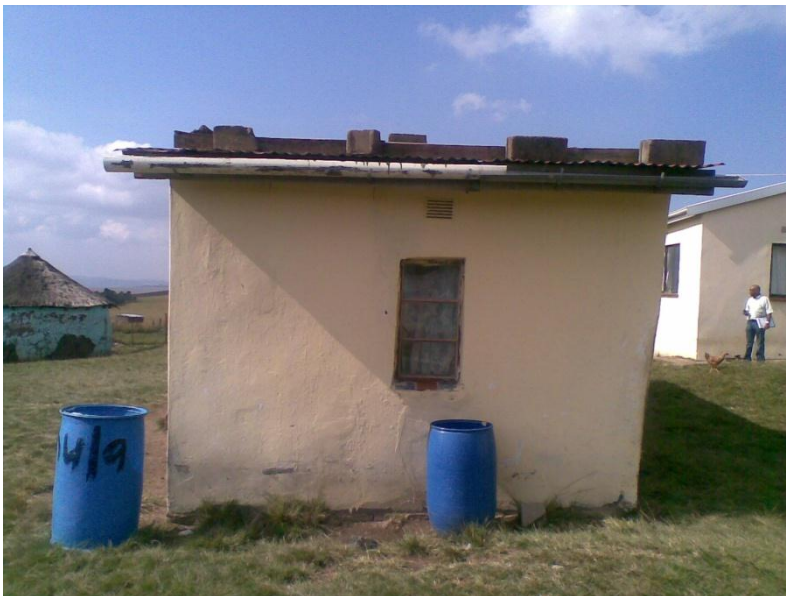
This is the right side elevation. Once again the back wall leaning outwards is clear. The façade shows signs of being touched up recently, so there are no obvious cracks, but we expect them to appear due to the leaning wall. Note also the condition of the roof. The sheets will need to be replaced.

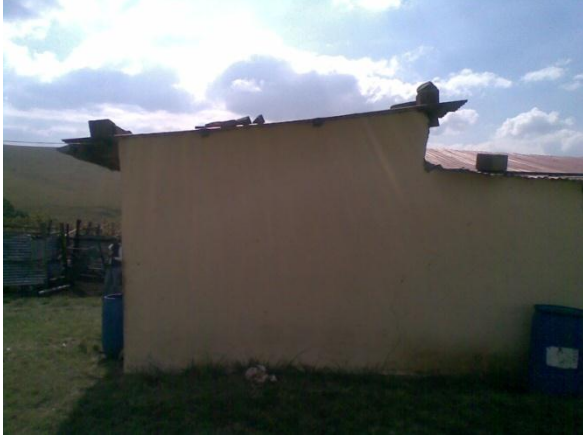
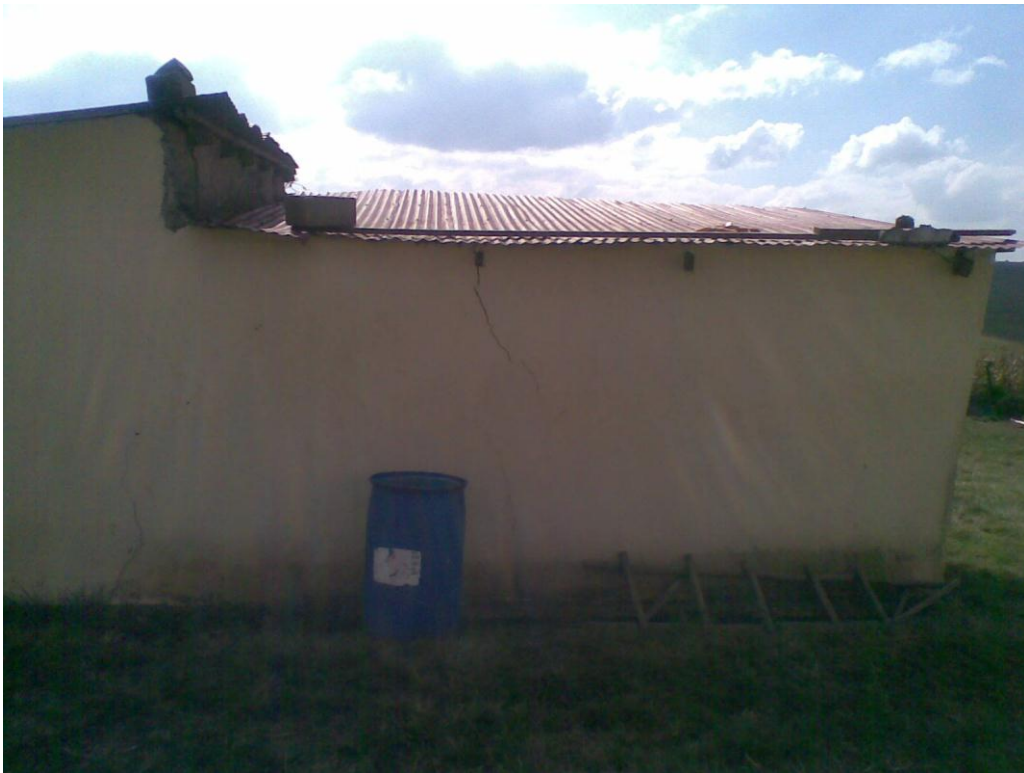
The two photographs above show the whole back wall. The left and right walls are leaning outwards in each case. The back wall itself has two full height cracks, from the ground to the roofline. One is by the change in height of the wall, which is reflected at the front wall above the doorway and the other is just right of the blue drum.

The walls need to be reinforced as they are not straight, in order to avoid or significantly reduce continuous cracking taking place. The back wall appeared to be the worst case, so the plaster will have to be removed to expose the blocks and the problems within. A solution will be to "stitch" the wall using reinforcement in the mortar joints. It will also be necessary to replace damaged blocks to ensure stability. In a similar way all the other walls where there are cracks, will be exposed and repaired, maintaining the existing shape of the wall, be it straight, at a slant or curved. The top three courses will have

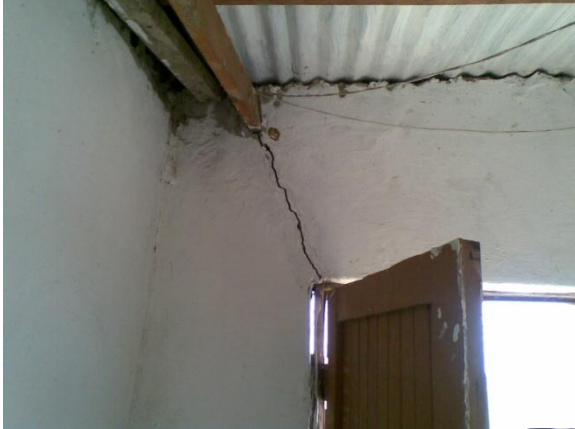
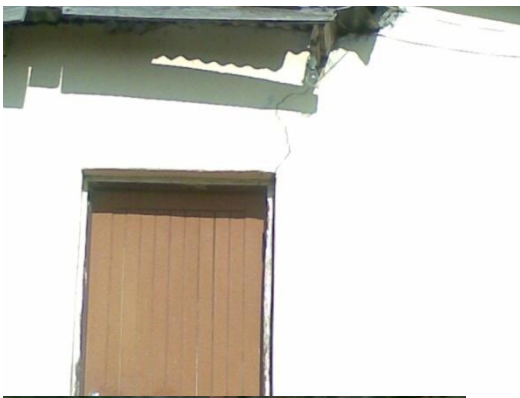
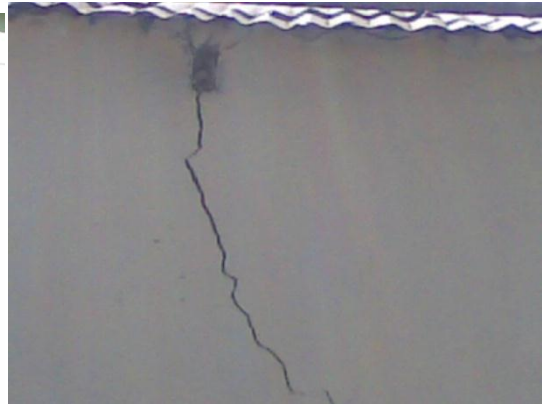
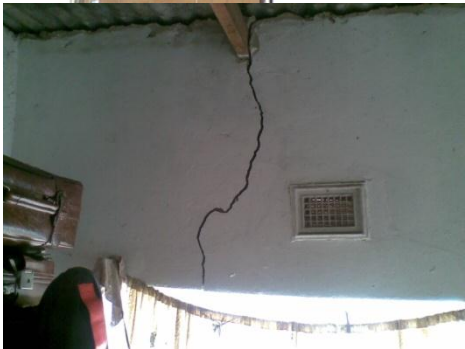
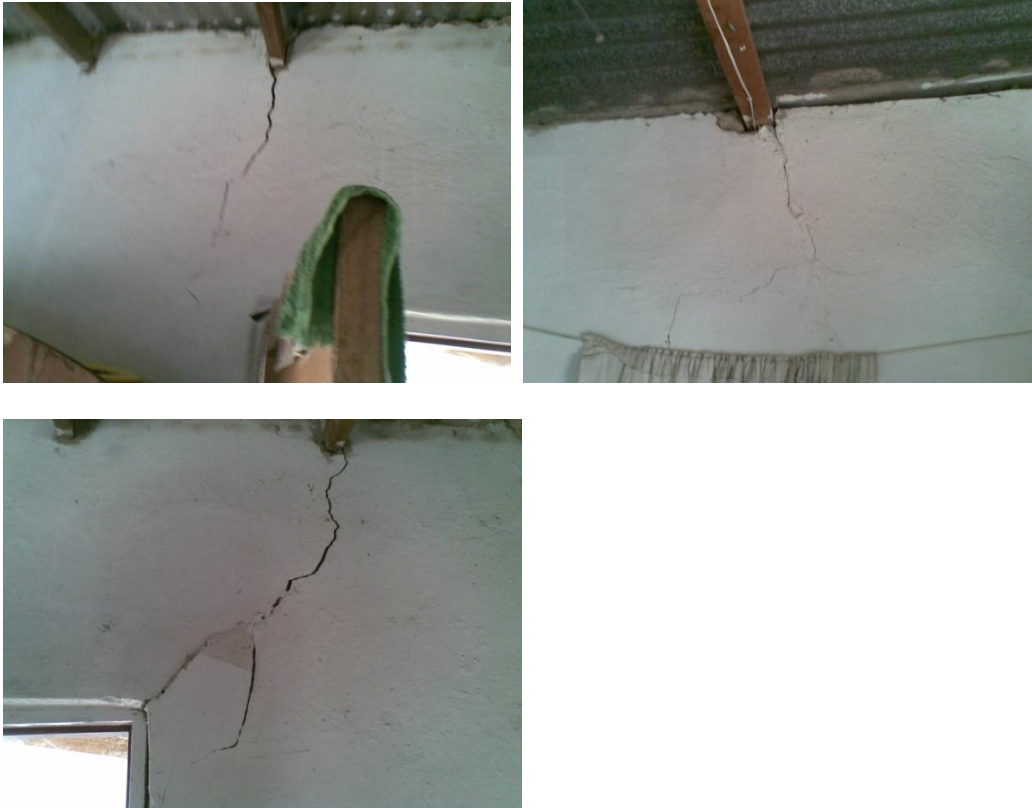
This collage simply highlights the fact that all the walls have cracks in them and that these need to be addressed.

Each crack will be exposed to the underlying block wall. The condition of the blocks will be assessed first, replacing any that are damaged. An angle grinder will then be used to cut into the mortar joints. The joints will then be washed clean. The next step will be to place 10mm high yield steel reinforcement into the joint together with fresh mortar. The mortar mix will be 1 part cement to 4 parts sand. The bars will extend 500mm minimum each side of the crack. This method is commonly called "stitching". This procedure will be carried out both externally and internally, but at different times so as to allow curing time for each side. Doing this to both sides at one time will weaken the structure, so it will not be accepted generally except where a block is being replaced. Finally plaster over with the standard plaster mix. This process will be repeated for all the cracks which are visible already.
