OR TAMBO LEGACY PROJECT -DAC HERITAGE PROGRAMME

ARCHITECT'S IMPACT REPORT ON STRUCTURAL REMEDIES

RESTORATION OF THE OR TAMBO DWELLING

6 JUNE 2014

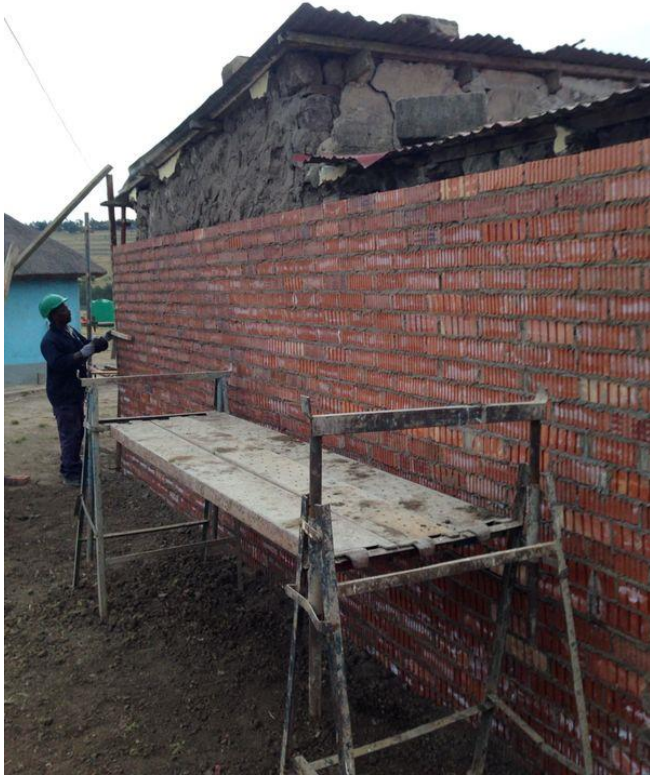
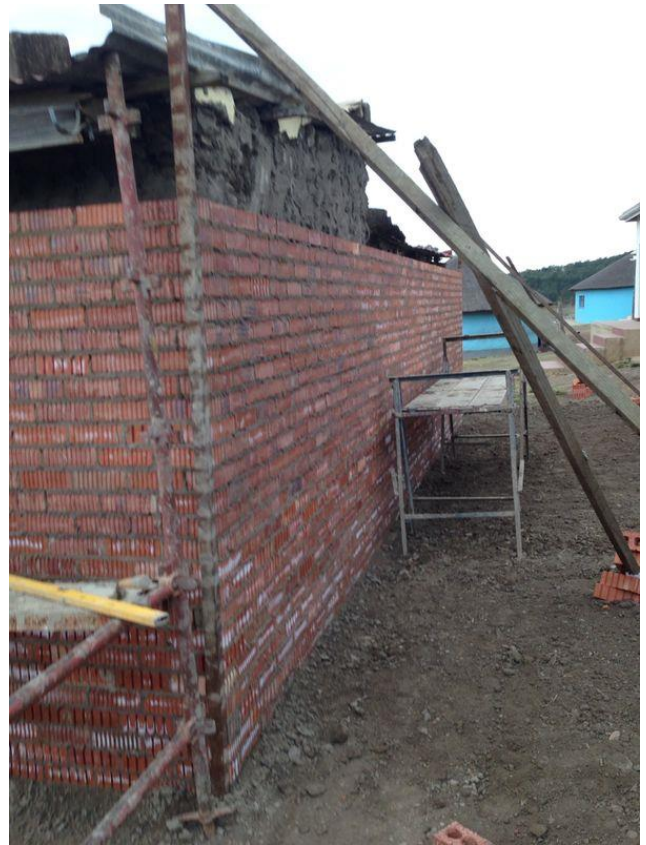
Images 001 & 002: Indicating damages to brickwork, roofing and gumpoles.

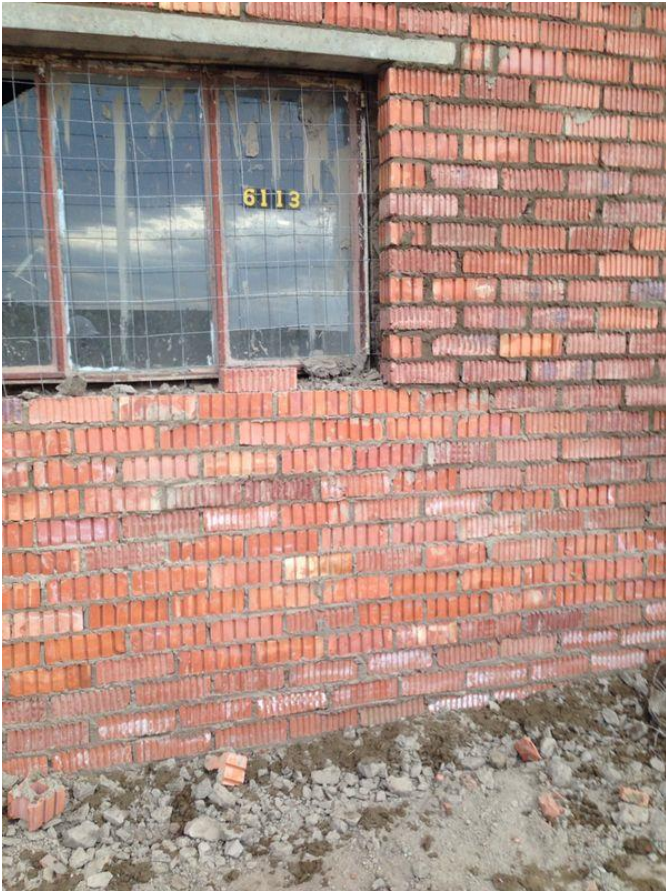
Images 004 & 005: Indicating damages to brickwork, roofing and gumpoles.

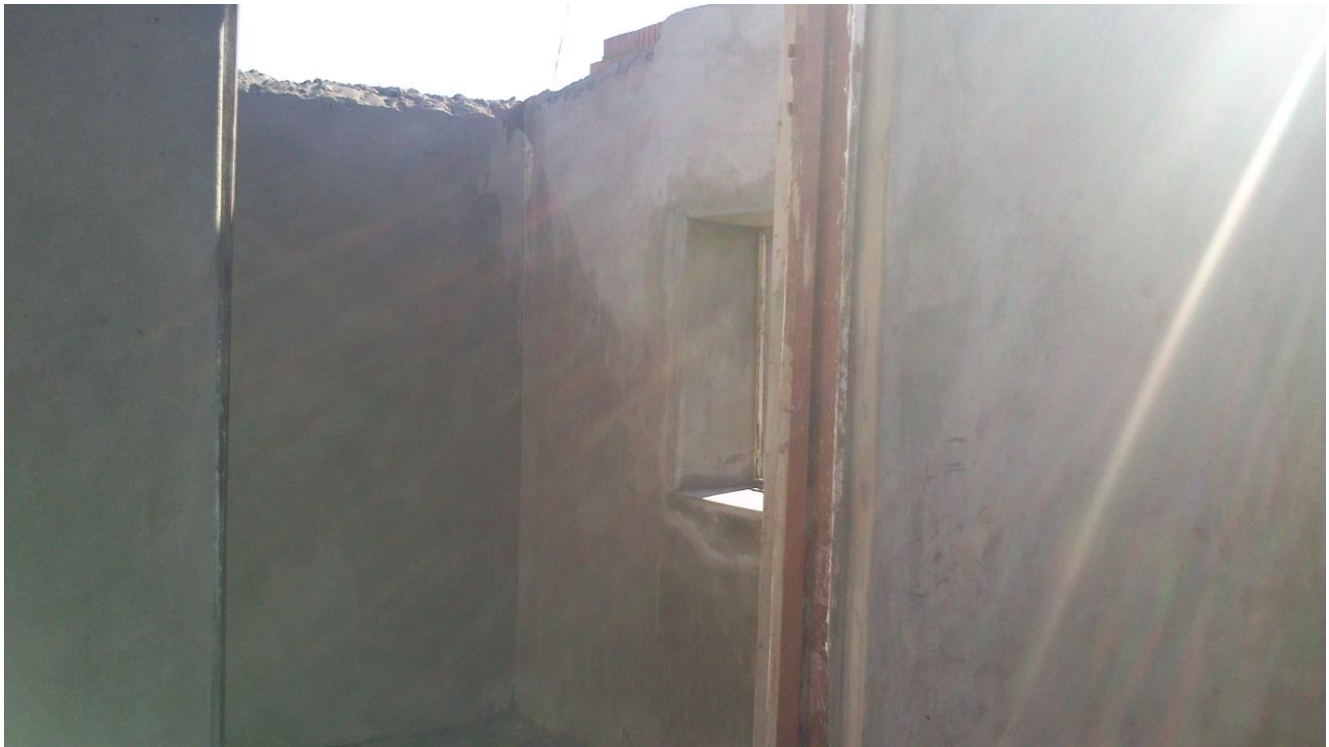
Image 007 Indicating door frame and in background window opening and internal cill

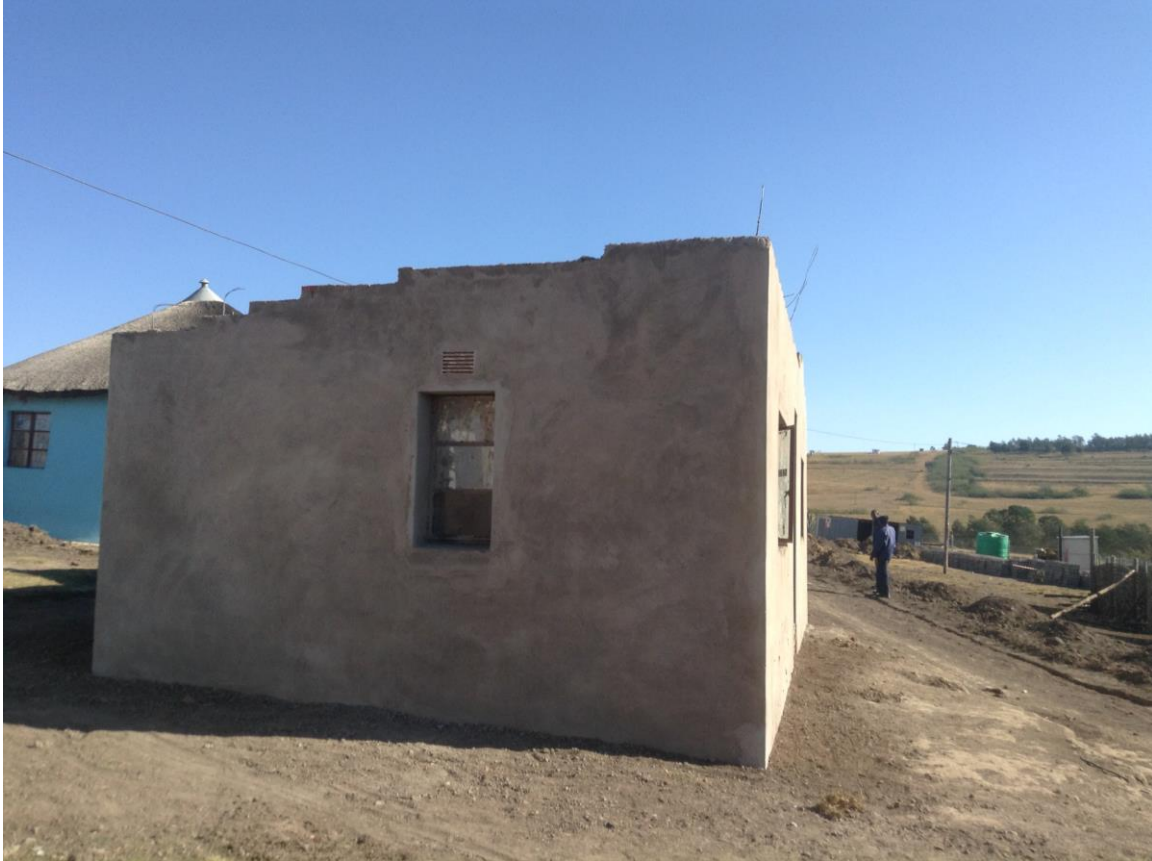
The original external walls of the dwelling which had cracks and were leaning away from the vertical had been covered by a new skin of brick work with a concrete filled cavity as support. The new external wall skin had been build to near perfect square.

The impact with this intervention is visual and the newly built walls are contrary in form to the uneven vernacular walls wich are found in the original walls of the buildings. The position and scale of the ventilation openings in the external walls have been maintained and therefore not affected. It is recommended that the plastering trade is redone to achieve an uneven but smooth texture to achieve the aesthetic integrity of the original dwelling. The overall elevations in length have been increased by 380mm as a result of the new external skin and cavity.

Image 008 Indicating Internal new plaster work external walls

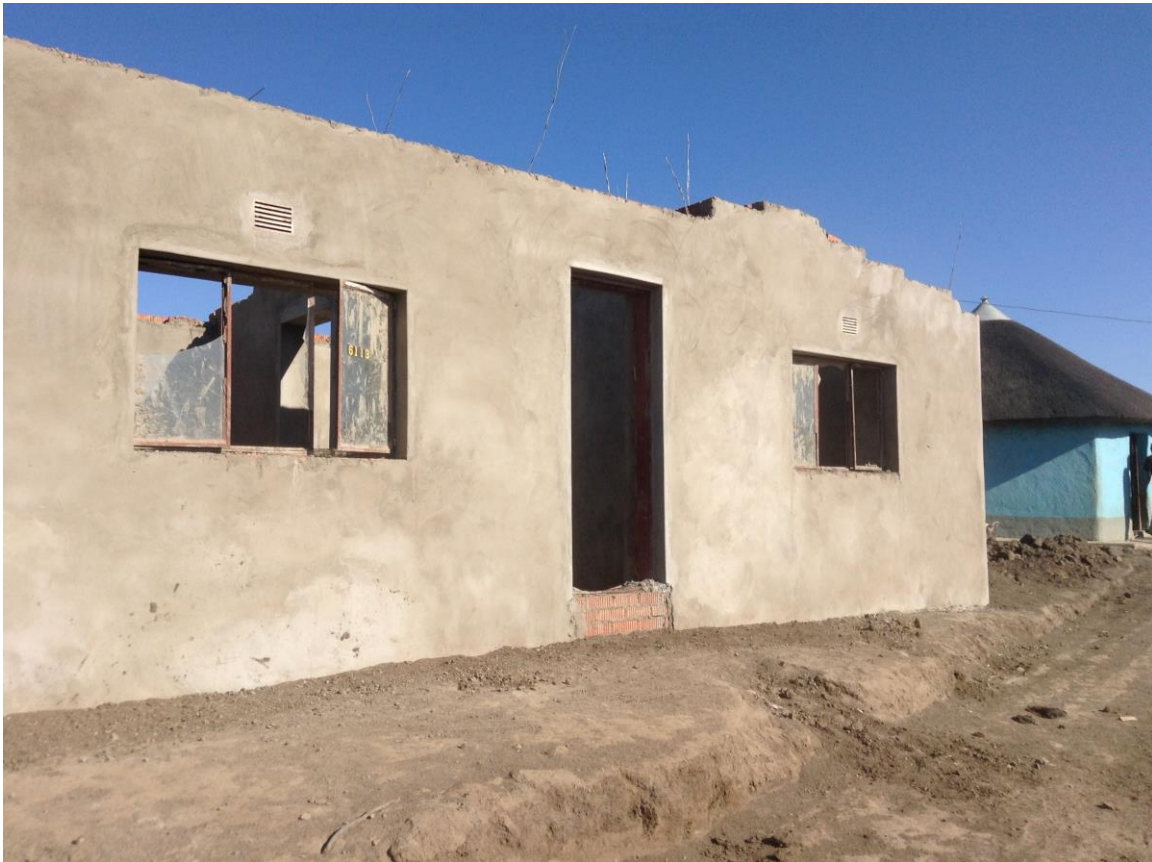
Image 009 Indicating unaffected window, doors and ventilation openings on external walls
