PARLIAMENT PRECINCT: OLD ASSEMBLY BUILDING
PERMIT APPLICATION : CONSTRUCTION OF TEMPORARY ROOF : 2ND FLOOR,
OLD ASSEMBLY BUILDING
BUILT ENVIRONMENT UNIT
DATE: 14 – 04 – 2022

6. Extend of the fire damages at the Old Assembly building

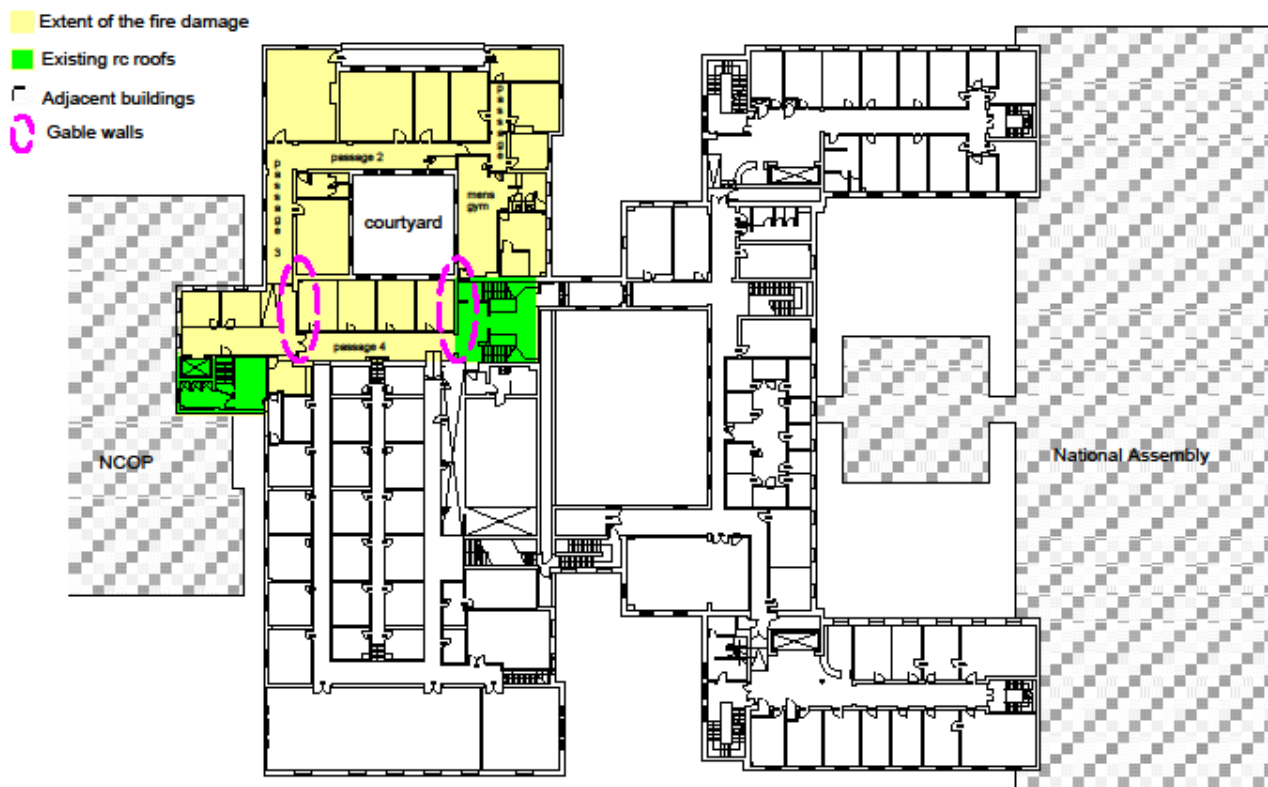
The floor have been completely gutted by the fire. The only remaining structures are the existing brick walls and concrete beams/lintels.

2nd Floor layout, Old Assembly building – Extent of the fire damage

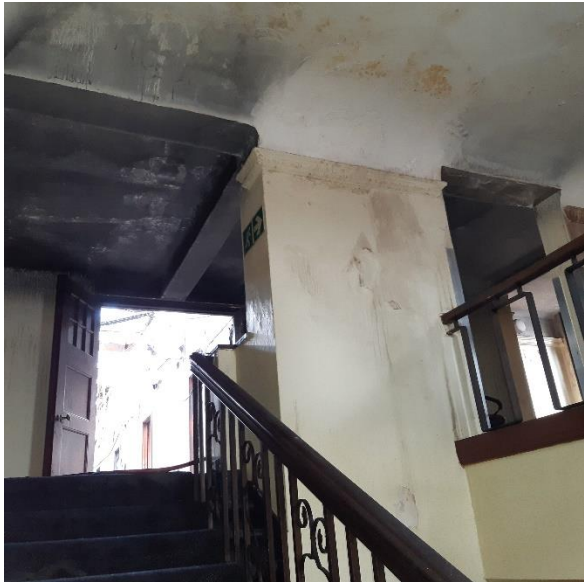
Picture 1 : RC roof over stairs. View from Staircase towards the entrance to the 2nd floor

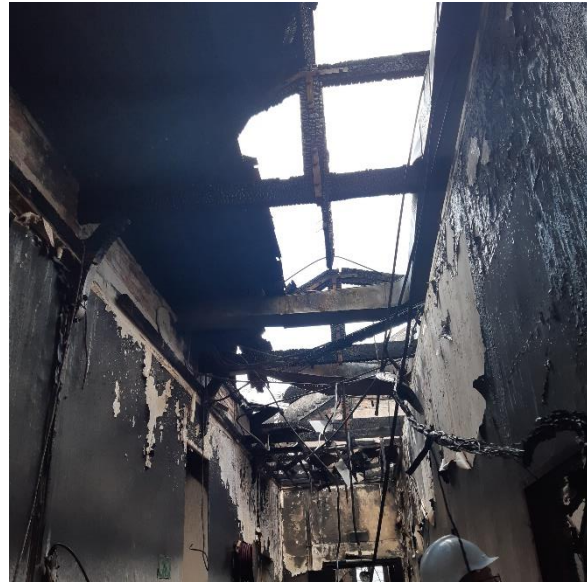
Picture 2 : View down Passage 4

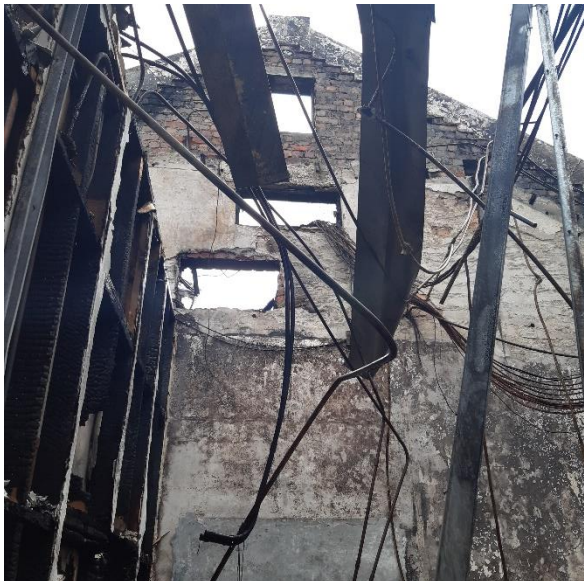
Picture 3 : View towards gable roof

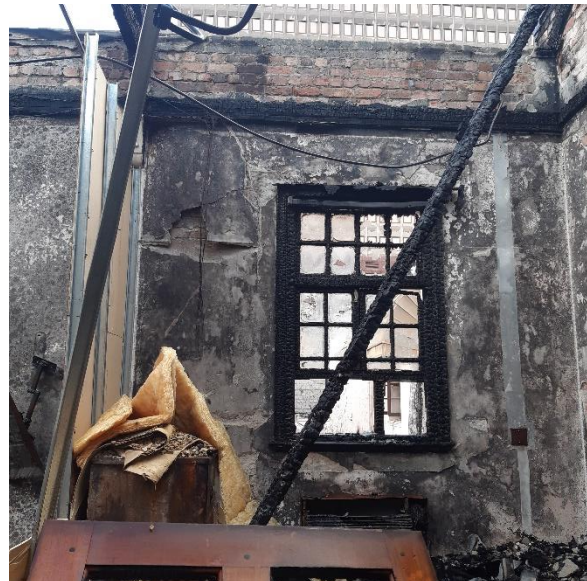
Picture 4 : View in one of the Offices – burned windows

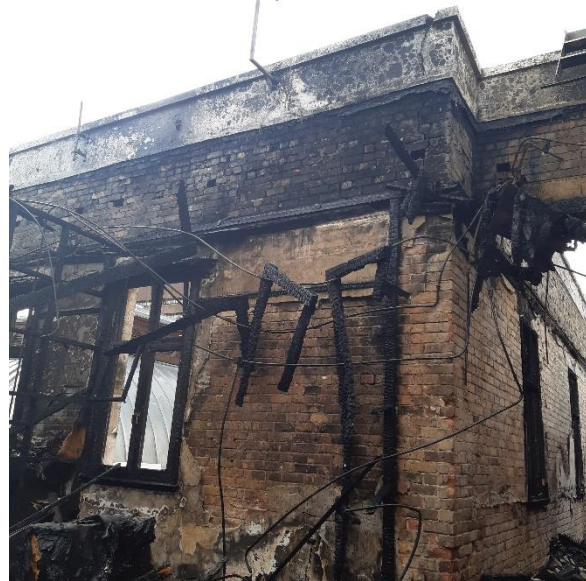
2. The brickwalls, which includes the perimeter parapet walls, two gable walls and intermediate brick walls, are still intact. Cracks have appeared on the façade walls which requires repair and which will have to be dealt with before the temporary roof is installed.
3. The existing timber framed windows have been completely destroyed (burned-out).
4. Part of the suspended timber floor (in the most South Eastern corner of the building) have collapsed. The surviving timber floor has to be tread on carefully.

Picture 6 : Parapet wall – crack in wall

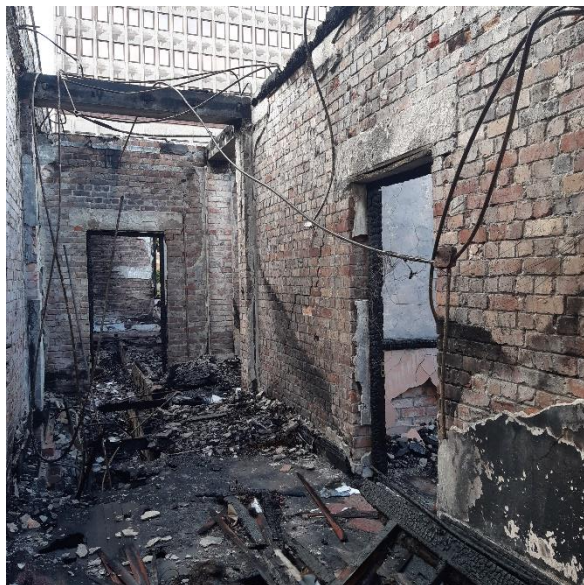
Picture 7 : View down Passage 3

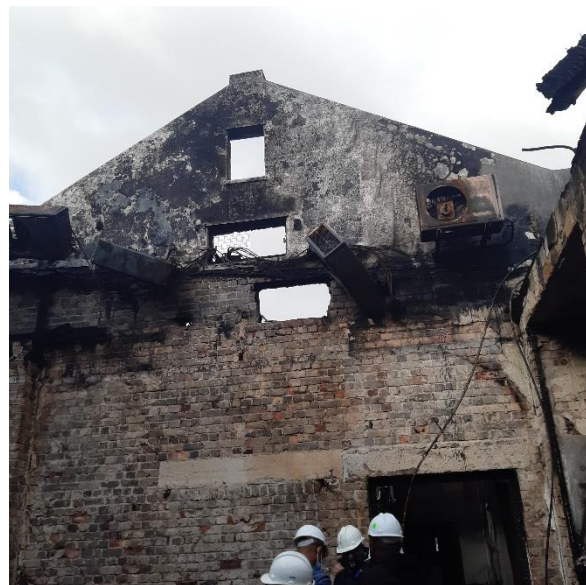
Picture 8 : Close-up of gable wall

1. Making safe the walls, particularly the 2 gable walls by bracing them to avoid the possibility of them falling over.
2. Provide a temporary roof cover over the whole area to avoid further water damage to the lower floors which was largely unaffected by the fire.

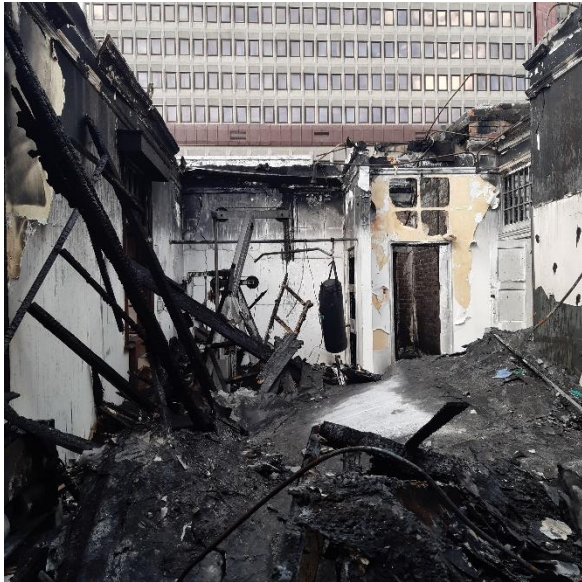
Picture 9 : Men Gymnasium

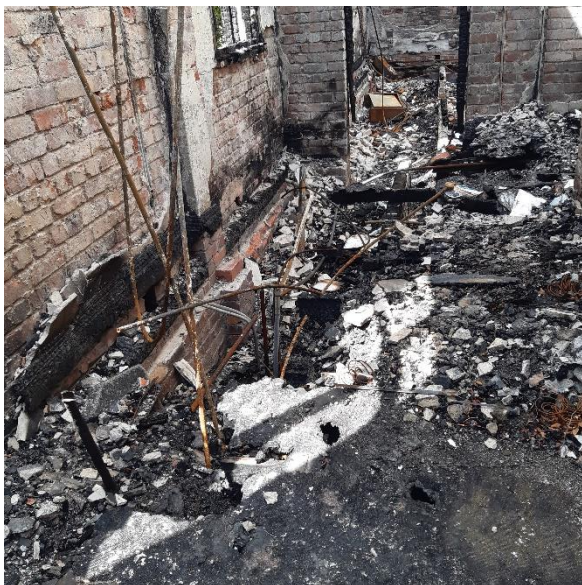
Picture 11 : Collapse of timber floor

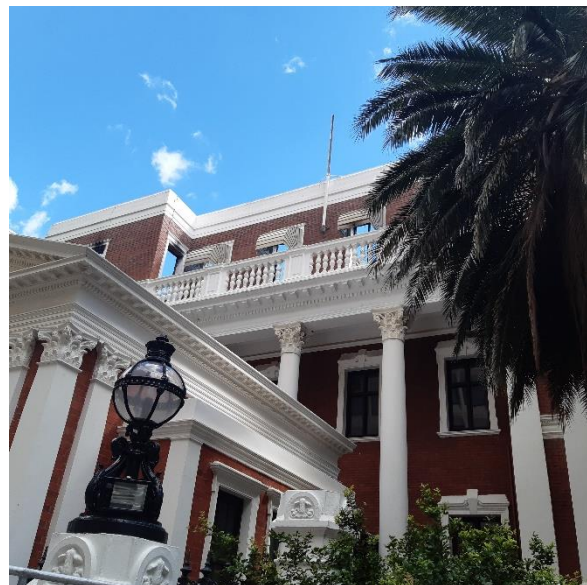
Picture 12 : External view of facade
