# Old Bethlehem – Wine Cellar

PHOTOGRAPHIC  
RECORD OF  
RESTORATION WORK  
for SAHRA

Elisabeth Davies Architect

20 May 2013

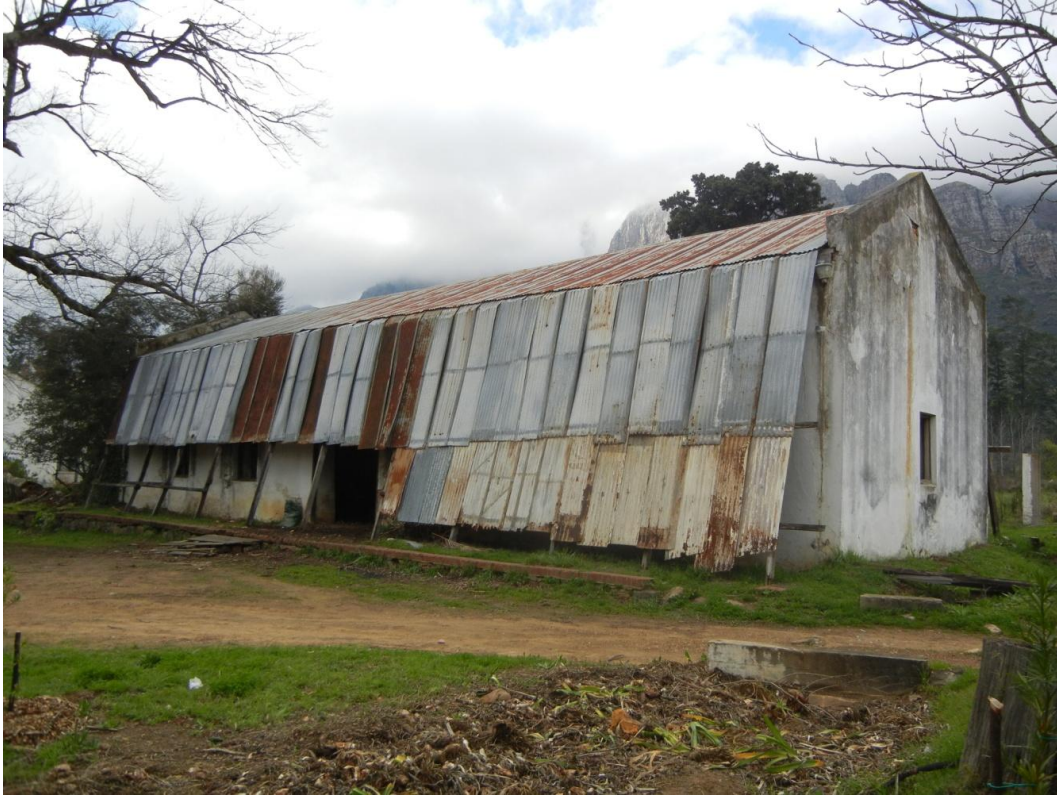
View of Wine Cellar with its protective coat, before restoration

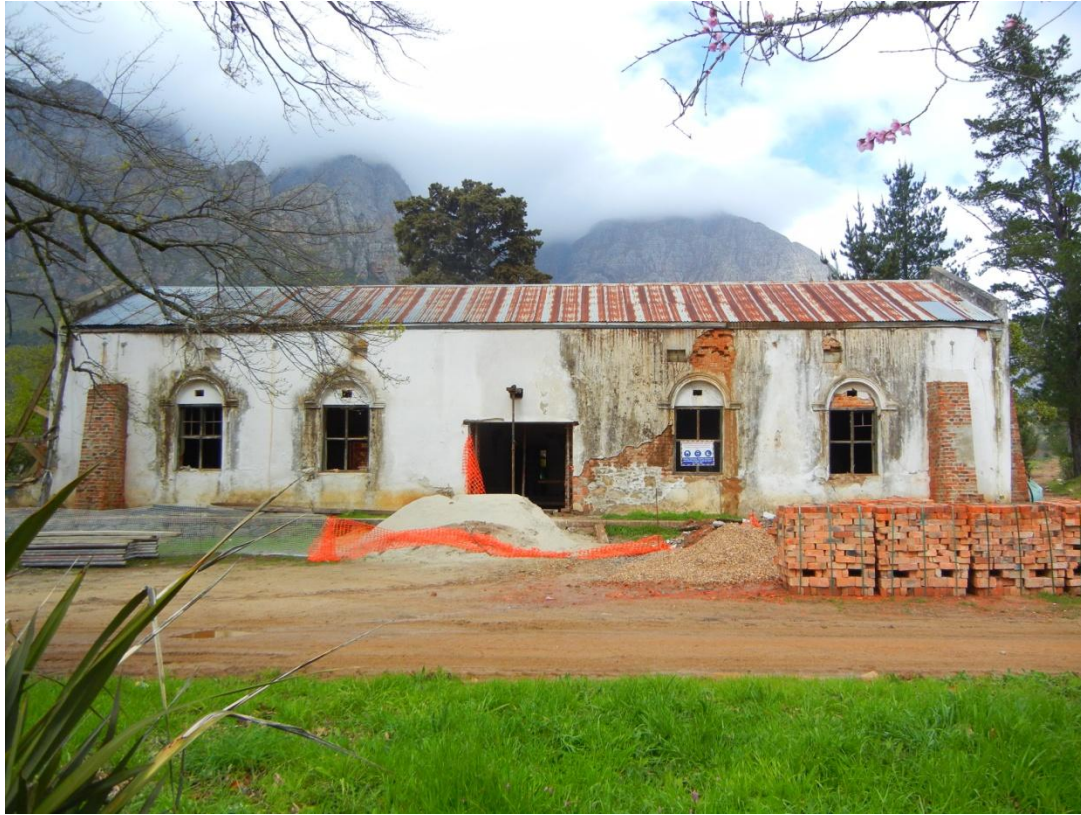
Front View of Wine Cellar at the beginning of the Restoration – Brick Buttresses begun

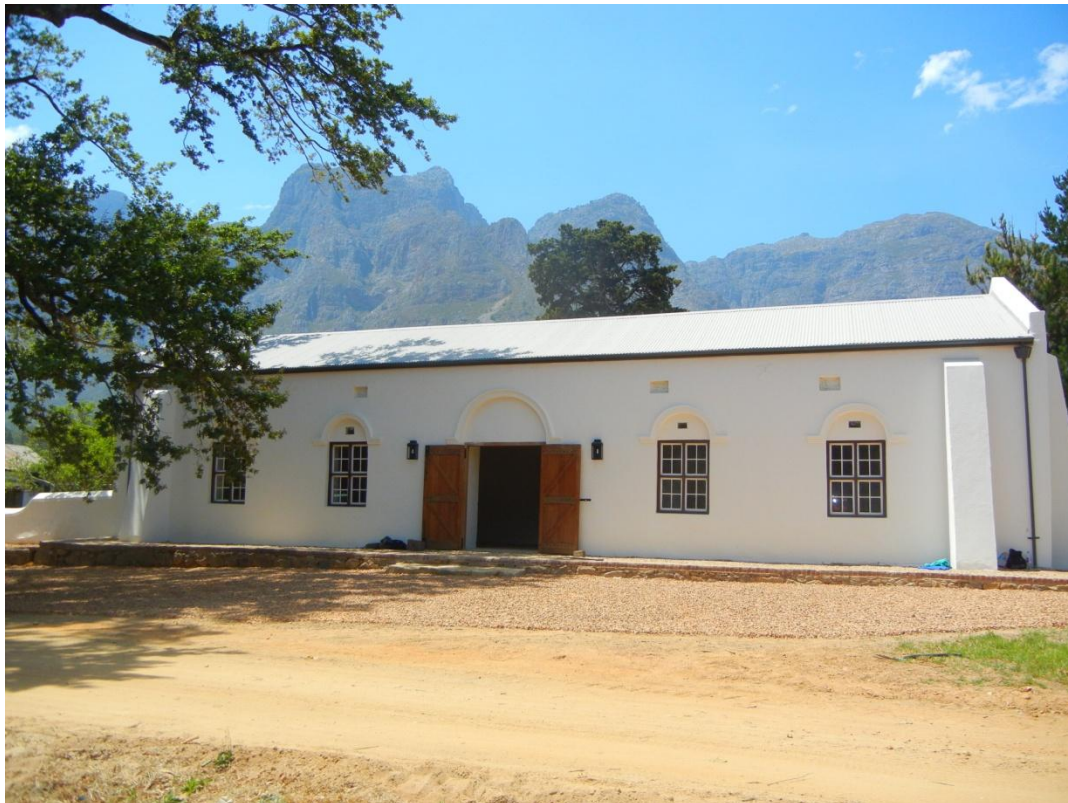
Front View - After Restoration – Dec 2012

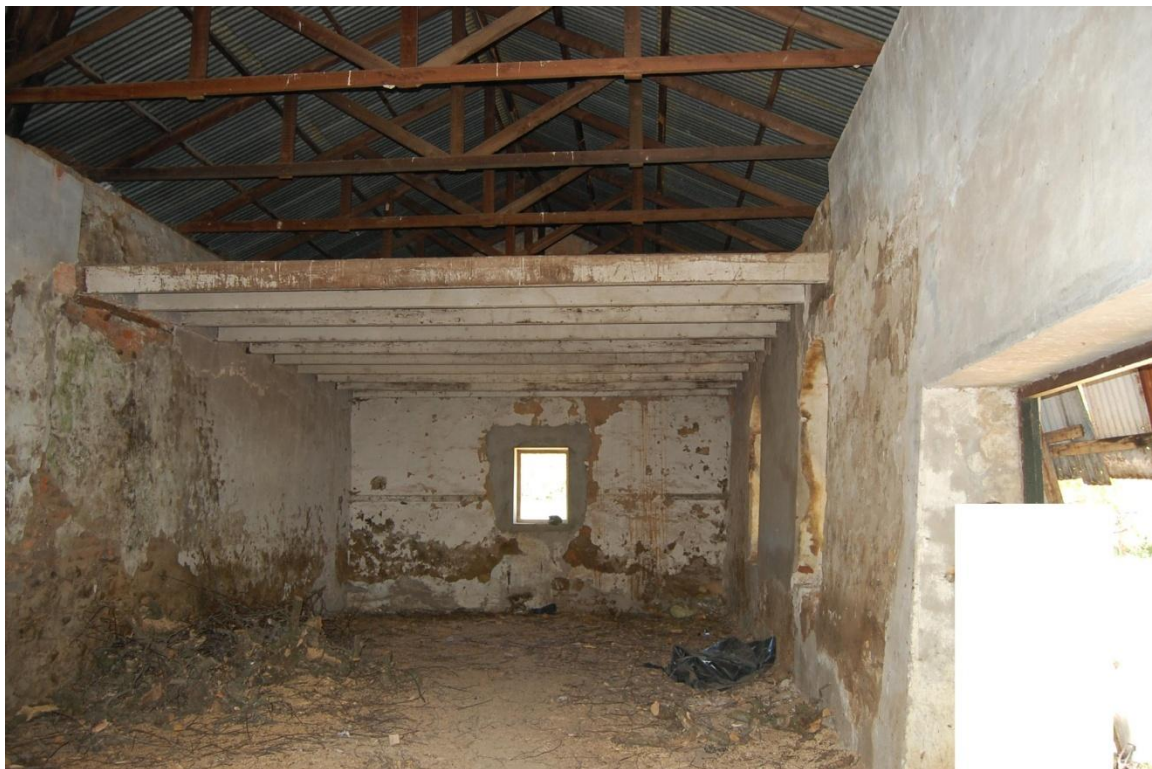
West View of Front Section towards Partial Loft to be removed

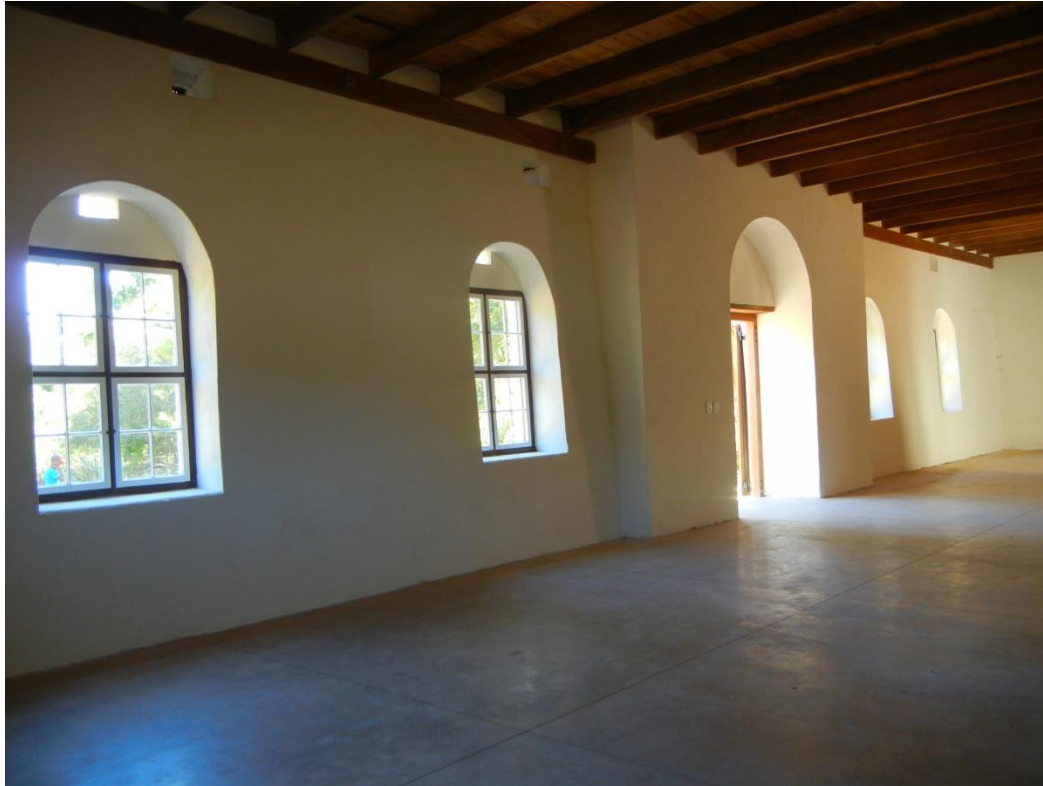
Interior East View – Showing New Arched Interior Buttressing Wall

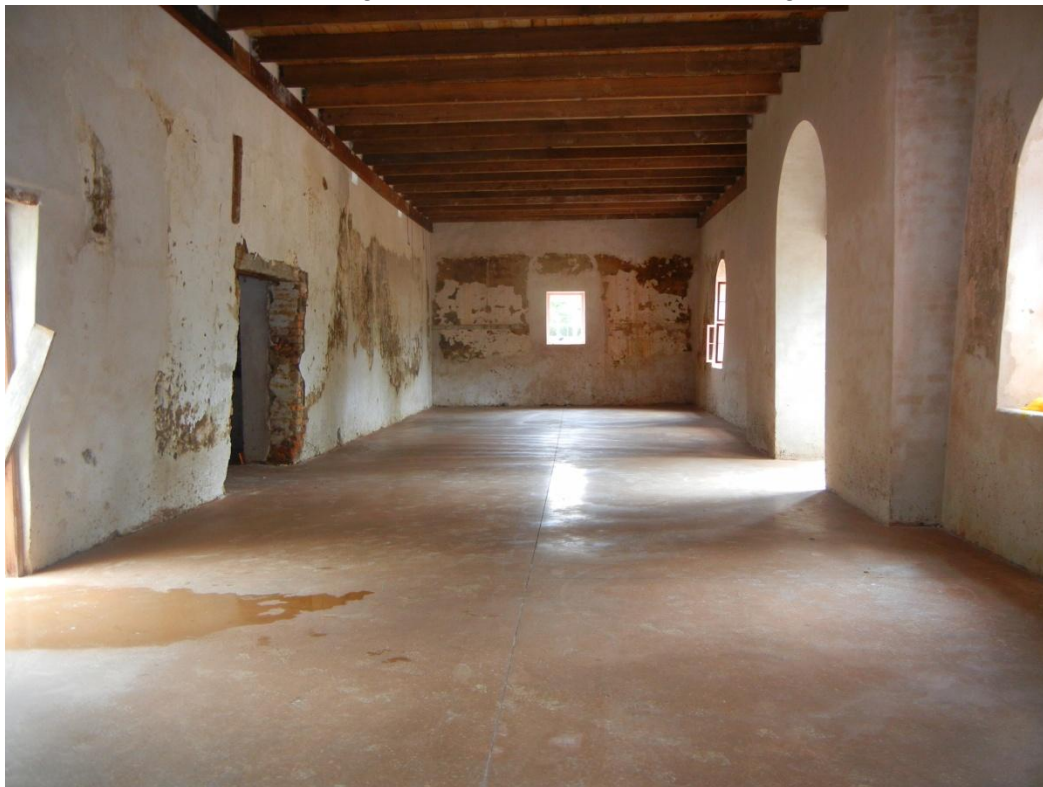
Interior West View – Loft Removed , New Ceiling in place – before Lime washing

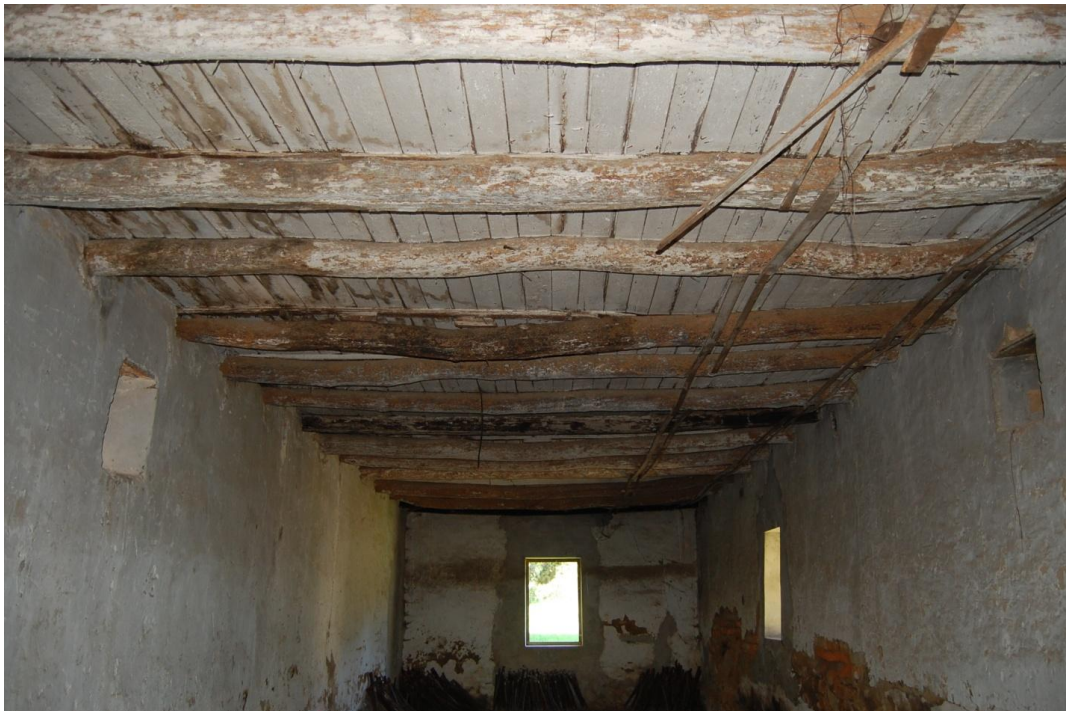
View into Tail Section showing Original Loft Ceiling to be retained

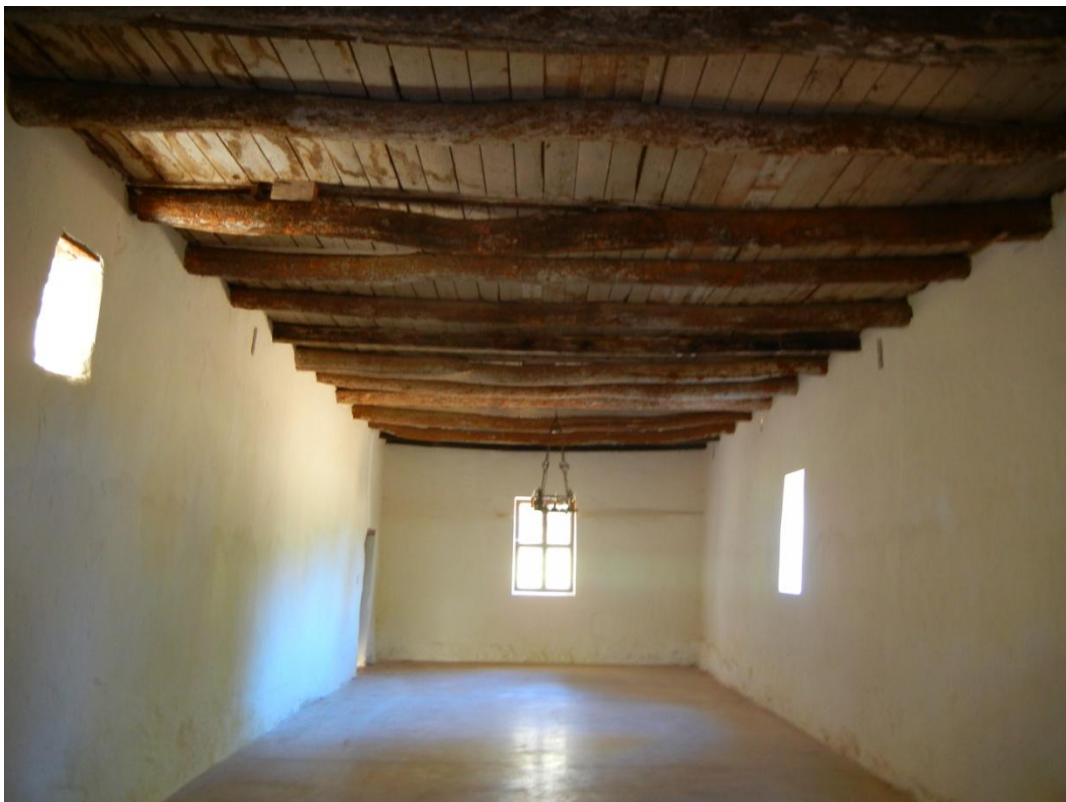
Tail Wing restored – Ceiling Strengthened from above – left unrestored

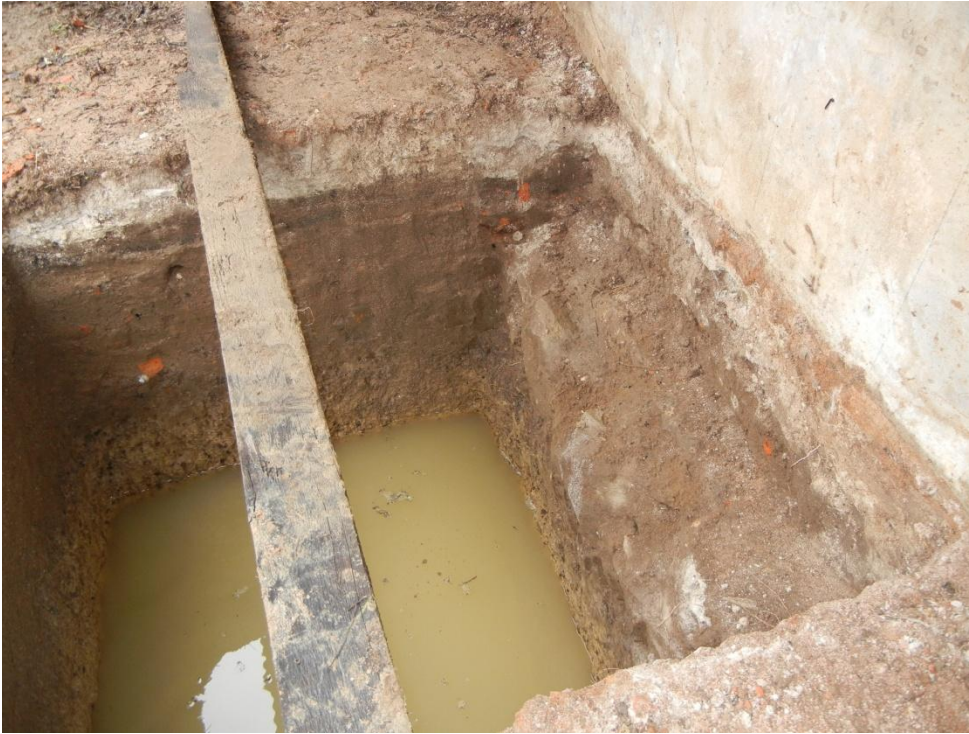
Excavations full of water due to high winter water table

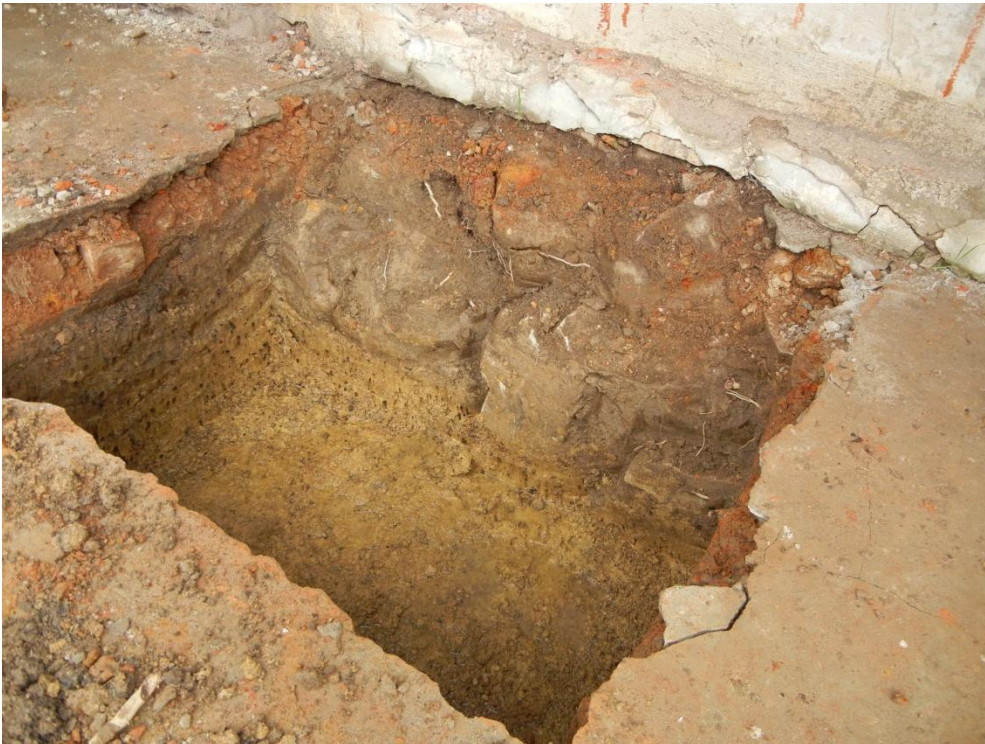
Baled out – showing clay bed and old Stone Foundation

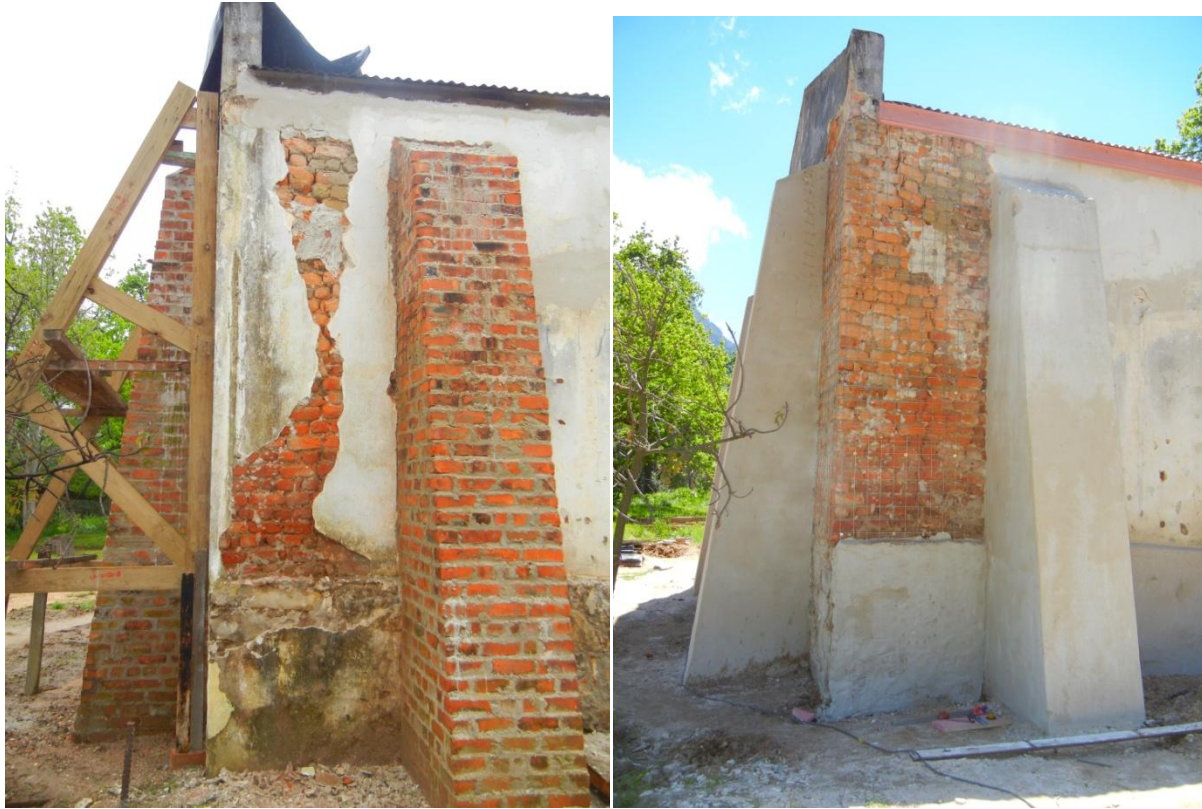
Corners braced, Buttresses built, Cracks opened up and strengthened with Stainless steel mesh screwed in and bent around the corner

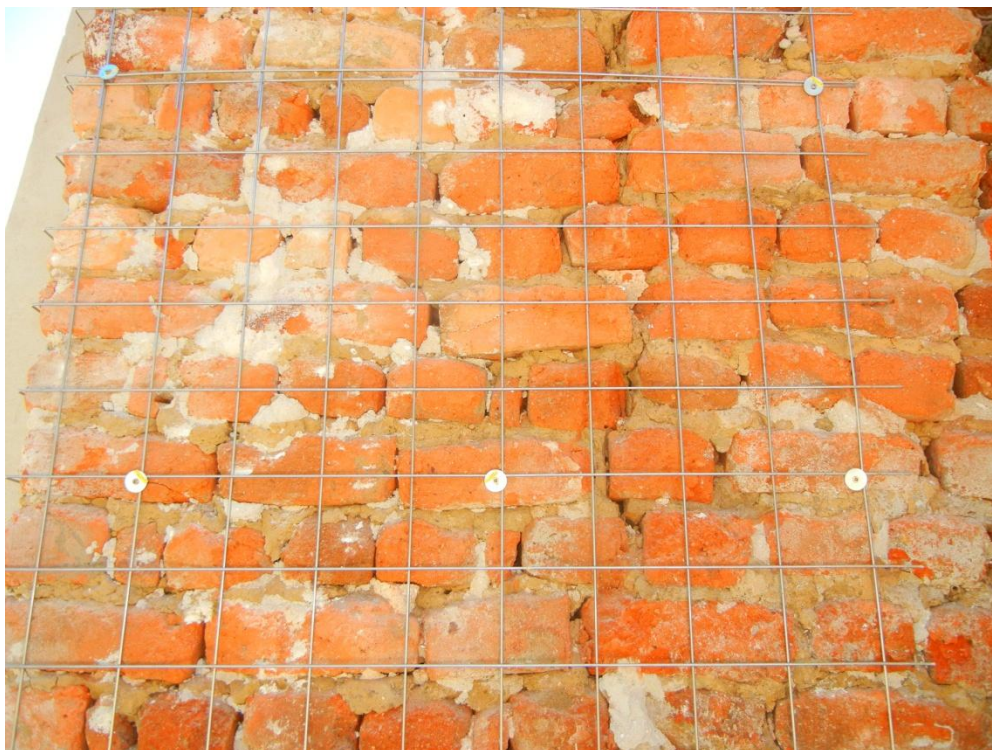
Close up of Mesh Reinforcing, fixed with Wall Plugs and stainless steel washers

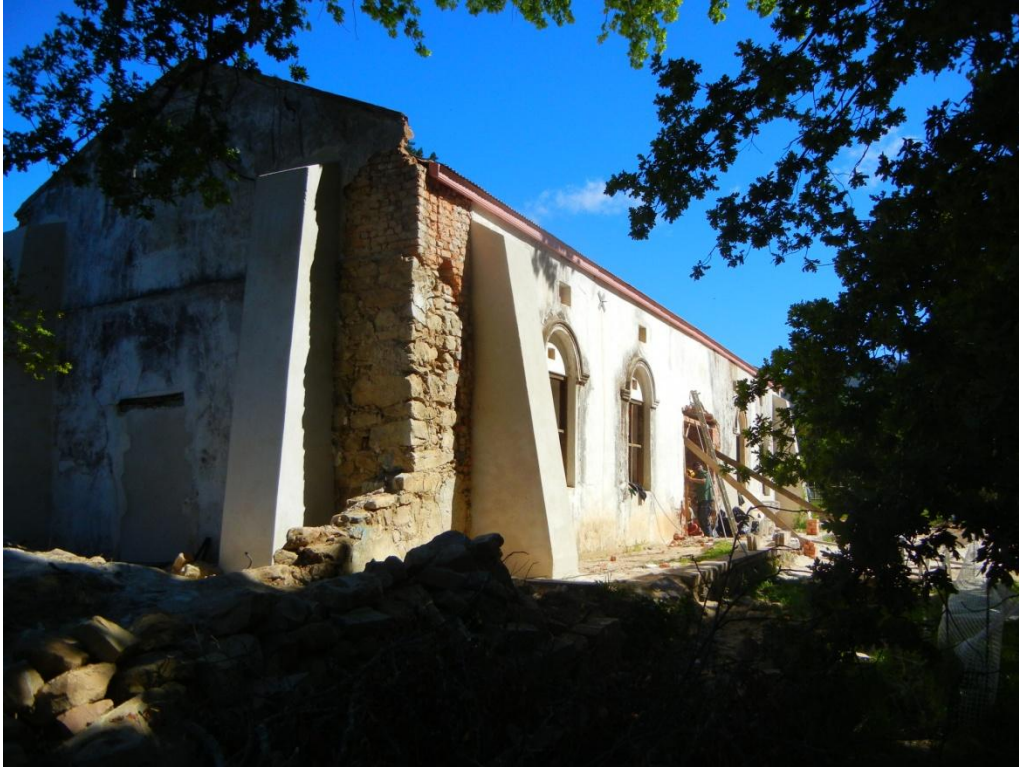
Stone Corner before Stainless steel mesh strengthening and collapsed werf wall before rebuilding, reusing as much original material as possible

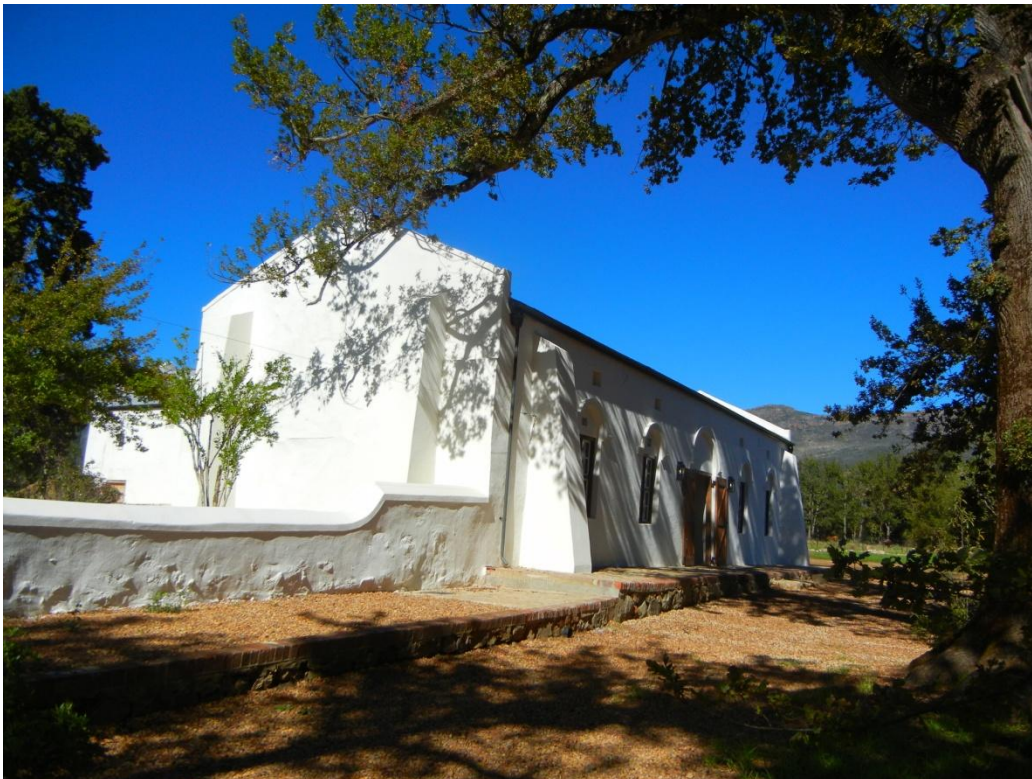
Completed Corner and Wall – Lime Plaster and Lime Washed

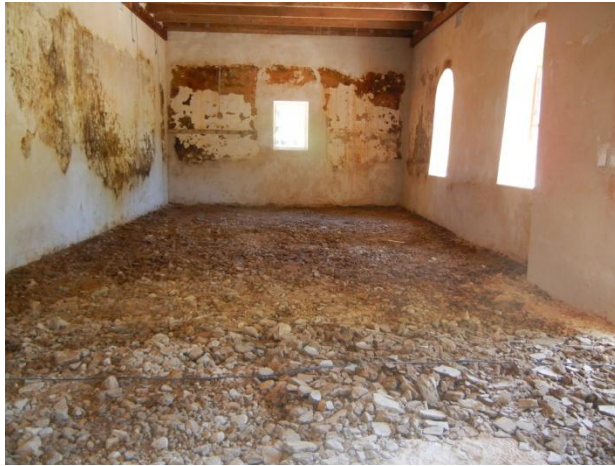
Chopping up existing crumbling concrete floor

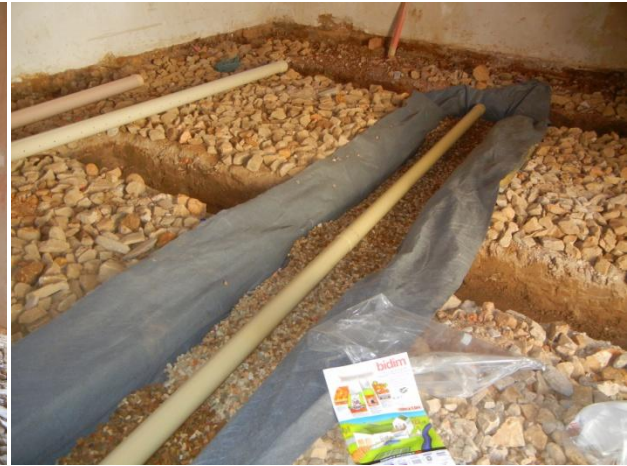
Laying Subsoil Drains

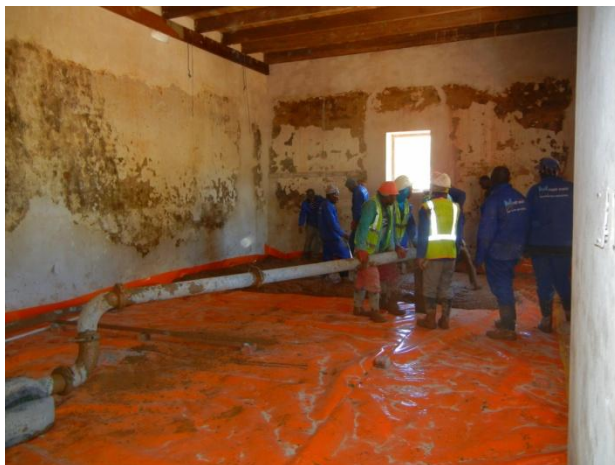
Pumping Coloured Concrete Readymix to cast Floor Slab

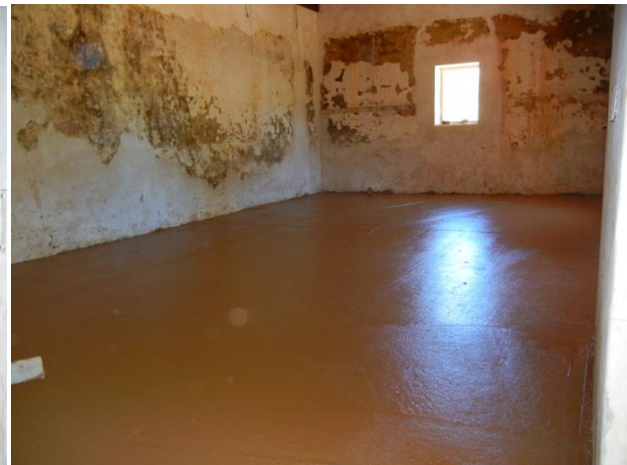
Finished floor

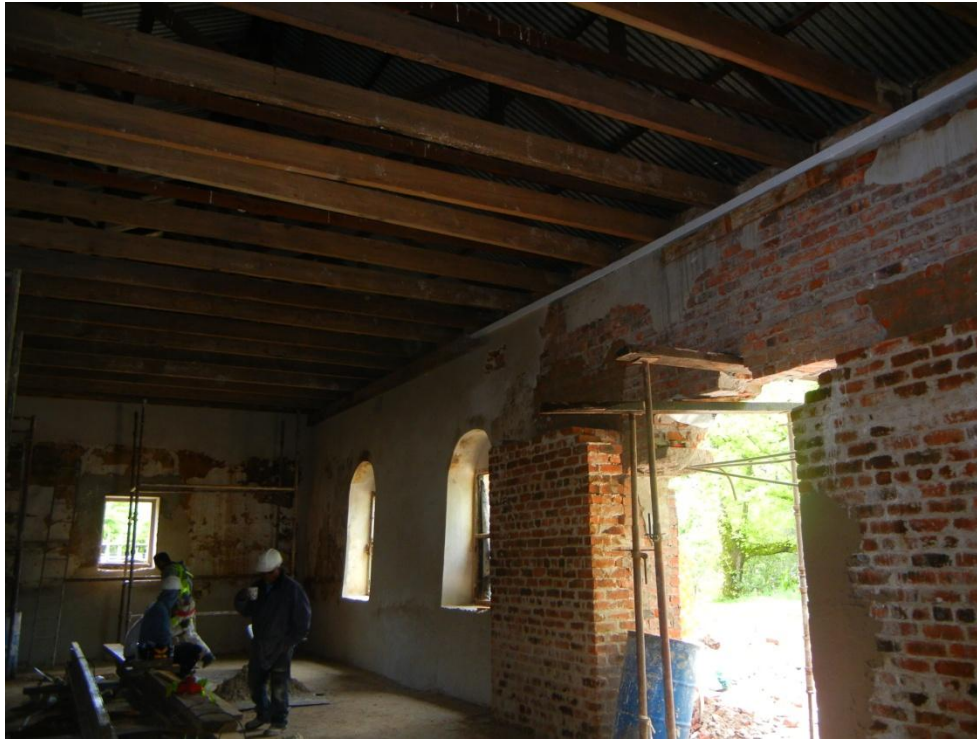
Ceiling Beams fixed to horizontal wall plate with hoop iron.

Wall Plate is screw fixed to Beam against wall, to form an L- Shaped Ring Beam, anchored into the wall with a system of stainless steel threaded rods, plates. The ring beam together with the cross beams and the ceiling boarding serve to 'tie the building together'

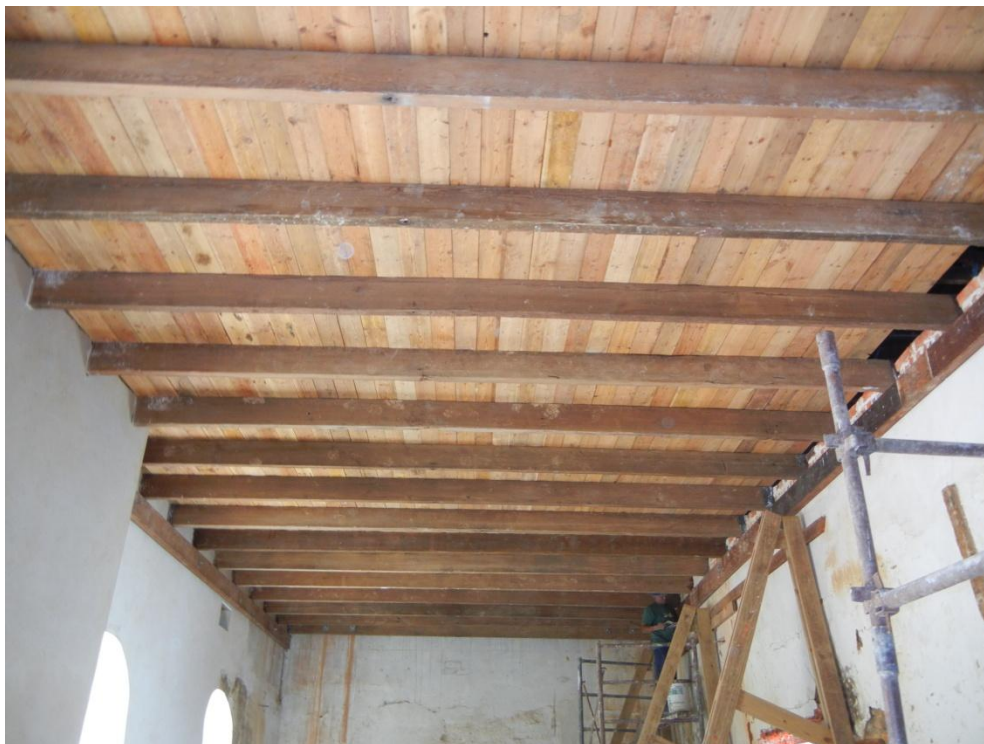
Ceiling Beams: 'Oregon Pine' reused from Salt River Railway sheds. Same proportions as original loft beams

Ceiling Boards: Recycled Floor Boarding – 'Oregon Pine' similar size to original loft boarding

Finish: cleaned and fumigated, left natural

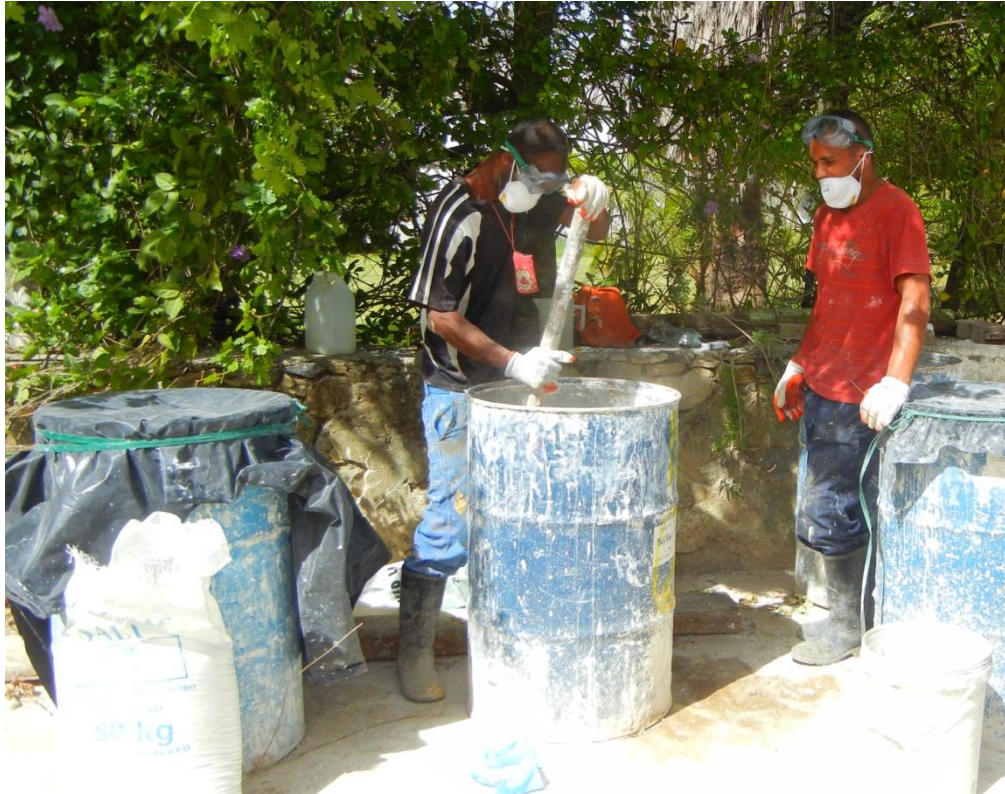
Slaking Lime for use in Mortar, Plaster and Limewash

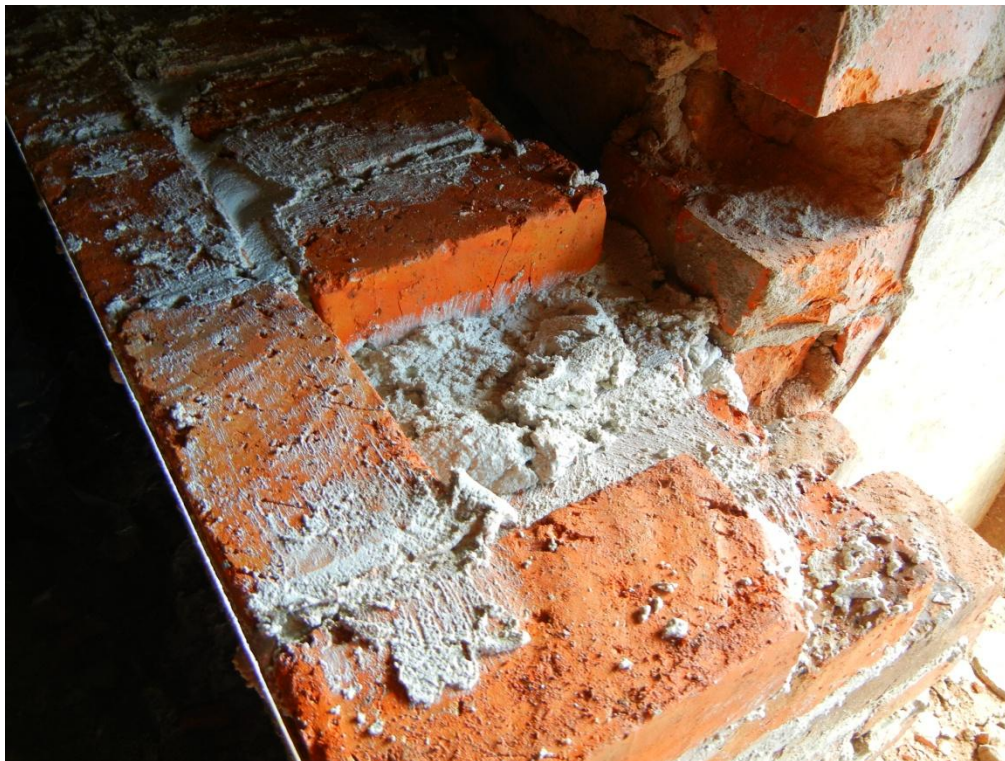
Lime Mortar 1:3 mix and “Underburn” Bricks from a local brickyard

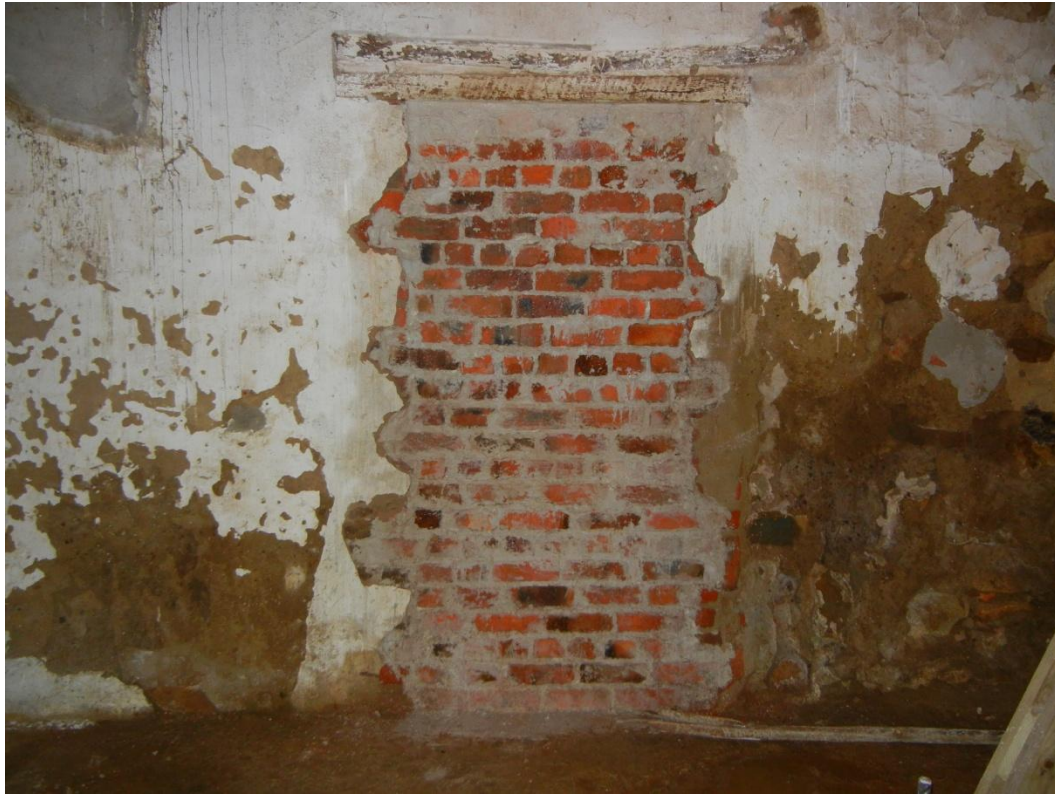
Doorway bricked up, (lintol kept as reminder), cement plaster about to be removed

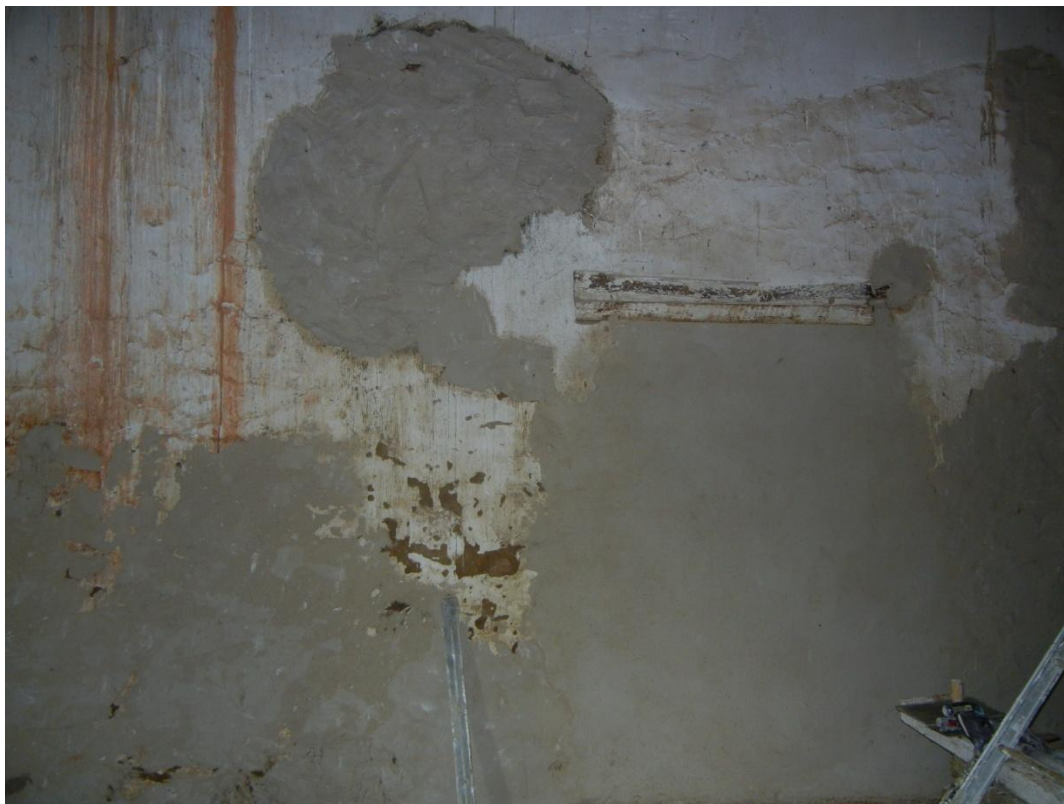
All patched with pure lime plaster

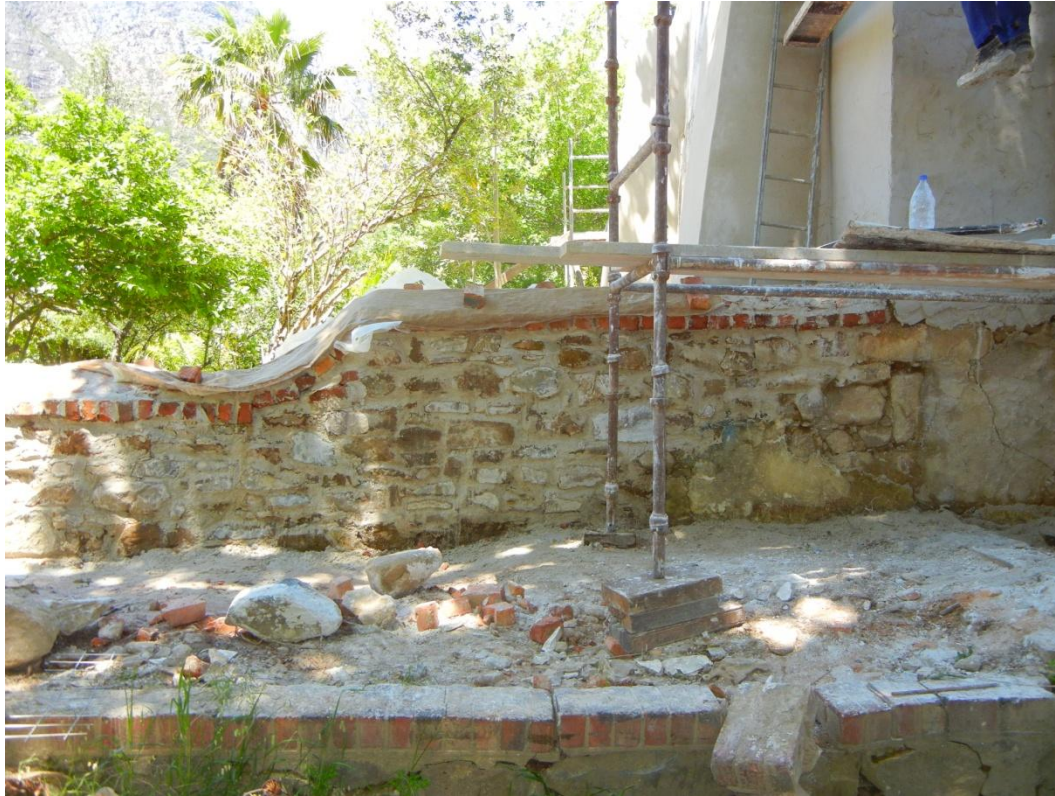
Werf Wall rebuilt with Lime Mortar – originally built with clay/earth mortar

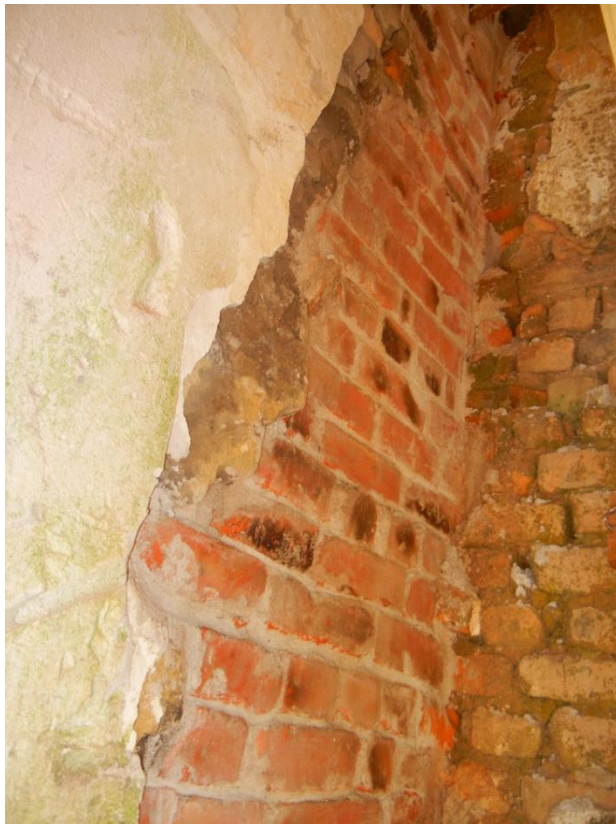
Lime Mortar and Underburn bricks used for all repairs. Existing fabric consisted of various earth, Clay and Lime mortars, which were difficult to match and as the building was so fragile, a slightly stronger material was needed to stabilise the crumbling areas.

Buttresses were built with a lime rich cement mortar for structural strength.

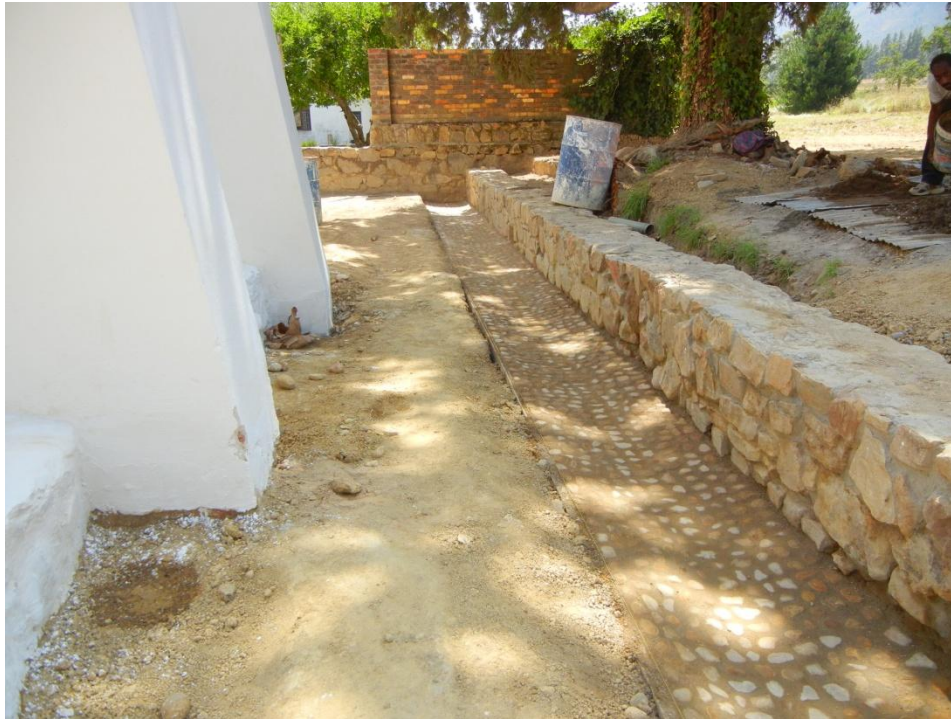
Level reduced around building, stone retaining wall and pebble channel, using stone found on site, set in cement.

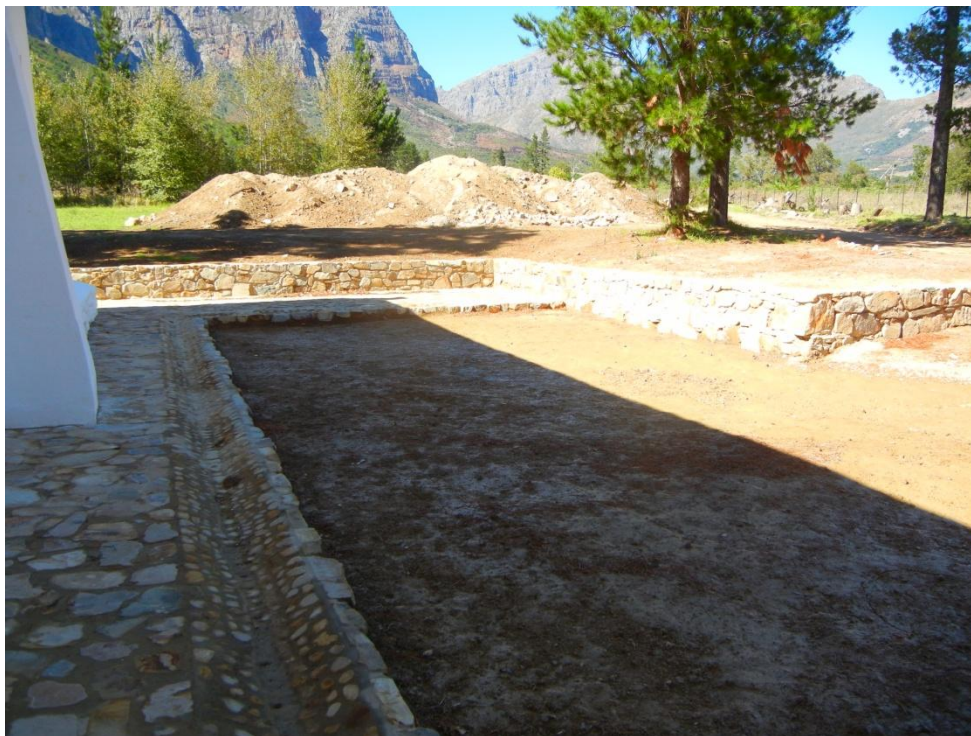
Stone "Skirt" around base of building with pebble stormwater channel.

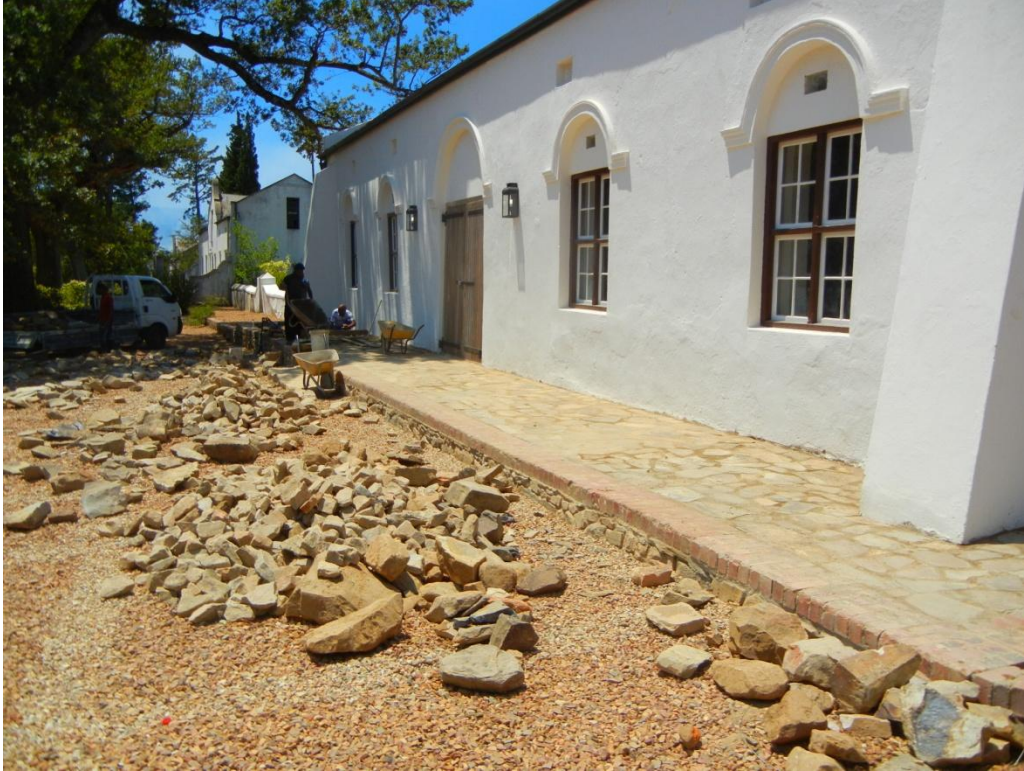
Existing Stoep paved with stone from site. Existing brick edge on low stone plinth retained

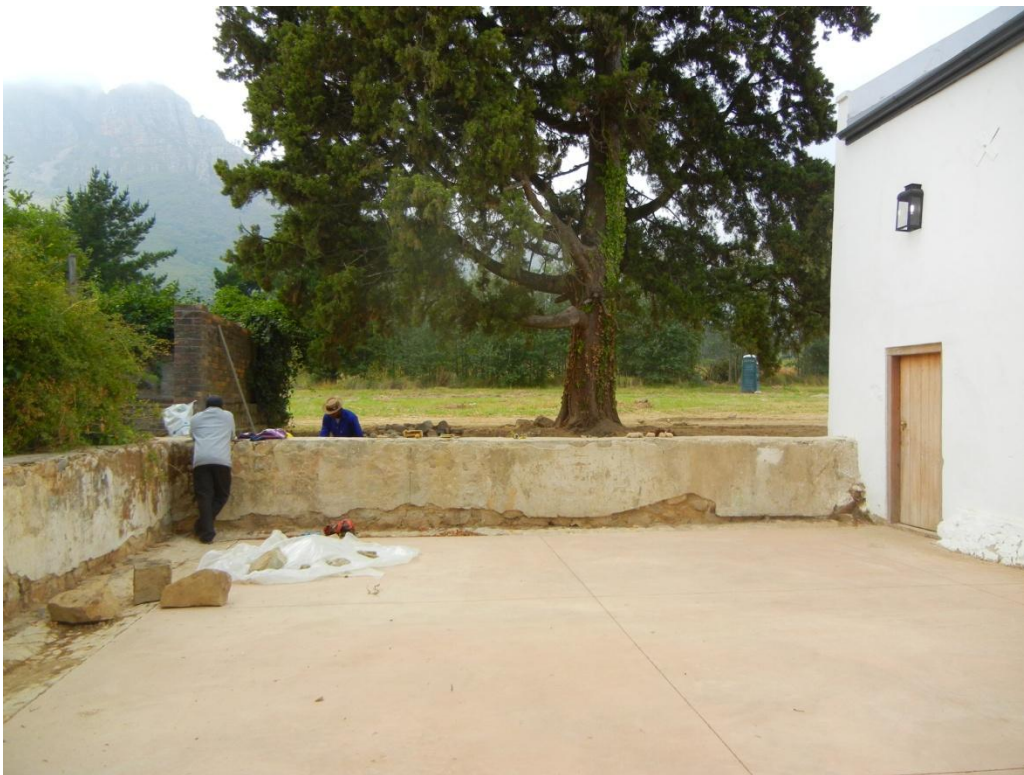
Courtyard: Existing cement floor replaced with Coloured Concrete slab, cast against wide pebble channels
