**OLD BETHLEHEM FARM 153
DWARS RIVER VALLEY, DRAKENSTEIN
STRUCTURAL & RESCUE INVESTIGATIONS DURING
WINE-CELLAR RENOVATIONS 2012**

JANUARY 2013

**Report prepared for
RESIDE PROPERTIES (PTY) LTD**

**H. N. VOS (BA, MA Arch., US)
Historical Archaeologist & Consultant
ARCape Consultancy PO Box 379 Stellenbosch 7599**

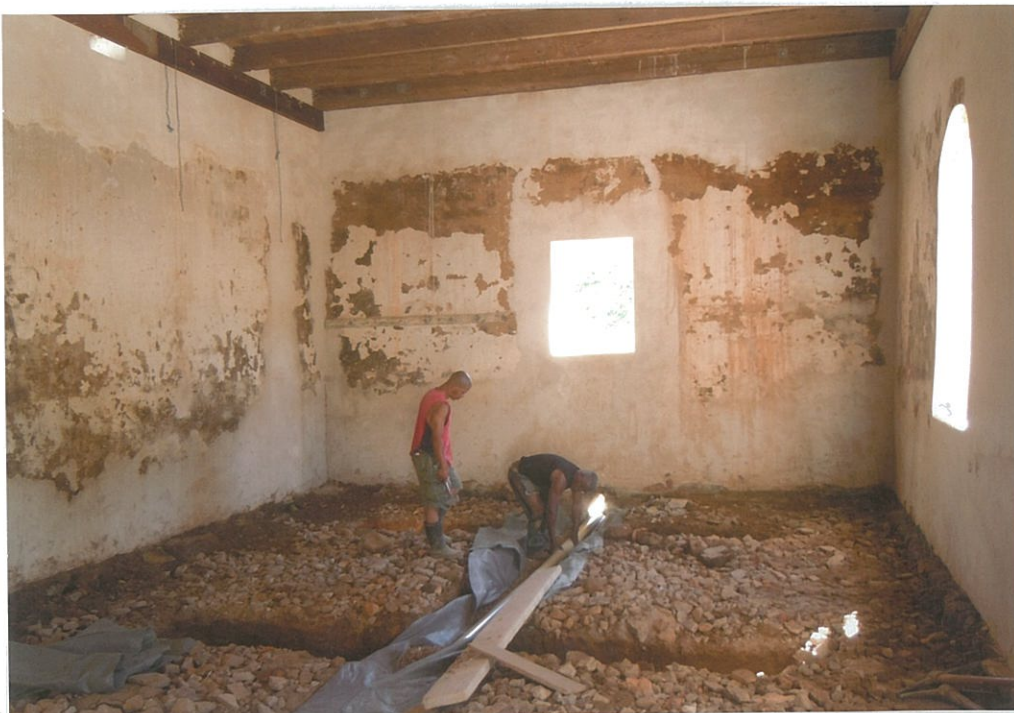
2. View towards Room C with a central trench (already filled) two trans-verse open trenches. The area of the blackened stones is marked "Hearth" (look W).

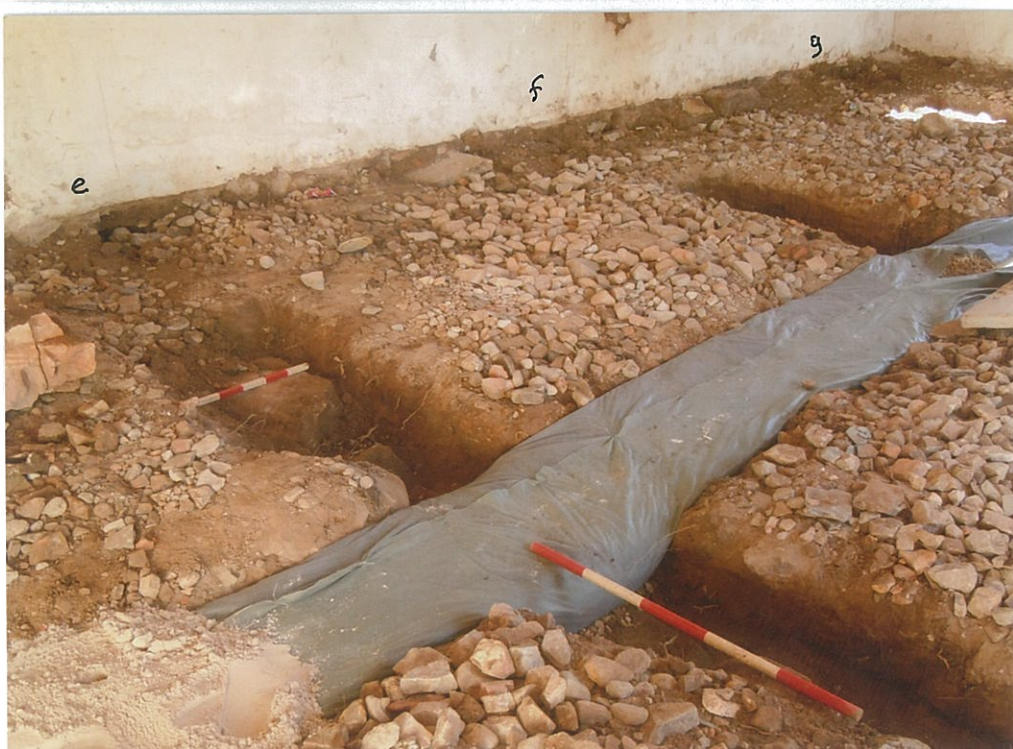
3. Similar view of Room C, but close-up of the remnant stone foundations in Trench e (scales 50 cm, 100 cm)(look SW).

A peculiarity was that the granite stones did not form a straight line. About 240 cm from the inside of the front façade wall (B1), a definite change of about 20 cm rerouted the demolished wall to the rear wall B3.

Both of the demolished walls were built in granite and some sandstone, with widths of about 50-60 cm. The depth of the foundation could not be determined (restricted by space and workers' deadlines). The large size of the stones indicates a substantial foundation to carry a wall reaching to eaves height. Substrata of a yellowish clay with charcoal specs were conspicuous.

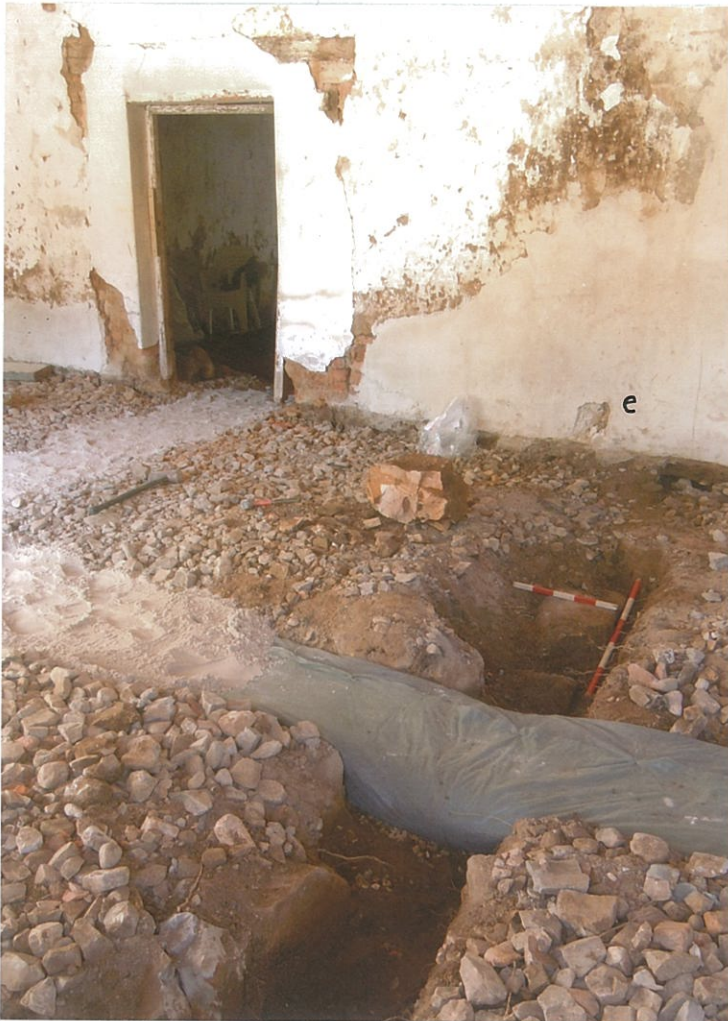
4. View of Rooms B/C, with the entrance of the T-wing on the left. Note the large granite block moved out of context by the labourers (look S).

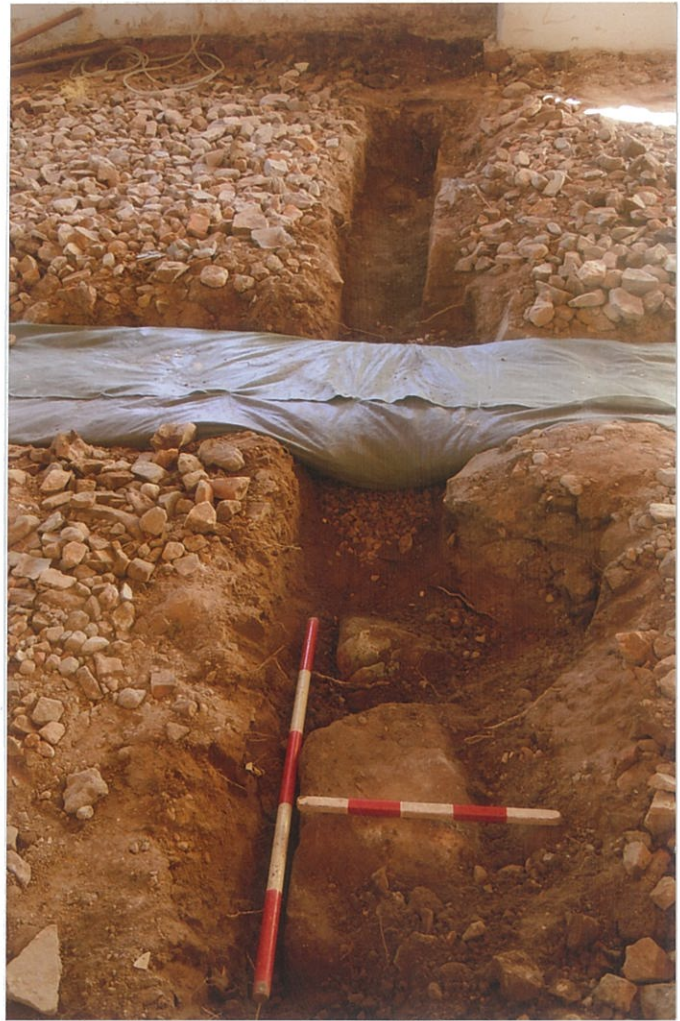
6. View along dividing wall, looking N along Trench e. Note the 20cm kink in the wall, traced via stones at the surface. Shortly afterwards the trenches were filled with stone (scales 50 cm, 100 cm).

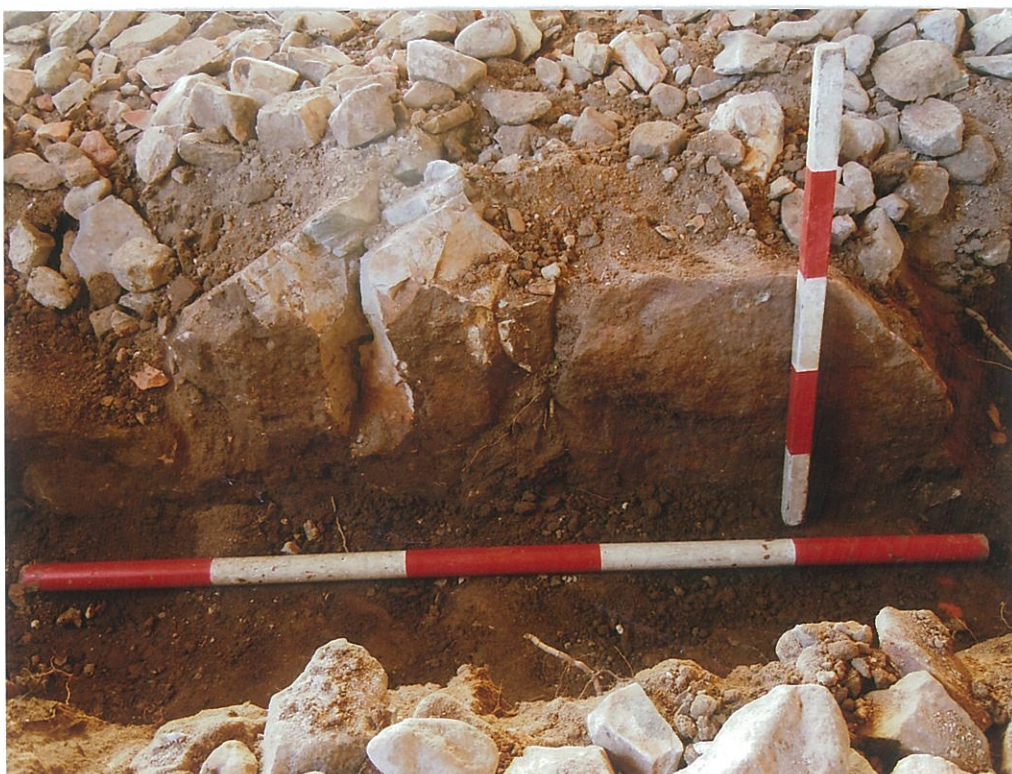
5. Close-up of Section 1 foundations. The trench is about 30 cm deep with *in situ* clays at the base (scales 50 cm, 100 cm)(look E).

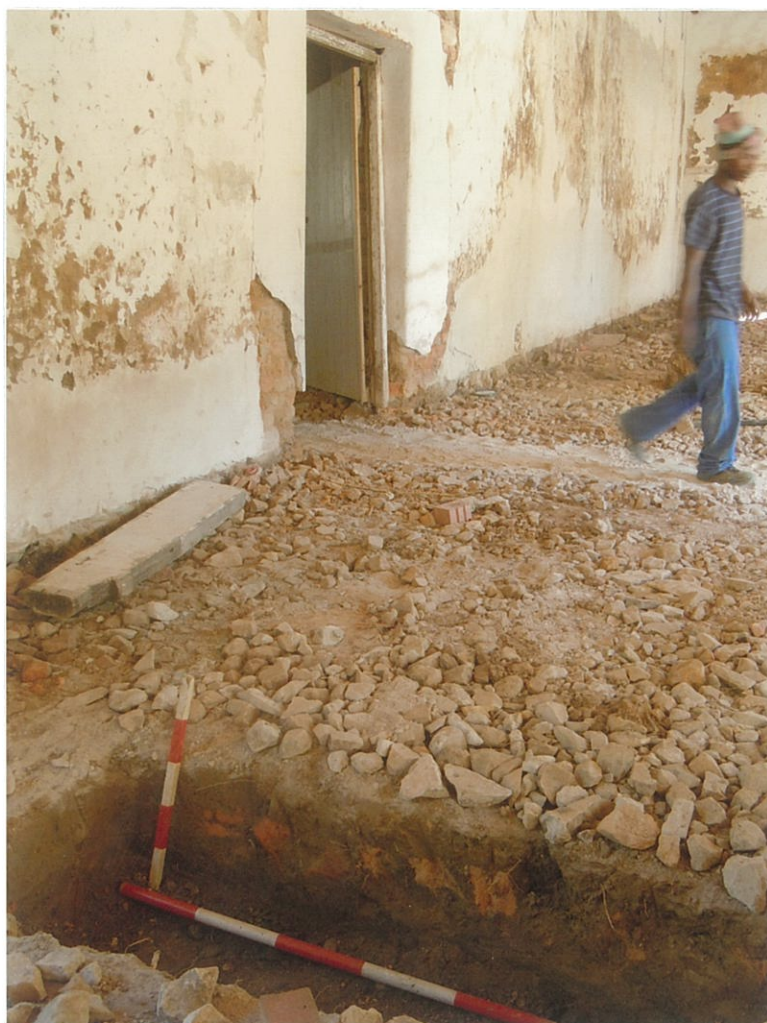
9. View of Rooms AB (look W) with the entrance to the T-wing on the left. In front is Trench c, showing the stratigraphy of the old floor of crushed brick (scales 50 cm, 100 cm).

A fairly level surface of crushed brickwork formed the earlier Cellar floor, which is quite common for barns or Cellars. The brickwork consists of low-fired chunks of orange brick, which would give it some impermeability to rising damp. The compacted floor rested a few cm lower down on a hard, yellow clay layer with numerous black charcoal specs.

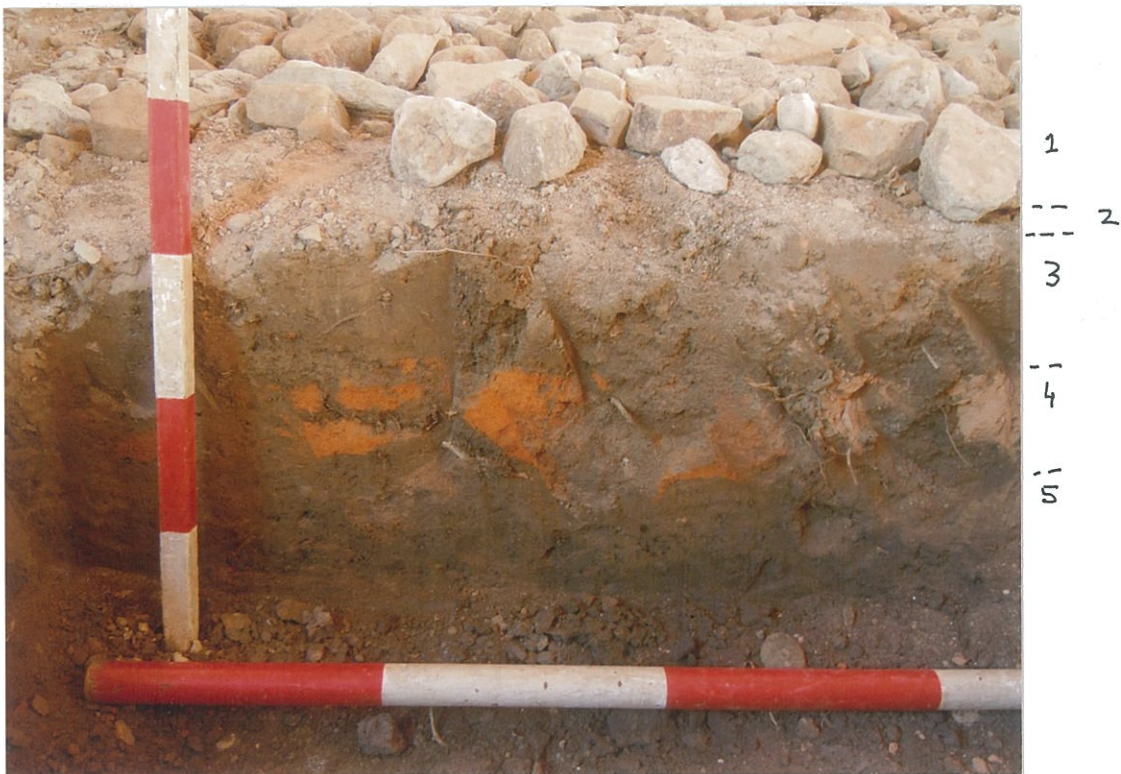
My first impression was that the latter represents an earlier surface with signs of fire charcoal on top. It was surprising to find that the charcoal continued in the clay layer for another 10 cm! When I discovered the same yellow layers and charcoal in the back wing and at a rear trench on the exterior, my suspicions were confirmed that it actually represents an *in situ* clay matrix of millennia earlier. More on this later.

10. Close-up of Trench c (Room A/B) with the stratigraphy:
1. Recent stone gravels (2012)
 2. Removed cement floor (1950s)
 3. Soil substrata (20th c)
 4. Layer of compacted fired brick, the original floor (18th c)
 5. Yellow clayey soils imbedded with charcoal specs (look^W)
(scales 50 cm; 60 cm in 20 cm divisions)

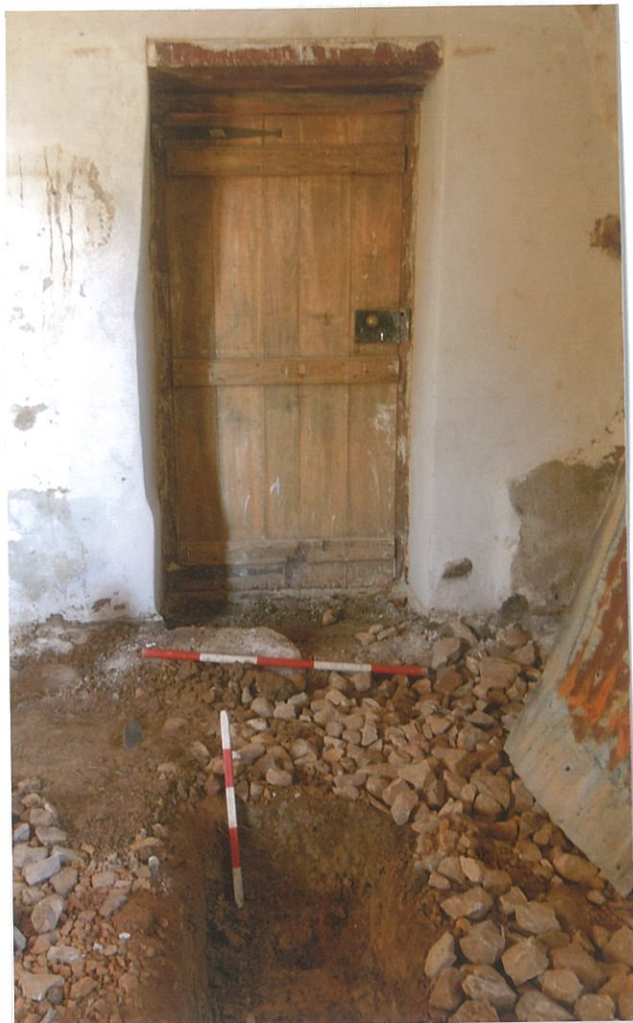
12

12. An old door is repositioned in the earlier opening. Below is the last drainage trench with the yellow clays at base.

The earlier door opening (enclosed with brick c.1890s) at wall E2, was rightfully opened up again and fitted with an appropriate 18/19th century door.

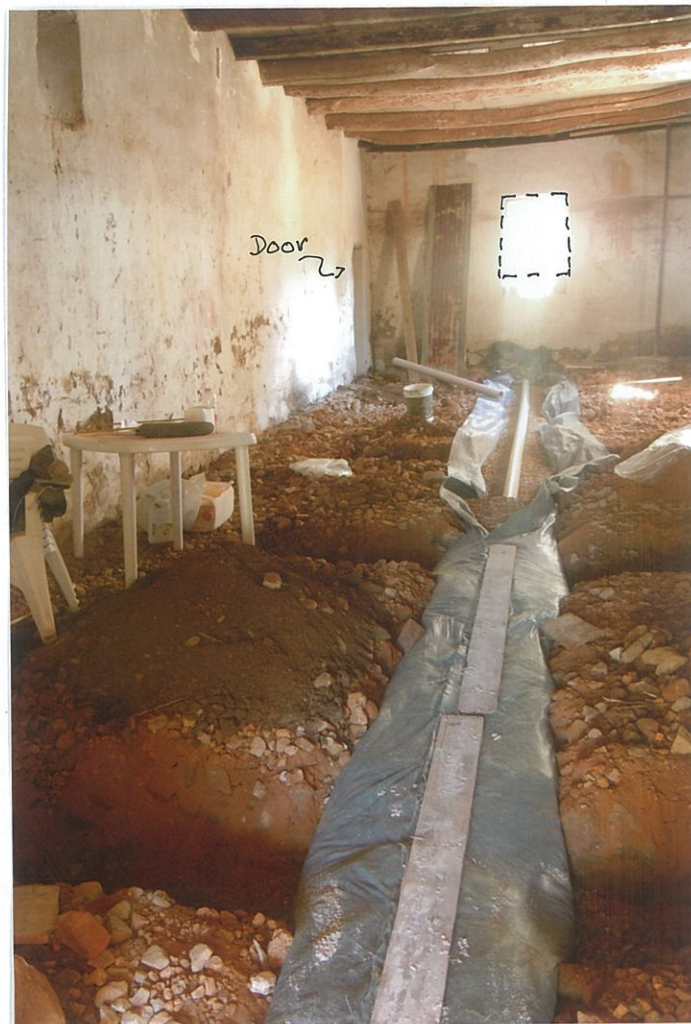
11

11. View southwards in the T-wing (Room DE) along the central trench, enclosed in biden cloth. Right at the end (next to window) is the old door opening.

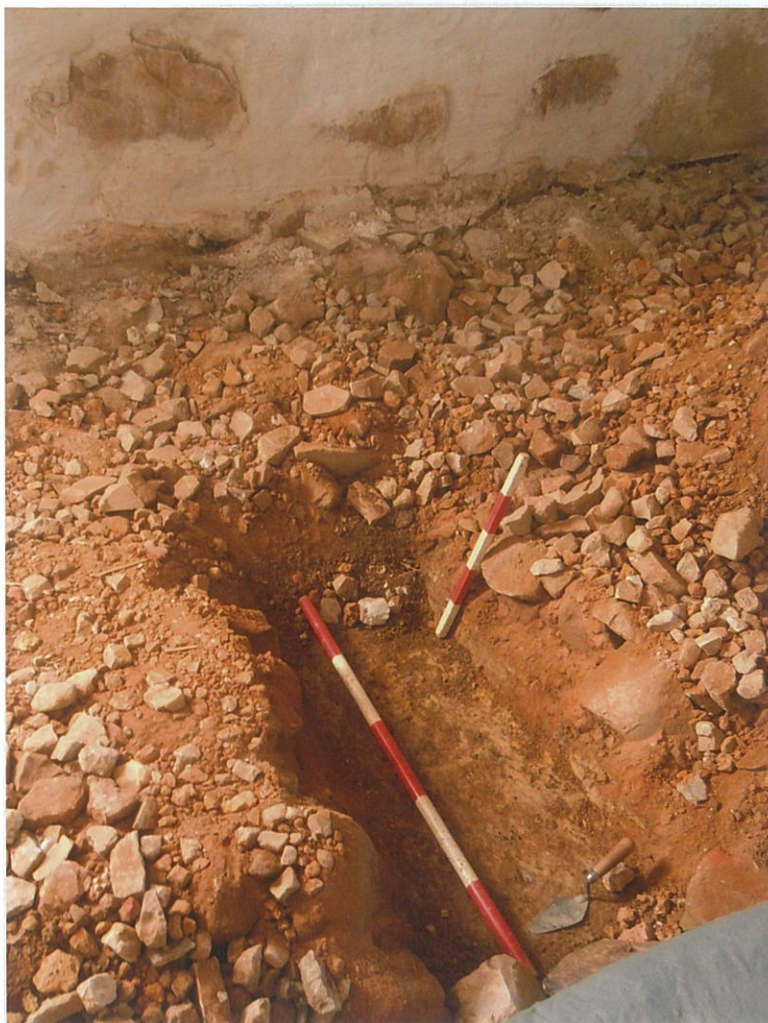
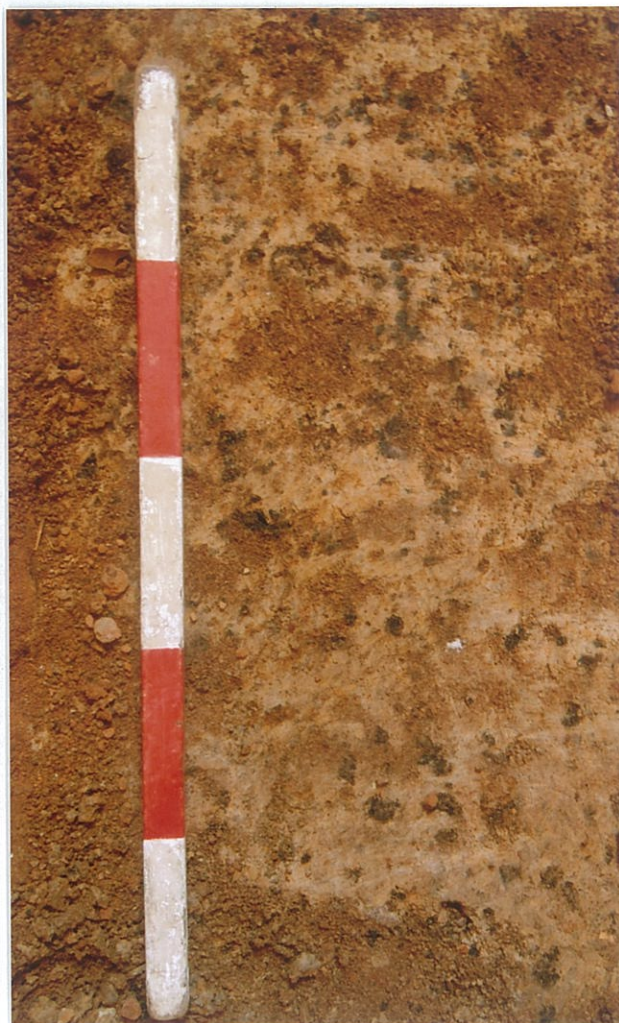
A network of drainage trenches were being filled in with crushed stone enveloped by cloth. In all the open trenches brown clayey soils were visible, lying on top of very hard yellow clays, again filled to some depth with charcoal specs and nodules, the original *in situ* clays of the area. On closer inspection, the brown soils consisted of a matrix of unfired mud-bricks which served as a substratum for an earlier floor, but since destroyed by the cement floor (removed 2012).

14, 15. In Rooms DE a small trench was cleared (look W). Its base was scraped to expose the yellow clay bed and nodules of black charcoal. They represent the *in situ* clays of millennia ago (scales 50 cm, 100 cm).

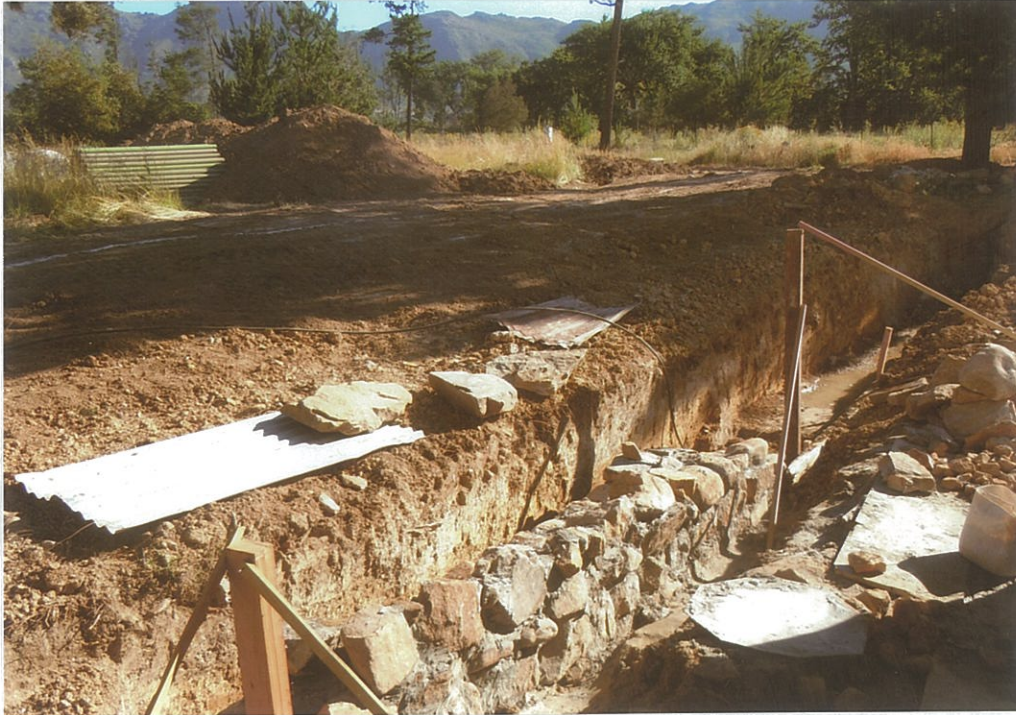
18. Directly at the rear of the T-wing (Room E), a trench was dug into the clay slope. A new stone wall would inhibit any flow of water to reach the Cellar (look SW). This trench continues to the east, as seen in the next photos.

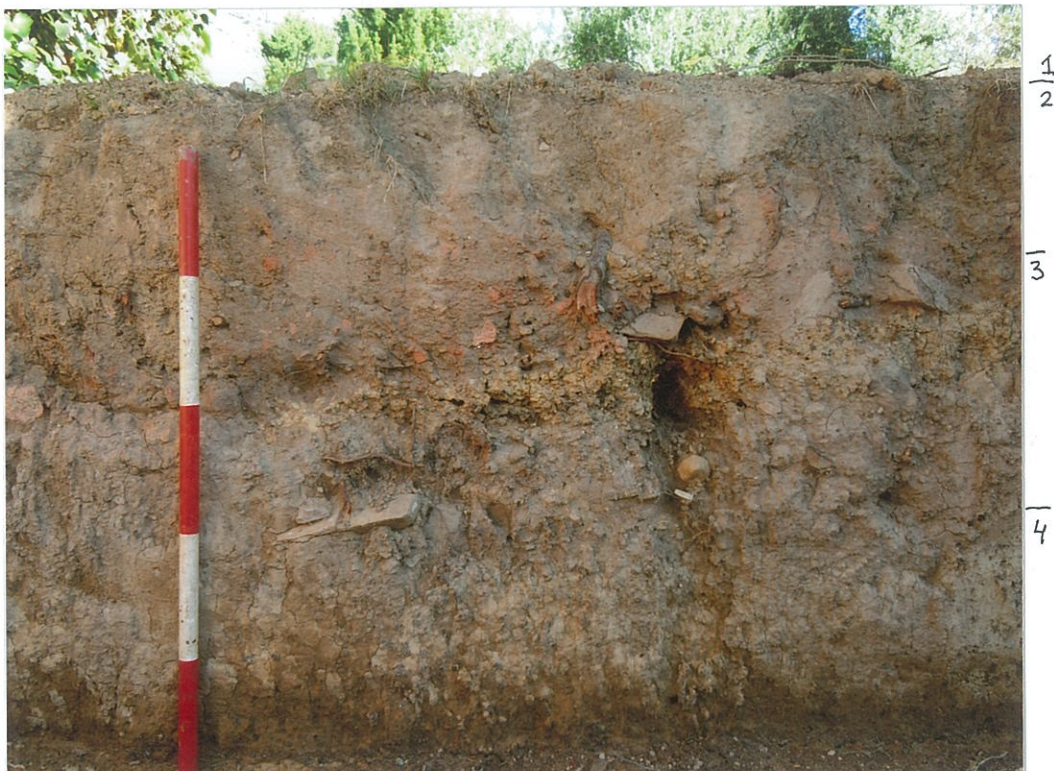
20. Close-up of above sections where the stratigraphy is as follows:

1. Grass and upper soil.
2. Clayey yellow soils (iron rich sediment)
3. Filled-in portion with stones / brick specs
4. *In situ* yellow clays with concentrations of charcoal nodules and specs (look S).

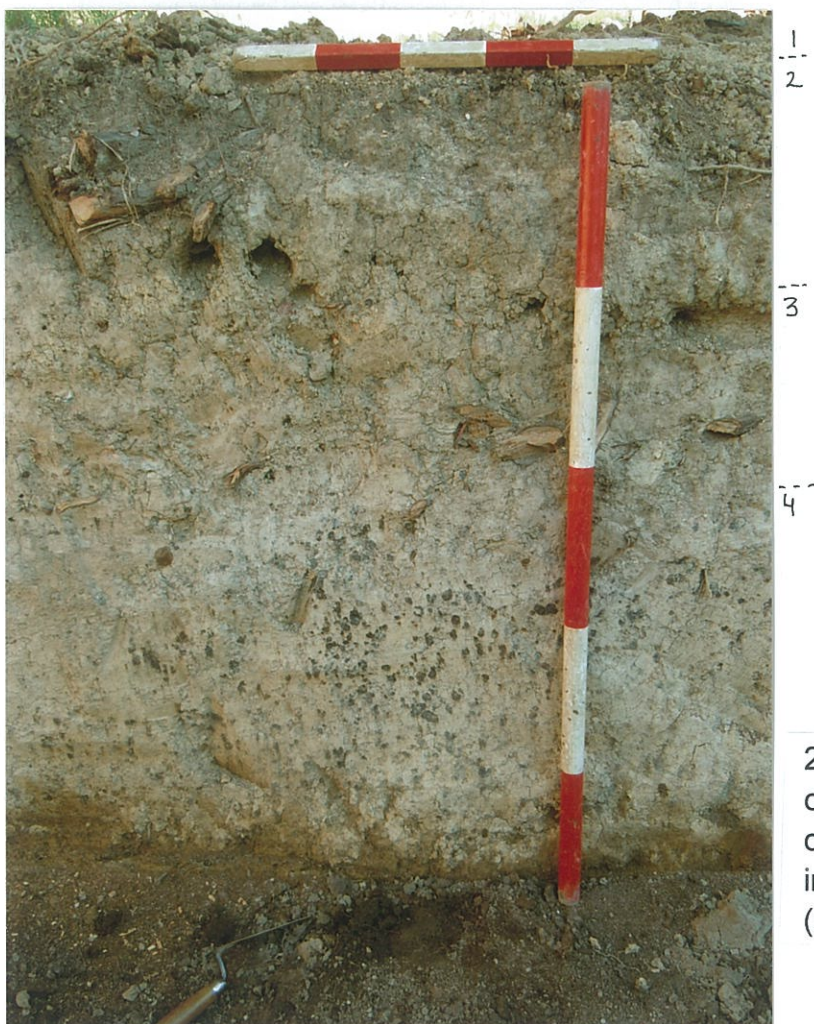
21. Close-up view of the sidewall of the Trench where its yellow clay composition and charcoal imports are evident (look S) (scale 100 cm).

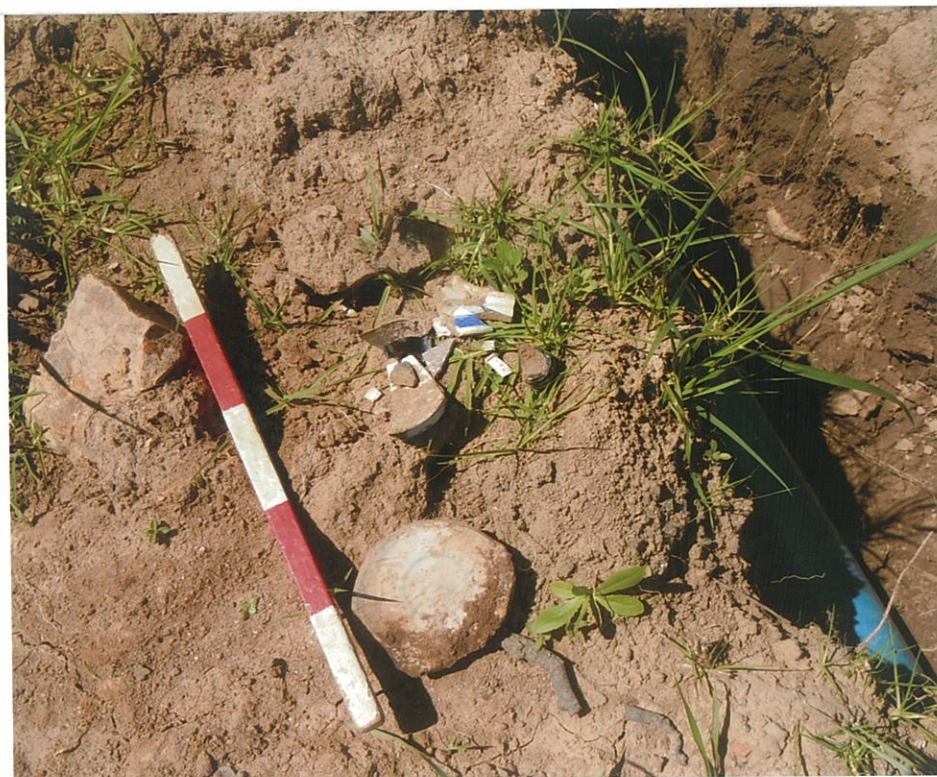
28. Some of the Chinese ceramics (imbedded in clay), part of the surface finds (scale 50 cm). The potential of a larger scatter of a refuse dump is likely.

The Chinese ceramics include the finer quality of porcelain of North Provincial China. They would have formed part of the general food service articles of the household of the 1770s. The present location is merely an outlier of a greater scatter-dump of kitchen refuse. Care should be exercised when any digging activity is undertaken in this area and within the farmyard near the old kitchen. The Recommendation is to call the archaeologist in the *planning stages* to investigate pro-actively any farmyard site.

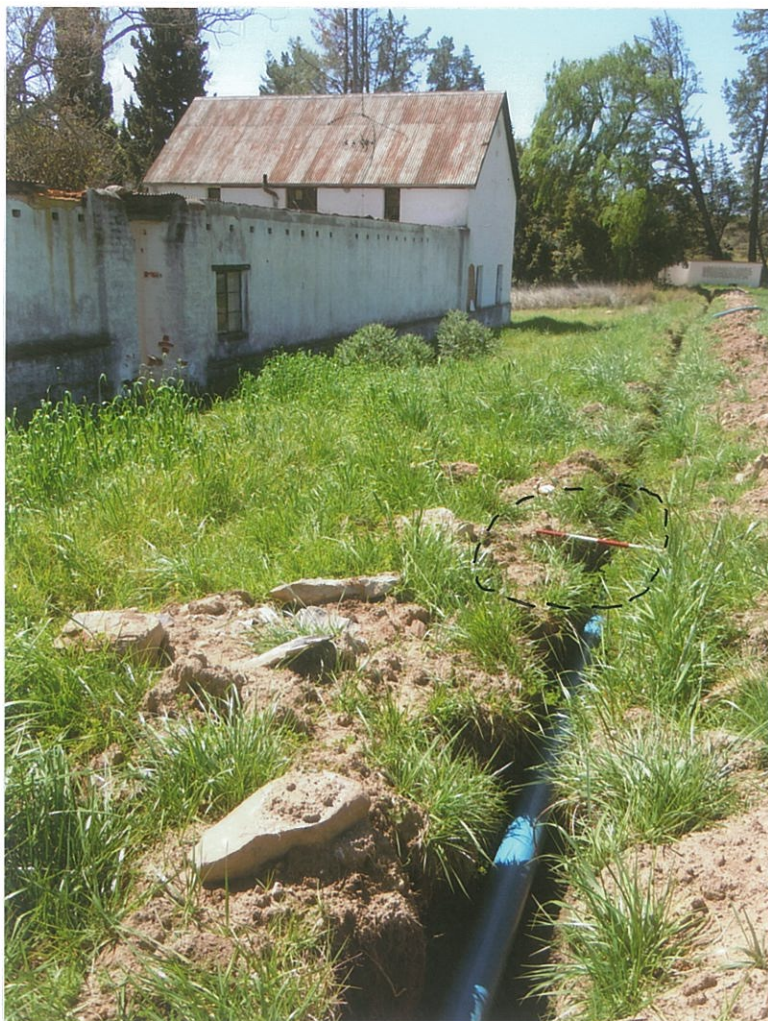
On the surface heaps of clay we saw a concentration of a number of 18th century ceramics, as well as some bone splinters and charcoal. Along the vertical trench side a lens of brick specs and some artefacts indicated the layer for the source of these artefacts. The clays of the long hilly slope have crept over the early deposit over the years.

26, 27. At the rear of the farmyard, about 5-6 metres from the back building line, a narrow irrigation trench for a blue pipe cut through clay sediments and refuse of an earlier 18th century dump. The 1 m scale is positioned where a few of the ceramics were concentrated (look NE).
