PROGRESS REPORT 05: April 18 – May 08, 2012

Towers 198 - 32

PROPOSED 400KV TABOR-WITKOP TRANSMISSION LINE, LIMPOPO PROVINCE

For: Stefanutti Stocks Power

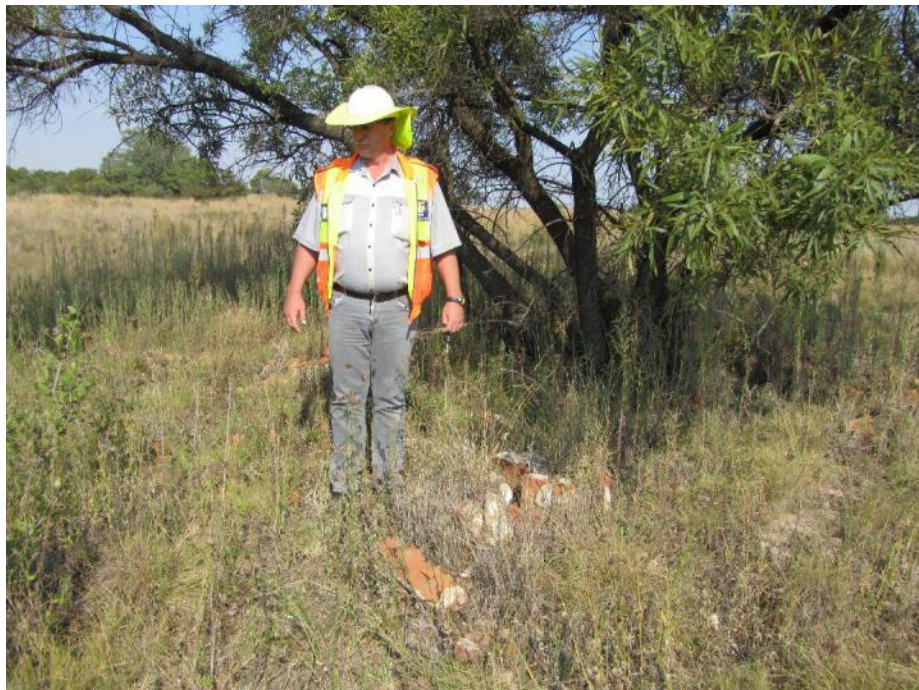
Figure 2. S24°00'21.4" E29°26'47.8". The clay brick foundations of a small rectangular structure ($\pm 1,5 \times 2,5$ m). The past use of this structure is unknown, but it could have housed a generator or have functioned as a tank stand.

Recommendations: Demarcate during construction and protect from future traffic.

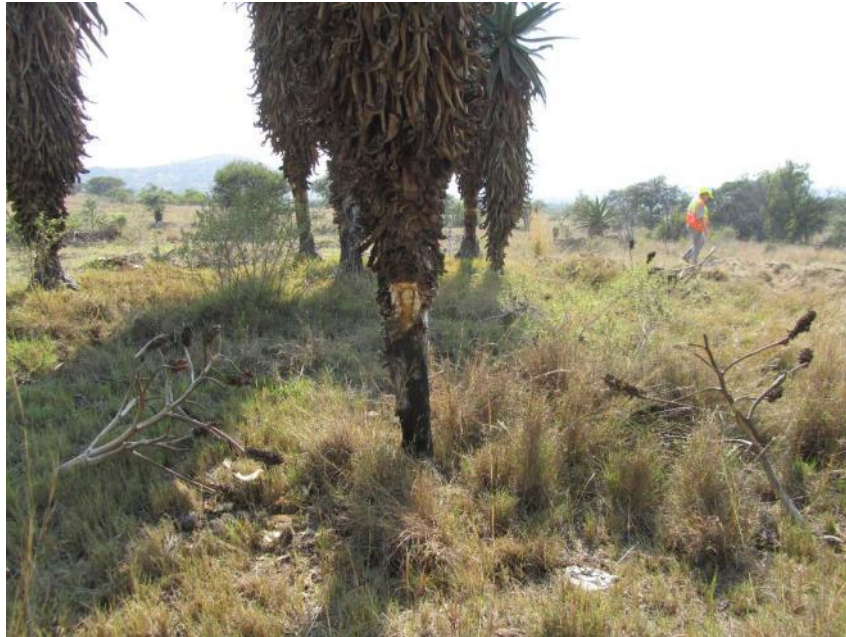
Figure 3. S24°00'21.4" E29°26'49.2". These aloes are standing on a little mound and are located close to Tower 198. It is known that aloes prefer to grow in ashy soil since the soil temperature is conducive to their seed germination. These are usually signs of a midden or cattle byre.

Recommendations for features in Figs 3 & 4: Should any archaeological finds be detected while work on the foundations are conducted, the archaeologist should be notified immediately. It is possible that human remains could be present.

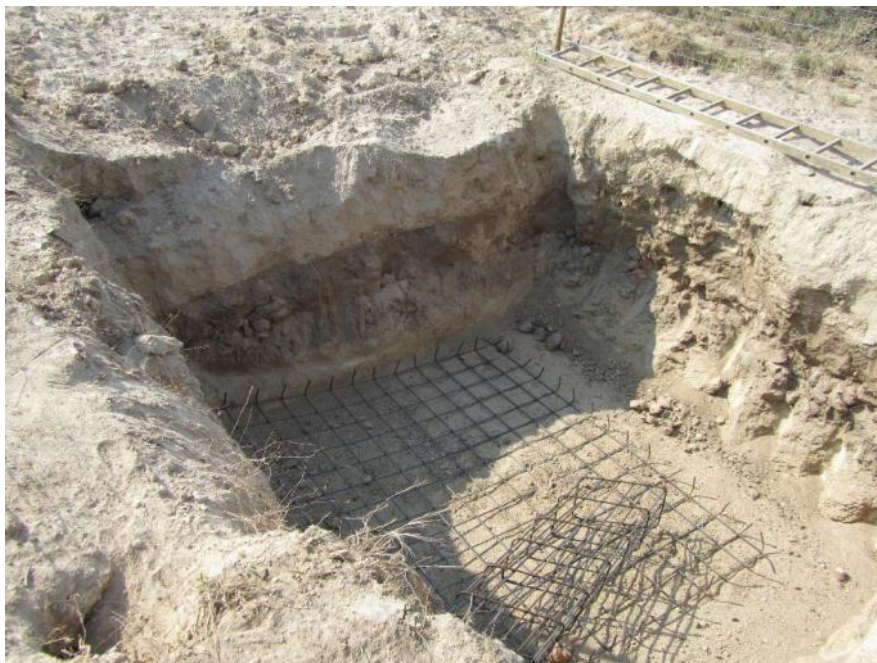
Figure 4. Position of Tower 198. The foundation exhibits some stratigraphy; the topsoil (\pm 10 cm) exhibits a light grey colouring. This could be signs of either a midden or a cattle byre. Both have a light grey colour, and human burials often occur in either.

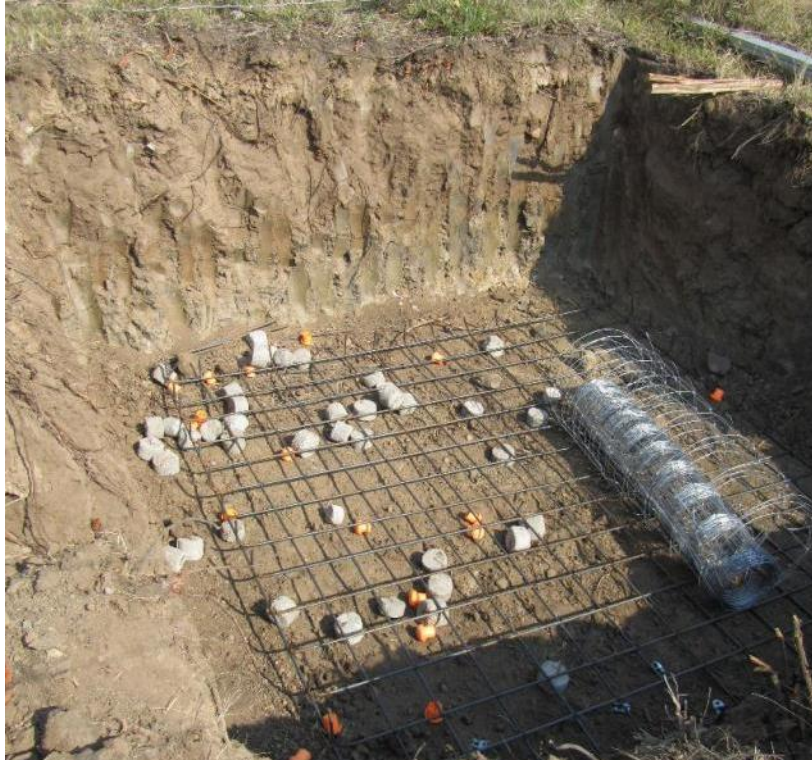
Figure 5. The second foundation of Tower 198. The soil colouring and texture differs markedly from the foundation (Fig 4) and is more clayey.

Recommendations: No recommendations are necessary.

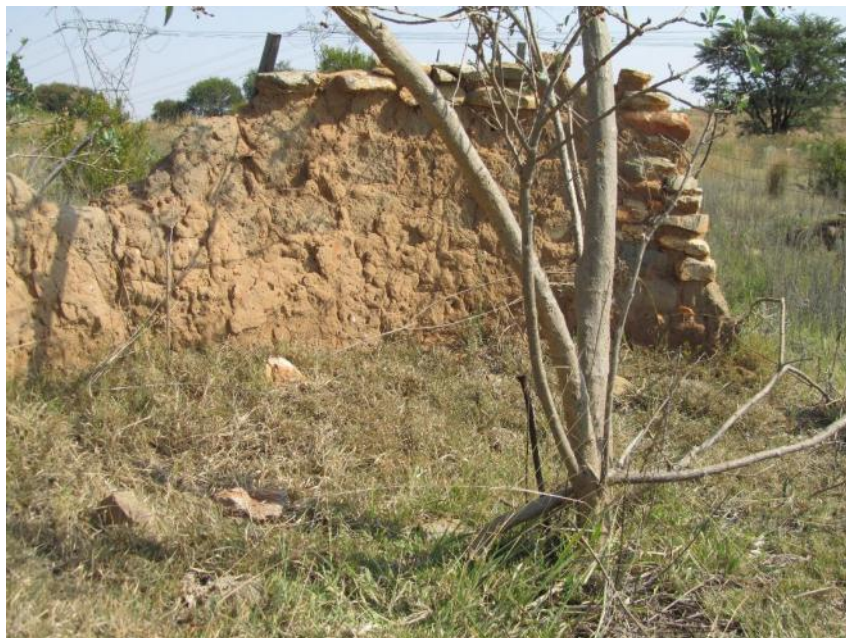
Figure 6. S24°00'23.8" E29°43'6". This homestead consists of a combination of square and circular stone walls. The square structures are built of clay bricks while the circular structures consist of stone and dagma walls plastered with clay. This was probably a farm labourer's homestead. The difference in building material could be due to later additions.

Recommendations for structures in Figs 6-10: These structures will not be affected by the towers or transmission line but was reconnoitred for it has historical relevance and is close to the activities. Avoid all traffic. If necessary, demarcate.

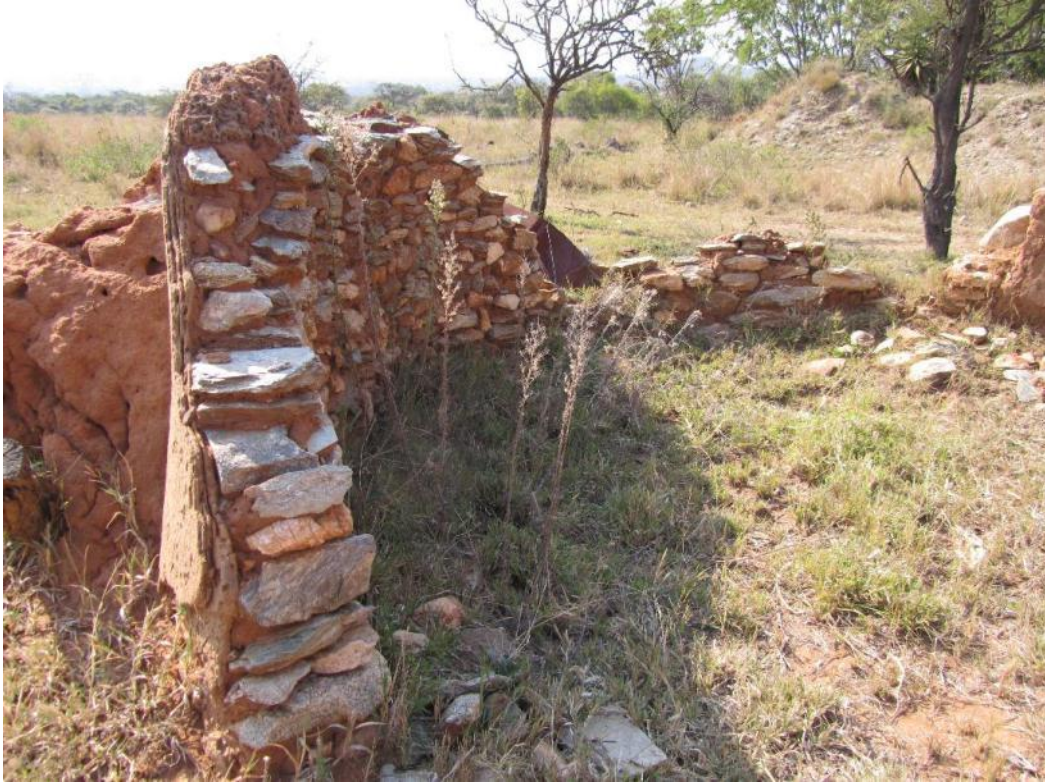
Figure 7. Part of a circular structure, built from stone and clay dagha.

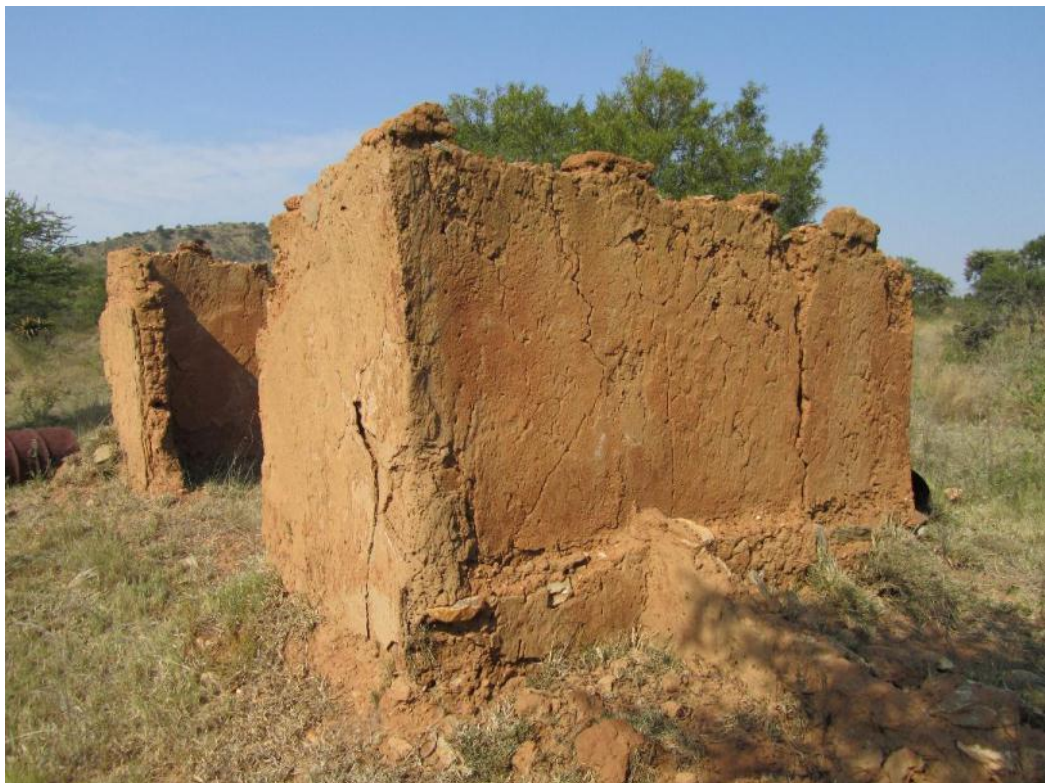
Figure 8. A rectangular structure built with raw clay bricks and plastered with clay. It is possible that this was the first of the rectangular buildings, the later additions built with fired brick.

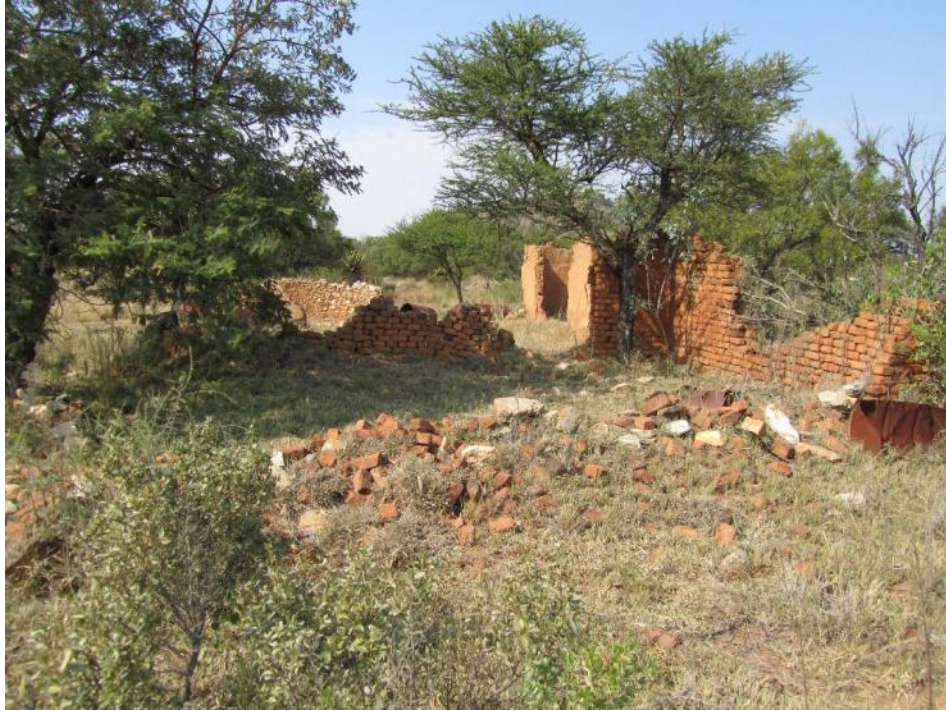
Figure 9. Some of the structures are more recent than the others. This is clearly visible in the stacked clay brick walls, while the walls of the structure in the background have been built with raw bricks and plastered with clay (see Fig 8).

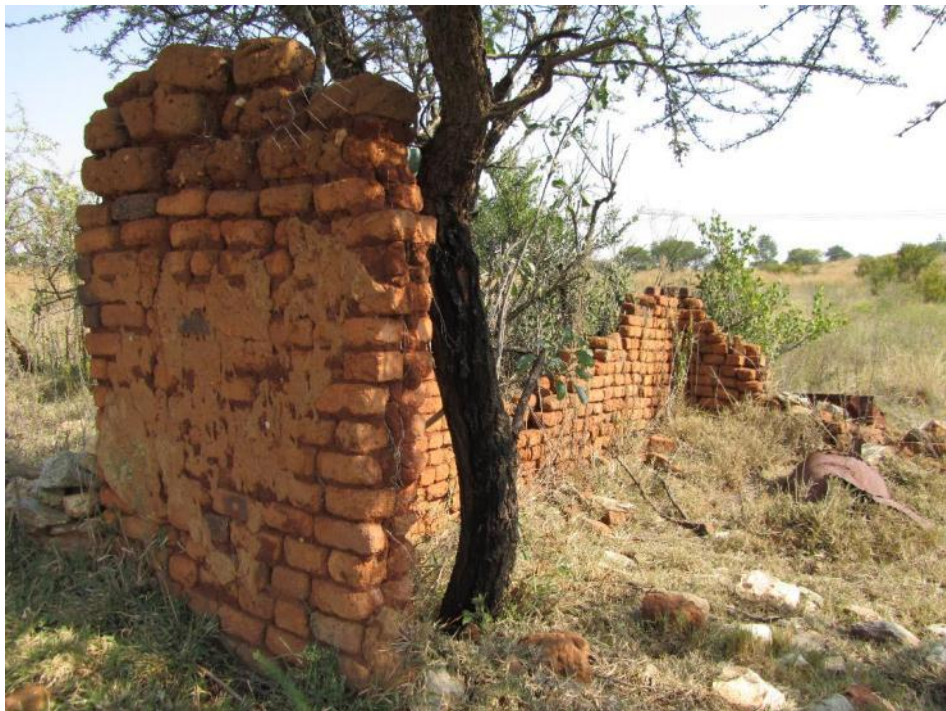
Figure 10. Another rectangular structure built with fired clay bricks. This could probably be younger than the raw brick and stone and dagha structures.

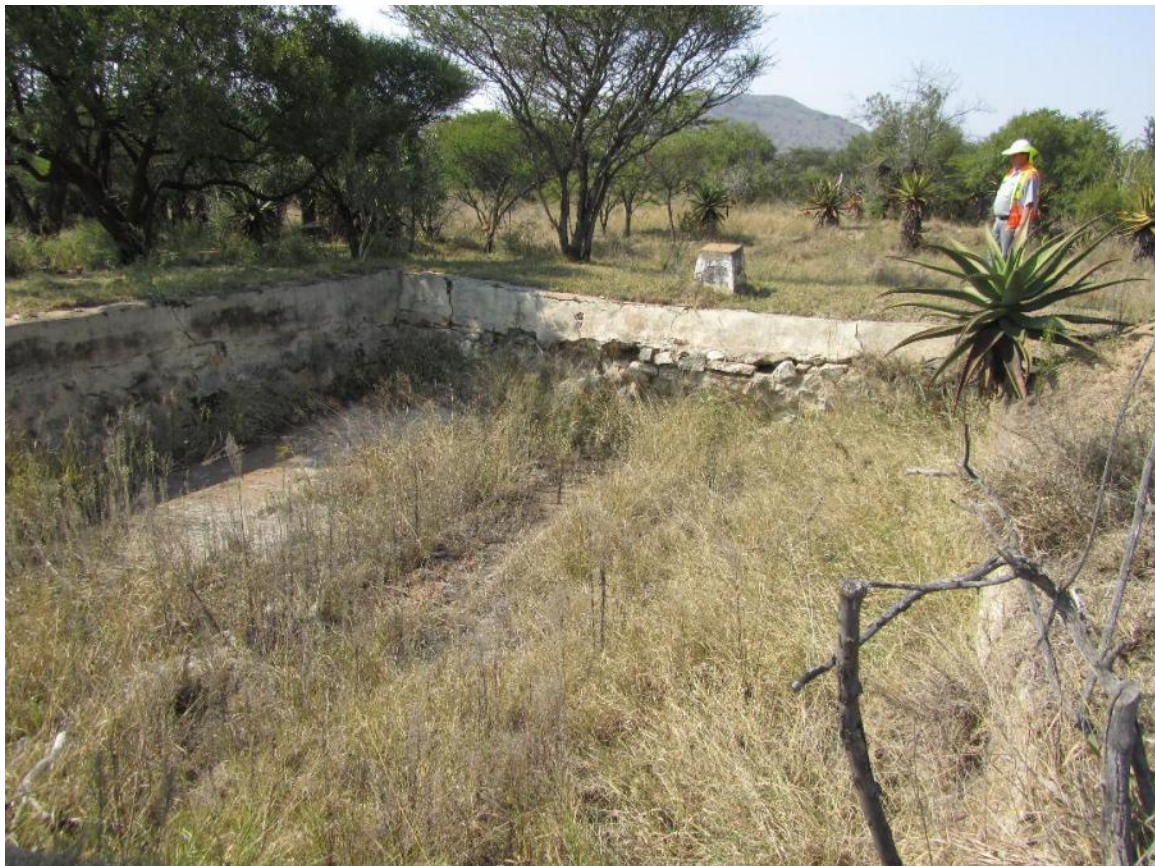
Figure 14. The sunken concrete reservoir.

Recommendations for structures represented in Figs 14 - 17: The reservoir and accompanying structures are close to the transmission line and could be endangered by the activities and traffic related to the transmission line. Avoid and demarcate a clear access route. Demarcate the three depressions for they are a great risk.

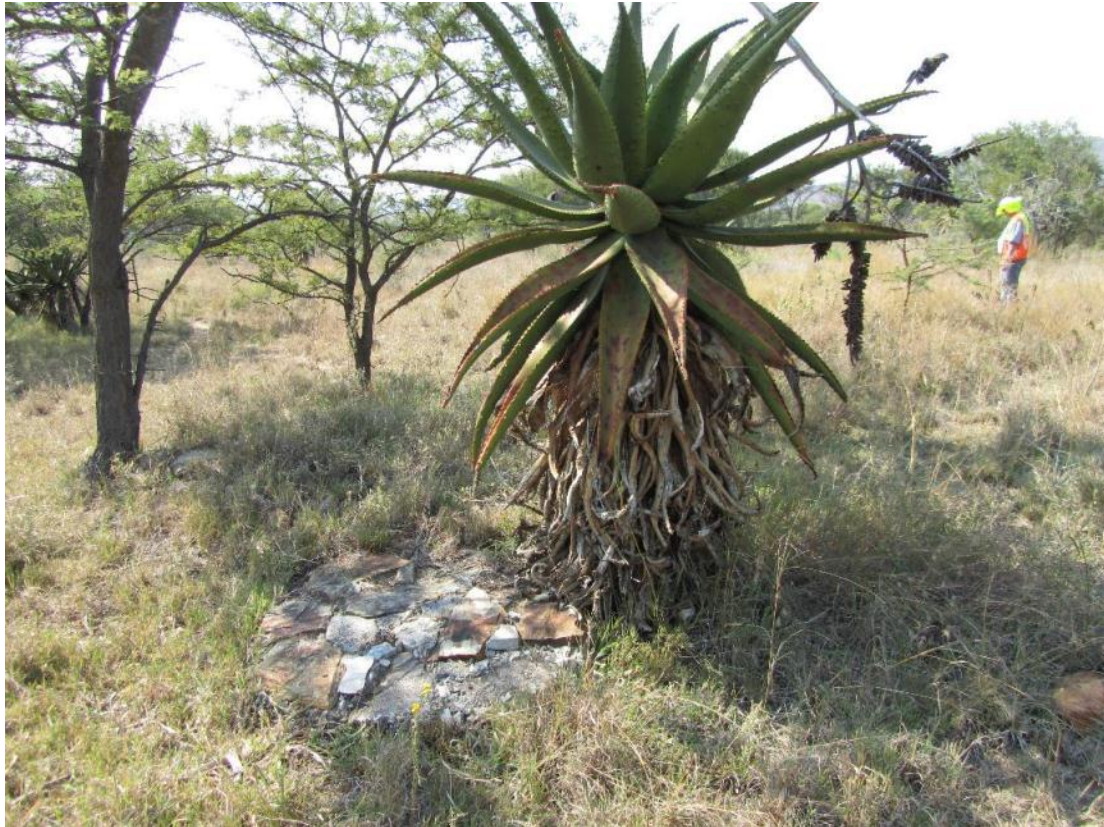
Figure 17. A small circular paved area in the vicinity of the reservoir.

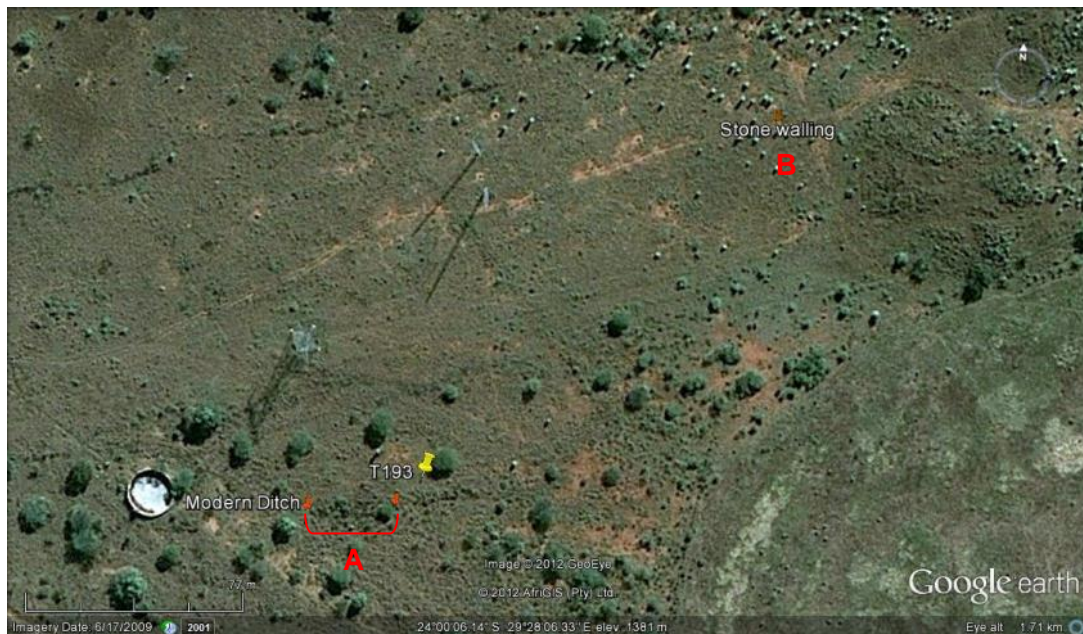
Figure 18. On clearing the area around Tower 193 the debushing team reported seeing graves. On inspection the archaeologist identified it as a recent trench (S24°00'08.3" E29°28'04.5"), here marked "A". It is close to the one foundation of the tower, approximately 30,54 m long and in some places at least 1,5 m deep, becoming shallower towards the western side, with embankments on either side. Another, previously unidentified stone walled site, marked "B", was also identified.

Recommendations: No action is necessary.

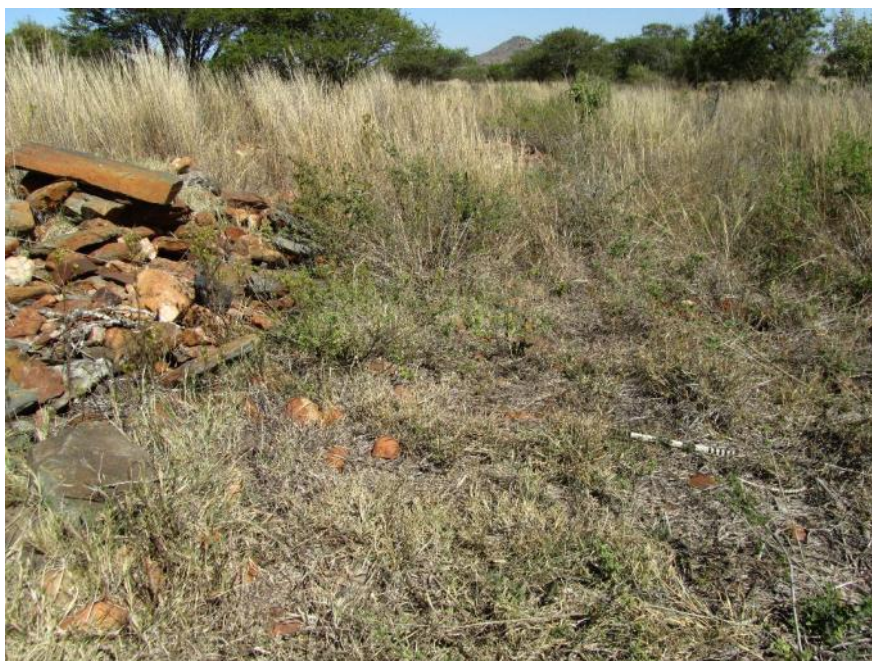
Figures 19. Visible in this image is one of the cairns which led the debushing team to thinking it to be a grave. This image was taken while standing in the trench. The scale used is 50 cm.

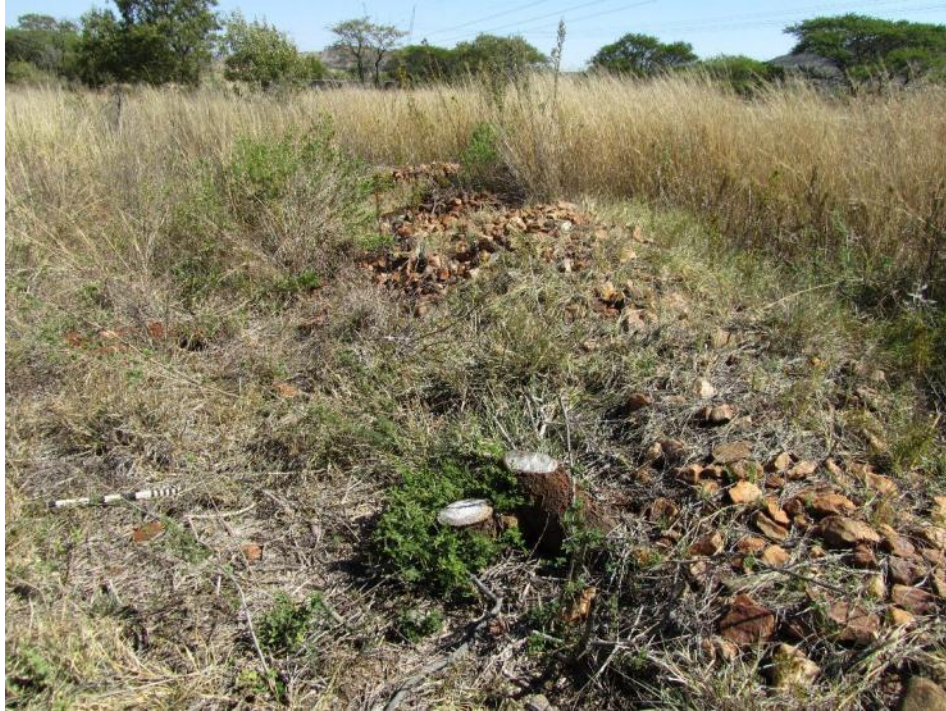
Figures 20. The stone cairns which looked like graves, and the trench itself.

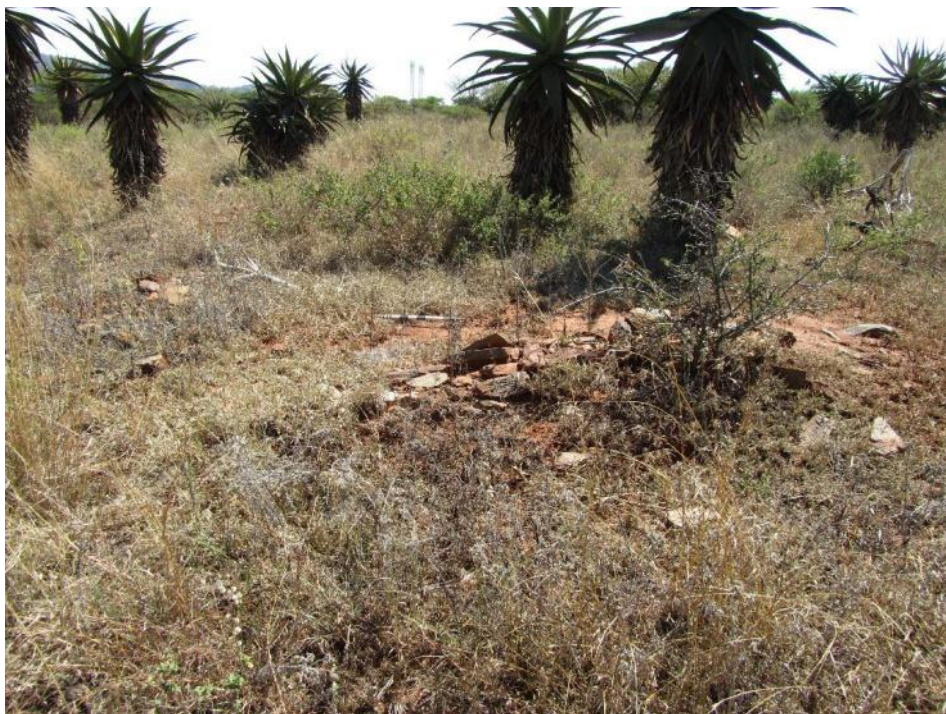
Figures 21. In the vicinity of Tower 193 and right next to the access route this small stone walled structure, previously unnoticed, was identified (S24°00'03.8" E29°28'09.0"). The presence of the large aloes indicates past human presence, and more structures like this one would probably be present. An ideal site for human habitation, this sloping area was doubtless inhabited not only in Late Iron Age times, but also during the historical period.

Recommendations: No action is necessary. The site will not be impacted upon, but care should be taken not to damage it. If necessary, demarcate.

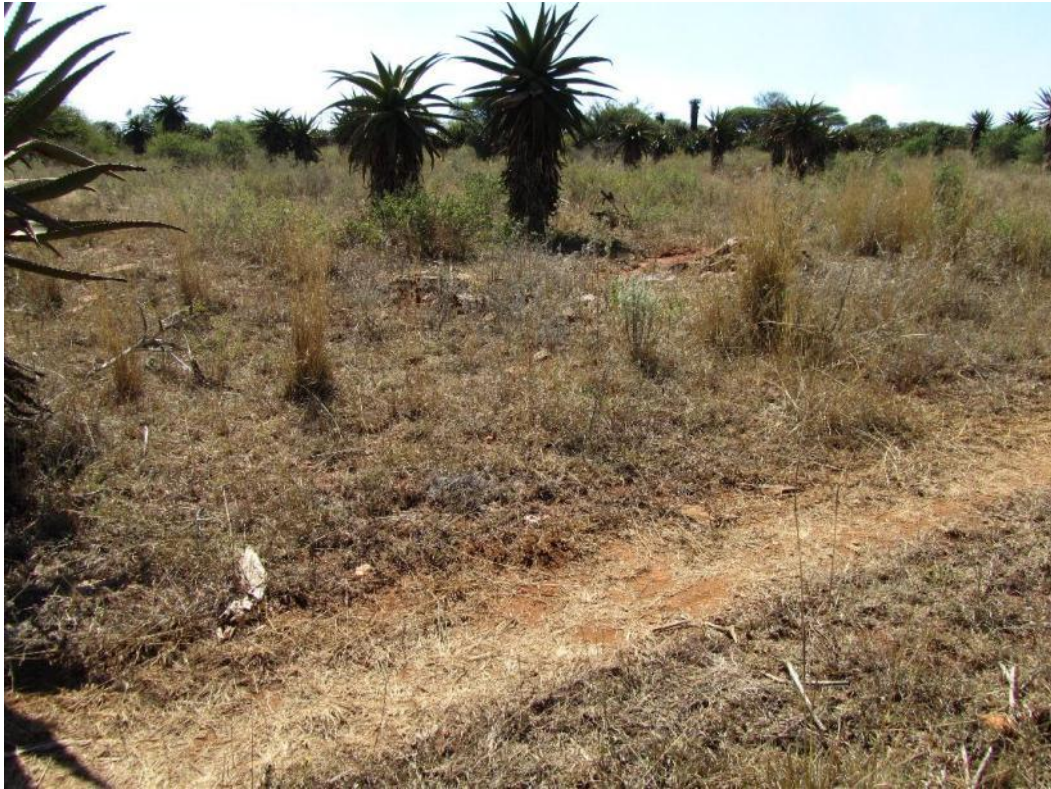
Figures 22. A view of the same site seen from the access route. Its diameter is approximately 7 m, suggesting it to be a goat or calf byre.

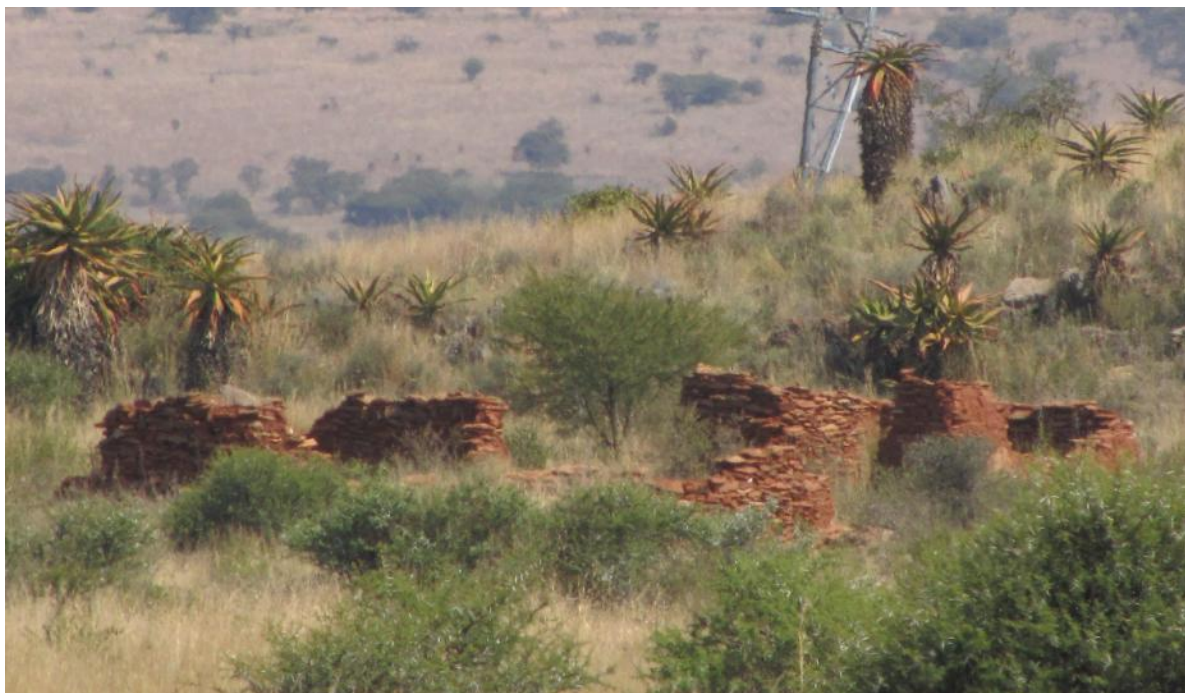
Figure 24. The one homestead is located underneath the previously erected power line (the tower is visible in the background) and will not be in danger of being harmed.

Recommendations: Neither of these structures will be directly affected by the construction of the transmission line. However, the structure closest to the tower might be impacted on by the access road and spanning of the line. An archaeologist should indicate the position of the access route. Demarcate.

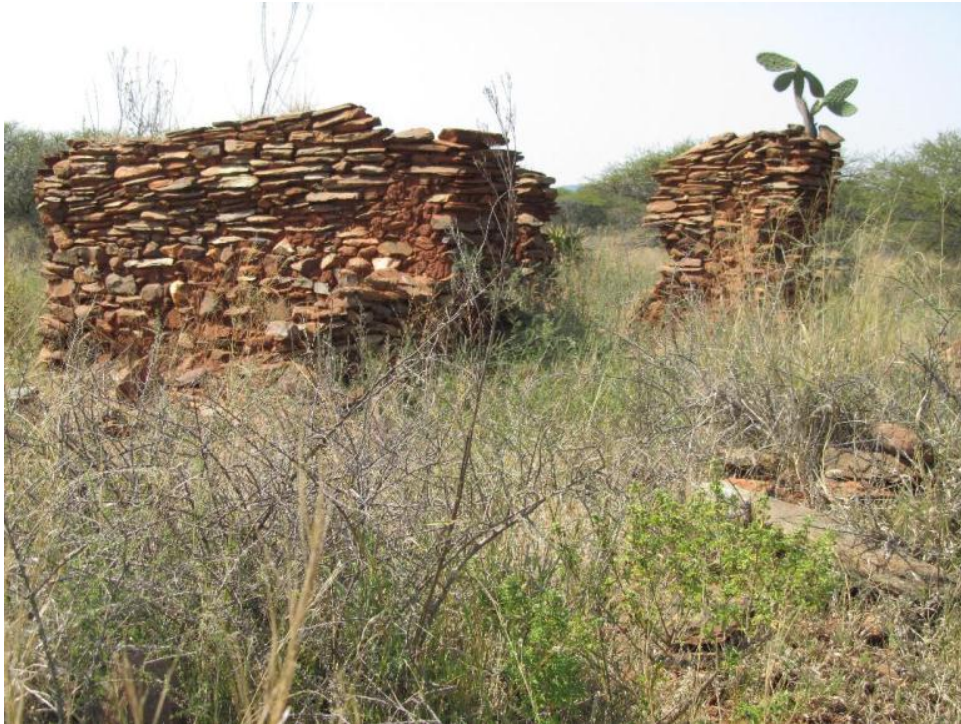
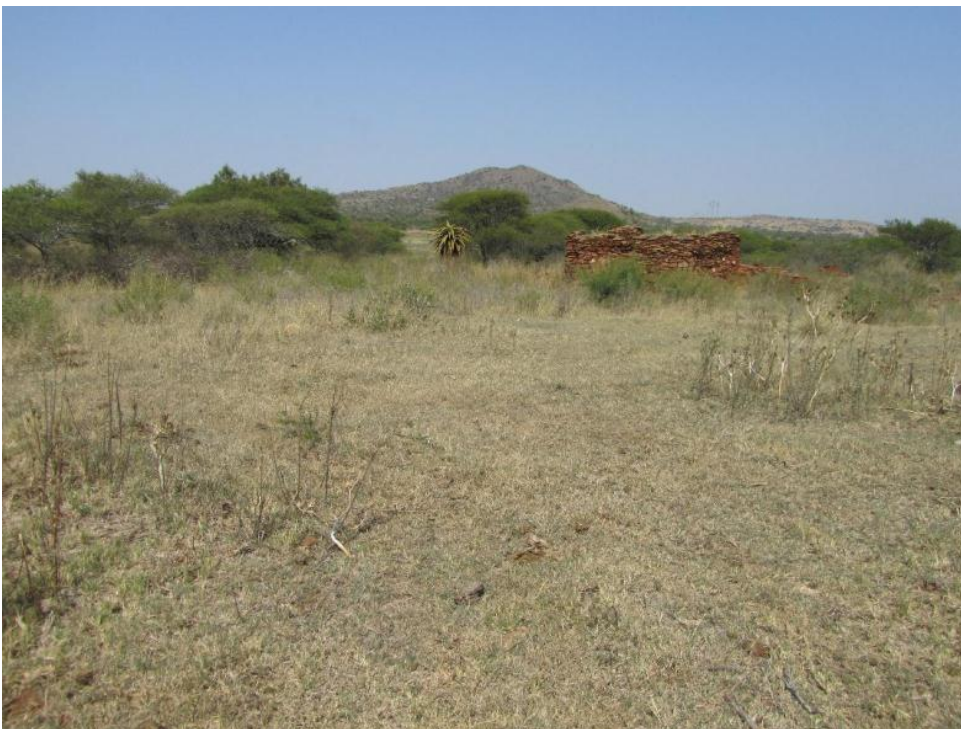
Figures 25 & 26. The homestead that might be affected by the construction activities and traffic. In the image below the greyish soil is an indication of a cattle byre. This is a sensitive area since it might contain burials. The head of the household and his male relatives were usually buried in the cattle byre.

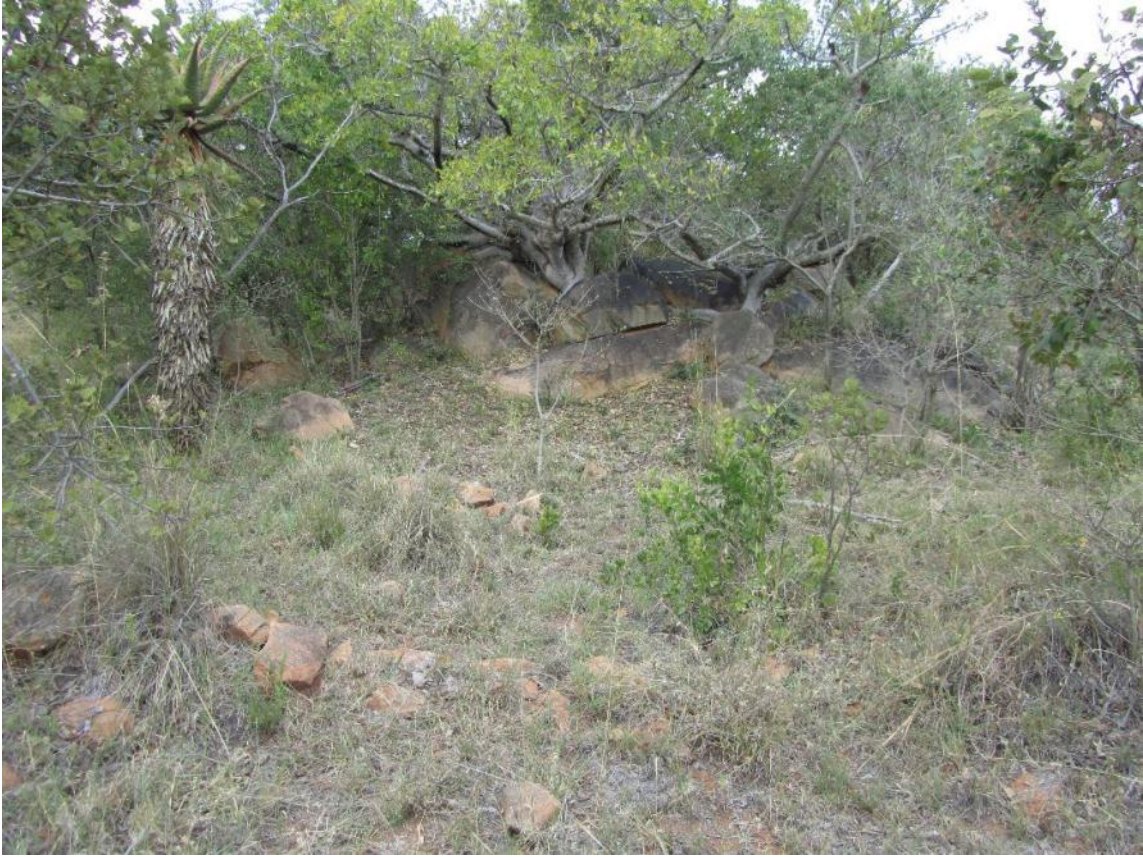
Figure 31. The stone wall (with only the foundation remaining) not only connects the two units but also include the rocky outcrop. A stone cairn within these confines could be a grave.

Recommendations: The tower will not impact upon the site, but the line will cross the one structure. An archaeologist should be present during the *initial* excavation of the foundations for Tower 168, since the area could contain cultural material and again when the line is spanned.

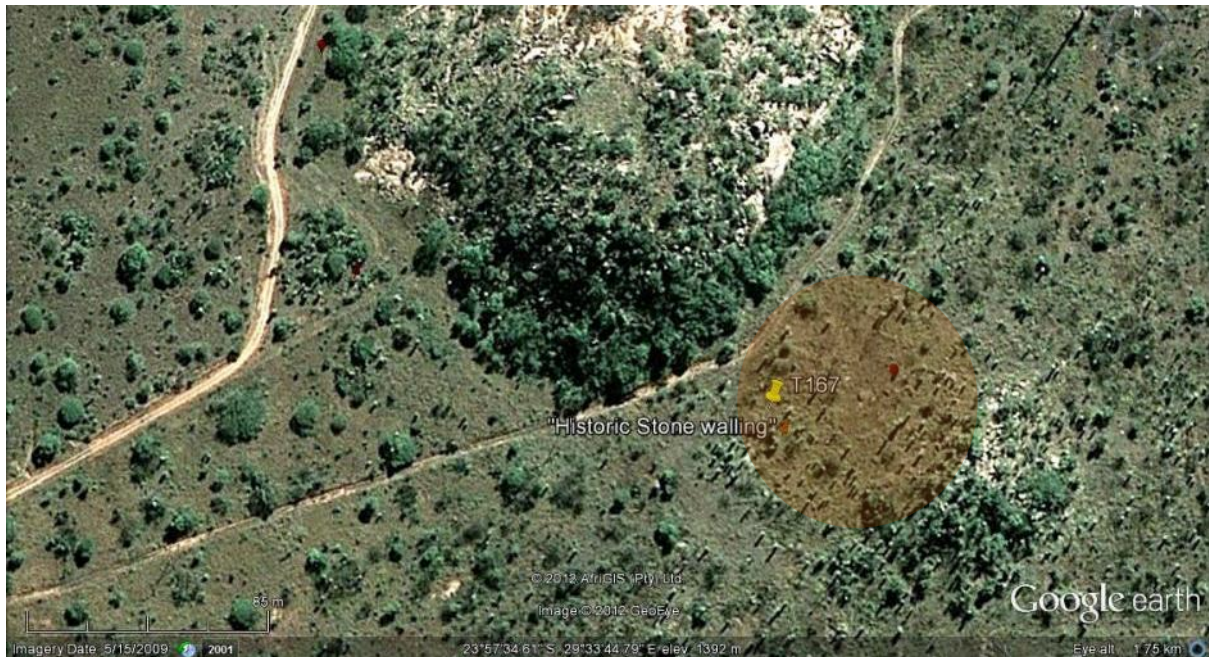
Figure 32. S23°57'35.9 E29°33'46.9". The entire plateau between the two hills is a Late Iron Age archaeological site, roughly indicated in the image with a brown circle. The historical graves and Iron Age stone walled site (indicated by the red dots in the left of the image) will not be affected by the transmission line.

One tower of a previous line intrudes on the archaeological remains and had caused damage. The present access road also cuts through the site. Tower 167 will be placed among the stone wall remains. The full extent of the entire site was not established during the reconnaissance. This site should be avoided since it is protected by the National Heritage Resources Act, 1999 (Act No 25). *Please refer to **Appendix A** for applicable quotations from the act.*

Recommendations: The position of Tower 167 as well as the access road should be relocated or a Phase 2 should be implemented. A SAHRA permit and excavation should be conducted prior to construction. If the tower is relocated, an archaeologist should be in attendance during excavation and construction.

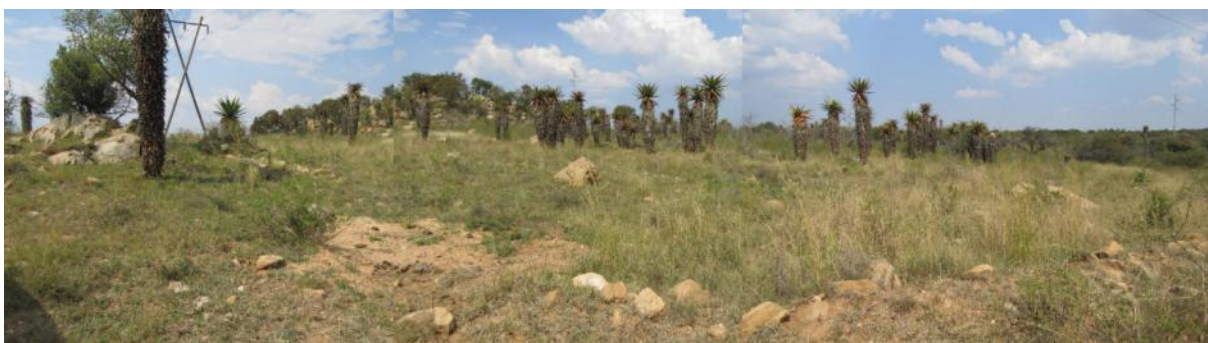
Figure 33. Some of the robbed stone wall foundations are visible in the foreground, while the position of another, smaller circle is indicated by the aloes. The intrusive 86/88 KV tower is visible at left.

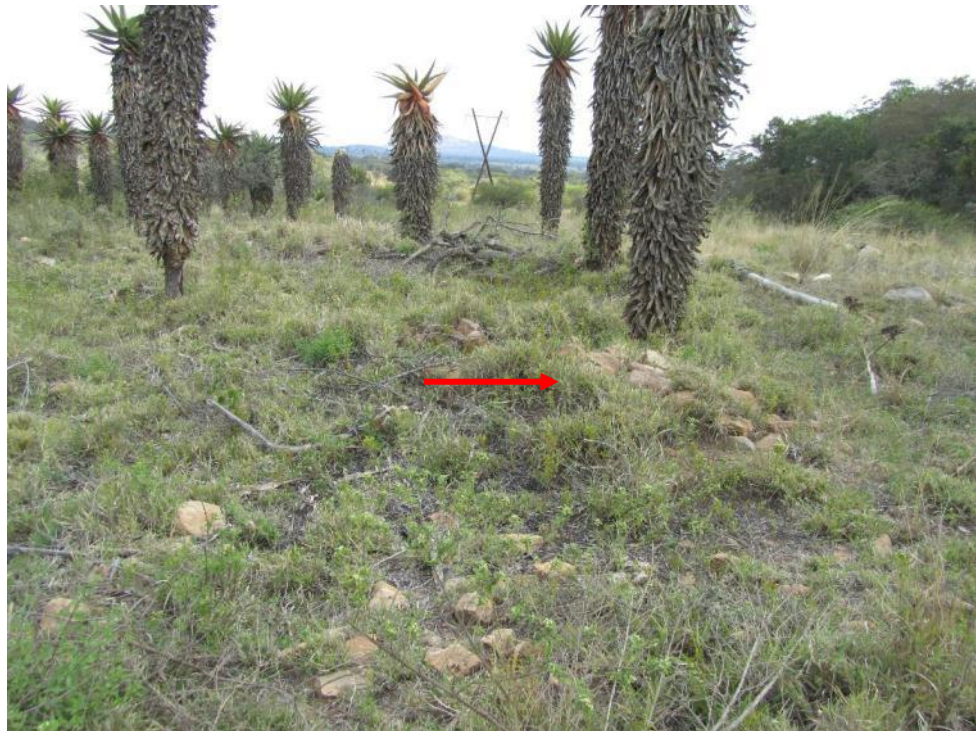
Figure 35. The stone cairn indicated by the arrow could be more foundations or a possible grave.

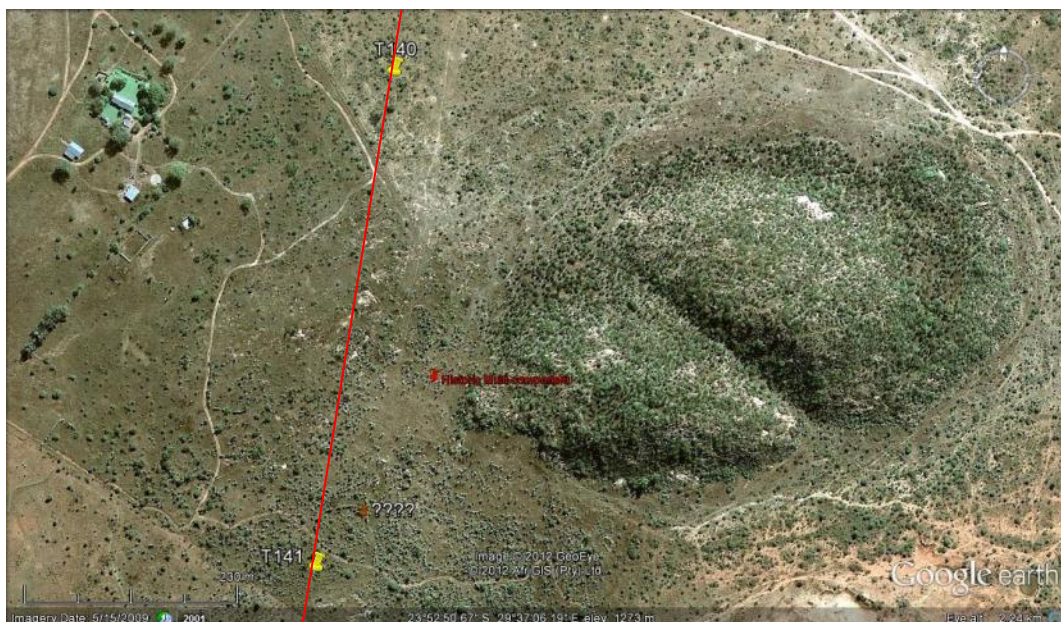
Figure 41. In this image it is clear that the historic multi-component site identified by Van Schalkwyk in 2010 is much larger than what was indicated. The specific site (“Historic Multi-component”) on the slope of the hill will not be impacted by the transmission line; however, the other large Late Iron Age site will be affected, especially at the position of Tower 141 and the access route.

Recommendations: The historic multi-component site needs no mitigation, but the extensive site at Tower 141 needs protection since the tower foundations and access road will impact upon it. Human burials will not necessarily be visible on the surface and could be located practically anywhere on the site, especially in the cattle byres, of which there are several. None of the hut floors had been located. These clay floors would only have been preserved if the place had burned down. Women and children were often buried under the hut floor or next to the hut.

It is recommended that an archaeologist be present during the excavation of the tower foundations and when the line is brought in.

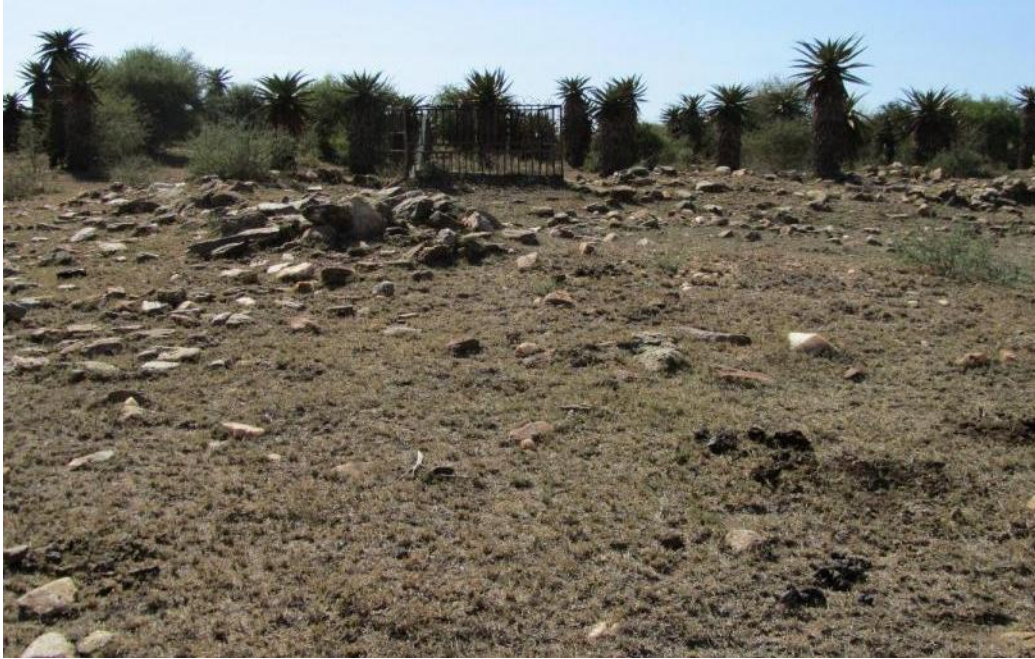
Figure 44. The large open area which is surrounded by stone wall foundations. This was probably a large cattle byre since the soil has a grey colouring as opposed to the surrounding red soil of the area. A modern grave stone was erected in a smaller stone walled area.

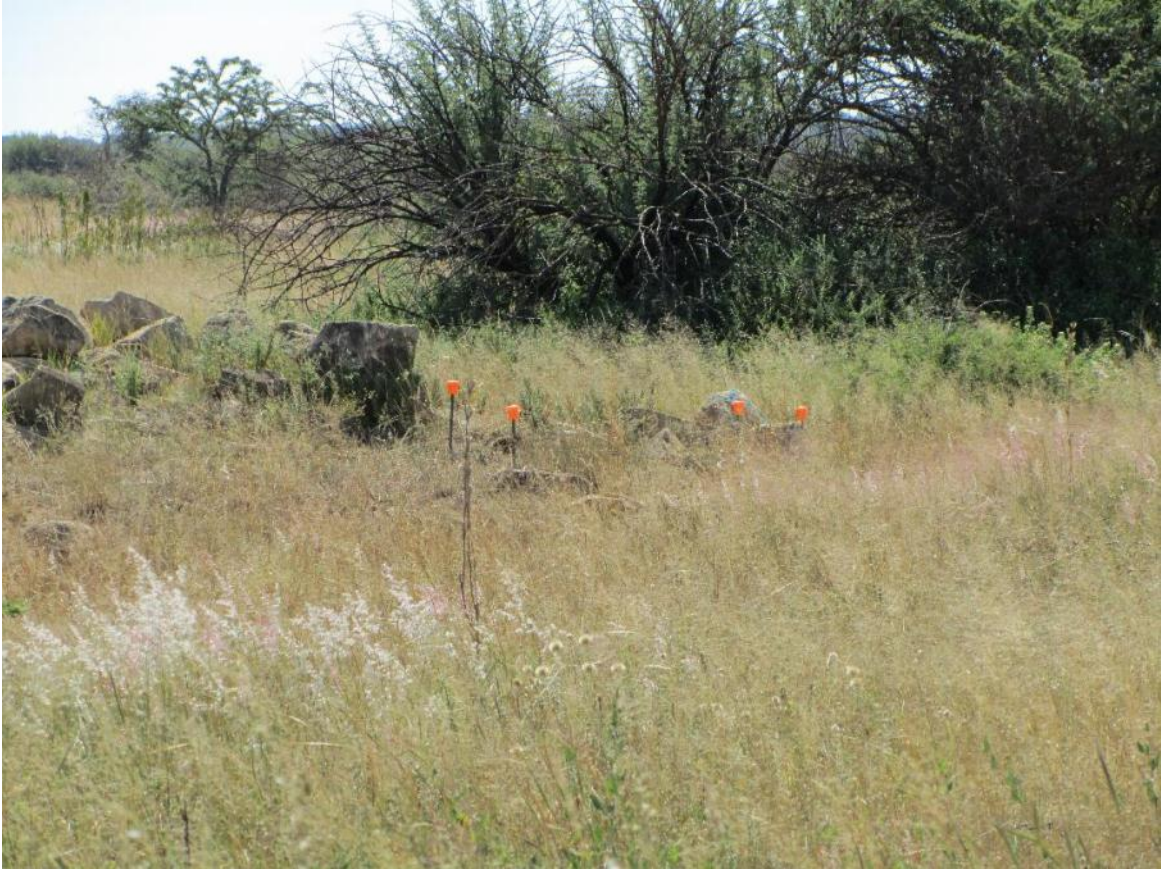
Figure 49. The one foundation of Tower 99 is among the rocks.

Recommendations: Although this structure is historic, its significance on the regional level is low (HIA Report, Van Schalkwyk, 2010) and it is not necessary to relocate the tower foundation. However, care should be taken not to cause any further damage.

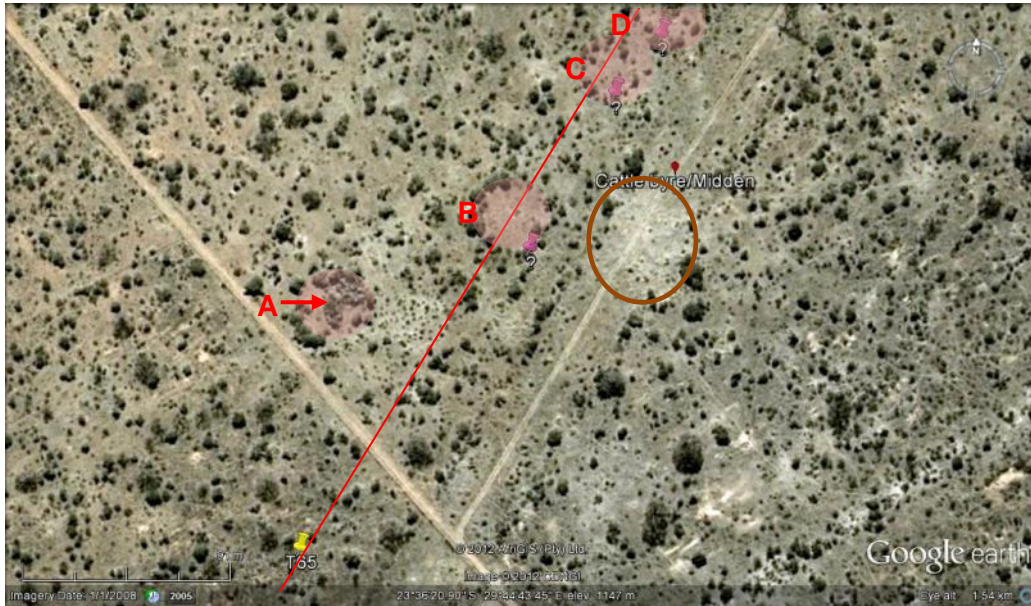
Figure 52. S23°36'19.0" E29°44'45.7". A historic multi-component site. Indicative of human habitation and activity is the distinctive light grey colour of the soil, suggesting a cattle byre or midden. Its location is delineated with a brown circle to show the extent of it. The arrow points to Site A, a clump of sisal (see figure below). While on site, the archaeologist could find no signs of habitation, but an aerial view clearly show distinctive circular structures at the points marked "B" and "C" (the pink tinted areas). Point "D" is rectangular in shape.

Recommendations: The tower is not located on these sites, however, the transmission line will cross it and the access road will pass through it. Care should be taken not to damage the structures when the line is being spanned. Access routes should preferably avoid these areas and its location should be mitigated with the archaeologist.
