PROGRESS REPORT 05: April 18 – May 08, 2012

Towers 198 - 32

PROPOSED 400KV TABOR-WITKOP TRANSMISSION LINE, LIMPOPO PROVINCE

For: Stefanutti Stocks Power

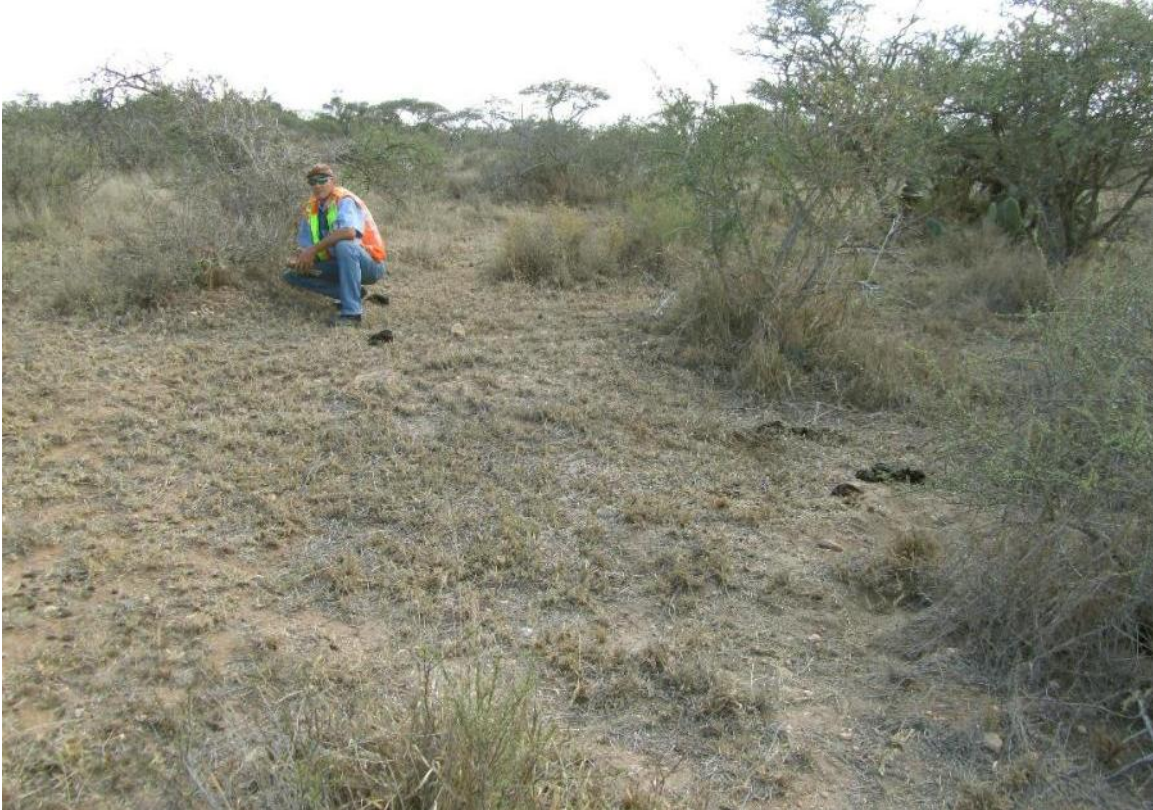
Figure 59. The raised feature to the right of Mr Scarrott could be a grave. Different from later burials, it consists mainly of small stones. The grey colouring of the soil is obvious, indicating either a cattle byre or a midden, the preferable burial places for the male members of a community.

Recommendations: It is recommended that the archaeologist should be present when the foundations of Tower 58 are excavated, since human skeletal material could be retrieved. Great care should also be taken not to damage cultural remains when the transmission line is spanned. Since the previous access route has already damaged the site, it is advised that this route should also be utilised for the Tabor-Witkop transmission line and that the shortest possible access route or a route which will cause the least disturbance should be demarcated from the original access.

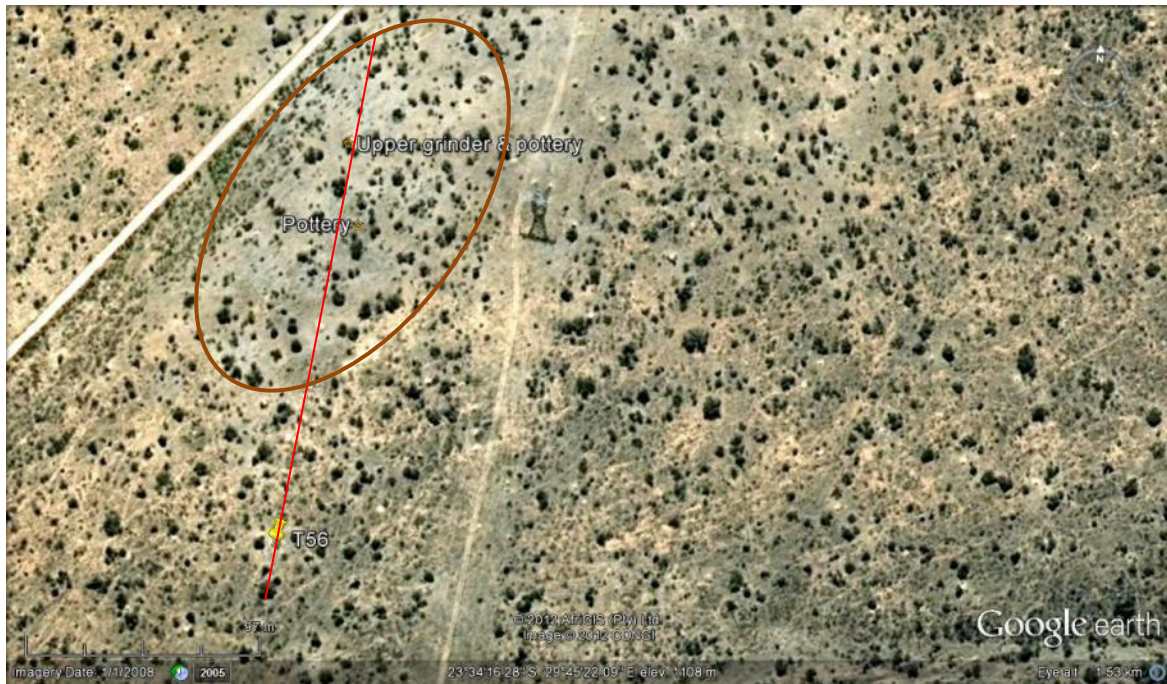
Figure 63. A large midden or cattle byre is roughly delineated here. The site extends beyond the dirt road at left as well as the access route of the previous Eskom line.

Recommendations: The same as for Tower 58: The archaeologist should be present when the foundations for Tower 56 are excavated, since human skeletal material could be retrieved. Great care should also be taken not to damage cultural remains when the transmission line is spanned. Since the previous access route has already damaged the site, it is advised that this route should also be utilised for the Tabor-Witkop transmission line and that the shortest possible access route or a route which will cause the least disturbance should be demarcated from the original access.
