## **PROGRESS REPORT 07: May 22, 2012**

### **Tower 205 & List of Previous Recommendations PROPOSED 400KV TABOR-WITKOP TRANSMISSION LINE, LIMPOPO PROVINCE**

**For:** Stefanutti Stocks Power

**Hester Roodt**

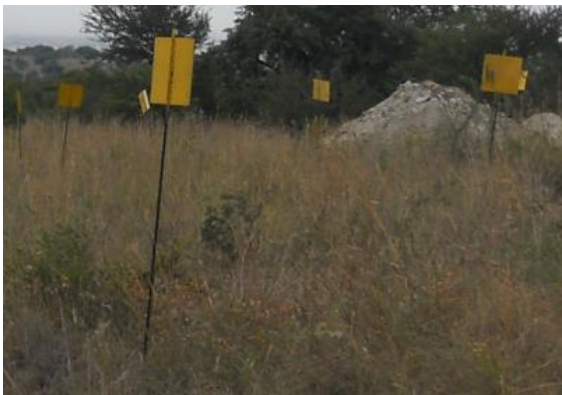
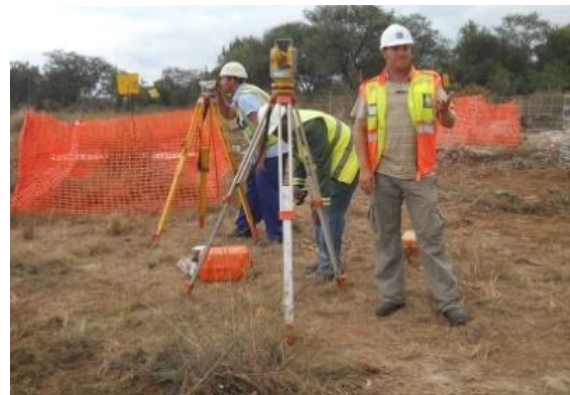
**Figures 1 & 2.** *The above images illustrate the temporary demarcation of graves: yellow boards which were clearly visible and orange netting around the two graves next to and under the tower.*

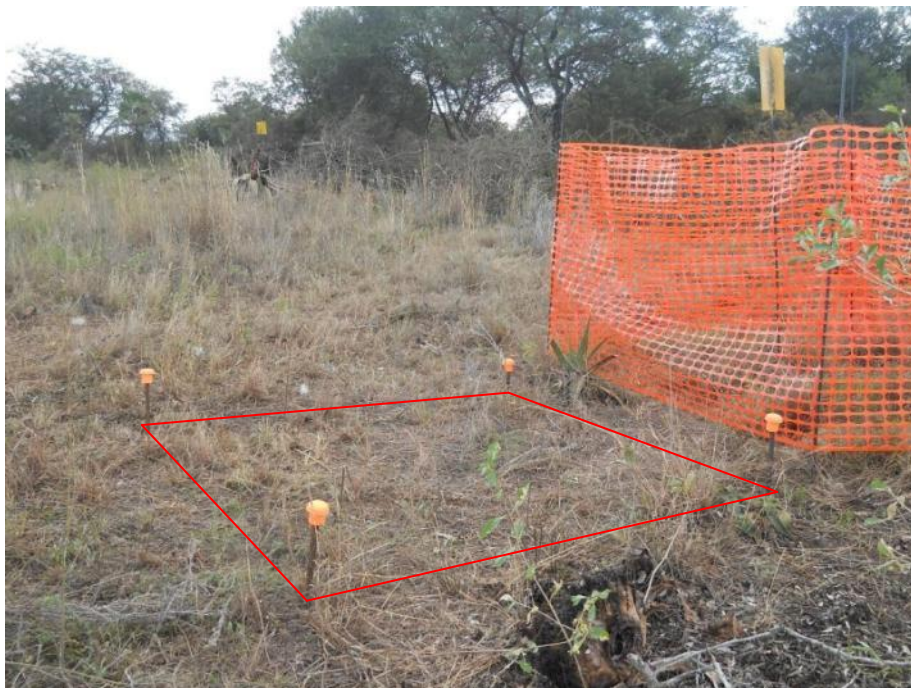
**Figure 3.** The position of Leg C of Tower 205 is marked with steel rods and yellow caps (indicated with a red square). The burial is temporarily demarcated with the orange netting. From the above image it is clear that the one leg of the tower is almost on top of the grave.

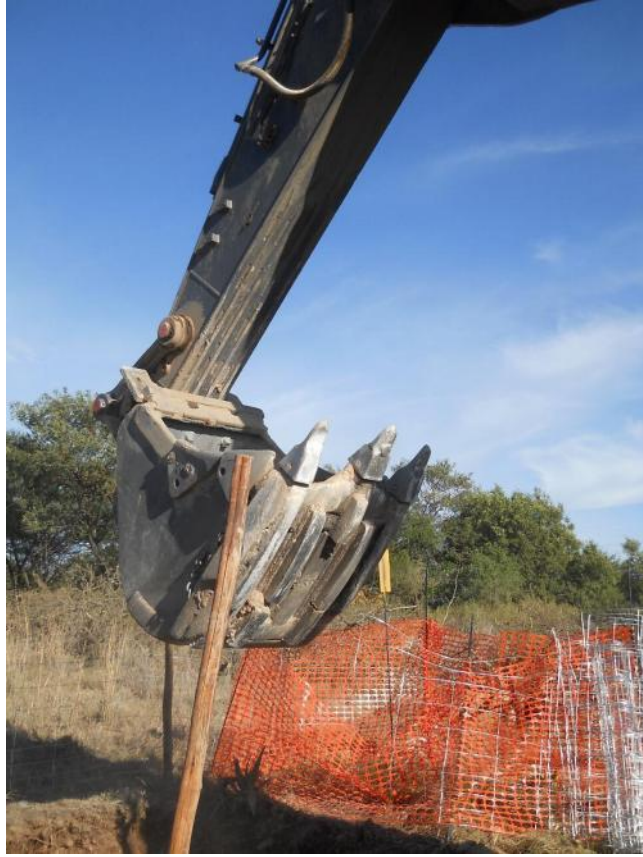
**Figure 4.** Great care was taken during excavation to prevent damage to the grave: when the bucket teeth blunted and made excavation not only difficult but also endangered the grave, another excavator replaced the previous, larger one.

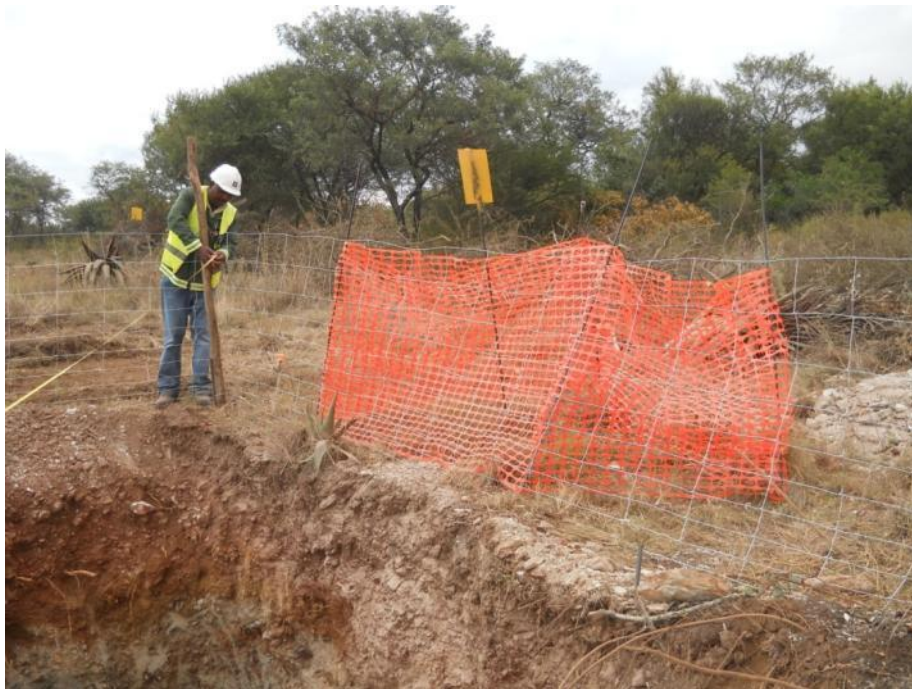
**Figure 5.** The excavation being complete, it is clear that the grave is quite close to it. The temporary demarcation is still in place.

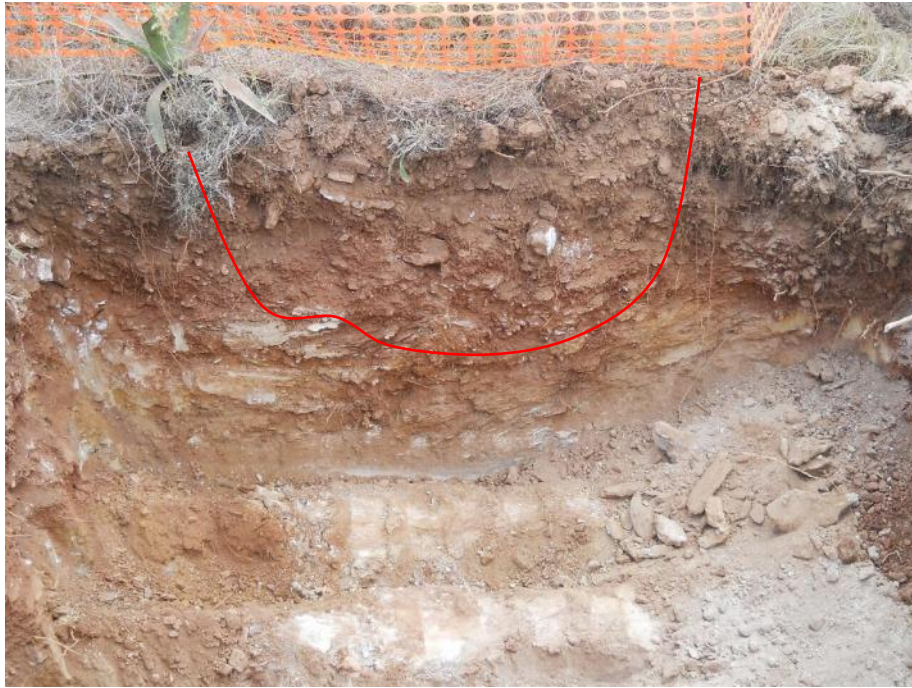
**Figure 6.** *The disturbance of soil from the stratigraphy of the dug grave (delineated in red). It is clear that the excavation cut through a small portion of the grave. No skeletal material, however, was visible or was removed. The excavation was completed without any further damage to the burial.*

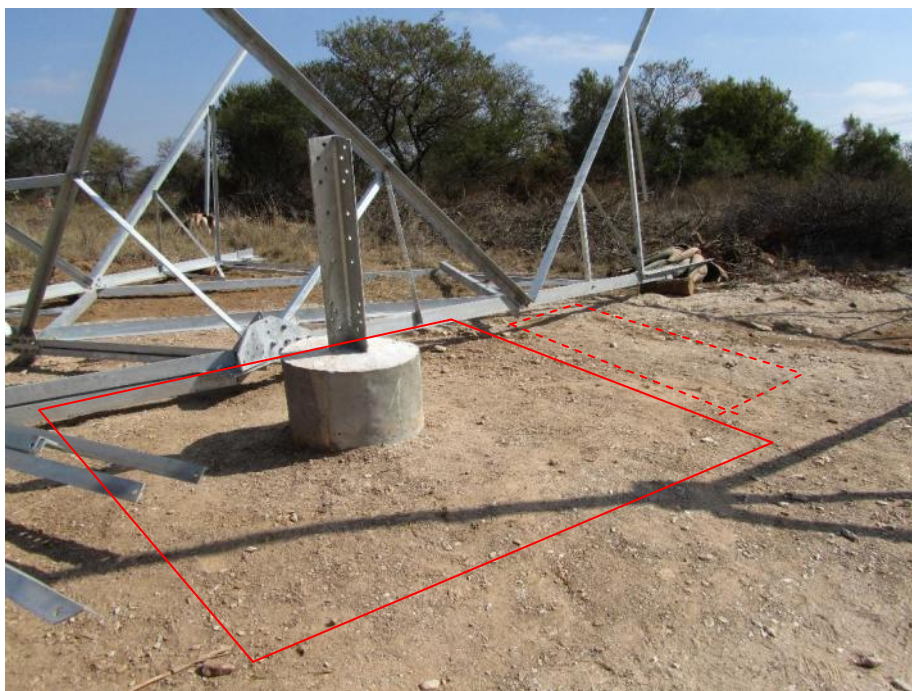
- No demarcation of the area was undertaken;
- There is no sign indicating parking for the vehicles of the construction workers/inspection;
- The two graves that stood in immediate danger of being damaged were temporarily demarcated with orange netting and maintained during excavation and the casting of the foundations. These had been removed, which resulted in the one grave being destroyed;

**Figure 7.** *This photograph was taken on May 22, 2012 when the archaeologist inspected the site after it came under her attention that work had continued on the tower without her being informed of it. The red trapezoid roughly indicates the filled excavation and the dashed rectangle roughly indicates the previously demarcated area. The grave mound had been completely removed.*

- The archaeologist should receive a weekly schedule in order to know when work in the sensitive areas commences in order to be present.
- Immediate steps should be taken to safeguard the graves at Tower 205 before work commences. This would include the permanent demarcation of the cemetery with standard fencing materials (corner posts, wire and droppers, at least 1,2 m high with “No Access” signs fixed onto the wire).
- The access road and parking should be clearly indicated with permanent sign boards. The area used for parking was among graves, and this area should be out of bounds.

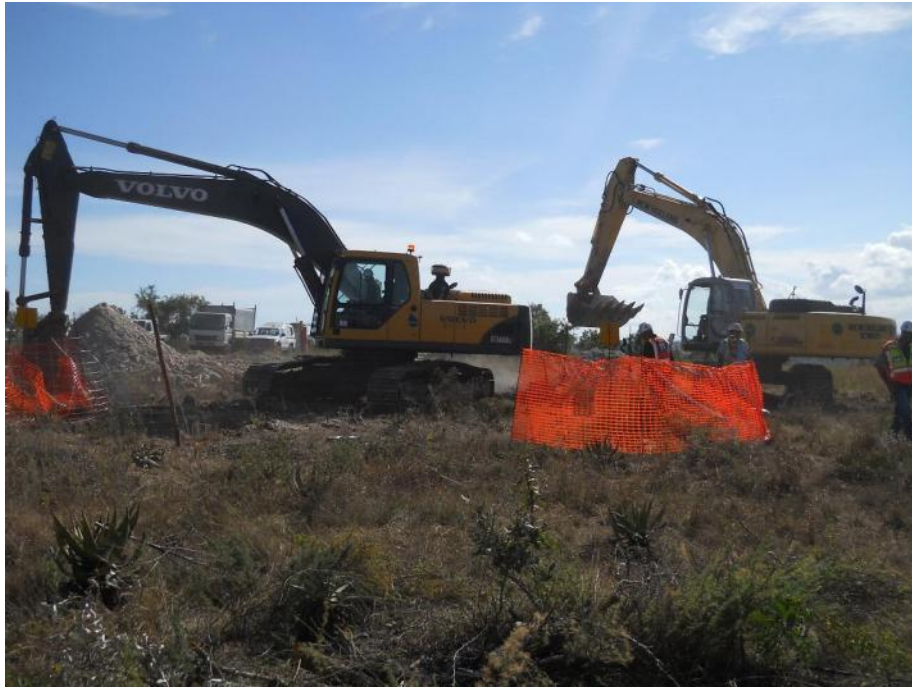
**Figure 8.** *The two excavators worked carefully around the two temporarily demarcated graves without any damage to it. The archaeologist was present at all times during excavation activities. At left is the demarcated grave which had been damaged during the filling of the foundation.*

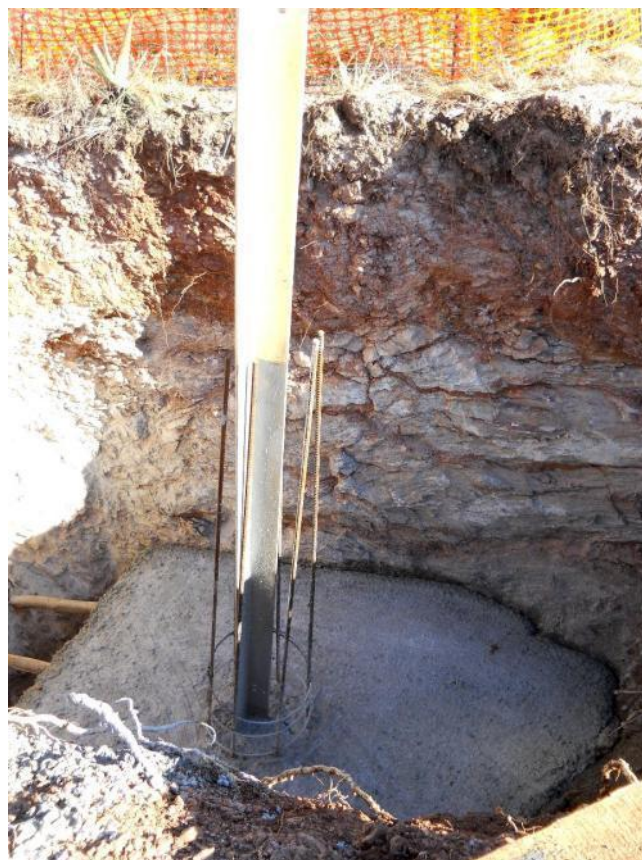
**Figure 9.** *The commencement of the casting process. The archaeologist was on site during this process. No damage was done to the grave.*

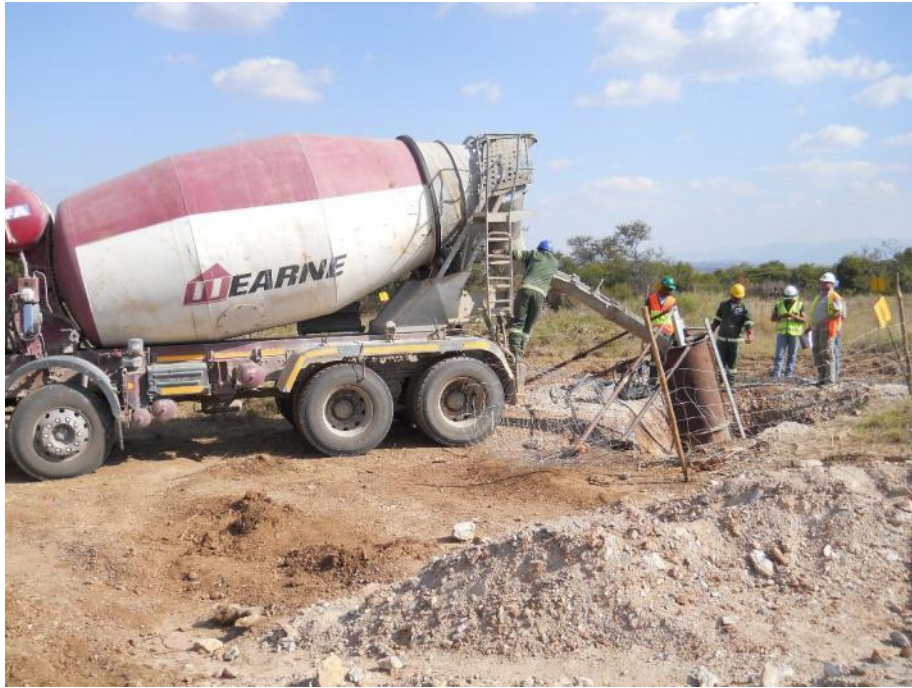
**Figure 10.** The final stages of the casting process. The archaeologist was also on site, informed about it in advance.

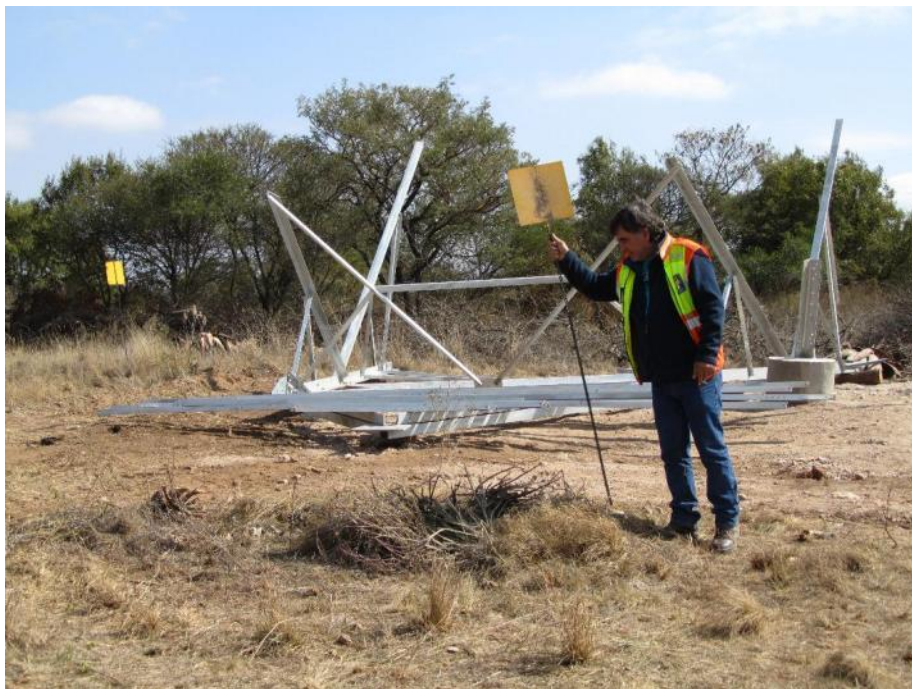
- No protection (i.e wooden boxes) for the graves was brought on site.
- The access road was not delineated as stipulated, and tracks are visible over some of the graves next to it.

**Figure 11.** The site on May 22: Mr O De Canha is standing at the site of the one grave with one of the yellow markers in his hand. This was picked up in the veldt beyond the construction material. No demarcation is in place and it is evident that vehicles were driven over it.

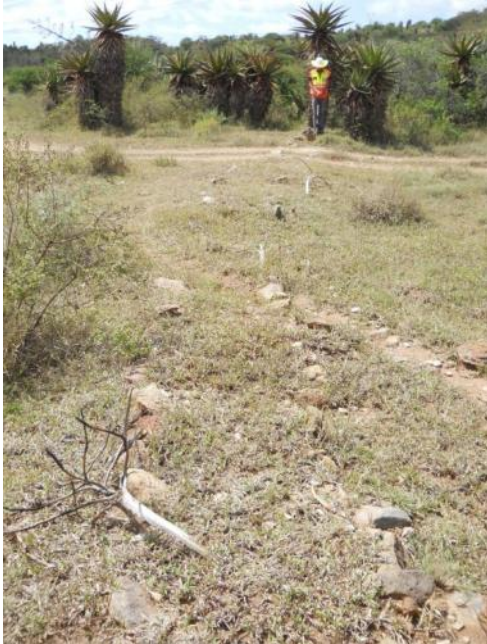
- The old access route is still being used. This is not acceptable. The present access road should be avoided to prevent any further damage to the Late Iron Age stone walling. *Immediate rectification is necessary regarding the access route, which should be closed off and rerouted.*

**Figure 12.** *The access road which had been utilised for the existing power line crosses foundations of walls of this LIA settlement at least three times.*

The present access road should be avoided to prevent any further damage to the LIA stone walling.

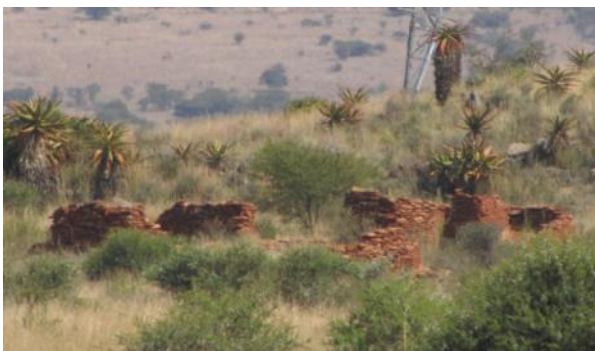
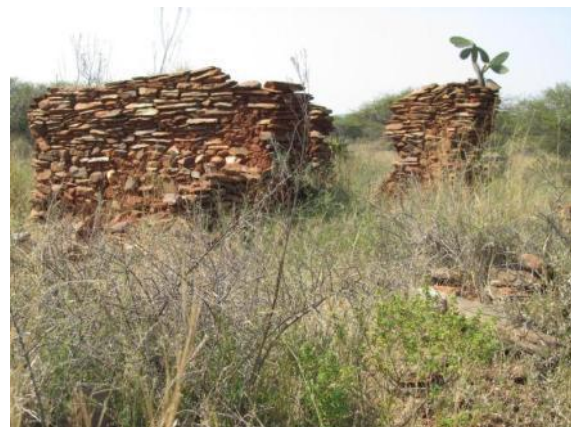
Neither of these structures will be affected by the construction or traffic concerned with the transmission line. However, precautions should be taken not to damage it. Demarcate if necessary.

**Figures 13 & 14.** *The historical remains of stone walled sites.*

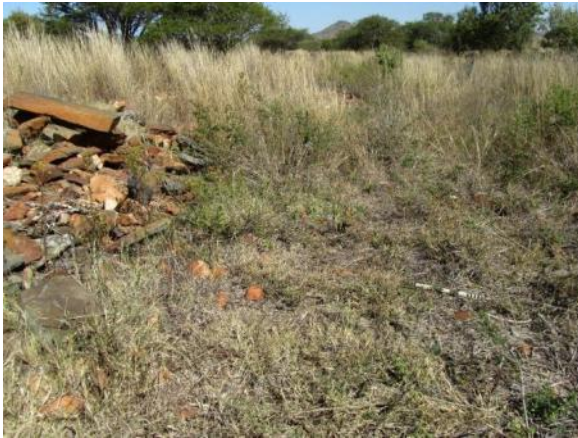
**Figure 15.** Trench. No action is required.

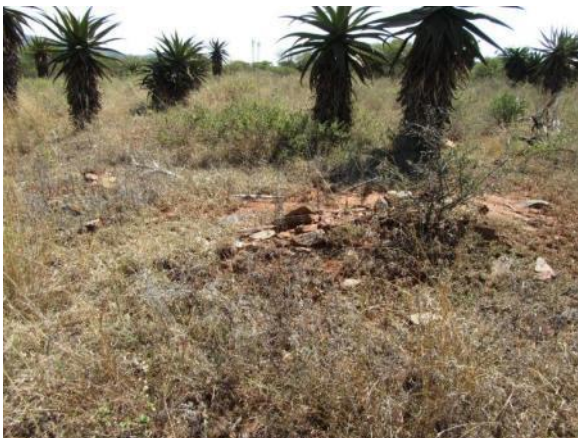
**Figure 16.** Stone structure in vicinity. No action is necessary. The site will not be impacted upon, but care should be taken not to damage it. If necessary, demarcate.

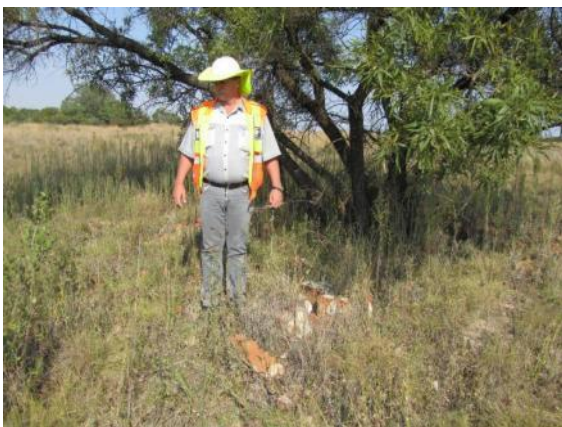
**Figure 17.** Small brick structure (tank/generator). Demarcate during construction and protect from future traffic.

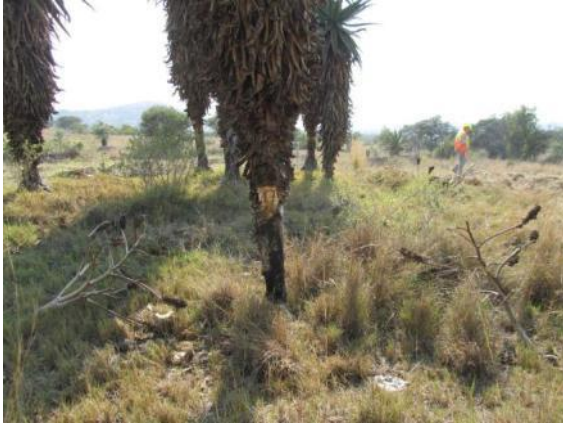
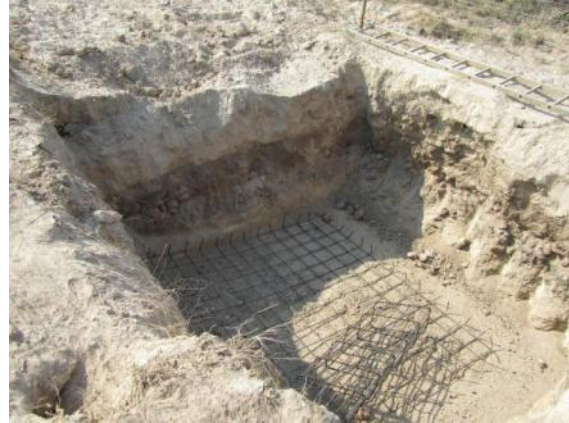
**Figures 18 & 19.** Aloes on grey soil & tower. Should any archaeological finds be detected while work on the foundations are conducted, the archaeologist should be notified immediately. It is possible that human remains could be present.

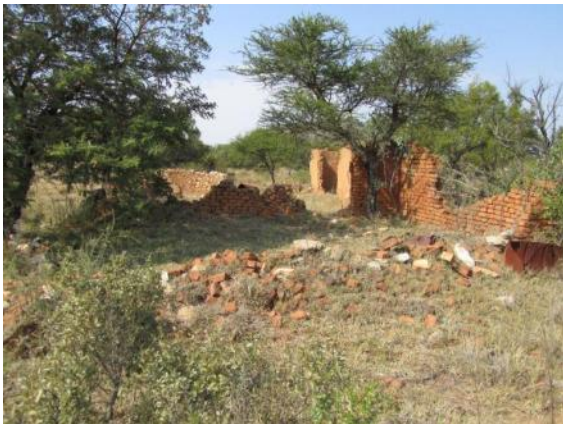
**Figure 20.** Homestead, farm workers. These structures will not be affected by the towers or transmission line but was reconnoitred for it has historical relevance and is close to the activities. Avoid all traffic. If necessary, demarcate.

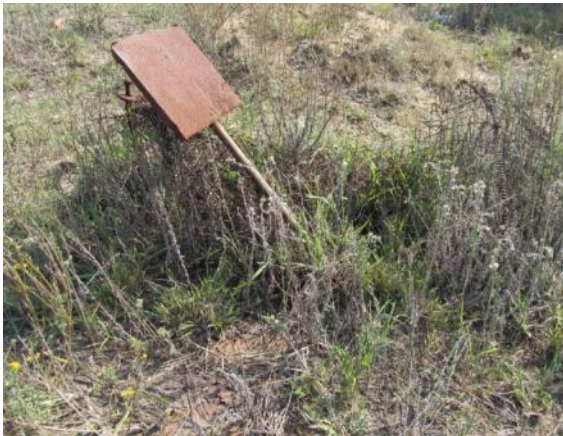
**Figure 21.** Goldfields marker. This marker is not in the way of construction traffic. Should the route change, demarcate and avoid.

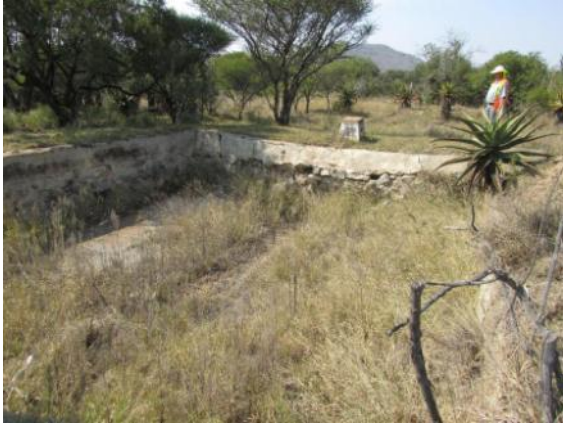
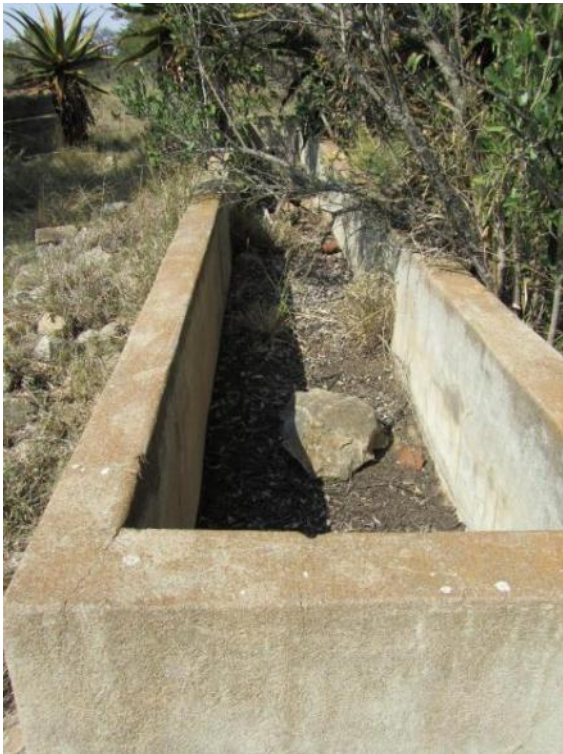
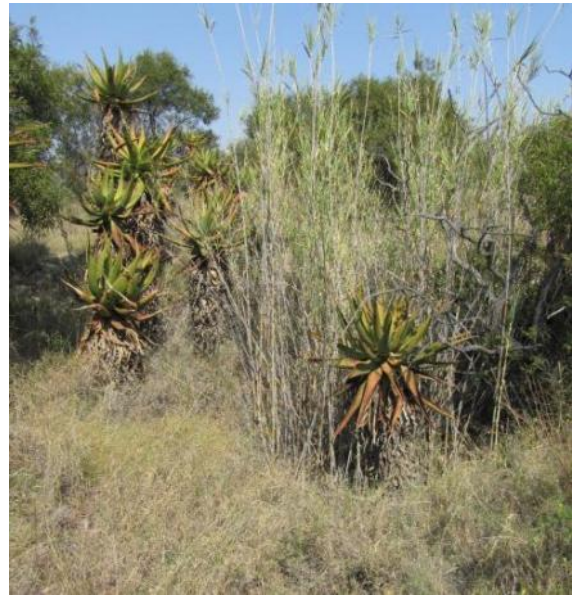
**Figures 22, 23 & 24.** Reservoir, drinking trough, etc. The reservoir and accompanying structures are close to the transmission line and could be endangered by the activities and traffic related to the transmission line. Avoid and demarcate a clear access route. Demarcate the three depressions for they are a great risk.

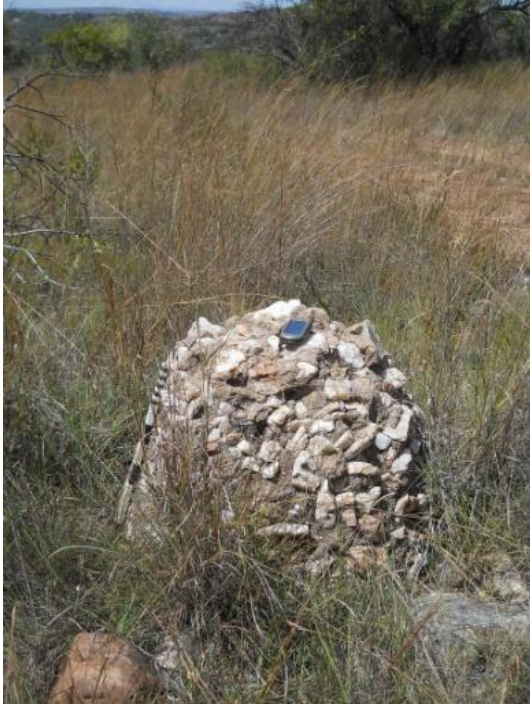
It is advised that this feature should be clearly demarcated for the duration of the tower construction in order for it to be avoided. At present it might seem not be of any great cultural value in the absence of more information. It is clear, however, that the feature was intentionally built and without doubt had relevance to some action that took place in the past.

**Figure 25.** *The stone and cement beacon.*

The beacon is safe due to its location next to the well marked access road to Tower 204. It is, however, advised not to remove or damage it (or any of the other and similar beacons) in any way.

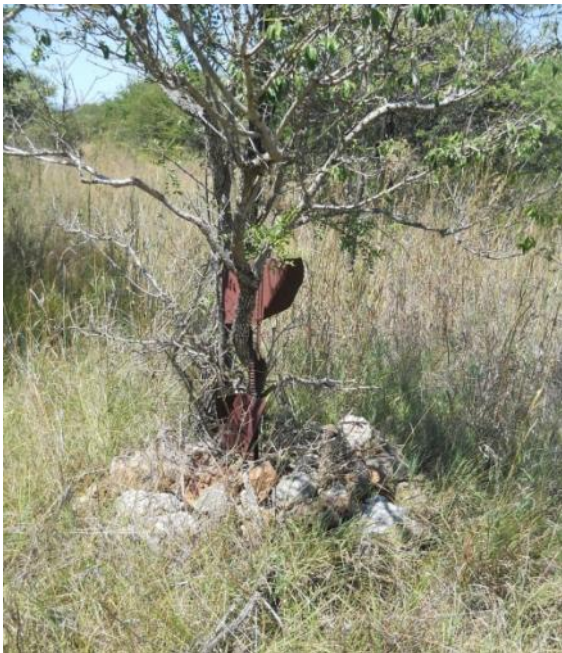
**Figure 26.** *This feature could be linked to a similar feature in the vicinity of Tower 204, and should be treated likewise.*

It is recommended that it should be clearly demarcated for the duration of the tower construction in order for it to be avoided and should not be removed or damaged in any way.

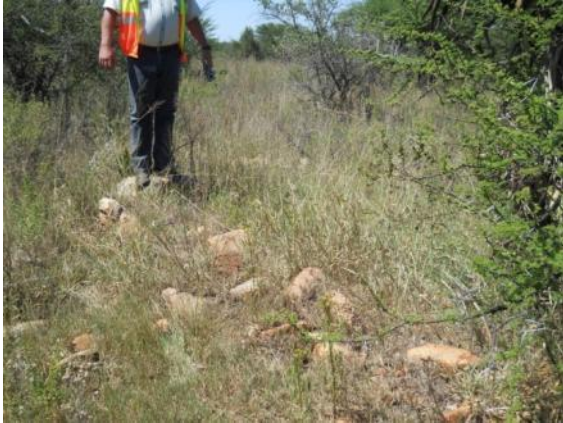
**Figure 27.** *The extent of these sites could not be clearly established due to the thick vegetation. It is possible that the structures are part of a single complex or that they are separate units, which could indicate historical occupation, e.g homesteads of farm workers.*

- a. These sites should be cleared of vegetation well in advance of excavation for the foundations for Tower 206, to enable identification, and if necessary, to implement a **Phase II** (excavation) archaeological operation, particularly in the region of the tower. It is possible that graves could be located in the immediate surroundings of these stone walls.
- b. Another viable option would be to relocate the position of the tower so as not to endanger these sites. If the transmission lines still cross the site, it should be clearly and permanently demarcated to prevent any future damage to the site, and an access road delineated for line/tower inspection.
- c. Application for a destruction permit should be obtained from SAHRA (the South African Heritage Resources Agency).

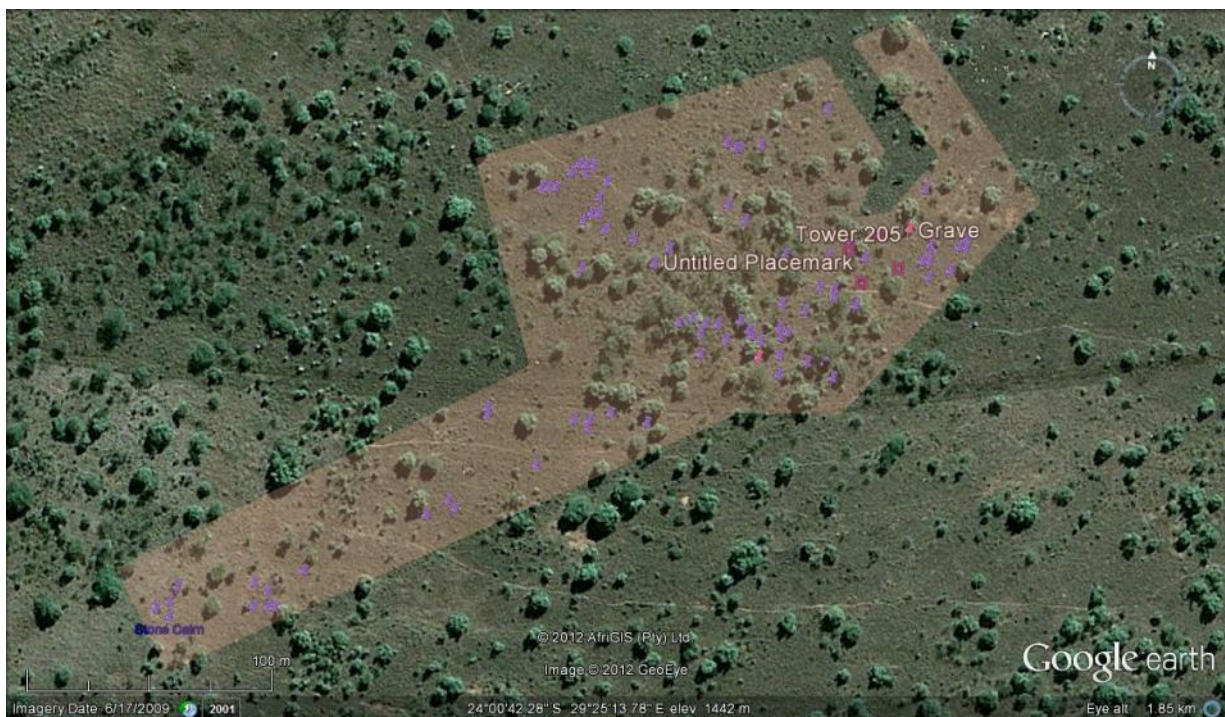
**Figure 28.** An approximation of the permanent demarcation necessary for the cemetery.
