PARLIAMENT PRECINCT: OLD ASSEMBLY BUILDING

**PERMIT APPLICATION : ENTRANCE HALL / NCOP LINK CORRIDOR – GROUND AND
FIRST FLOORS – STRIPPING OF EXISTING COLUMNS**

DATE: 29 – 11 – 2022

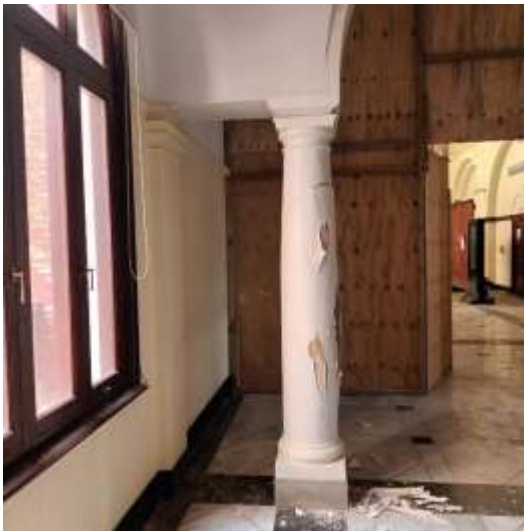
- 4.6.4.3 The columns are constructed out of reinforced concrete encased in a thick layer of plaster/gypsum material used for decorative effect. The plaster ranges in thickness from approximately 15 – 70mm. It appears that the plaster is cracking up (bursting open) as a result of moisture ingress. The columns are positioned away from any external walls, making the logical assumption that the water is travelling down from the top floors. (See the Structural Engineer's report for more information).

- 4.6.4.4 Currently nineteen (19) columns are affected, twelve (12) on the ground floor and seven (7) on the first floor.
- 4.6.4.5 The cracking of the columns (albeit the plaster) have raised safety concerns. The intention is to strip all the plaster from all the affected columns in order for the structural engineer to conduct proper investigations and tests to ensure that the integrity of the reinforced part of the concrete column have not been compromised. Saving and repairing the plasterwork would not serve a purpose in any event since the material has grotesquely swelled beyond repair.

Fig 3 : Ground floor – damaged column

- 4.6.4.6 Proposed reconstruction method for the :
- Apply lime plaster / rendering process in the reconstruction of the columns.
 - The lime plaster / rendering will assist in absorbing water readily. This breathable plaster will expel water as the weather dries up, conserving the substance below it and reducing damages. The lime plaster has room for contraction and expansion.

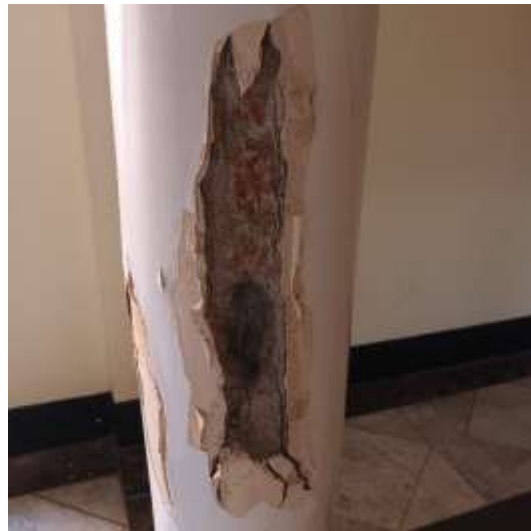
Fig 4 : Close-up of damaged column

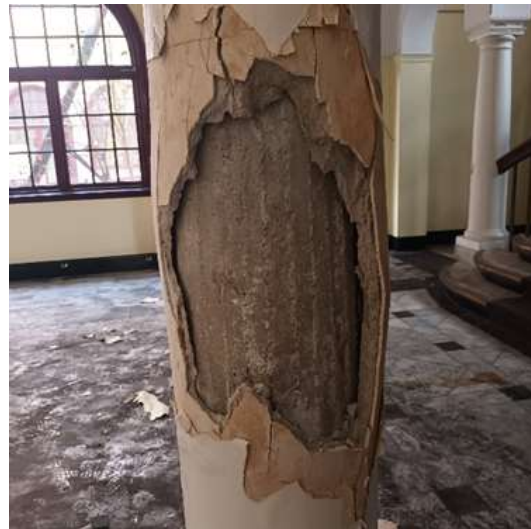
Fig 8 : Exposed concrete column

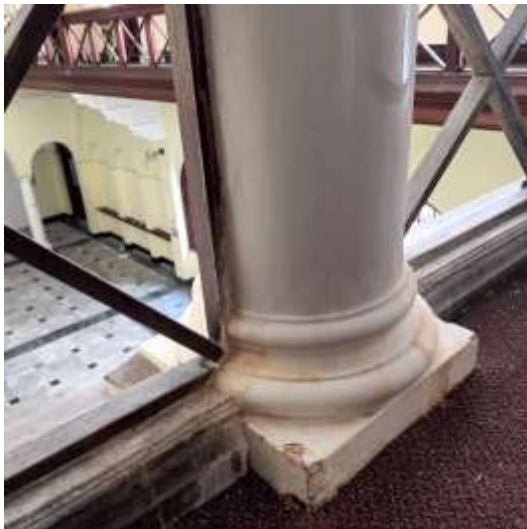
Fig 9 : First floor - Damaged base of column

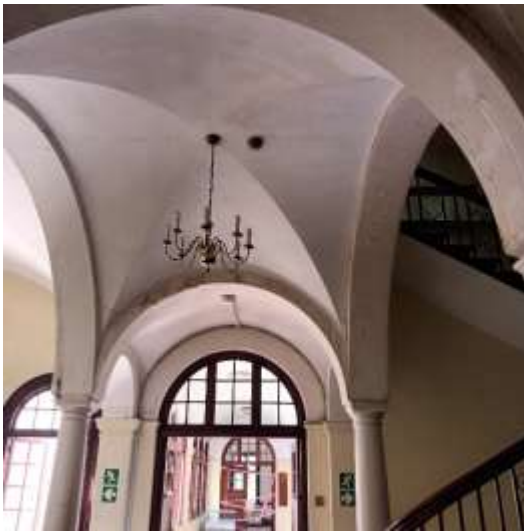
5.1.1.1 Water damage is evident on various areas of the ceilings and archways. The amount of damage is cause for concern. Trying to save these elements at a later stage might prove futile if they are allowed to deteriorate further.

Fig 11 : First floor ceiling

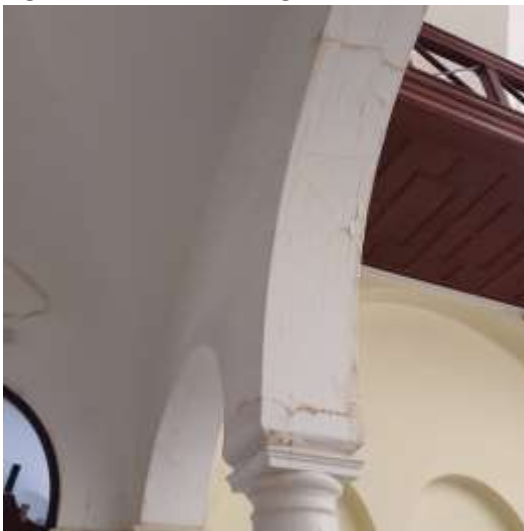
5.1.1.2 The curvature of the vaulted ceilings allows for the water to transverse across the ceilings and then settle at a lower point. In this case, evidence of water damage were noted mostly in areas between the edge of the vaulted ceilings and top of the columns, as well as around the arch areas.

Fig 13 : Ground floor - Damages to ceiling and arches

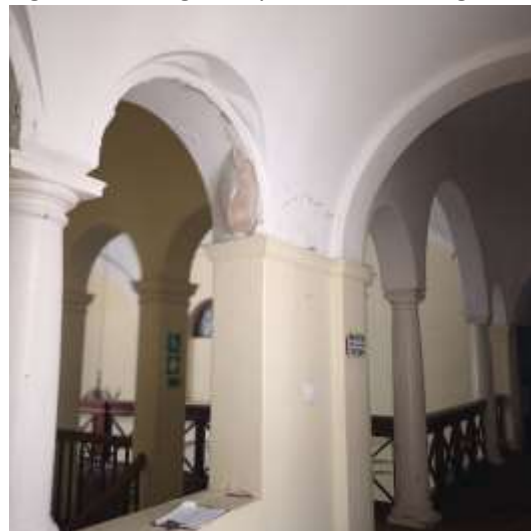
Fig 14 : First floor – Damages to the arches

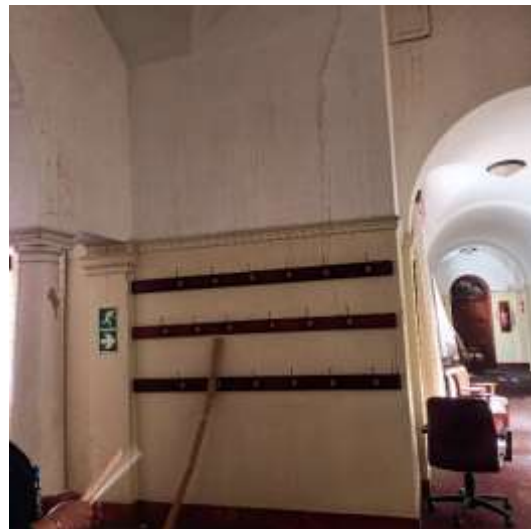
5.1.2.1 Shows signs of water stains, cracks in some areas and water ingress (peeling, flaking and bubbling of paint etc).

5. 1.2.2 Water ingresses into the walls from above, find their way downwards, settling in the columns and walls, resulting in the damages now experienced.

Fig 16 : First floor – Damages to the walls

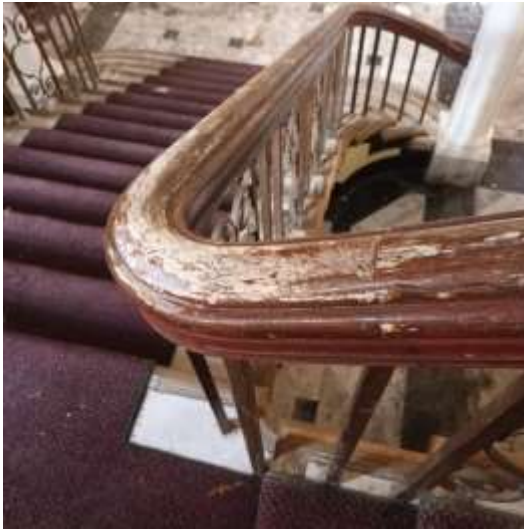
5.1.3.3 The timber handrail on the stairs shows signs of damage. No swelling could be detected.

Fig 17 : Stairs – damages to handrail

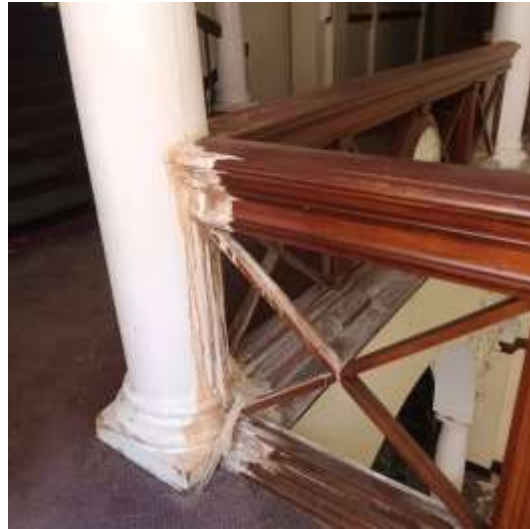
Fig 18 : First floor – Damages to handrail

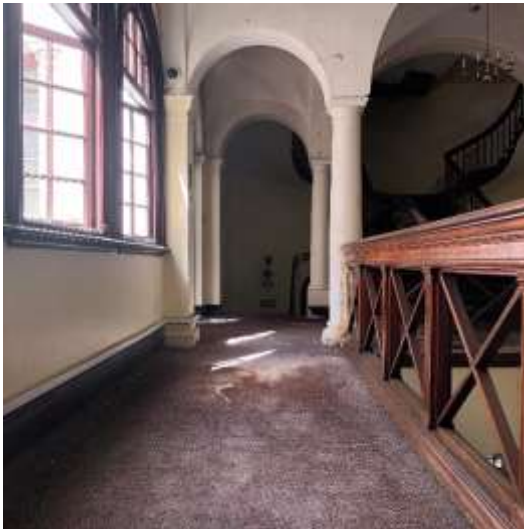
5.1.3.2 Carpeting covering the timber walkway floor surface was badly damaged by water. Any damages to the timber walkway itself could be concealed by the carpet, which can only be established once the carpet is removed.

Fig 19 : First floor timber walkway – water damaged carpet –
timber flooring below

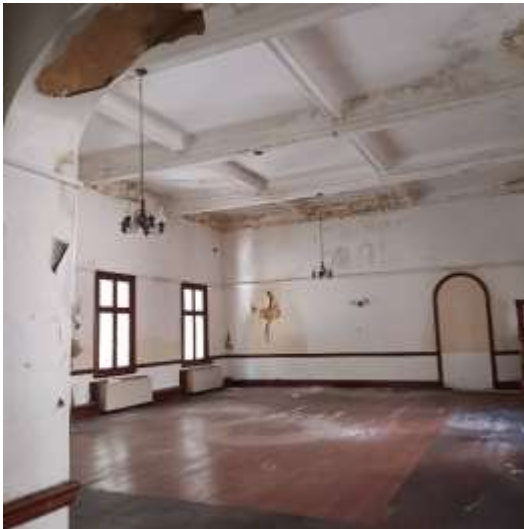
5.1.4.1 Damages to the Art Gallery (room) are very severe. Damp ingress has damaged the ceiling, walls and floor.

Fig 20 : First floor – Damages in Art Gallery

- 5.1.4.2 This room is situated on the first floor facing onto Parliament street, in the wing directly below where the fire occurred.
- 5.1.4.3 Every surface in this room might need to be assessed, possibly stripped and carefully restored / reconstructed. The warp timber flooring might need to be replaced entirely.
- 5.1.4.4 Black mould (fungus) on ceilings could pose respiratory responses in humans when exposed (coughing, sneezing, chronic fatigue, persistent headaches, irritation of the eyes etc).

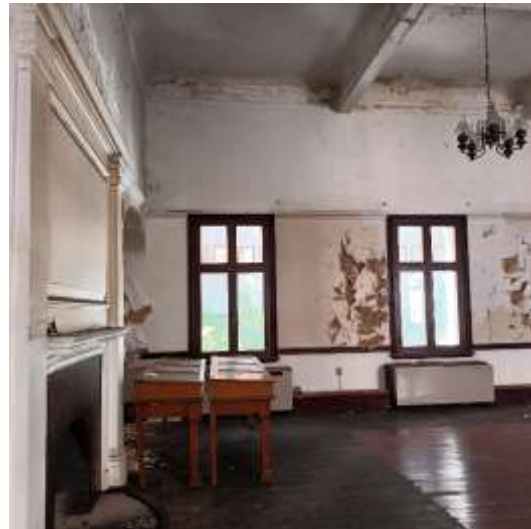
Fig 21 : First floor – Art Gallery – another view
