PARLIAMENT PRECINCT: OLD ASSEMBLY

PERMIT REQUIREMENTS: REMOVAL OF RUBBLE IN OLD ASSEMBLY,

NATIONAL & NEW ASSEMBLY

DATE: 14 – 04 – 2022

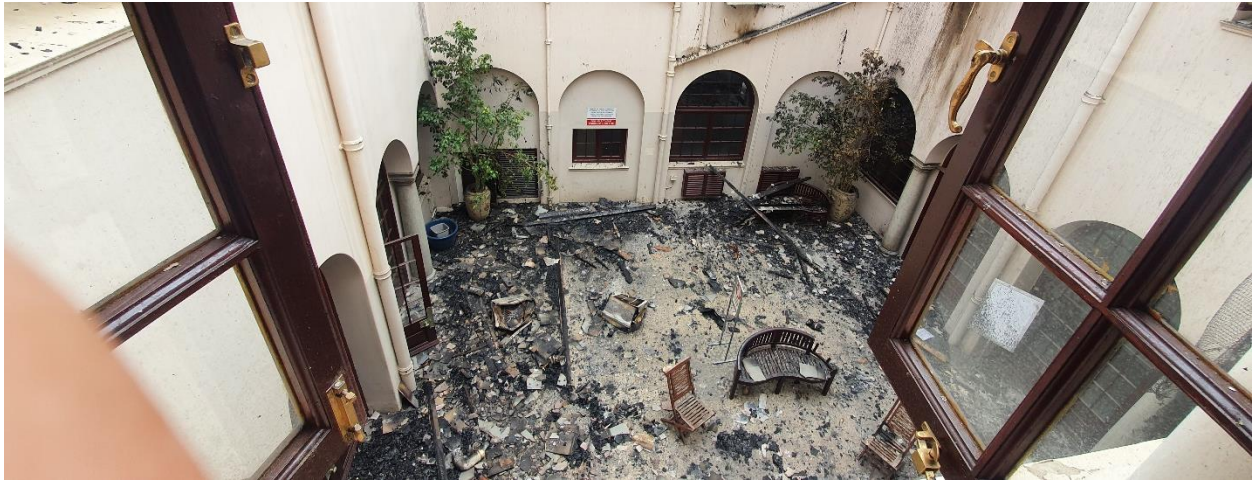
Image of Courtyard from first floor taken by DPWI official.

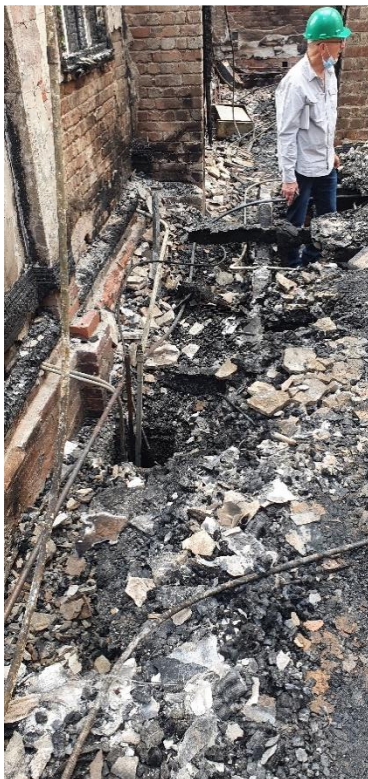
Image of rubble taken by DPWI official.

The Debris needs to be removed so that further investigations may commence.

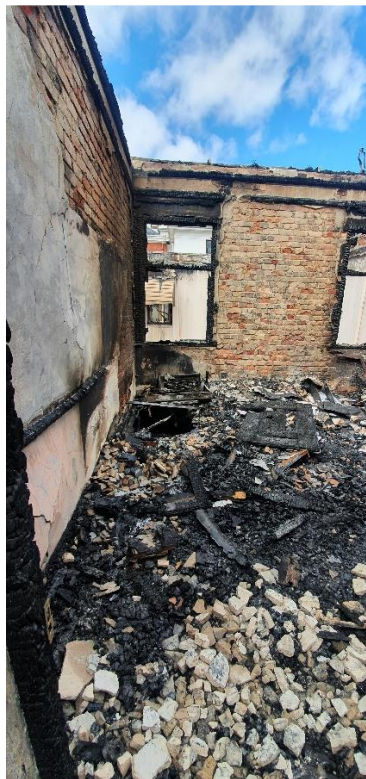
Image of rubble taken by DPWI official.

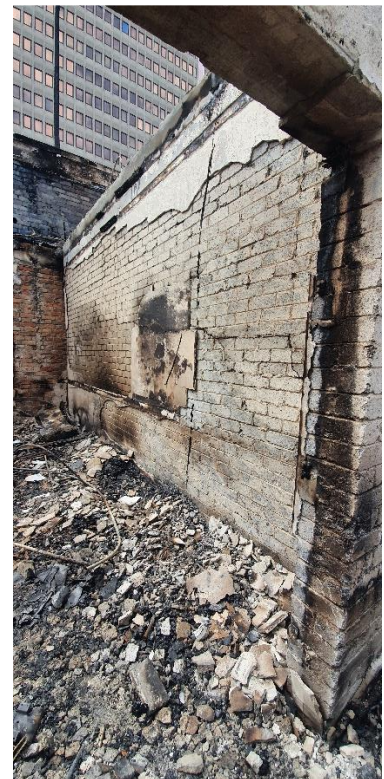
Image of rubble taken by DPWI official.
