Gansbaai Fishing Harbour

Repair and maintenance work to be conducted

Report Prepared by
Pieter Badenhorst Professional Services cc

September 2017

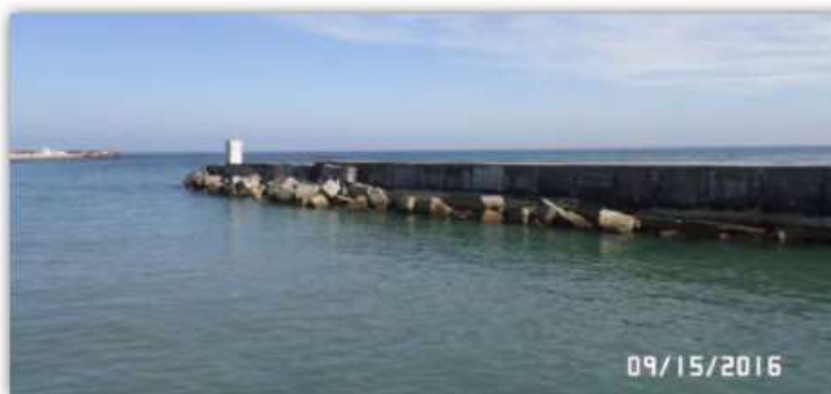
Figure 1: Breakwater 1

The main northern breakwater of the old harbour consists of a 370m long mass concrete breakwater protected with concrete cubes and armour units. The armour units (dolosse) are located only on the seaward face. (see Figure 1). The crown wall/crest element serves as an access road to Quay Wall and the head of the breakwater.

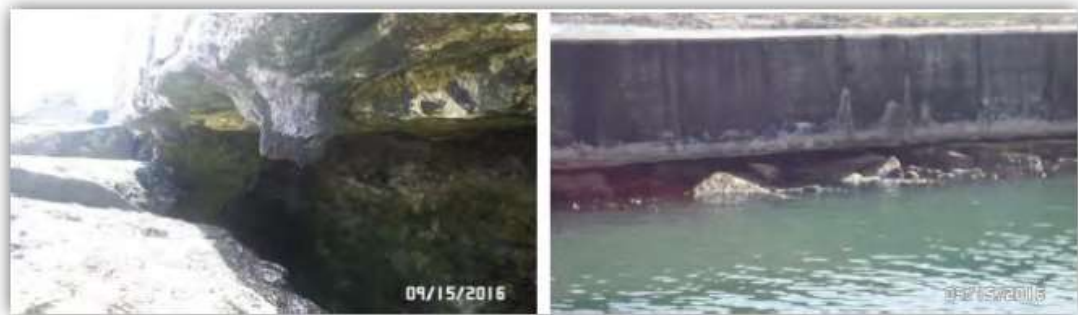
Figure 3: Voids to be filled and undermining to be capped

- Stabilising existing founding blocks by tremie concrete.
- Horizontal and vertical cracks to be pressure grouted (cement).
- Localised concrete repair and patching as required.
- Rehabilitation of toe of structure to original design function.

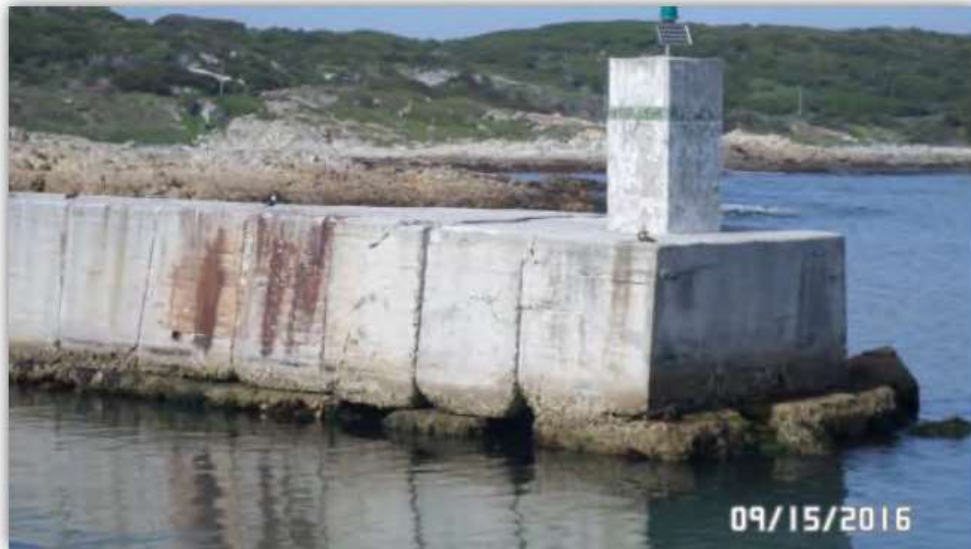
Figure 4: Breakwater 2

The breakwater is 140m long and comprises of mass concrete cast on bed rock and foundation block work, with cube armour units protecting the seaward face to approximately the high water mark.

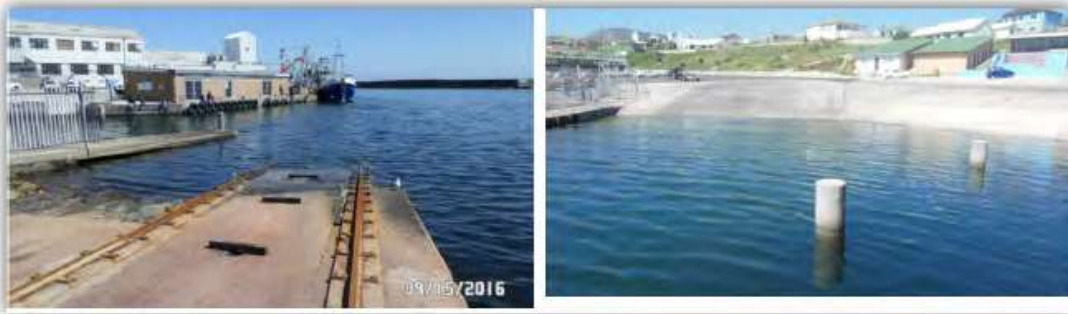
Figure 6: Slipway 1 (left) and Slipway 2 (right)

Slipway 1: This is a mechanised slipway with a steel cradle running on steel rails to launch and retrieve vessels by means of a special winch. It Can be used for vessels up to 50t and has a side slip for vessel maintenance. The slipway has recently been extended.

Slipway 2: 30m wide slipway that tapers seawards with a 20m long jetty boarding the slipway on the west side.

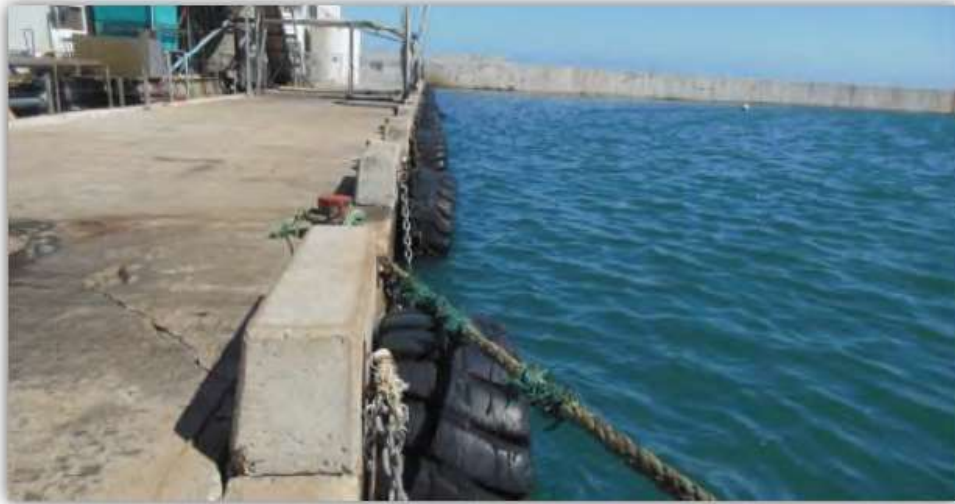
Figure 8: Quay wall

This 162m long concrete caisson quay wall consists of a 90m long suspended reinforced concrete slab structure and a 72m long concrete block structure as shown in Figure 8.

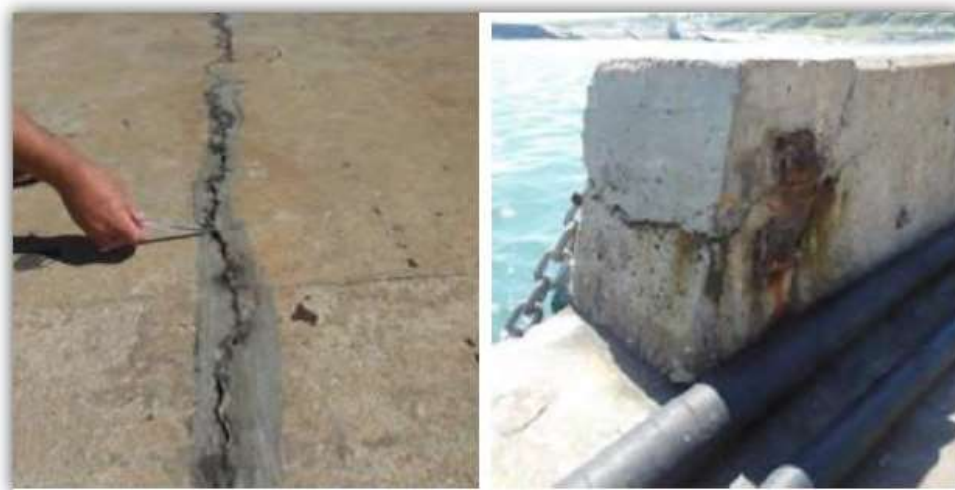
Figure 9: Structural cracks to be repaired

- General concrete repair and maintenance – e.g. Maintenance and concrete repair work to concrete fenders and reinforced concrete slabs.
