**RECORDING OF HISTORIC DWELLING AT STEENKOOLSPRUIT (SITE 2) AT
IMPUNZI MINE DEVELOPMENT
(WITBANK – NKANGALA DISTRICT – MPUMALANGA PROVINCE)**

Assessment of historic sites and buildings

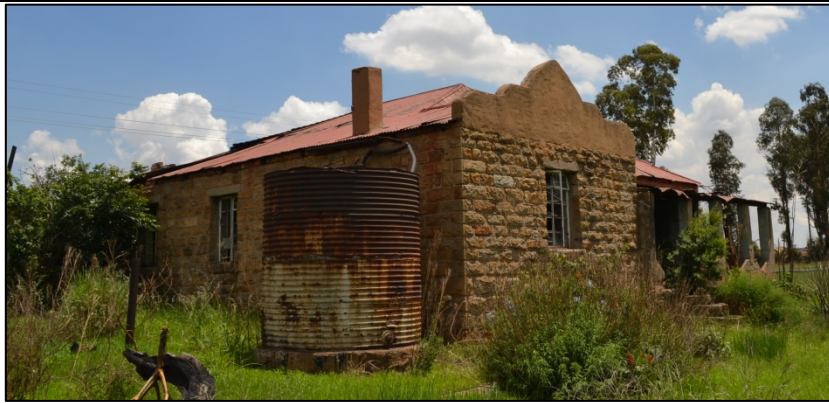
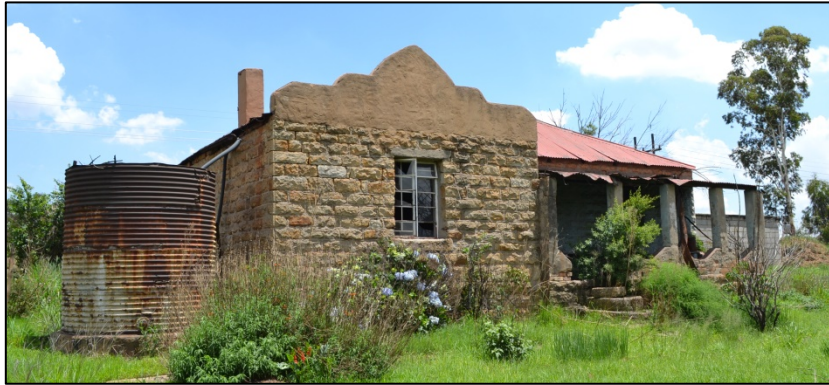
veranda originally had a timber support structure for the roof which was later replaced with plastered brick columns. This may have been altered during the 1020s or 1930s.

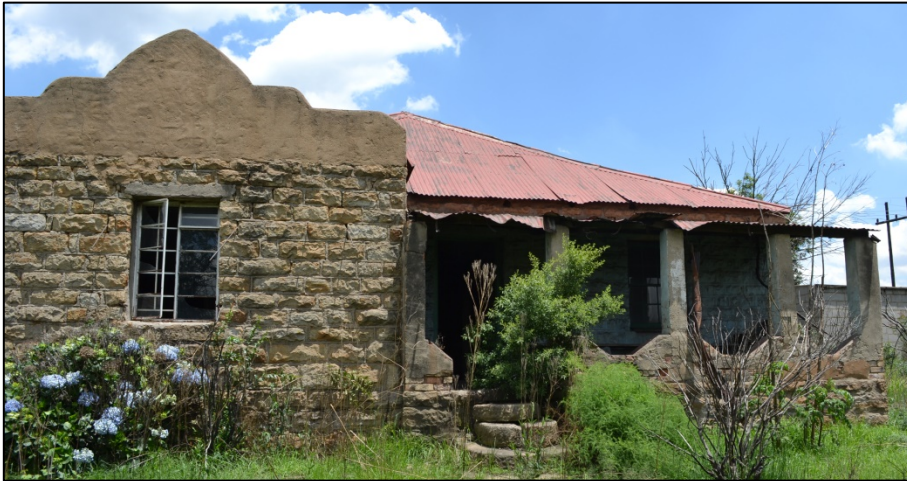
3. Southern elevation

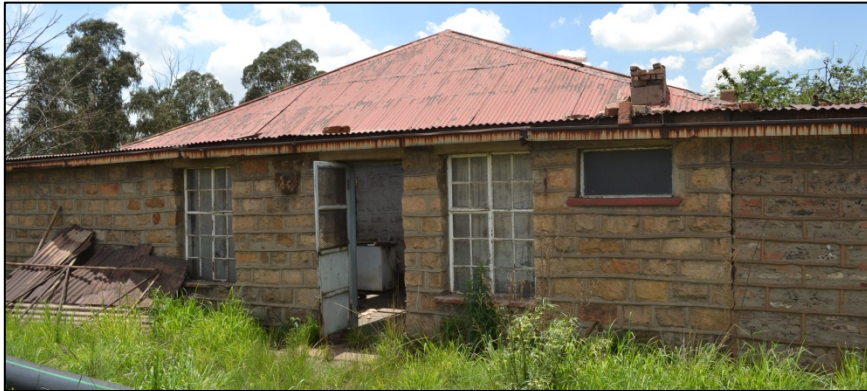
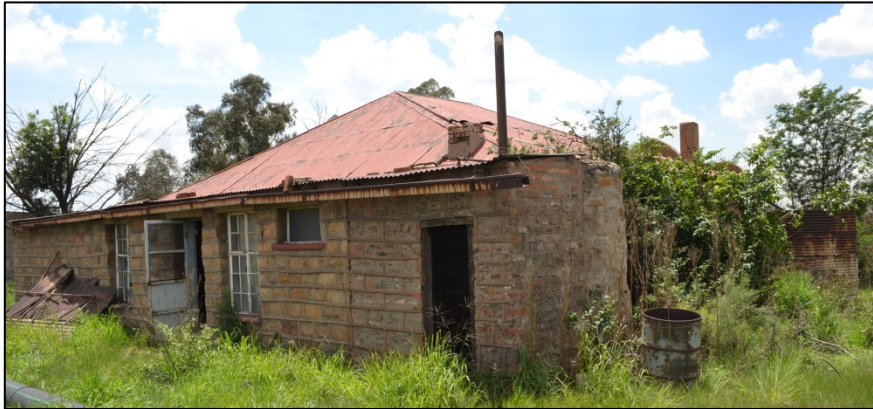
<i>Building elements</i>	<i>Photograph</i>
1.	<p data-bbox="249 1291 401 1320"><u>Foundations</u></p> <p data-bbox="249 1356 1297 1414">The original core section of the building was constructed with sandstone and the stone rises directly from the foundation upwards to ceiling height.</p>

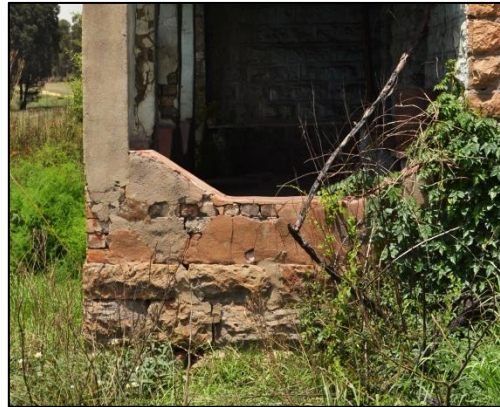
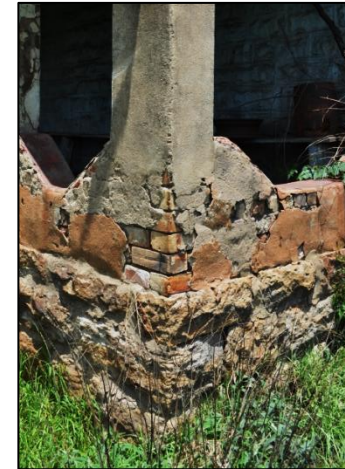
Figure 1. Exposed sandstone base of the front veranda indicating the difference between the sandstone base of the structure and the more recent introduction of baked bricks for the low veranda wall and supporting columns (Photograph: M. Naude 2016)..

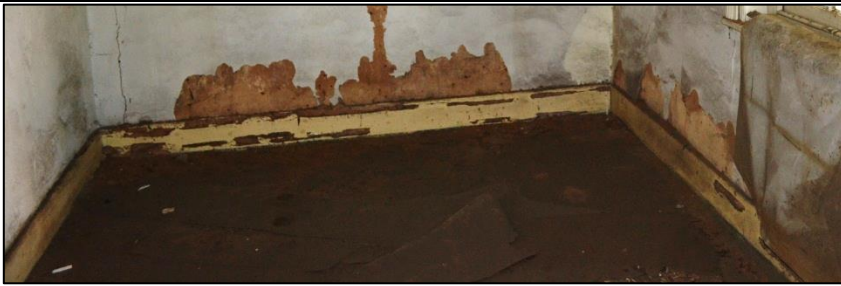
Figure 2. Floor of the front room facing the front stoep - note the rising damp problem just above the skirtings (Photograph: M. Naude 2016).

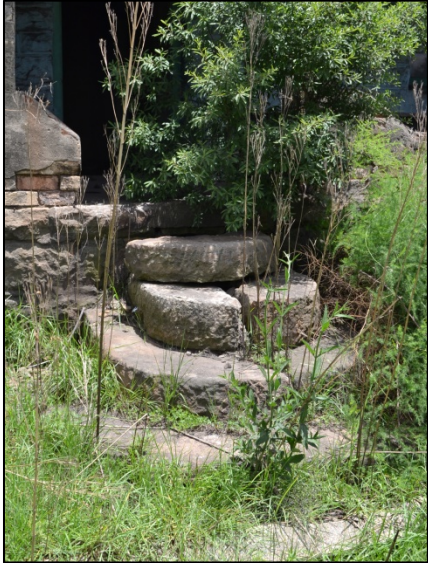
<p data-bbox="1325 797 1906 850">Figure 4. Stacked granite blocks shaped to serve as stairs towards the front stoep (Photograph: M. Naude 2016).</p>

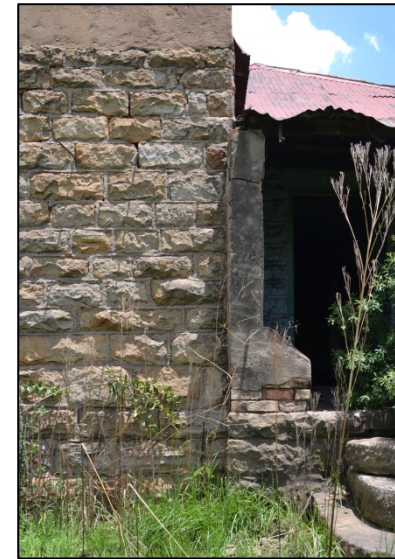
Figure 11. The columns of the front veranda were replaced with plastered brick columns while the foundation of the stoep is the same as the rest of the core structure (Photograph: M. Naude 2016).

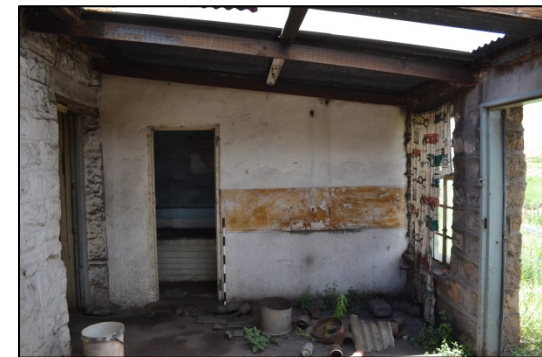
Figure 12. The back veranda was eventually closed in to accommodate a bathroom and an additional bedroom.

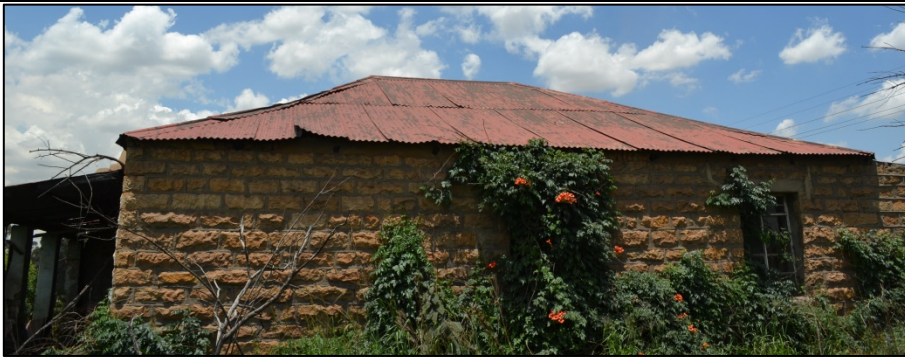
Figure 21. General condition of the corrugated sheet iron roof (Photograph: M. Naude 2016).

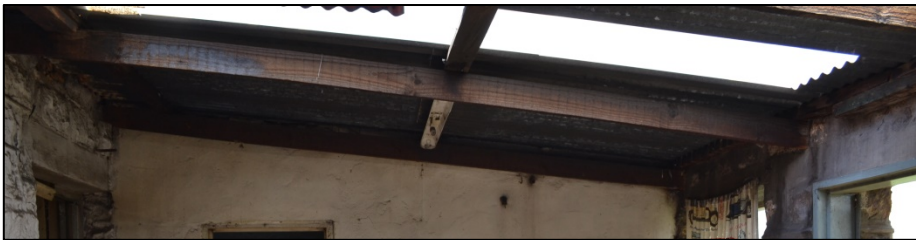
Figure 22. The roof of the back veranda has no ceiling and transparent glass-fibre sheeting was installed to allow light into the closed area (Photograph: M. Naude 2016).

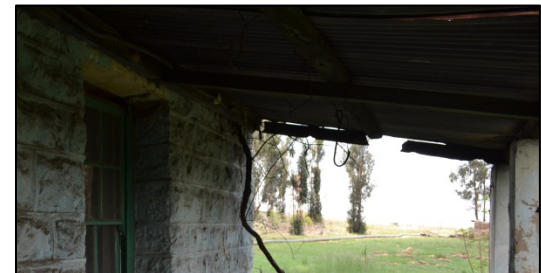
Figure 23. The corrugated iron sheets were loosely mounted on a simple timber frame for the front veranda (Photograph: M. Naude 2016).

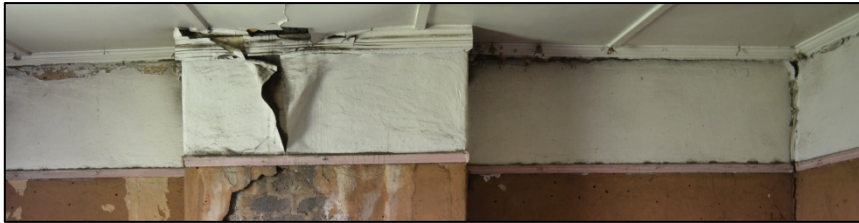
Figure 25. Gypsum boarding with pine planking and sealed with molded cornices (Photograph: M. Naude 2016).

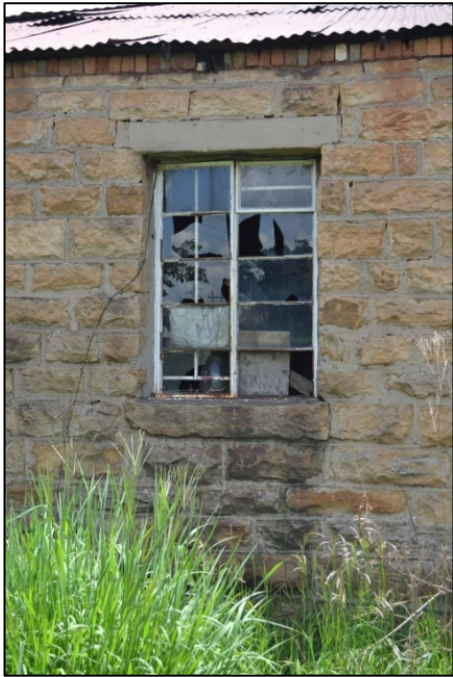
Figure 31. Steel frame window in the pantry cum breakfast room(Photograph: M. Naude 2016).

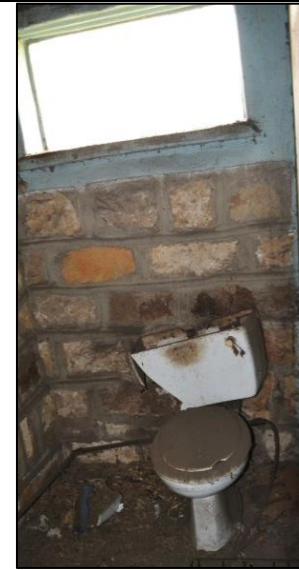
Figure 39. Porcelain toilet mounted along the exterior wall (Photograph: M. Naude 2016).

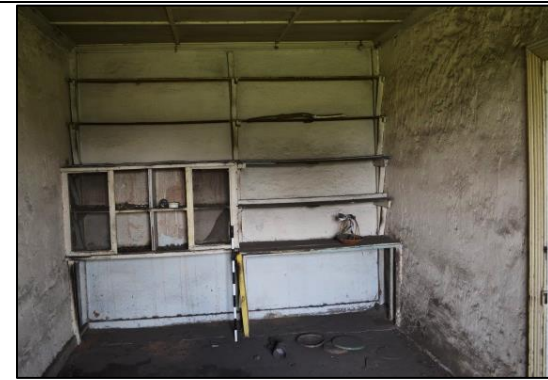
Figure 40. Shelving and racking in the pantry. this room may have been used as a breakfast room (Photograph: M. Naude 2016).
