RECORDING OF HISTORIC BUILDING AT STEENKOOLESPRUIT IMPUNZI MINE (WITBANK – MPUMALANGA PROVINCE)

Recording: M. Naude & C.M. Naude
Date: October - November 2014

RECORDING OF THE FLOOR PLAN AND ELEVATIONS OF THE DWELLING.

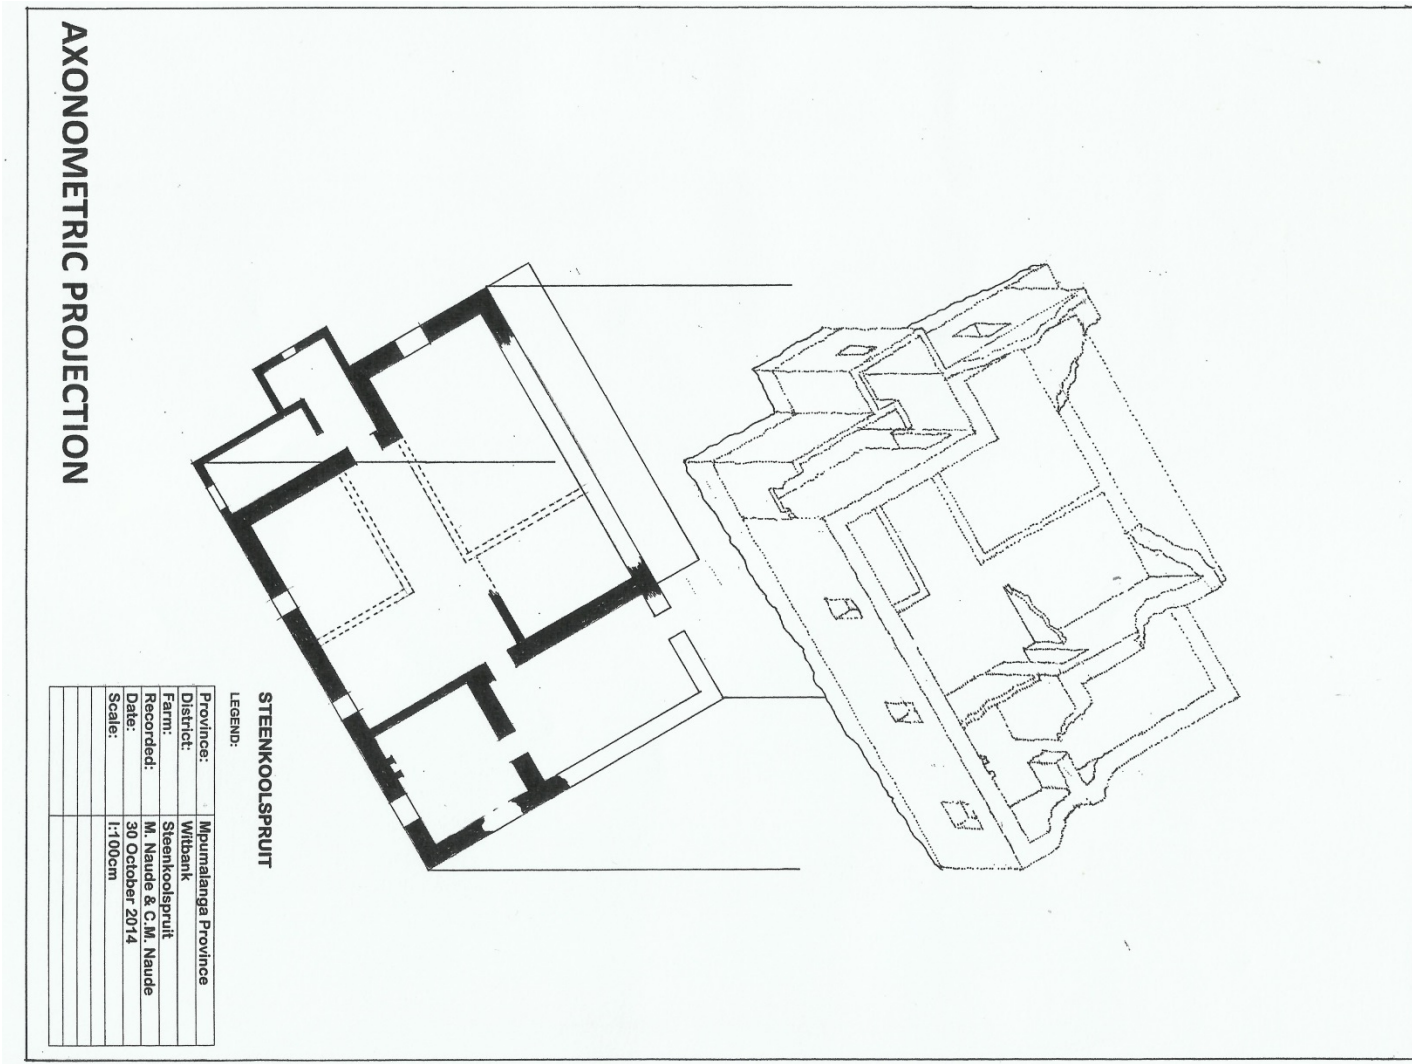
Figure 1. Axonometric view of the ruin indicating the floor plan layout and condition of the dwelling (Drawing: M. Naude 2014)

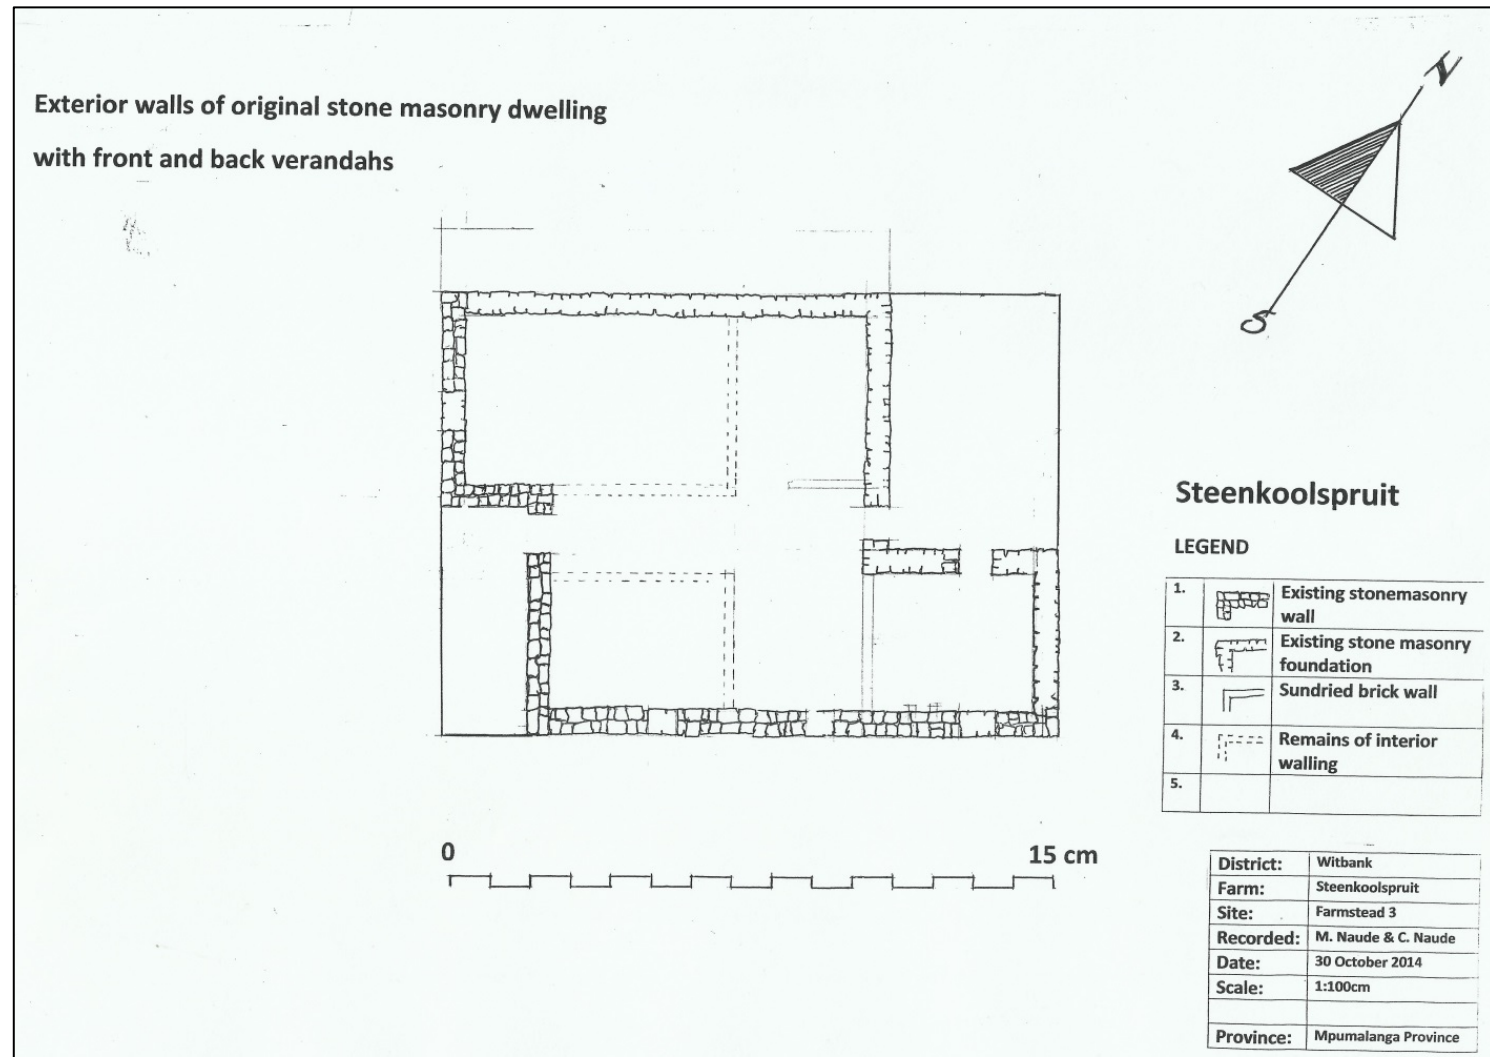
Figure 2. Floor plan of the original dwelling with the exterior stone masonry walls and the hypothetical interior division of spaces as most of the sundried brick walls have disappeared - scale 15cm equals 15m (Drawing: M. Naude 2014).

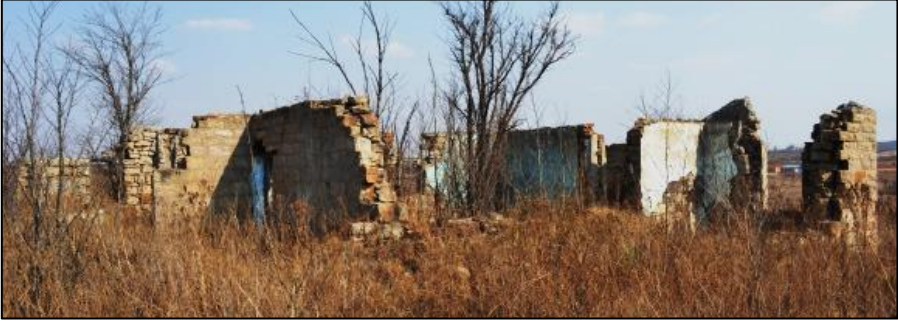
<p data-bbox="800 1040 1058 1065">North-western elevation</p>

1.	<p data-bbox="279 537 554 561">North western elevation</p> <p data-bbox="279 597 1535 654">The building is not orientated according to the exact north-south axis but is set slightly off this coordinate. Almost the entire façade has been demolished and no evidence is available in the structure in order to reconstruct the elevation.</p>

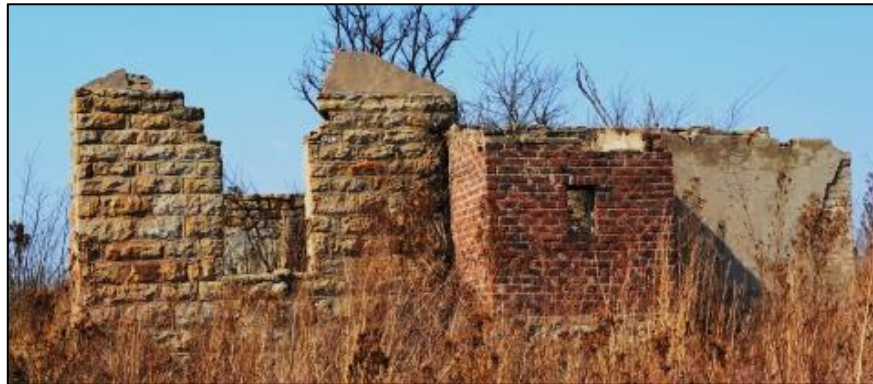
The façade seems to have been the principle facade of the dwelling and faces downhill towards the Steenkoolspruit valley and flood plain. The most significant feature is the original protruding sandstone gable and the red brick toilet which is a later addition. This façade was originally defined by the sandstone gable and a small verandah to its right. The verandah was later closed with walls (red brick and plastered section in the picture) to create a bathroom and toilet.

Figure 3. South-eastern facade with gable and recent toilet and bathroom additions done in red bricks.

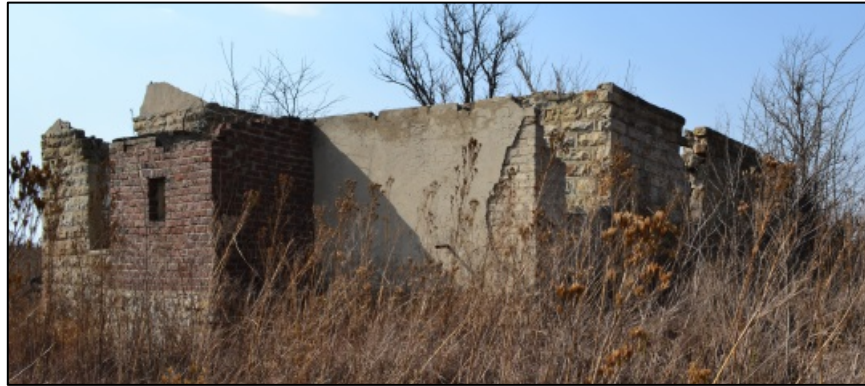
Figure 4. This used to be the principal facade with gable and stoep where the red brick and plastered room were added to form the bath room and toilet

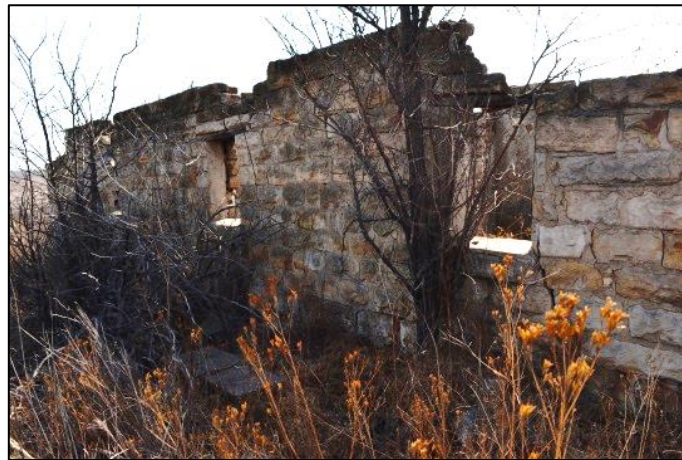
This elevation has remained almost completely intact and contains most of the remaining windows. It contains no entrances. The entire wall section consist of sandstone walling up to ceiling height.

Figure 5. South-eastern elevation and facade is the only facade that has remained intact	
4.	<p>North western elevation</p> <p>The entire north-western elevation has become a ruin without any remaining walls. No photographic recording could be done. The best evidence of what this elevation consist of is reflected in the axonometric drawing. It is assumed that this elevation also boasted a verandah and formed the back of the dwelling. The verandah was later closed-off with walls and became a dining room.</p>

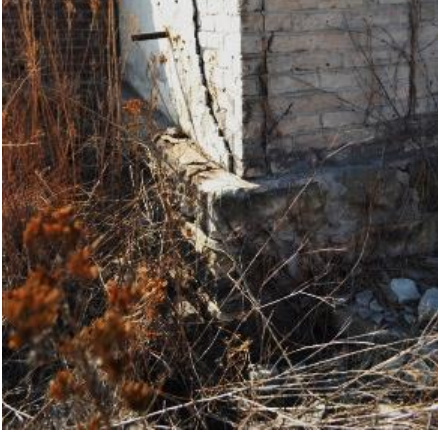
<p style="text-align: center;">Figure 6. Plinth where the original stone foundation of the stoep was used as base for a later addition</p>

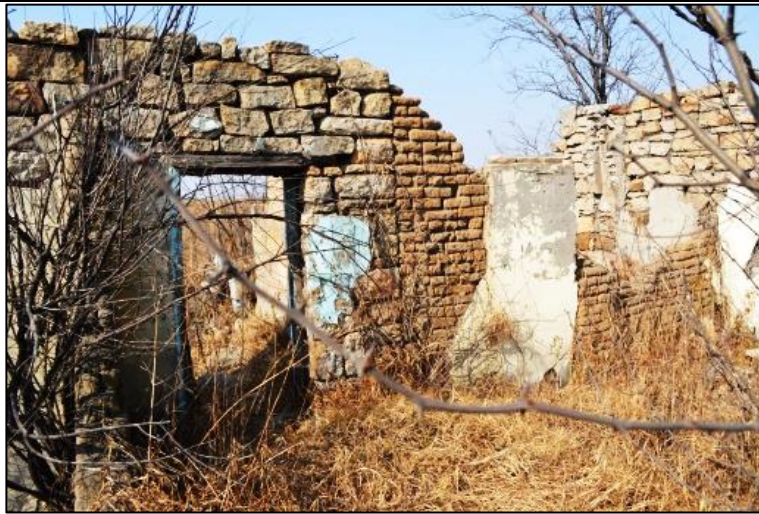
Figure 7. Part of the exterior walling with clay bricks forming part of a later addition

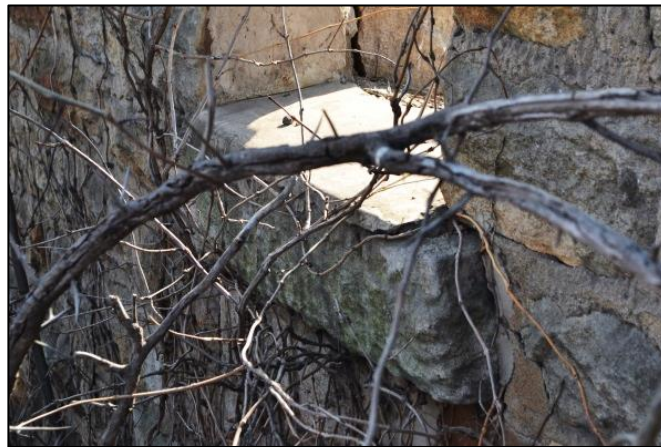
Figure 8. Projecting dressed sandstone window sill neatly incorporated as part of the exterior walling

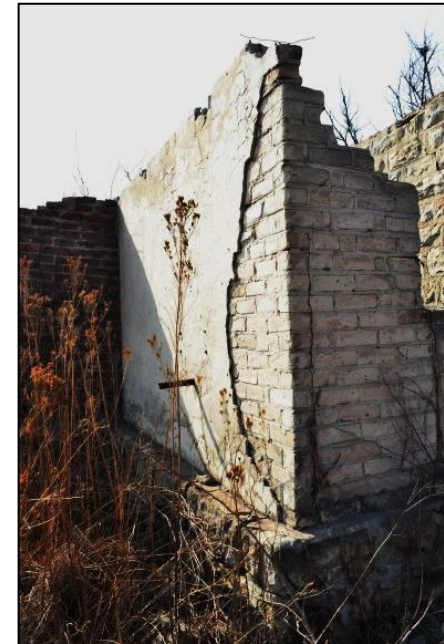
Figure 12. Sundried bricks exposed after the plastering have been washed off the addition along the southwestern facade

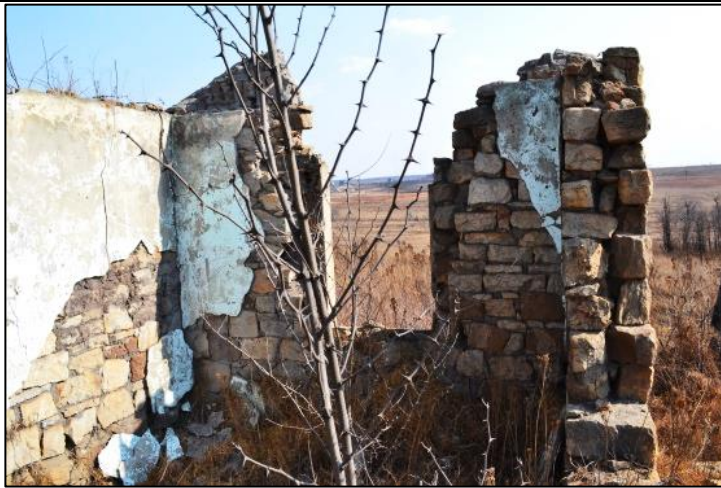
Figure 9. Exposed stone masonry walling of the gable

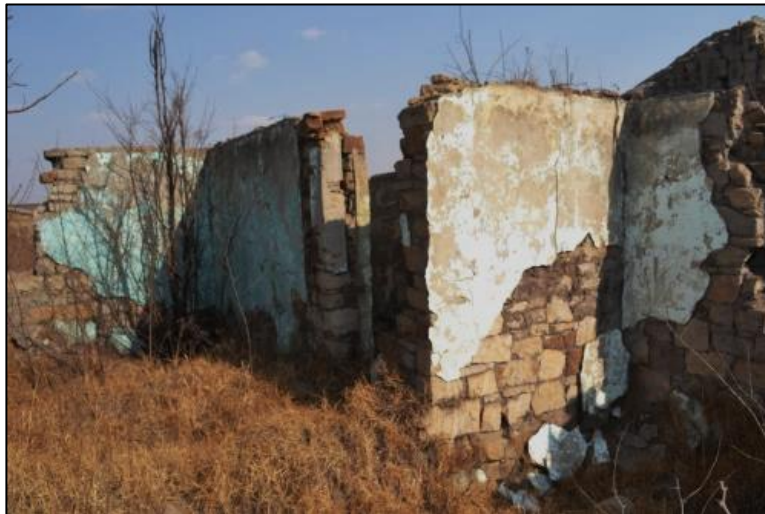
Figure 10. Painted cement and sand plastering along the interior of the original exterior walls

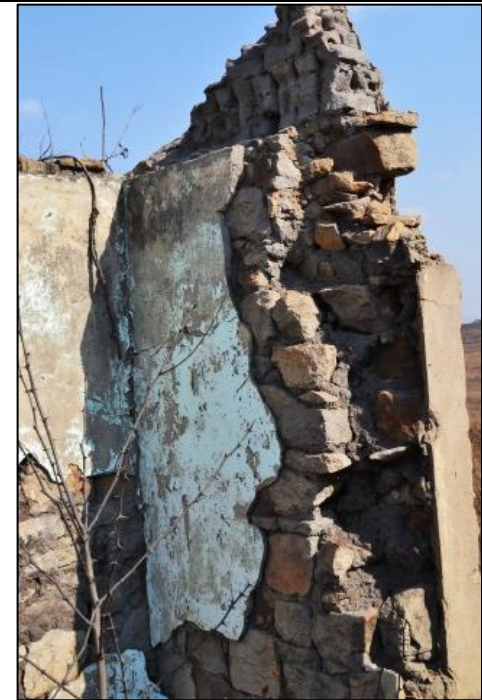
Figure 13. Sundried clay bricks on top of the sandstone wall, define the triangle of the remains of the gable

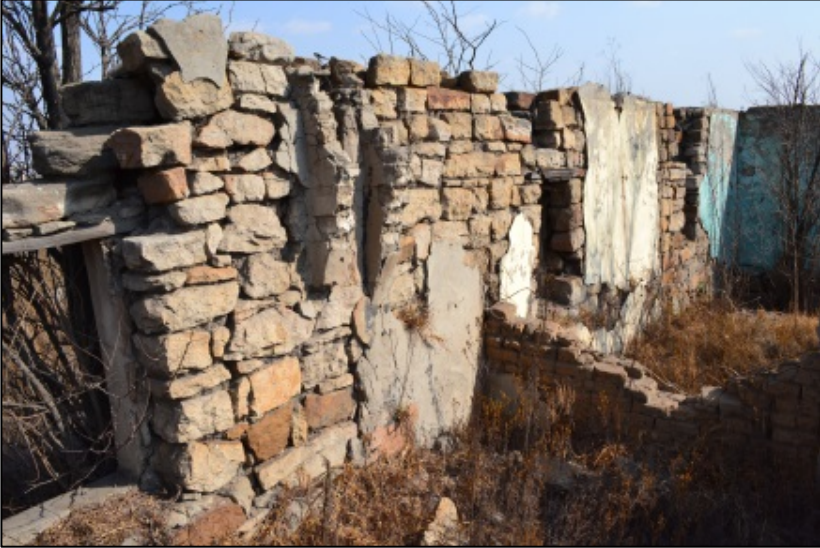
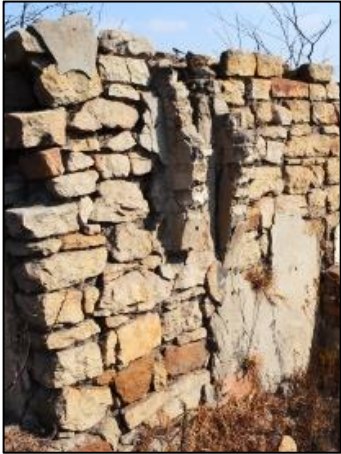
5.	<p><u>Fire places and chimneys</u></p> <p>No formal hearth was identified in the floor plan but the remains of a chimney sheath defining the exit of a chimney for a coal stove or slow combustion stove was identified in what could have been the kitchen.</p>

<p>Figure 14. Remains of plastered brick chimney fluting guiding the round metal chimney pipe of a coal stove</p>

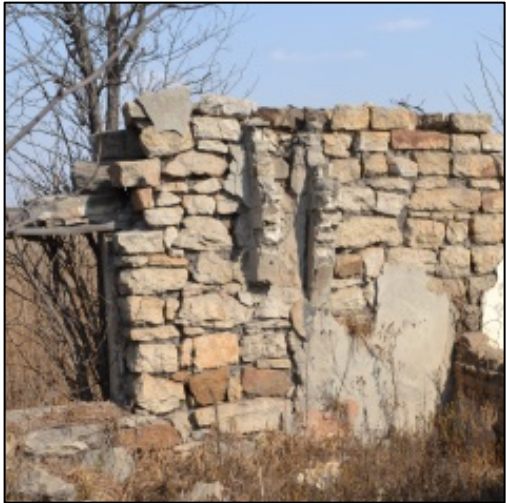
<p data-bbox="1356 732 1913 813">Figure 15. Remains of the chimney fluting to guide the metal chimney of a coal stove through the ceiling and roof</p>
6.	<p data-bbox="249 878 317 902"><u>Roofs</u></p> <p data-bbox="249 935 1251 1024">The entire roof has been removed and no evidence of the roof structure or roof covering have remained on the structure or on the site. It is only assumed that the dwelling had a timber roof structure with corrugated iron sheet covering.</p>	
7.	<p data-bbox="249 1092 344 1117"><u>Ceilings</u></p> <p data-bbox="249 1149 1234 1174">No remnants of any ceilings, ceiling boarding or supporting structure are left in the dwelling</p>	
8.	<p data-bbox="249 1255 317 1279"><u>Doors</u></p> <p data-bbox="249 1312 1293 1369">No doors have been left in the building and all the door frames have been removed. A single door frame has been left intact.</p>

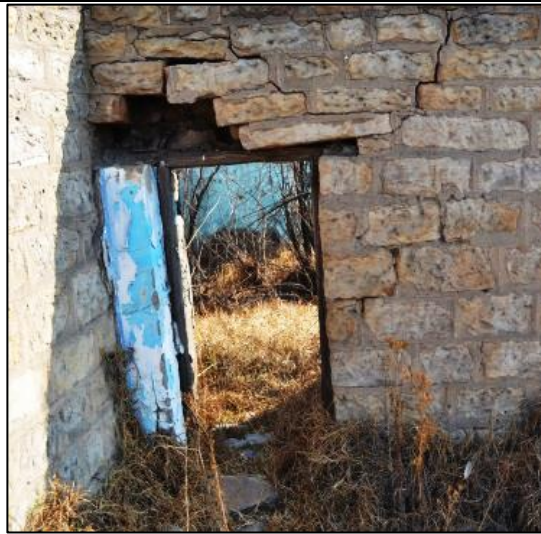
Figure 16. Remains of a single door frame

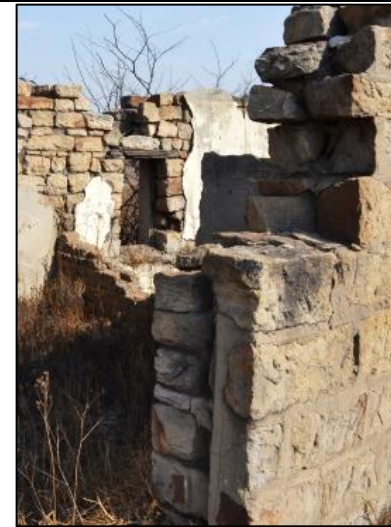
Figure 17. Remains of a door where the frame has been removed.

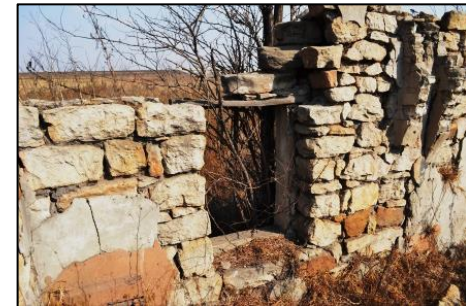
Figure 21. Small window with remnants of the timber lintel at the top

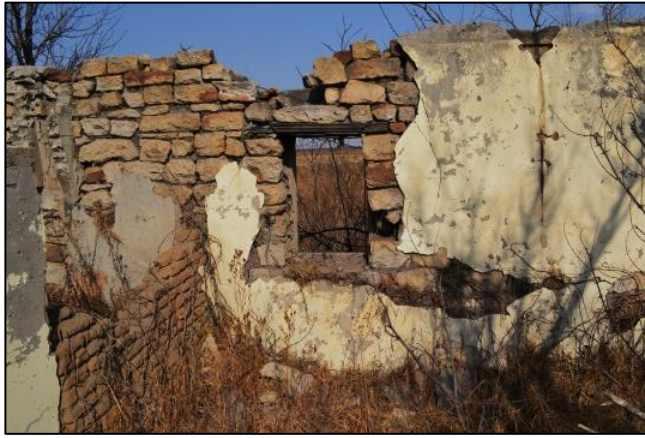
Figure 18. Window with lintel and a short section of the top part of the architrave intact

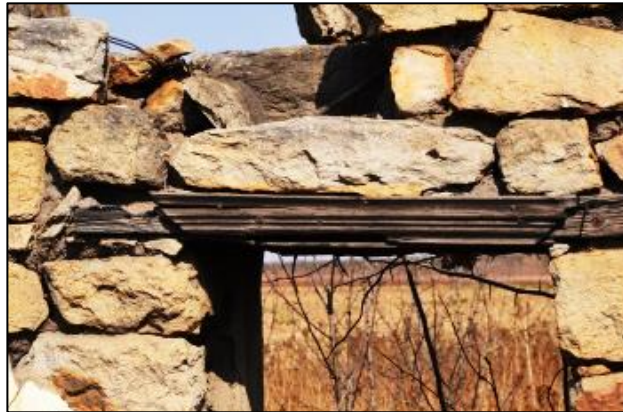
Figure 19. Window with lintel and architrave intact

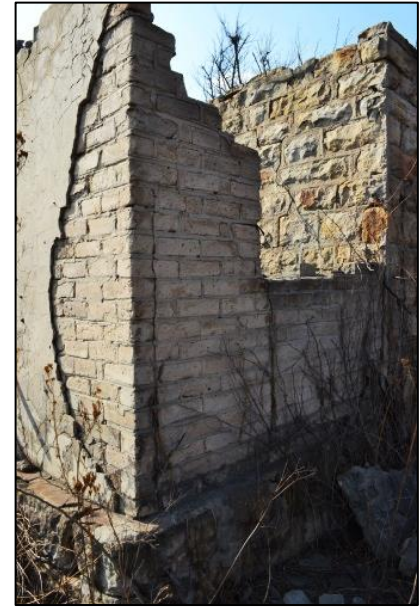
Figure 22. Well-prepared sundried clay bricks used for this recent addition exposed after the plastered was broken and had fallen off

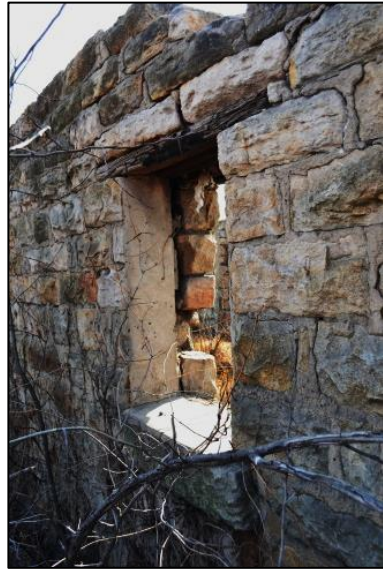
Figure 20. Window with timber lintel intact

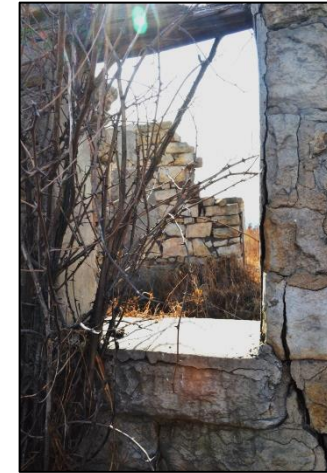
Figure 23. Window with solid sandstone window sill
