**Specialist Report: Historical Slimes Rehabilitation - Design Report and DWAS
Correspondence**

REHABILITATION OF HISTORIC SLIMES DAMS DESIGN REPORT

Date: August 2013
Project Number: FM/100/01
File Reference: IPC/100/01

INPROCON CONSULTANTS cc
Consulting Environmental & Civil Engineers

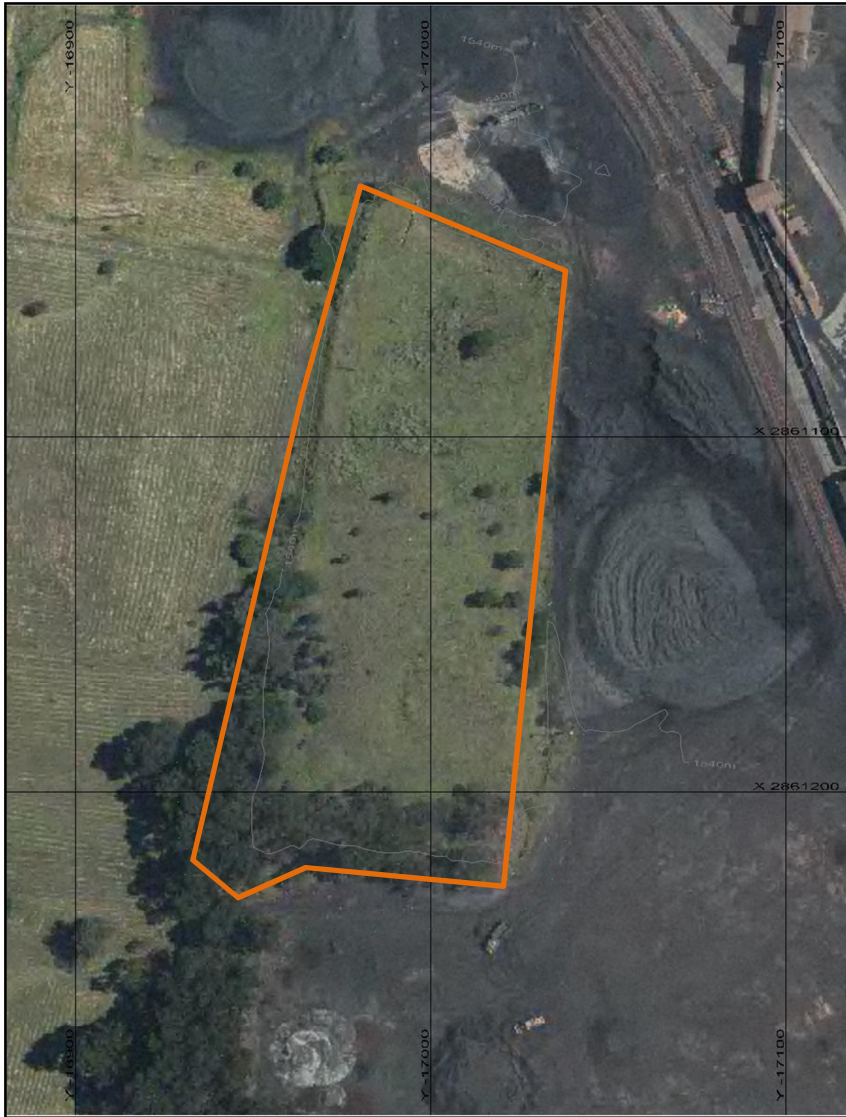
Figure 2.2: Historical South Slimes Dam

This dam has dyke like embankment walls and the crest is rather flat. The crest in some areas has been covered with a soil layer and the embankment slopes are vegetated. Some spots on the crest of the South Dam the slimes have not been covered or erosion has stripped the soil layer leaving the slimes exposed.

The current soil cover is rather less than 200mm thick. The crest is not free draining and ponding is visible where reeds are growing.

At the southwest corner of the dam a ramp that is currently been demolished provided access to the top of the embankment and crest. An aerial survey image of the dam is seen in **Figure 2.2**. The natural ground slope dips in a southwest direction with the highest embankment the south wall.

The side slopes of the embankment vary from 1v:1,2h to 1v:2h which is steep based on closure standards.

Eucalyptus globulus (Blue gum) trees have established also at the south end of the dam at the toe and side slope area. The decommissioning of the dam requires upgrading to be compliant with requirements.

Holes were hand augered to determine the cover soil depth and it was observed that the slimes were very moist.

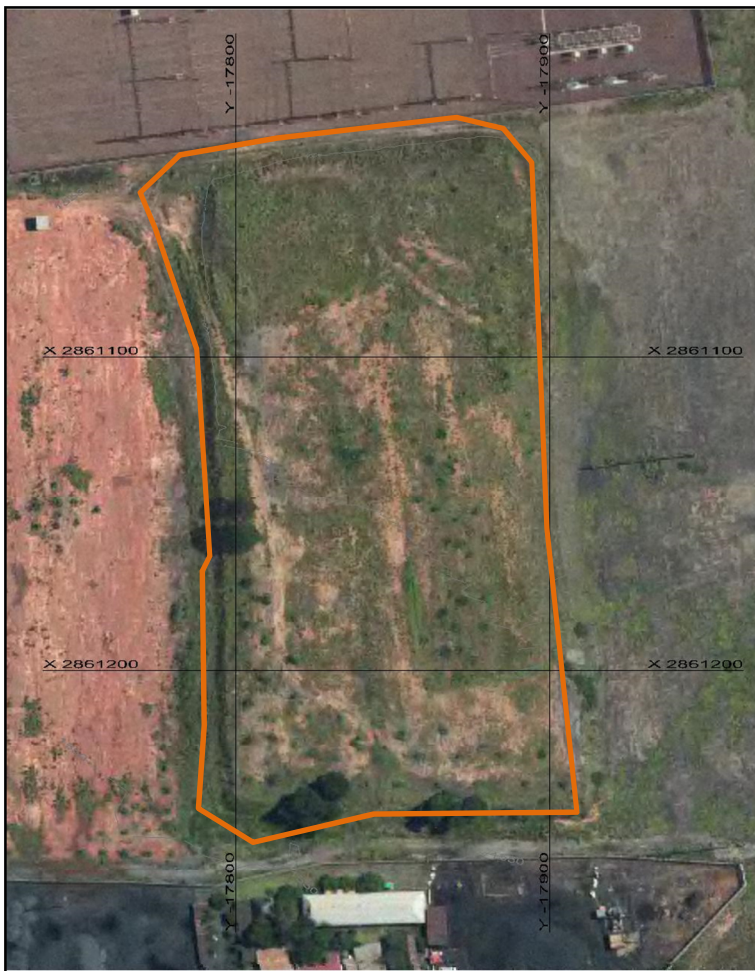
Figure 2.3: Historical East Slimes Dam

This dam has also a dyke like embankment perimeter wall with the crest it seems has been recently levelled with a natural gradient to the south that follows the natural ground slope. The crest has been covered with a marginal soil layer in direct contact with the slimes and vegetation appears to be scattered. Some spots on the crest of the East Dam the slimes have not been covered and erosion has also stripped of the soil layer leaving the slimes exposed.

The current soil cover is rather less than 100mm thick. The crest is free draining with the gradient like mentioned above similar to the ground slope which is $\pm 2\%$. The runoff from the crest appearing as sheetflow will cause erosion of the cover layer as accumulated runoff flows southwards and discharging at the south toe area.

At the northwest corner of the dam a ramp that is providing access to the crest. An aerial survey image of the dam is seen in **Figure 2.3**. The natural ground slope dips in a southwest direction with the highest embankment the south wall.

The side slopes of the embankment vary from 1v:1,44h to 1v: 2.26h which is steep based on closure standards.

Eucalyptus globulus (Blue gum) trees have established also at the south end of the dam and some number of indigenous trees has also been planted on the crest. The decommissioning of the dam requires upgrading to be compliant with requirements.

Pits were excavated by TLB to determine the cover soil depth and it was observed that the slimes at shallow depth were very moist.

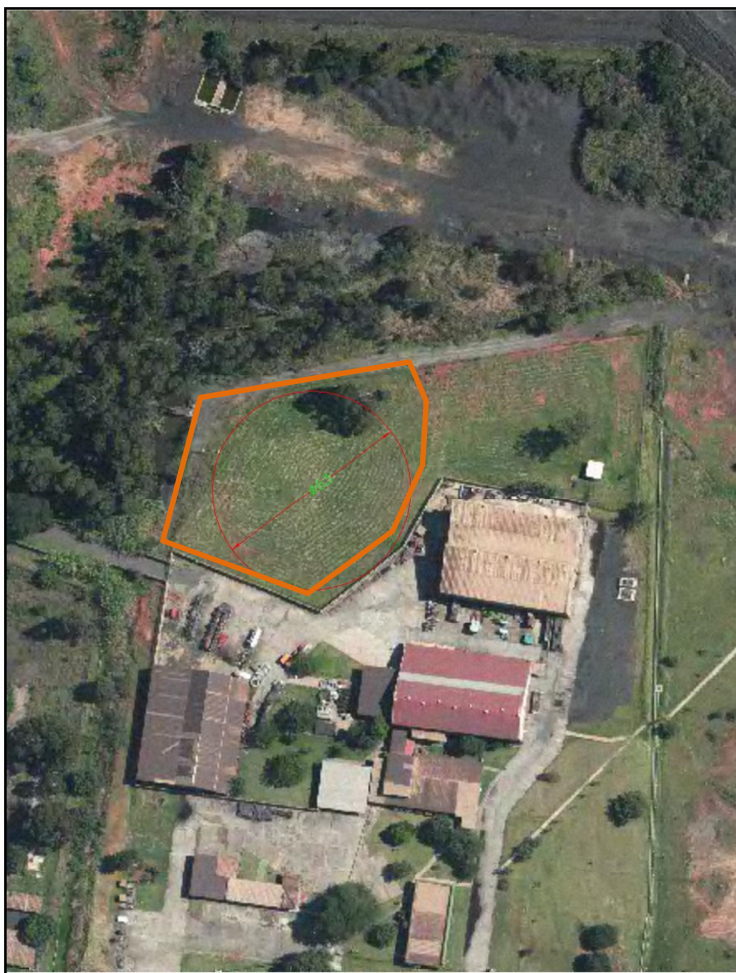
Figure 2.4: Historical Stores Slimes Dam

The Stores Slimes Dam is a small dam with a basin suppression of approximately 1,5m deep sunk into the ground. The dam has been covered with a soil layer varying but approximately 1m thick and in direct contact with the slimes. The walls have been sloped and blends in with the natural ground slope. The crest at the west lowest toe area is less than 1-1,5m high. The kikuyu grass has established and is flourishing. The site is fenced off and used for an ostrich camp.

Pits were excavated by TLB to determine the cover soil depth and it was observed that the slimes were very moist.

The Stores Slimes Dam is close to the stores and is shown in Figure 2.4.
