Decommissioning & Rehabilitation of Existing Slimes Dam Facility, Construction of New Slimes Dam Footprint, Emalahleni, Mpumalanga.

SAMANCOR FERROMETALS

REHABILITATION OF HISTORIC SLIMES DAMS DESIGN REPORT

Date: August 2013
Project Number: FM/100/01
File Reference: IPC/100/01

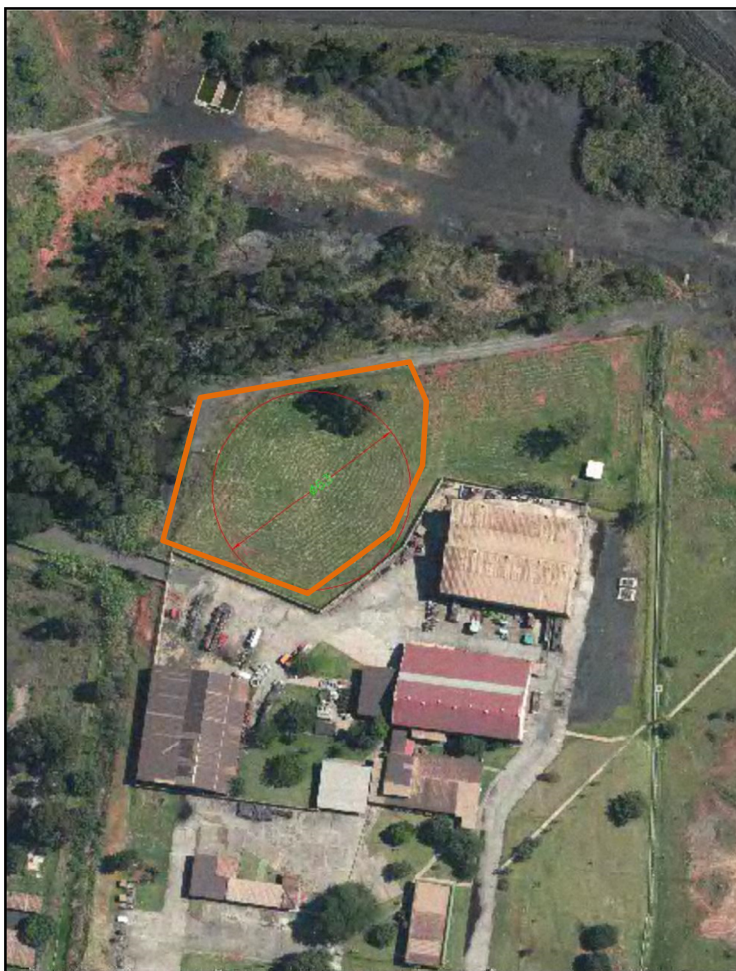
Figure 2.4: Historical Stores Slimes Dam

Pits were excavated by TLB to determine the cover soil depth and it was observed that the slimes were very moist.

The Stores Slimes Dam is close to the stores and is shown in Figure 2.4.

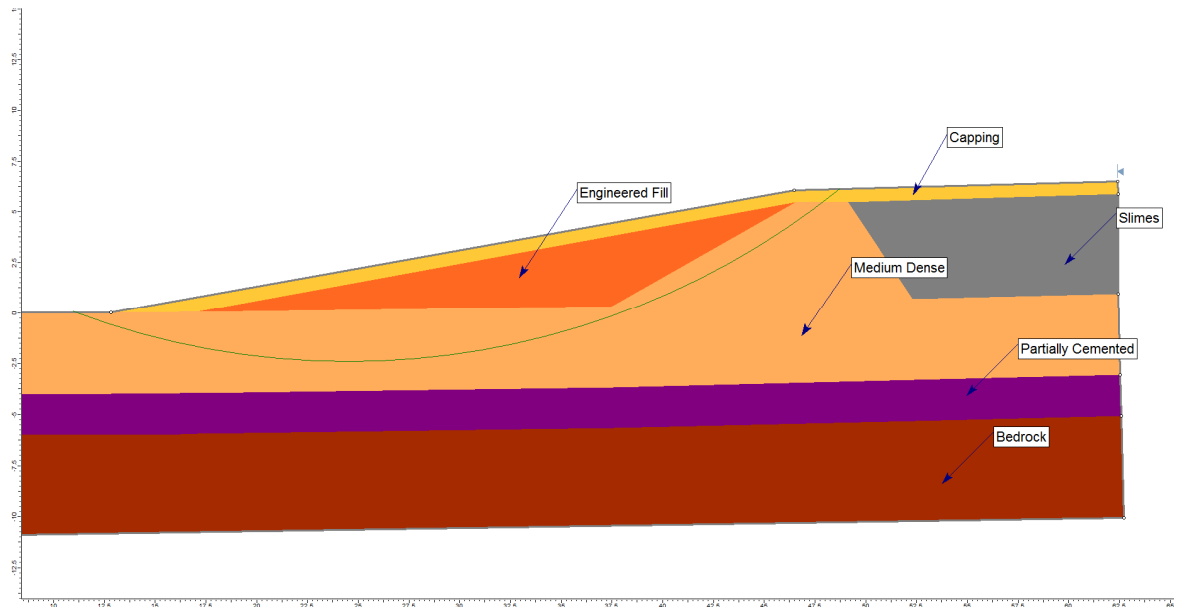
Figure 3.6: Side Slope profile at highest wall

The **Figure 3.6** is the South Slimes Dam profile at the highest wall height along the perimeter that is at the southwest corner. The actual horizontal and vertical scales are shown. The slope stability analysis was thus performed for the dam after rehabilitated profile and capping.

It is clear from the outcome that a flat side slope of 1:5 will be very stable. The fact that the embankment is also not high contributes to a very stable side slope. The cumulative probability plot in Figure 3.7 states that the minimum factor of safety is 3.8 and a 0% probability of failure.

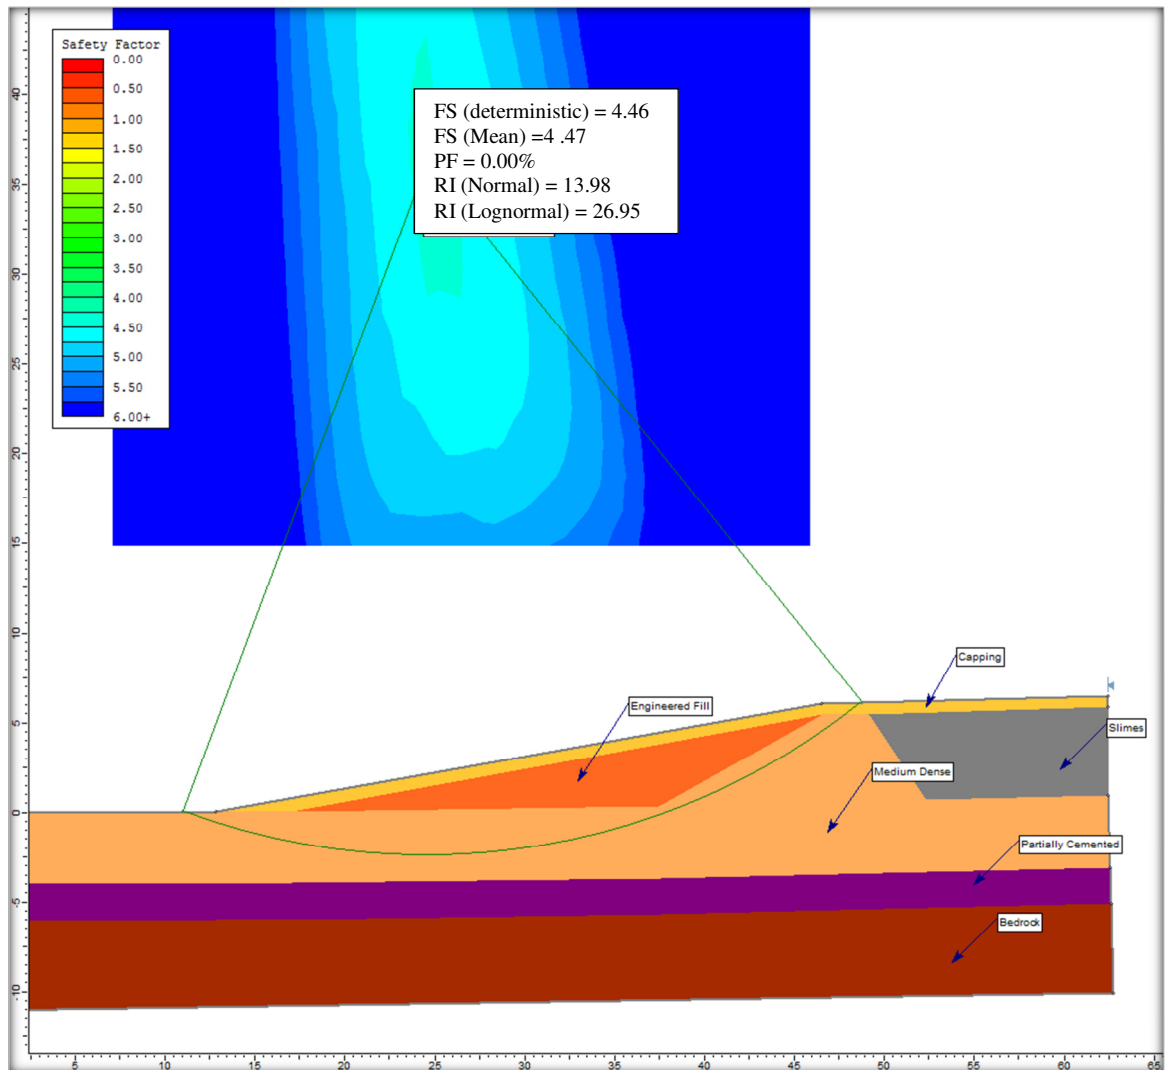
Figure 3.8: Global Minimum Slip Surface FoS- Circular slip

The Global Minimum slip surface is indicated in Figure 3.8. This is the slip profile with the smallest FoS. The mean FoS is 4.46 with reliability index $\gg 3$. The Reliability Index is another commonly used measure of slope stability, after a probabilistic analysis. The Reliability Index is an indication of the number of standard deviations which separate the Mean Safety Factor from the critical safety factor ($= 1$). A Reliability Index of at least 3 is usually recommended, as a minimal assurance of a safe slope design.

It is clear that the stability of the side slopes is more than sufficient as the highest embankment has a minimum FoS above 3.8.

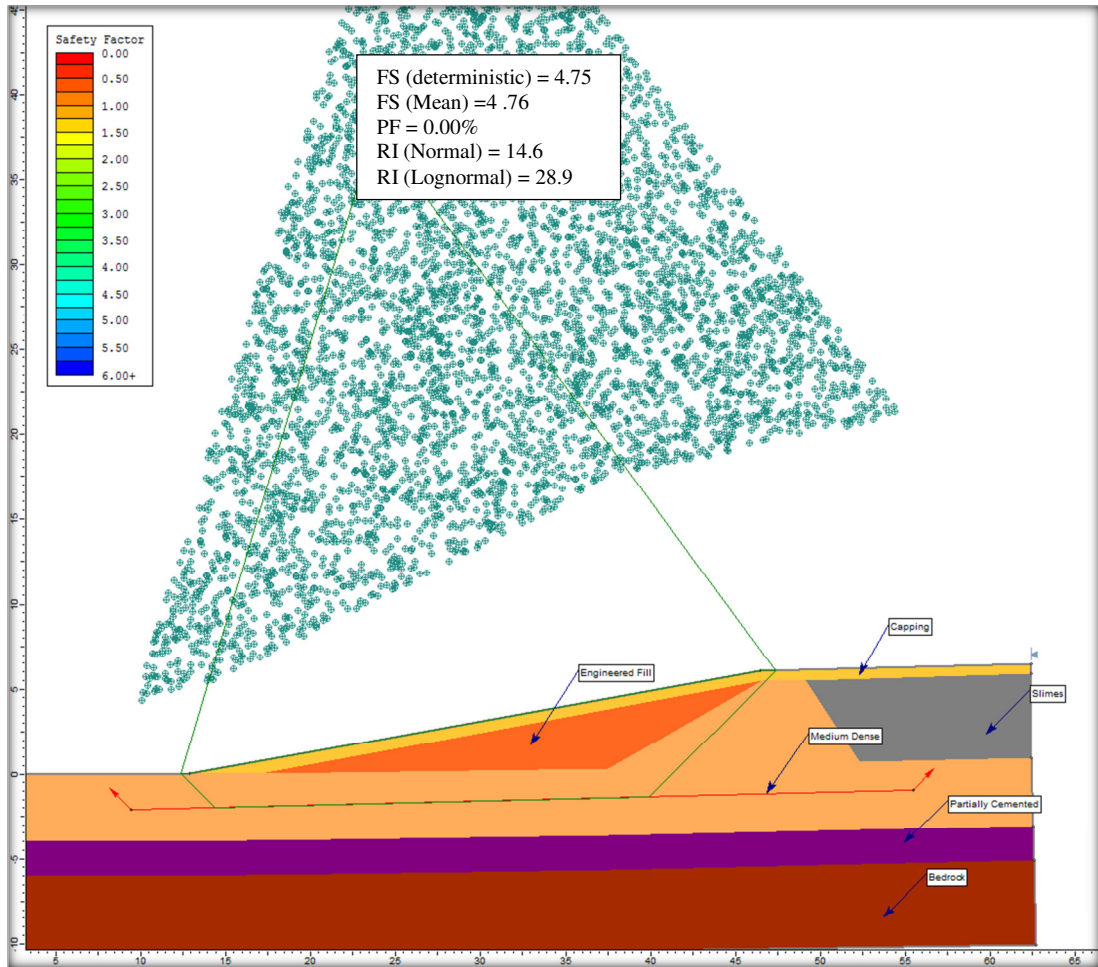
Figure 3.9: Global Minimum Slip Surface FoS- block slip

A non-circular or block slip has been evaluated where the slip surface is within the weakest medium dense zone. The slip face is indicated in Figure 3.9. A histogram plot of the FoS for block slip is indicated in Figure 3.10.

The circular mode failure and non-circular slip modes produces similar results in that the factor of safety well exceeds the 1,3 which is the minimum acceptable norm.

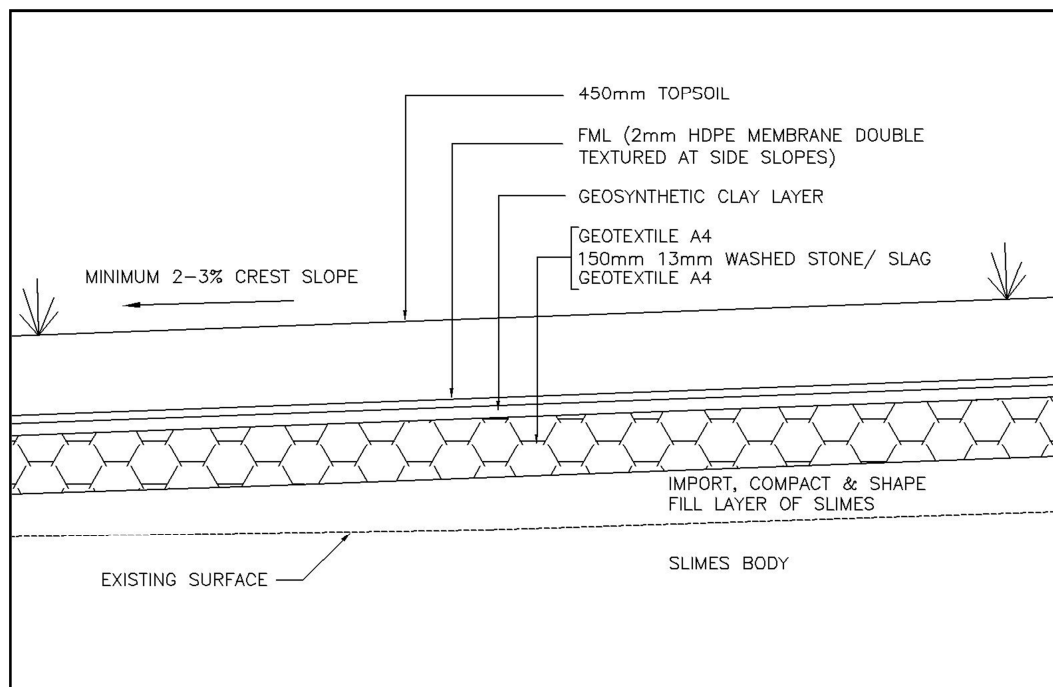
Figure 4.2: Proposed Composite Lining for Capping

The 450mm thick soil acts as protection layer but most importantly as weight to ensure intimate contact between the FML and the GCL.

The capillary break and drainage layer will prevent negative pressures below the FML and any leakage from the capping will be preventing from escaping to the crest surface. Refer also to the drawings indicating all details.
