HARBOUR MAINTENANCE CHECKLIST FOR SUBMISSION TO DEA GANSBAAI HARBOUR

Gansbaai Harbour

Pieter Badenhorst Professional Services CC

Date: 24 February 2017

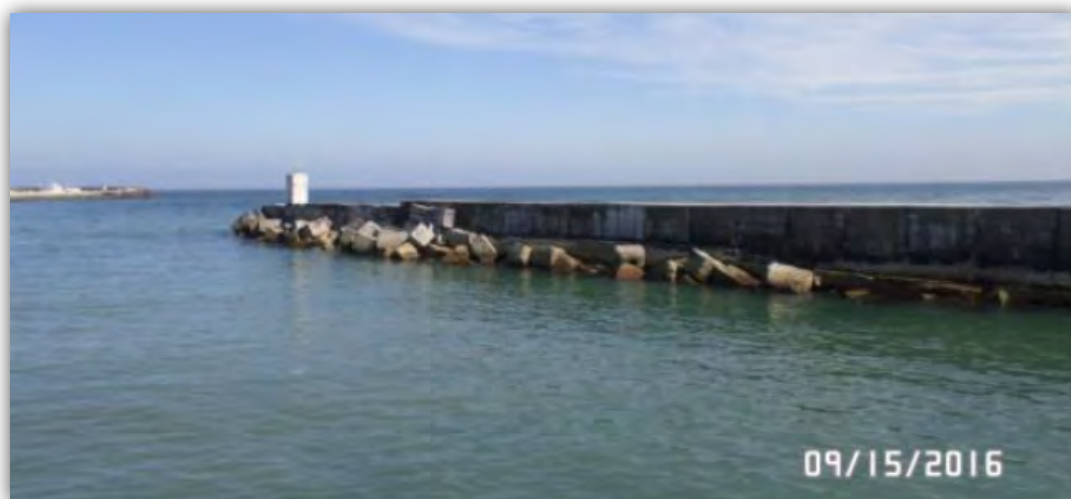
Figure 1.2.1.1: Breakwater 1

The overall condition of this breakwater is very poor. There is evidence of severe cracking and settling at the end of the breakwater. The extensive movement is likely to affect the structural integrity of the structure. Displacement, movement and breakage of concrete cubes and primary armour units (dolosse) were noted on both sides of the breakwater. Severe undermining of the breakwater was observed in several places, on both the seaward and leeward slopes, of the breakwater.

The deterioration of the breakwater is due to subsidence of the structure from wash out of core material from wave action. To arrest the deterioration of the breakwater it is recommended that the core be stabilised (through cement grouting) and the armour protection rehabilitated to provide its original design function (see Figure 1.2.1.2a for detail of existing footprint and proposed work). A detailed study (Crane and ball survey) of the positioning of the armour units is required to evaluate the extent of the repair and rehabilitation of the breakwater.

- Stabilising existing founding blocks by tremie concrete. Same detail as per Stilbaai with geotextile bags acting as a shutter.
- Horizontal and vertical cracks to be pressure grouted (cement)
- Localised concrete repair and patching as required
- Rehabilitation of toe of structure to original design function

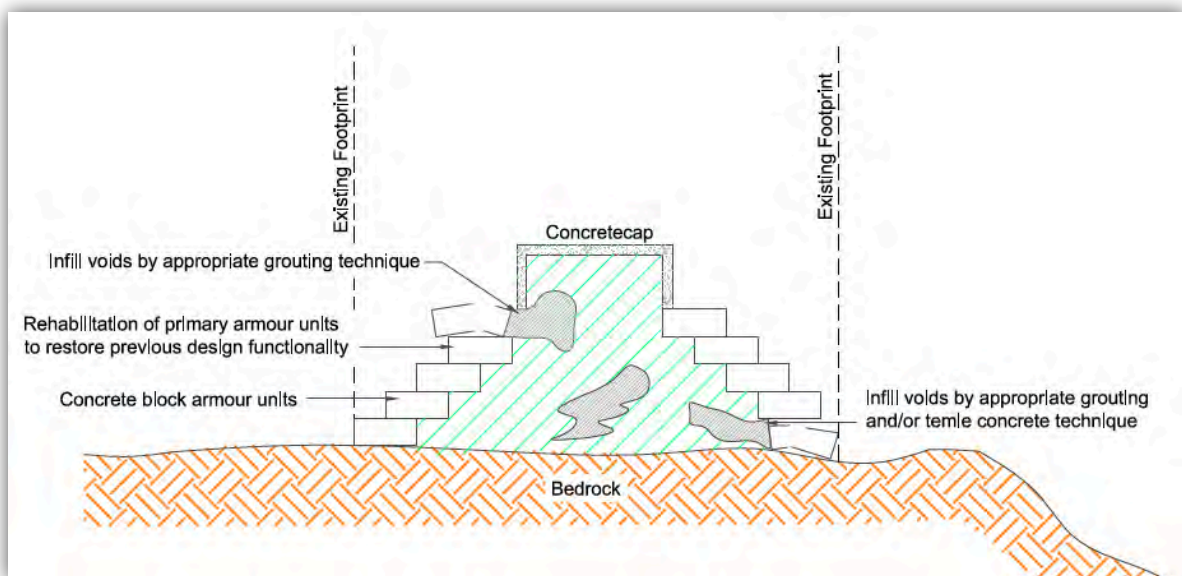
Figure 1.2.1.2a: Section through Breakwater 1

It is not anticipated that works will be carried out to level the concrete cap, but cracks will be pressure grouted where required.

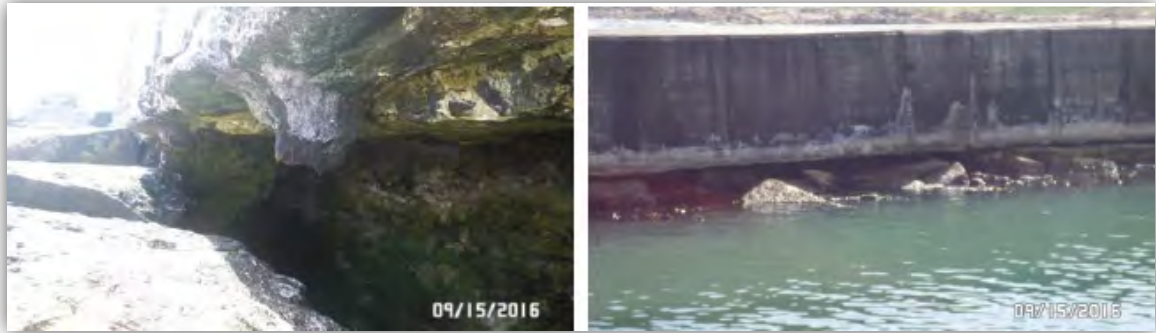
Examples of void and undermining damage are shown in Figure 1.2.1.2b.

Figure 1.2.1.2b: Voids to be filled and undermining to be capped

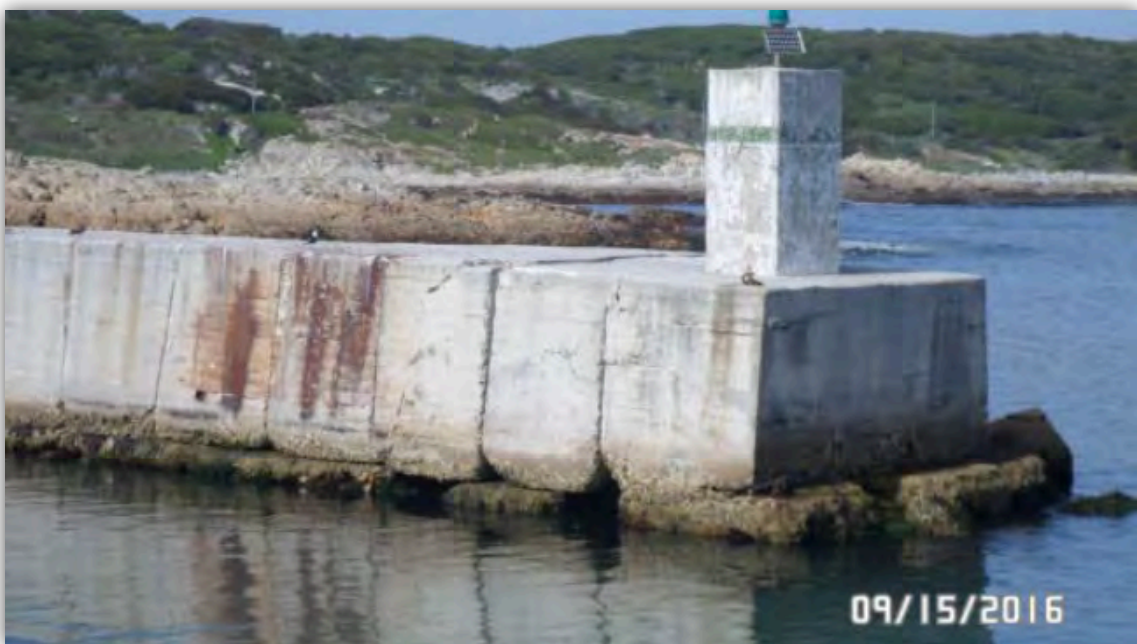
Figure 1.2.1.1: Breakwater 2

Severe structural cracking and movement was noted at the head of the breakwater. This is most likely due to undermining of the breakwater at the head. A long longitudinal structural crack can be seen along the crest of the breakwater. Copings were found to be in poor condition due to spalling of concrete and corrosion of reinforcing. Visually the navigational light is in poor condition (see Figure 1.2.1.1).

- Stabilising the founding concrete blocks under the mass concrete breakwater using tremie concrete. A diving survey is required to analyse the extent of the repairs required.
- Horizontal and vertical cracks to be filled by pressure pointing (cement grout) as required
- Cement pressure grouting of cracks in the breakwater concrete units

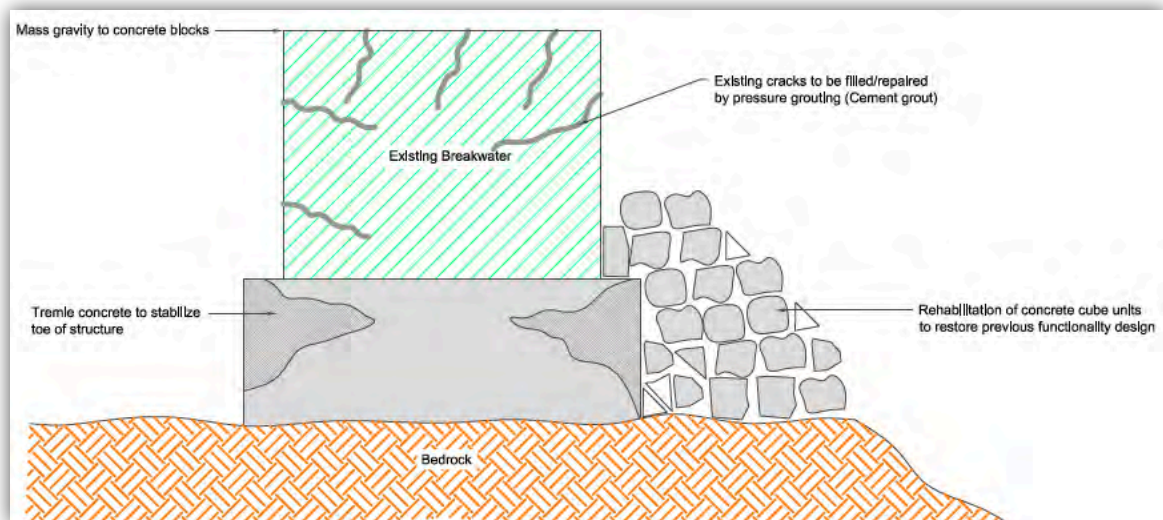
Figure 1.2.1.2: Section through Breakwater 2

Figure 1.2.1.2 shows detail of the proposed filling of cracks and rehabilitation of concrete cubes on the existing footprint.

- Stabilising existing founding blocks by tremie concrete. Same detail as per Stilbaai with geotextile bags acting as a shutter.
- Horizontal and vertical cracks to be pressure grouted (cement)
- Localised concrete repair and patching as required
- Rehabilitation of toe of structure to original design function

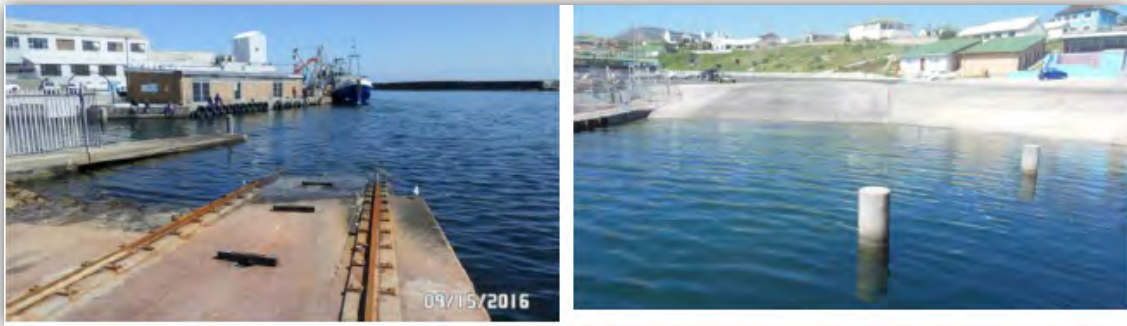
Figure 1.2.2.1: Slipway 1 (left) and Slipway 2 (right)

Slipway 1: The mechanised slipway is in good condition and recently extended with repair work done. The concrete apron surrounding the side slip at the top of the slipway has cracks, and sections are showing settlement. A severe structural crack was noted at the corner of the seawall.

Slipway 2: Minor cracking and abrasion of concrete was observed. Marine growth/algae were observed on the lower end of the slipway below the high water mark. The jetty is in good condition and no major defects were observed.

It is still, however, recommended that a specialist service provider undertake a full diagnostic report to confirm the integrity of the mechanised system.

Maintenance and concrete repair works are required for both slipways, and a pick list will be developed in the detail design to attend to the more critical items identified.

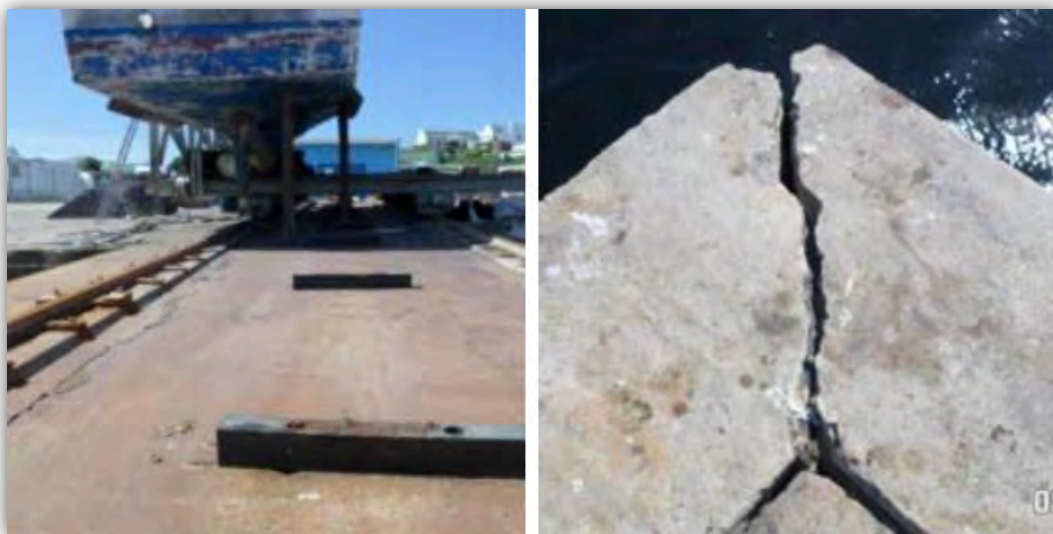
Figure 1.2.2.2: Proposed maintenance of slipways

See Figure 1.2.2.2 for a view of the mechanised slipway and other cracks .

- Repair and maintenance of mechanised slipway.
- Refurbishment of plant and equipment of the mechanised slipway to original design parameters.
- Crack to corner of slipway to be pressure grouted (cement)
- Localised concrete repair and patching where required to both slipways

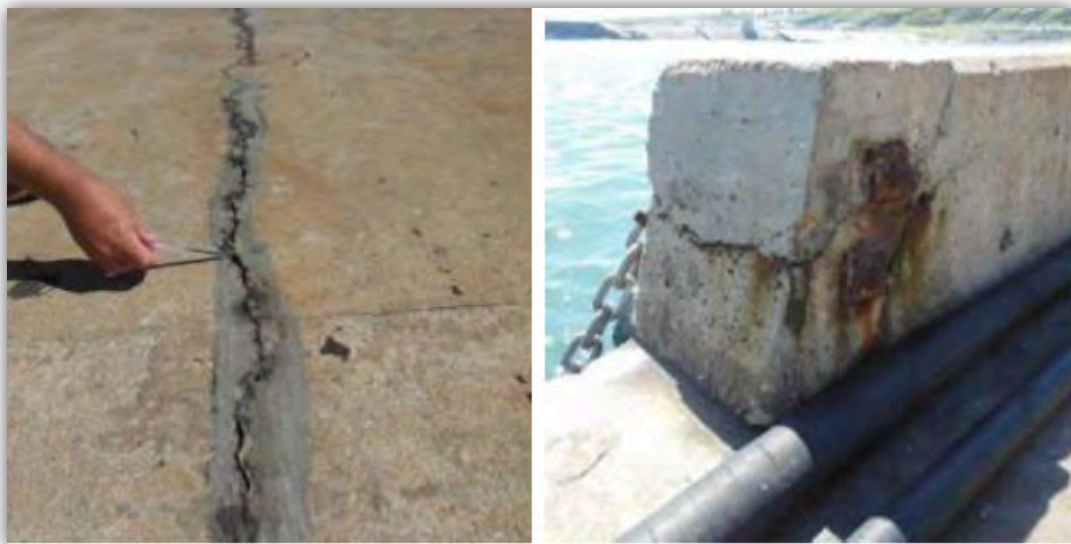
Figure 1.2.3.1b: Structural cracks to be repaired

Concrete fender blocks where tyres are attached have structural cracks and concrete spalling. Reinforcing is exposed and is corroding. The reinforced slab deck has structural cracking and previous repair methods have failed (see Figure 1.2.3.1b).

Maintenance and concrete repair work to concrete fenders and reinforced concrete slabs. Examples of damage shown in Figure 1.2.3.1b.

- General concrete repair and maintenance

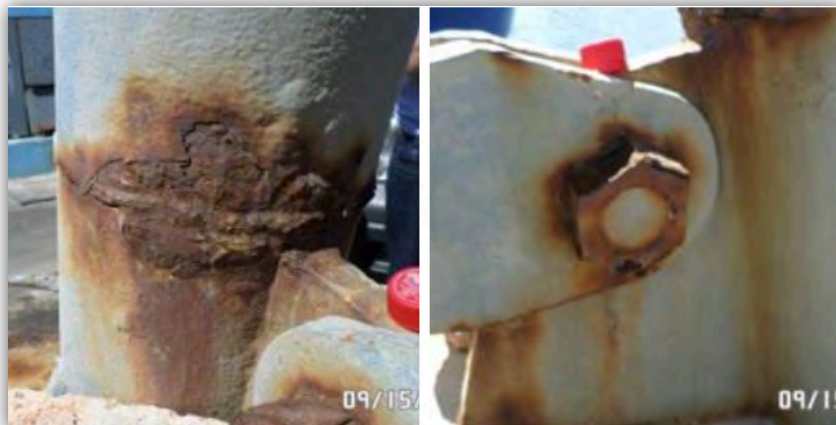
Figure 1.2.3.1d: Damage to vertical members and fixing detail

Corrosion is evident throughout the structure as shown in Figure 1.2.3.1d. However, there were no immediate indications of duress to the steel structure.

For its operational requirements, the crane is deemed to be adequate. In conversation with the Doc Master, he gave no indication that the crane is negatively affecting the harbour operations. It is anticipated that only rehabilitation is required by providing maintenance through sand-gritting and recoating with corrosive protection paint.

It is however recommended that a specialist service provider do a full diagnostic to verify the operational capability of the crane and inform on the way forward.

- Worst case scenario to replace crane with “like to like” (further site investigations to take place)
- If not replaced repair and maintenance. Grit blasting and recoating with non-corrosive paints where required.

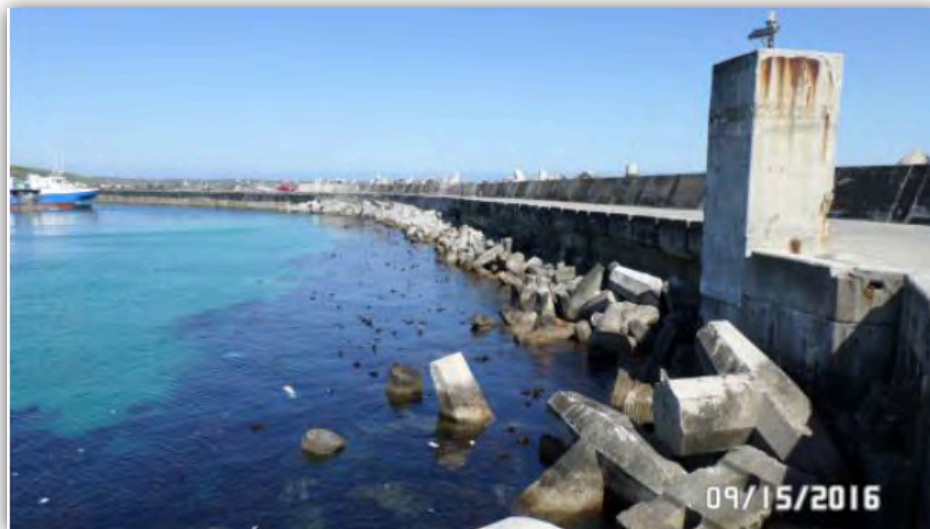
Figure 1.2.2.1: Breakwater 3

Waves overtop the structure during storms and the Dock Master made mention that during severe storms vessels have to be moored away from the breakwater for safety. Dolosse on the leeside of breakwater have broken into pieces. Mention was made of scouring/undermining of the inside of breakwater but this could not be viewed, however, it was seen that water passes through the breakwater at the joints. Cracking and spalling of concrete was observed in localised sections with staining due to corrosion. Rebar has not been exposed (also see Figure 1.2.2.2).

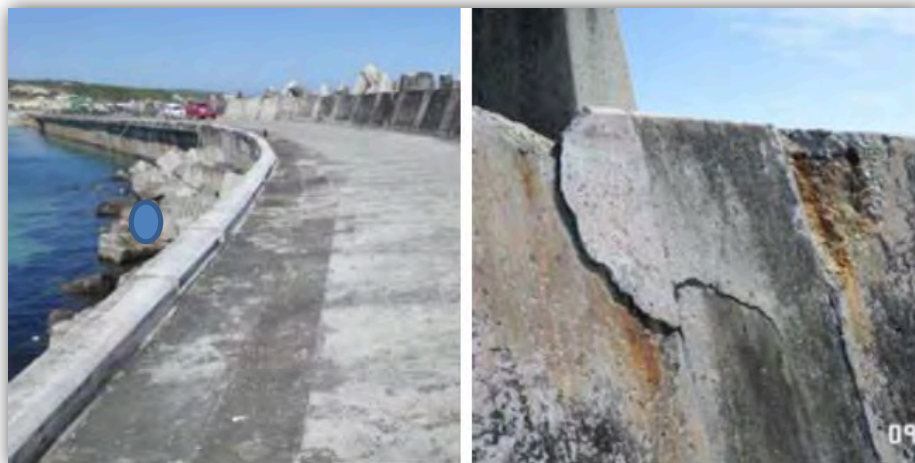
Figure 1.2.2.2: Damage to Breakwater 3 and area where water is allowed through (see blue circle)

Further detailed analysis of the bathymetric survey is required to confirm the condition of the toe and to what extent remedial work is required. The toe will be reinstated using tremie concrete as per Breakwater 2 detail.

Concrete remedial works are required to the capping slab and crown wall. A list of critical works will be identified during detail design after in depth concrete assessments have been completed.. A detailed study (Crane and ball survey) of the positioning of the armour units is required to evaluate the extent of the repair and rehabilitation of the breakwater.

- Remedial work to the toe as per Breakwaters 2 and 3
- Sealing of joints through the breakwater by grouting (cement)
- Localised concrete repair and patching as per concrete repair methodology section 9

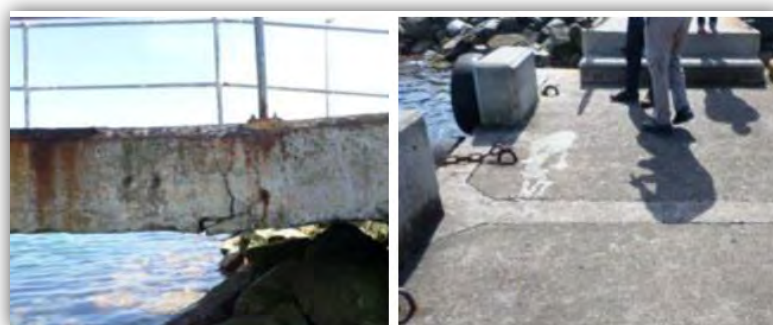
Figure 1.2.2.4: Damage to Jetty 2

The dolphin berth is in good condition but the concrete access bridge is in very poor condition. The concrete bridge has deflected and shows severe structural cracking and corrosion. The structural integrity of the structure is compromised. The hand rails are in poor condition and require replacing. It was noted that this jetty is used for tourism (see Figure 1.2.2.4).

- Replace the “bridge” with a new reinforced concrete structure as a like for like. The dolphin berth is in good condition and minor concrete repairs are required.

- Demolish “reinforced concrete bridge”
- Replace with new concrete bridge
- New fencing to side
- Minor localised repairs and maintenance to the dolphin structure

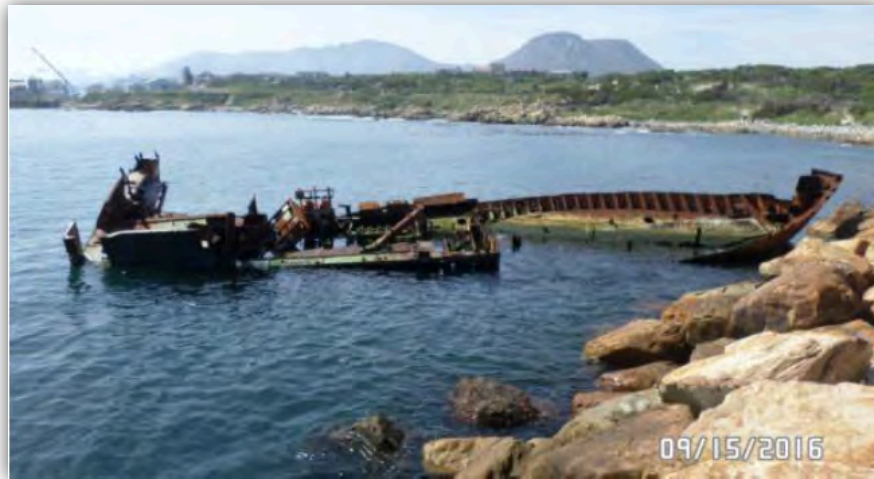
Figure 1.2.4.1: Remains of vessel

The steel hull of the vessel, which sank about 2-3 years ago, remains mostly intact. Most of the smaller pieces of metal have already been stripped. The vessel has been wrecked up against rock armour unit of breakwater 4 and is not fully submerged. The access concrete road on breakwater 4 is 10m from the wreck.

Gansbaai has only one sunken vessel that can be verified visually. The sunken vessel does not pose a hazard to port operations but over time will deteriorate and sections of the wreck could break off and drift into areas used by vessels. The deterioration of the vessel will also become aesthetically unpleasing and a hazard to public should they attempt to board the wreck.
