**Professional Consultancy Services for Coastal Engineering Infrastructure  
Proclaimed Fishing Harbours Western Cape**

# **HARBOUR MAINTENANCE CHECKLIST FOR SUBMISSION TO DEA STILBAAI HARBOUR**

## **Stilbaai Harbour**

**Date: 7 February 2017**

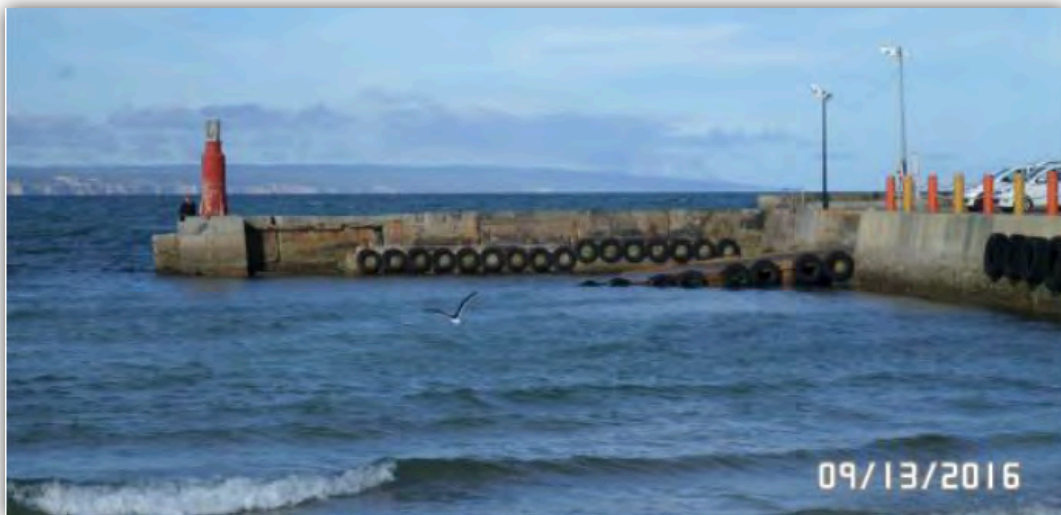
**Figure 1.2.1.1: Stilbaai Breakwater 1**

This 24m long breakwater (see Figure 1.2.1.1) consists of concrete precast caisson/gravity blocks with minimal rocks serving as armour/toe protection. A navigation light is positioned at the end of the breakwater. A small quay is situated, on the landside of the breakwater, in close proximity to the end of the breakwater.

Erosion of the seabed at the toe or in front of the foundation may have caused the vertical breakwater to move and tilt vertically. Precast caissons/gravity units are not fully seated. The cap of the breakwater is uneven. The structure shows signs of severe cracking, spalling and corrosion and, notably, there is large vertical structural crack running through the entire structure (see Figure 1.2.1.2 below). Bollards are showing signs of advanced corrosion. The lower section of breakwater is severely abraded on the seaside with possible undermining of toe structure.

The remedial works envisaged is to stabilize and strengthen the existing breakwater. This is to be done by:

- Stabilising the toe using tremie concrete.
- Horizontal and vertical cracks to be filled by pressure grouting/pointing (cement grout)
- Reinforced concrete cap as well as encasement, anchored into the existing breakwater
- Replacement and rehabilitation of existing bollards.

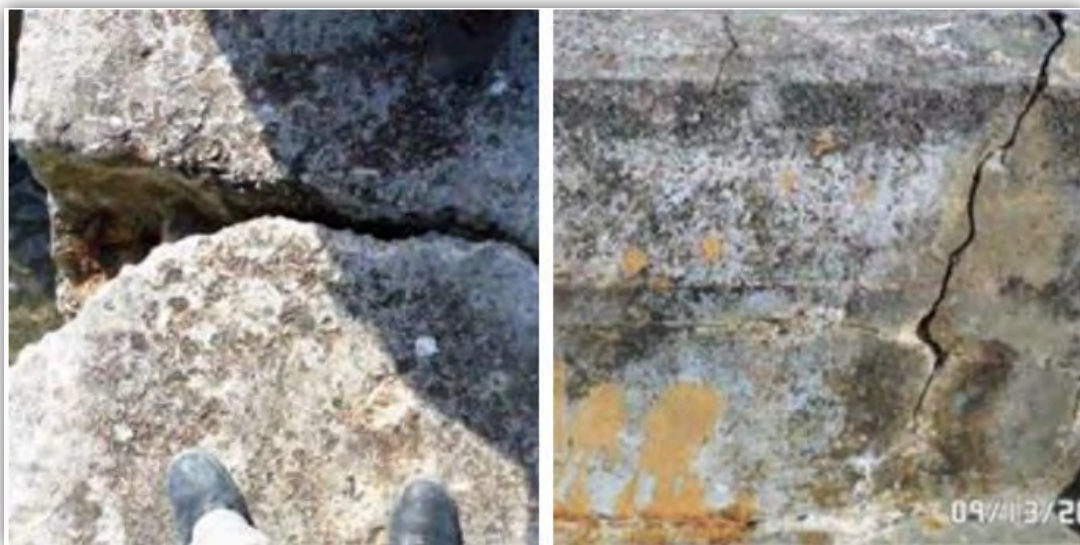
**Figure 1.2.1.2: Large structural crack to be pressure pointed (cement grout) Similarly, vertical cracks to be cement grouted**

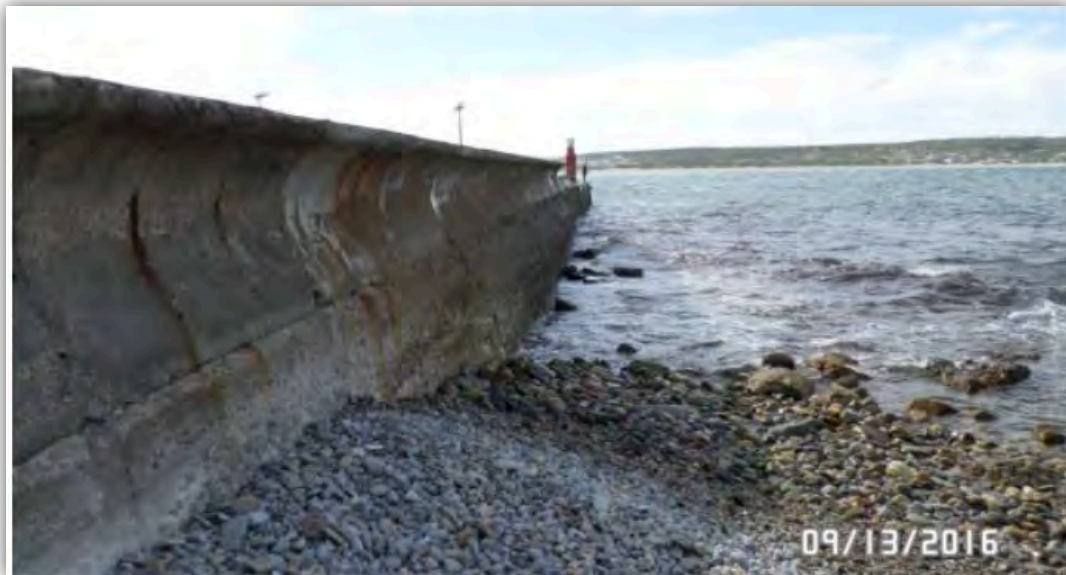
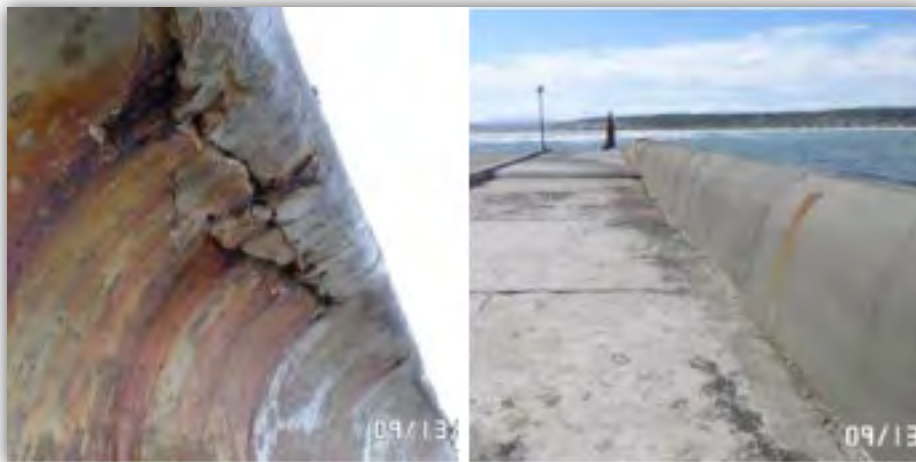
**Figure 1.2.2.1: Stilbaai Breakwater 2**

This part of the breakwater (48m long) consists of a vertical concrete wall and recurved copings as shown in Figure 1.2.2.1 together with examples of damage. This coping will be replaced with a new coping as shown in Figure 1.2.2.2.

- Existing copings demolished and removed
- Galvanised bars dowelled into existing structure to anchor new RC beam and coping
- New precast concrete coping to have same crest level as existing
- New precast coping/beam to be designed for enhanced durability
- General maintenance and repair to existing concrete required (see generic repair methodology chapter 9)

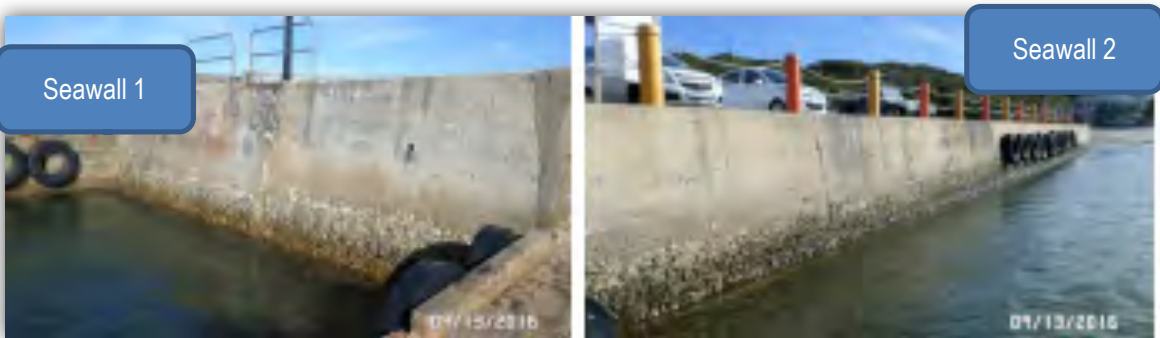
Figure 1.2.3.1b: Views of Seawalls 1 and 2

**Seawall 1:** The loss of backfill material is evident as the slipway sidewall and concrete slab behind the seawall has subsided by approximately 80mm. Although the sections behind the seawall underwent settling, the upper and lower concrete blocks of the seawall seem to be standing firm. Due to no visual evidence of recent settlement, it can be assumed that the loss of backfill material has not accelerated over time.

The integrity of the toe of the seawall could not be viewed for scour, but it is assumed that the cause of the settlement behind the wall is most likely due to loss of backfill material leaching through the wall.

Abrasion of concrete was noted on the lower blocks, below the high water mark. Significant staining, minor cracking and spalling is evident throughout.

**Seawall 2:** The seawall above the high water mark is in good condition, however the lower section in the tidal zone indicates that abrasion is taking place. There is visible settlement, unevenness, and collapse of the paving blocks behind the seawall. There is a void under the paving, probably caused by a loss of fill material leaching out under the seawall and/or alternatively through the joints. The integrity of the toe of the seawall with regards to scour is not confirmed,

**Seawall 1:** Repair works is required to resolve the continuing settlement behind the seawall. Further investigation is required to establish whether settlement is continuing or has been arrested. This is to done through site investigations by excavating behind the seawall and analysing the toe of the structure.

The envisaged extent of the repair works required is likely to include the following: repair of toe protection, replacement of backfill material, sealing of joints between concrete blocks and concrete paving slab.

**Seawall 2:** The likely reason for the loss of backfill material behind the wall is the leaching of sediment through the joints in the structure. This is deduced on the bases that the crest of the wall is even and is showing no signs of settlement. However, sediment may also be leaching through the toe and this requires further investigation. To verify the extent of the voids/settlement behind the wall further site investigations are required where a strip behind the seawall will be opened and profiling of the sections along the seawall will be completed.

Repair works envisaged: repair of toe protection, sealing of backfill against leaching paths, replacement of backfill material and reinstatement of paving.

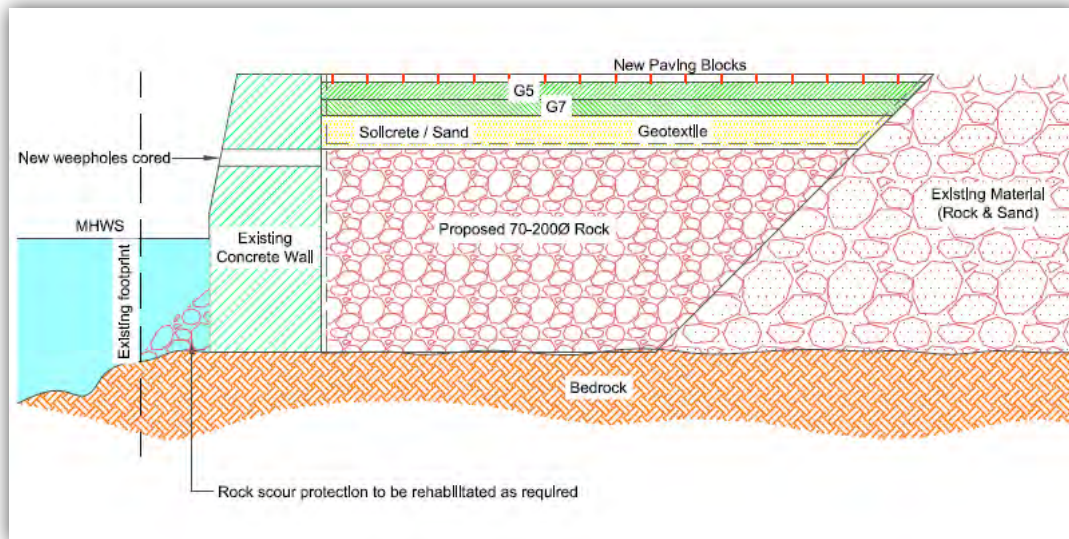
**Figure 1.2.3.2: Maintenance of seawalls 1 and 2.**

However, the surface landward of the walls require maintenance as shown in Figure 1.2.3.2 as well as improved toe protection within the existing footprint.

In the coordination meeting with the Civils service provider (Bosch Projects) it was agreed that Mott Macdonald would replace the paving like for like and would open up a strip of 5 to 8 metres behind the wall for remedial works.

The protective fencing to the edge of the seawall 1 requires replacement and same details as seawall 2 will be used (concrete bollards with chains).

- Excavate landside of seawall
- At joints in seawall add geotextile layer
- Backfill with rock, and layer works
- Replace existing paving as required
- Rehabilitate toe of the structure
- Provide new wheepholes

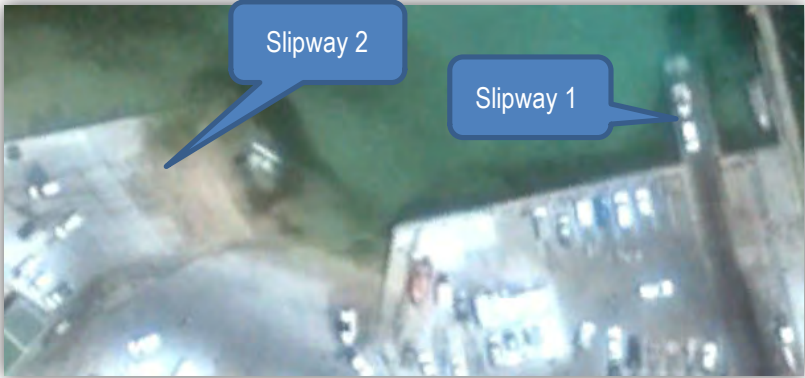
**Figure 1.2.4.1: Locality of Slipways 1 and 2.**

Slipways 1 and 2 requires localised concrete repairs and maintenance (see Figure 1.2.4.1 for locality).

Both slipways require varying degrees of concrete repairs. For generic approach to concrete repair methodology for marine structure see Section 9.

Current repairs at the joints to Slipway 1 have failed and the repair methodology and product used is to be improved upon. The hazard mentioned by the Doc Master concerning damage to trailers passing over open slipway joints will be resolved by casting a new concrete strip.

Sediment and rock hazards on and surrounding the slipways is noted and will be addressed as part of the dredging activity.

Localised concrete repair and maintenance to the slipway
