Department:
Arts and Culture
REPUBLIC OF SOUTH AFRICA

Repairs, Restoration & Reconfiguration of Existing Old Greys Hospital Buildings F & G to Offices for KZN
Department of Arts & Culture
March 2013
Status Quo Report – Block F

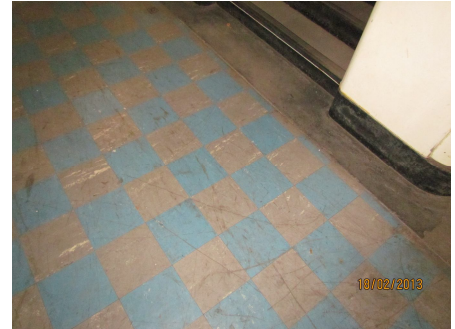
1.1 Vinyl Tiles onto Concrete Slab

Most areas have vinyl tiles laid onto a concrete slab. In some areas, tiles are missing but in most they are damaged, cracked or scratched. All flooring is to be removed, floor made good & replaced with new flooring as per finishes schedule.

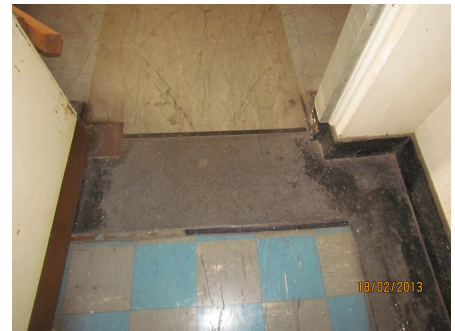
2.2 Grano/Cement coved Skirting

Some areas have a Grano/Cement screed skirting. In some places the skirting is cracked, chipped or missing skirting. All is to be chipped away & replaced with new timber skirting as for 2.1.

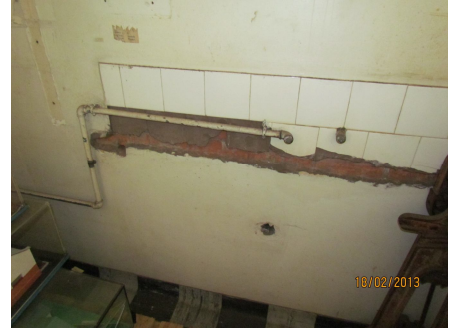
3.2 Ceramic Tiled Walls

Some walls have been tiled with ceramic tiles which are in very poor condition throughout. All is to be removed & only replaced where required (e.g. Kitchens, ablutions etc.) Where rooms are to be converted into offices, walls are to have plaster repaired & painted.

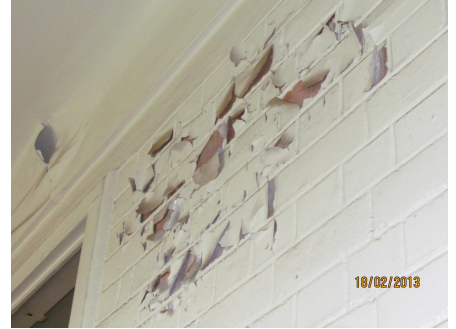
3.3 Painted Face brick Walls

There are a few areas that have paint over facebrick. The walls appear to be generally in good condition. All is to have paint removed, scabbled & coated with bonding liquid, plastered & then painted.

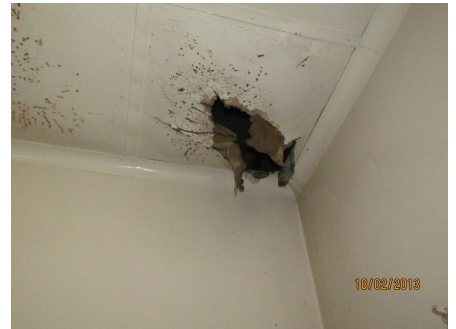
4.1 Plasterboard Ceilings

Some areas have plasterboard ceilings with half round joint strips & coved cornice all round which appear to be in poor condition due to water penetration from leaks in the roof. The entire ceiling (including brandering) is to be removed & replaced with a new aluminium suspended ceiling to suit new reconfiguration of all internal spaces into offices.

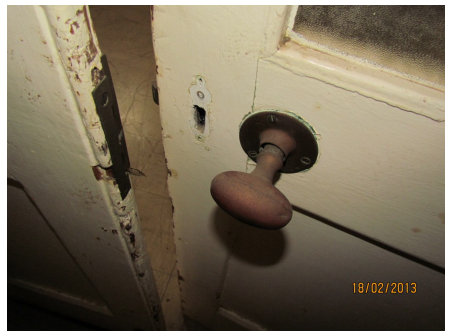
5.1 Painted Timber Doors, Frames & Linings

Most of the doors & frames are old & damaged mostly around the lock/handle/striker plate area. All internal doors that are to remain to be replaced with new doors to match existing. New doors within drywall according to the new office configuration are as per new door schedule. Doors along the perimeter (verandah) & external doors are to be replaced with new to match existing. All frames that are to remain must be repaired & re-painted. All glazed doors that are to remain must have all broken panes replaced & new glazing beads to match existing fitted where necessary.

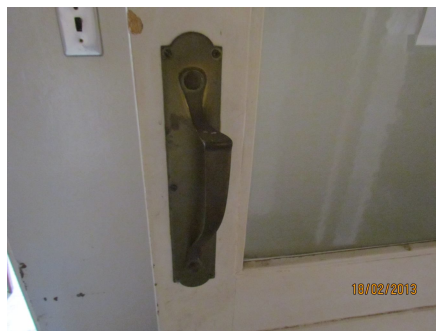
5.2 Ironmongery

Most of the locks & handles are damaged or missing. Due to the extensive reconfiguration into offices it is recommended that on the existing doors that are to remain, all locks, handles striker plates, hinges & rebate kits (double doors), doors stops, coats hooks, latches etc. to be replaced with new door furniture including for new partition walls as per ironmongery schedule. Locks are to be 3 lever for all doors on a master key system. All existing door furniture to be removed must be handed to the Heritage Council.

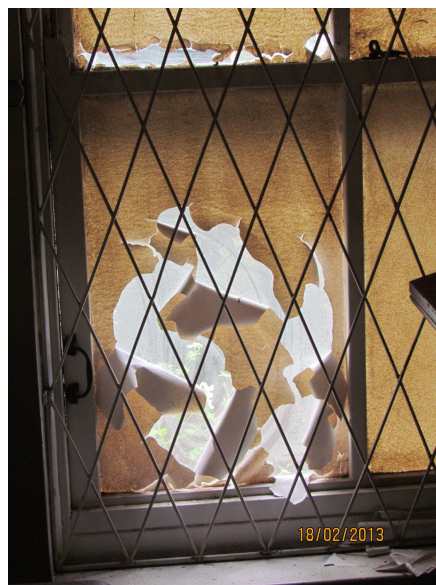
6.1 Painted Timber Sash/Casement/Top Hung Windows & Frames

The existing timber sash windows are generally in fairly good condition on the inside with a few needing major repair works that includes the removal of the affected sash & repair either with a filler piece before repainting. All existing sash cords & brass rollers to sash windows are to be replaced with new. All broken window panes as well as those with frosted or painted glass are to be replaced including new glazing beads in profile to match existing. Generally all glazing is to be cleaned.

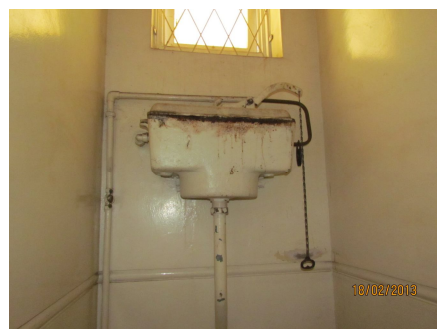
7.1 Sanitary Fittings, Storm water & Miscellaneous

All the fittings are old & appear to be in a very poor condition. All are to be replaced with new as per sanitary schedule. These include W.C's, WHB's, Sinks, Wash Troughs, Mirrors, Taps, Shower heads & Stoptaps,

Baths, Toilet Roll Holders & all associated plumbing pipes. All new water pipes are to be copper & chased into walls with PVC waste & sewer visible along walls over short distances (waste to be chased in wherever possible).

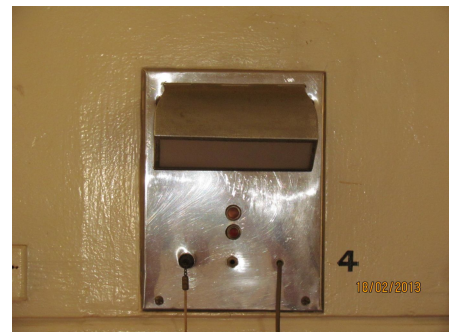
7.3 Electrical Fittings

All existing electrical fittings e.g. lights, plugs, switches, intercom systems, DB's & other are to be removed. New light switches, plugs, DB's, powerskirting & other are to be as per electrical engineers specifications. The entire building is to be re-wired. All old fittings that have been removed are to be handed over to the Heritage Council.

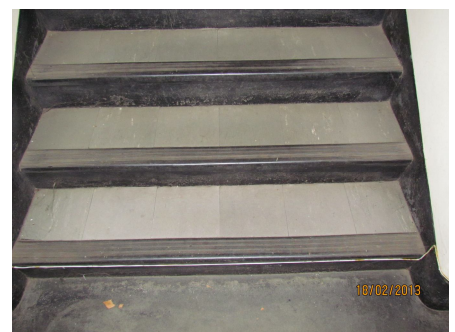
7.4 Lift Lobby & Main Stair

Existing vinyl flooring to lobby & stairs is to be replaced with new porcelain tiles including new brass stair nosing & edge strips including new timber skirting. Existing varnished timber handrail to be repaired, sanded & re-varnished with steel brackets painted.

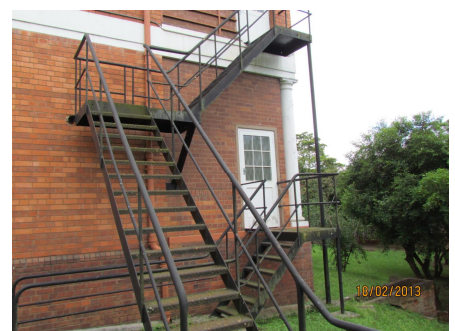
7.5 Fire Escape Stair

Existing steel fire escape to be replaced with new galvanised steel escape stair including new balustrade to new configuration.

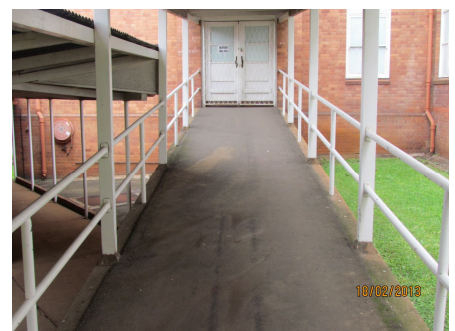
7.6 Disabled Access

The existing ramp to the entrance door does not conform to the current standards for disabled ramp access & would have to be demolished & replaced with new ramp access to be incorporated in the new design.

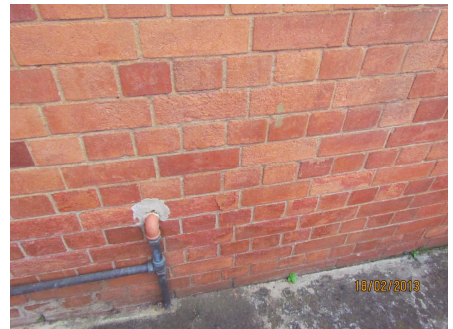
9.1 Facebrick Walls

All the external walls are generally face brick unless otherwise stated. They appear to be in fairly good condition with repair required in a few areas. Badly damaged bricks are to be cut out & replaced with similar second hand bricks or fagots taken from demolished walls elsewhere on site or from an external source. Minor repair would require a brick paste mixed from existing ground bricks. Where pointing has deteriorated, these areas need to be re-done. Major cracks are dealt with in structural engineers report. Where plaster has chipped or fallen off plinths, these would have to be repaired as for plastered/screeded steps. The entire building is to be cleaned as per AMAFA specification.

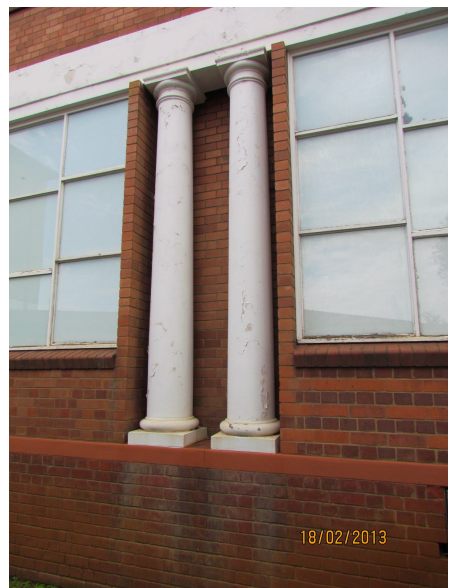
9.2 Plastered Walls/Beams/Lintels

All plastered walls & beams appear to be in fair condition with a few hairline cracks in places. These will have to be repaired & all repainted.

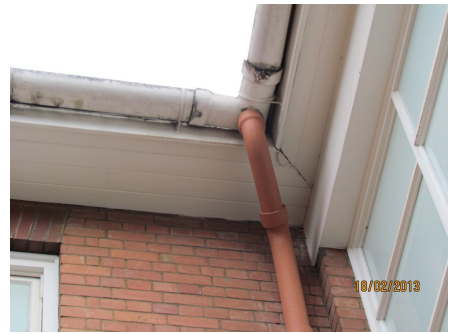
10.1 Open/Closed Eaves

The existing painted closed timber eaves appears to be in a fair condition but there may be water damage on the inside. All is to be replaced with new painted timber panels with groove pattern to match existing. Where eaves are open, exposed rafters are to be repaired where necessary, sand & re-painted.

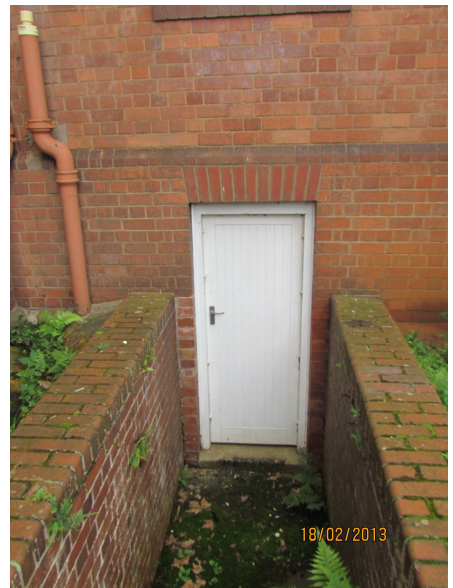
11.1 Painted & Varnished Hardwood/Meranti Doors, Frames & Linings

All external doors are to be replaced with new hardwood doors to match existing. All ironmongery to be treated as described internally. Where jamb linings, frames or architraves are badly damaged they would have to be replaced. All are then to be re-painted.

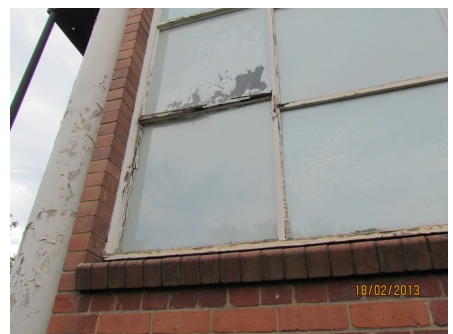
12.1 Painted Hardwood Sash/Casement/Pivot Windows & Frames

All external windows & frames are in a poor condition due to exposure to the elements. They would have to be repaired, sand, & re-painted. All furniture is to be removed, service & replaced. Badly damaged or missing furniture to be replaced with new to match existing where possible.

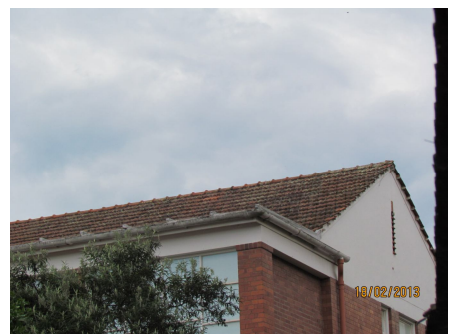
13.1 Marseille Tiled Gabled Roof

The Marseille tiles appear to be in fairly good condition although they would have to be carefully removed & stored for re-use after the new plastic underlay has been installed. Once the tiles have been re-layed, the entire roof is to be pressure cleaned. There is a likelihood that some tiles are damaged or will become damaged during this process so provision must be made for new tiles to match existing. The engineers report will deal with the condition of the roof structure & if necessary some trusses or battens may be replaced or rafters braced. Painted exposed rafter ends are to be re-painted where they are to remain.

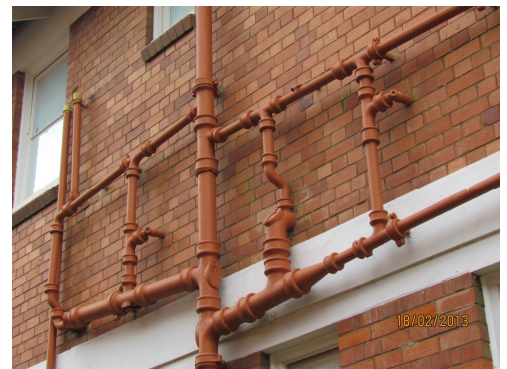
14.1 Painted Galvanised Soil, Waste, Vent pipes, Water.

Due to their age & the reconfiguration of internal spaces all plumbing pipes are to be completely removed. New PVC & Copper plumbing pipes to be installed above ground for sewer & waste respectively with below ground piping as per engineer's specifications.

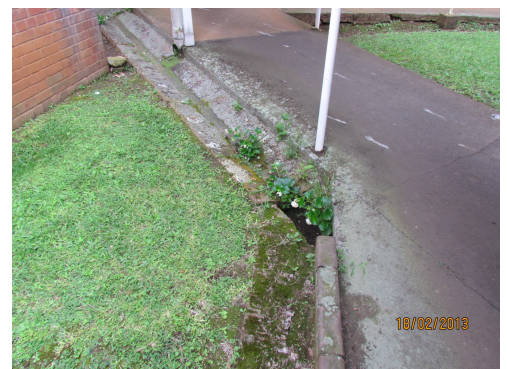
14.1 Surface Drains, Gulleys, Manholes etc.

All surface brick drains around the building are in a poor condition and will need to be rebuilt in some areas & minor repair in others. All is then to be pressure cleaned. All existing gulleys, manholes & below ground services are to be replaced as per engineers specifications.

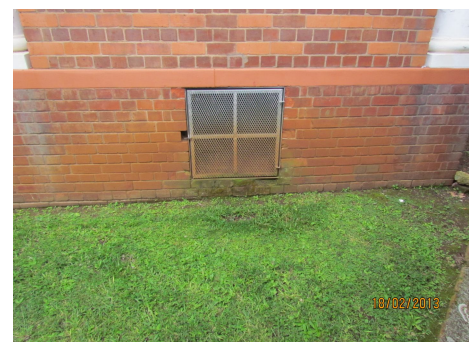
15.6 External Gates/Steelwork

Repair & repaint all external steelwork.
