Repairs, Restoration & Reconfiguration of Existing Old Greys Hospital Buildings F & G to Offices for KZN
Department of Arts & Culture
March 2013
Status Quo Report – Block G

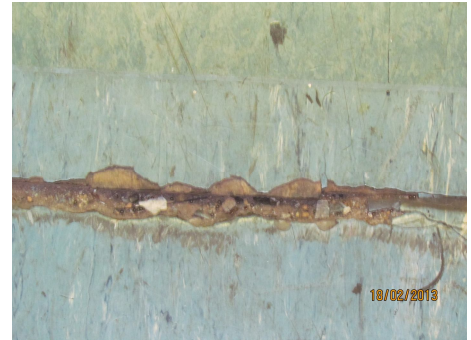
1.1 Vinyl Tiles onto Concrete Slab

Most areas have vinyl tiles laid onto a concrete slab. In some areas, tiles are missing but in most they are damaged, cracked or scratched. All flooring is to be removed, floor made good & replaced with new flooring as per finishes schedule.

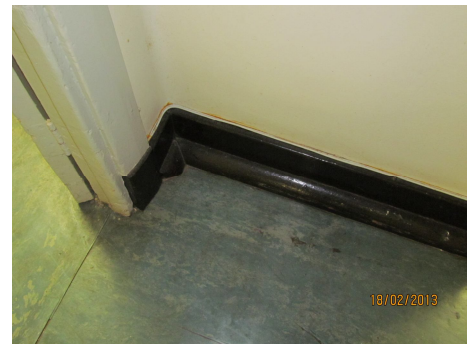
2.1 Timber Skirting

Some areas have timber skirting which appear to be in fairly good condition. Where skirting is damaged, this will have to be repaired, then all to be sand & re-painted. Where new skirting is required due to new layout, skirting to match existing.

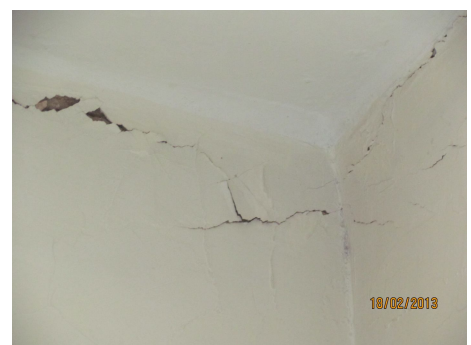
3.1 Cement Plastered Walls

Most of the walls have been cement plastered & appear to be in good condition with the exception of a few areas that show signs of hairline or structural cracks (to be assessed by a structural engineer) which would have to be repaired prior to painting.

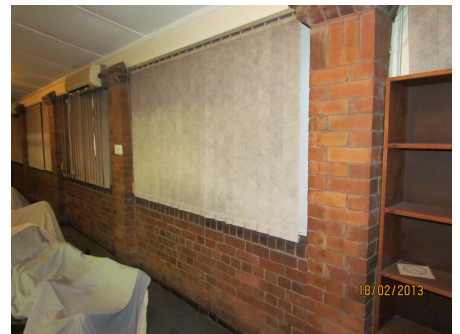
3.4 Painted Face brick Walls

There are a few areas that have paint over facebrick. The walls appear to be generally in good condition. All is to have paint removed, scabbled & coated with bonding liquid, plastered & then painted.

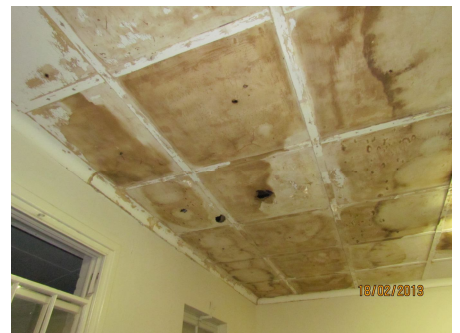
4.1 Plasterboard Ceilings

Some areas have plasterboard ceilings with half round joint strips & coved cornice all round which appear to be in poor condition due to water penetration from leaks in the roof. The entire ceiling (including brandering) is to be removed & replaced with a new aluminium suspended ceiling to suit new reconfiguration of all internal spaces into offices.

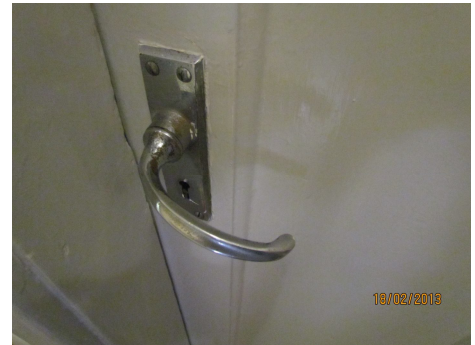
5.2 Ironmongery

Most of the locks & handles are damaged or missing. Due to the extensive reconfiguration into offices it is recommended that on the existing doors that are to remain, all locks, handles striker plates, hinges & rebate kits (double doors), doors stops, coats hooks, latches etc. to be replaced with new door furniture including for new partition walls as per ironmongery schedule. Locks are to be 3 lever for all doors on a master key system. All existing door furniture to be removed must be handed to the Heritage Council

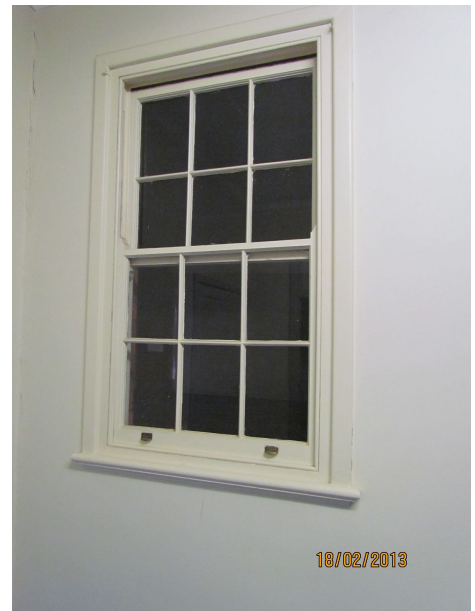
6.1 Painted Timber Sash/Casement/Top Hung Windows & Frames

The existing timber sash windows are generally in fairly good condition on the inside with a few needing major repair works that includes the removal of the affected sash & repair either with a filler piece before repainting. All existing sash cords & brass rollers to sash windows are to be replaced with new. All broken window panes as well as those with frosted or painted glass are to be replaced including new glazing beads in profile to match existing. Generally all glazing is to be cleaned.

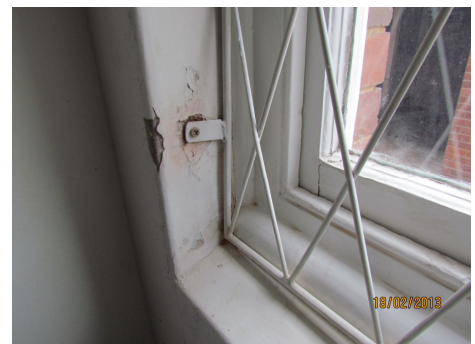
6.5 Ironmongery

Most of the latches, handles & stays appear to be in a fairly good condition & would require being removed for servicing & cleaning & then replaced after repair/repaint of the window/frame. Missing or badly damaged window furniture is to be replaced with new similar type where possible.

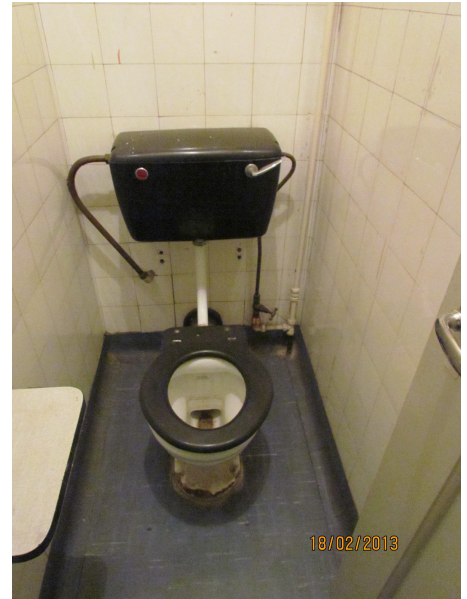
7.1 Sanitary Fittings, Storm water & Miscellaneous

All the fittings are old & appear to be in a very poor condition. All are to be replaced with new as per sanitary schedule. These include W.C's, WHB's, Sinks, Wash Troughs, Mirrors, Taps, Shower heads & Stoptaps, Baths, Toilet Roll Holders & all associated plumbing pipes. All new water pipes are to be copper & chased into walls with PVC waste & sewer visible along walls over short distances (waste to be chased in wherever possible).

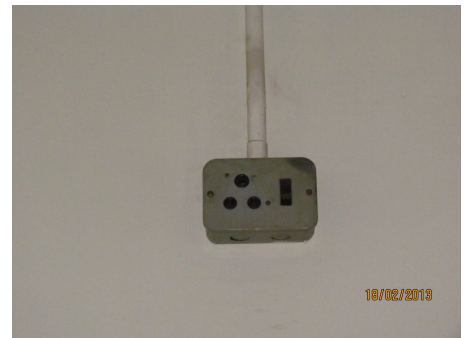
7.3 Electrical Fittings

All existing electrical fittings e.g. lights, plugs, switches, intercom systems, DB's & other are to be removed. New light switches, plugs, DB's, powerskirting & other are to be as per electrical engineers specifications. The entire building is to be re-wired. All old fittings that have been removed are to be handed over to the Heritage Council.

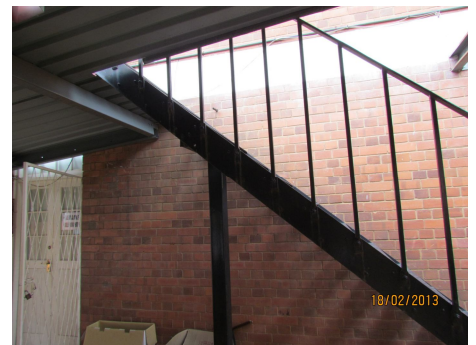
7.4 Lift Lobby & Main Stair

Existing vinyl flooring to lobby & stairs is to be replaced with new porcelain tiles including new brass stair nosing & edge strips with new timber skirting. Existing varnished timber handrail to be repaired, sanded & re-varnished with steel brackets painted.

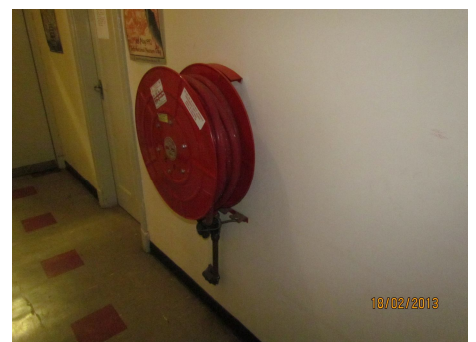
7.7 Fire Equipment

All existing internal fire equipment is in fairly good condition but would have to be replaced with new to suit new layout in compliance with SANS 10400.

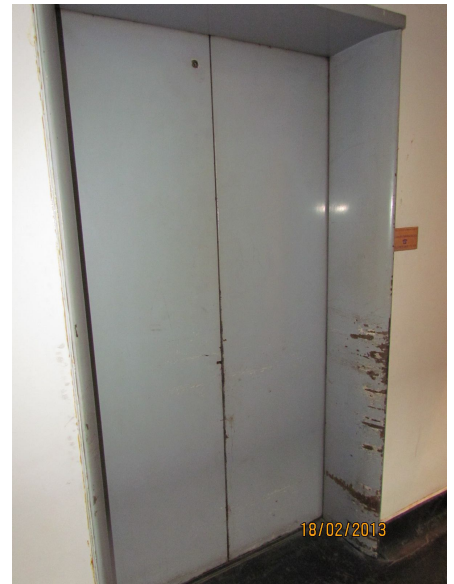
7.8 Lift

The existing lift is old & is to be replaced with a new disabled friendly lift fitted into the existing shaft. The lift motor room is to be assessed to ensure that the new lift motor equipment fits into the room. Motor room floors are to be generally cleaned with walls and soffit re-painted.

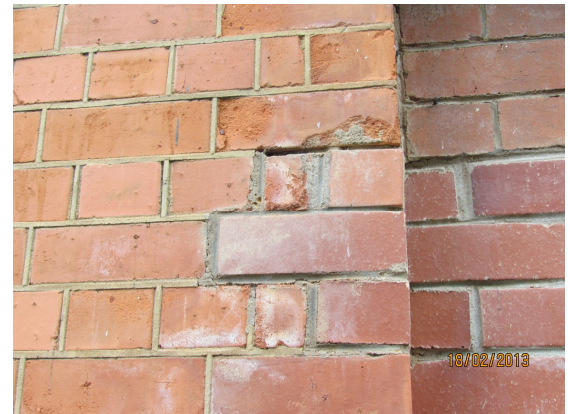
9.1 Facebrick Walls

All the external walls are generally face brick unless otherwise stated. They appear to be in fairly good condition with repair required in a few areas. Badly damaged bricks are to be cut out & replaced with similar second hand bricks or fagots taken from demolished walls elsewhere on site or from an external source. Minor repair would require a brick paste mixed from existing ground bricks. Where pointing has deteriorated, these areas need to be re-done. Major cracks are dealt with in structural engineers report. Where plaster has chipped or fallen off plinths, these would have to be repaired as for plastered/screeded steps. The entire building is to be cleaned as per AMAFA specification.

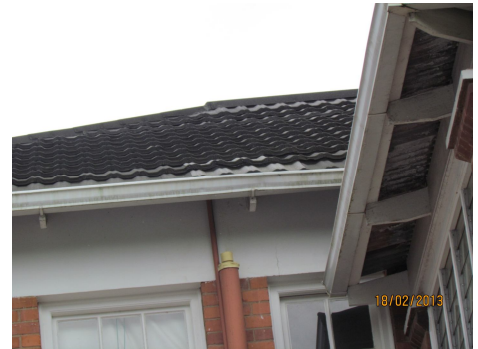
10.1 Open/Closed Eaves

The existing painted closed timber eaves appears to be in a fair condition but there may be water damage on the inside. All is to be replaced with new painted timber panels with groove pattern to match existing. Where eaves are open, exposed rafters are to be repaired where necessary, sand & re-painted.

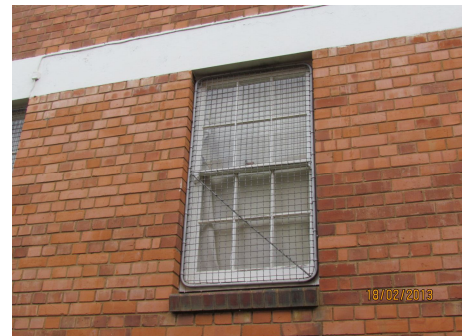
12.1 Painted Hardwood Sash/Casement/Pivot Windows & Frames

All external windows & frames are in a poor condition due to exposure to the elements. They would have to be repaired, sand, & re-painted. All furniture is to be removed, service & replaced. Badly damaged or missing furniture to be replaced with new to match existing where possible.

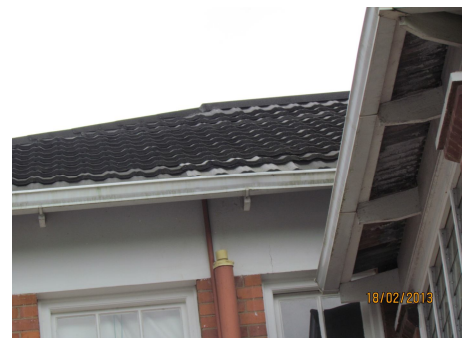
13.1 Double Roman Tiled Hipped Roof

The Double Roman tiles appear to be in fairly good condition although they would have to be carefully removed & stored for re-use after the new plastic underlay has been installed. Once the tiles have been re-layed, the entire roof is to be pressure cleaned. There is a likelihood that some tiles are damaged or will become damaged during this process so provision must be made for new tiles to match existing. The engineers report will deal with the condition of the roof structure & if necessary some trusses or battens may be replaced or rafters braced. Painted exposed rafter ends are to be re-painted where they are to remain.

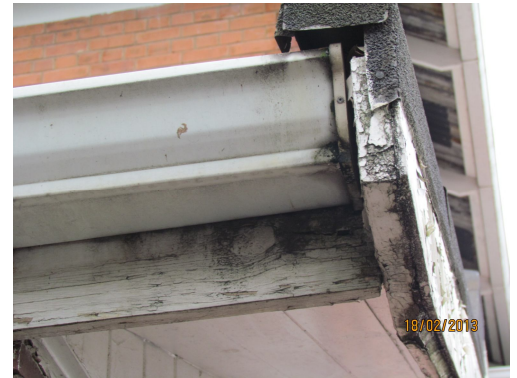
13.4 Aluminium Gutters & Downpipes

All aluminium gutters & downpipes are to be replaced with new.

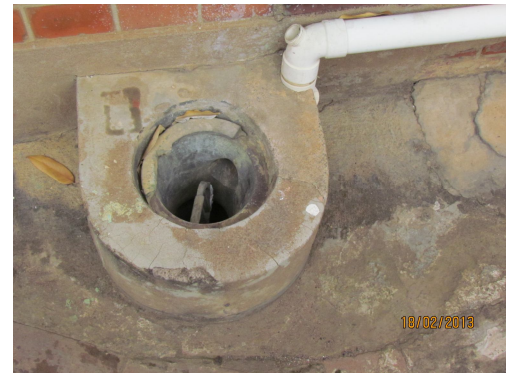
14.1 Surface Drains, Gulleys, Manholes etc.

All surface brick drains around the building are in a poor condition and will need to be rebuilt in some areas & minor repair in others. All is then to be pressure cleaned. All existing gulleys, manholes & below ground services are to be replaced as per engineers specifications.
