**Proclaimed Fishing Harbours – Work Package 3**

29-31 August Site Visit

**Coega Development Corporation**

26 September 2016

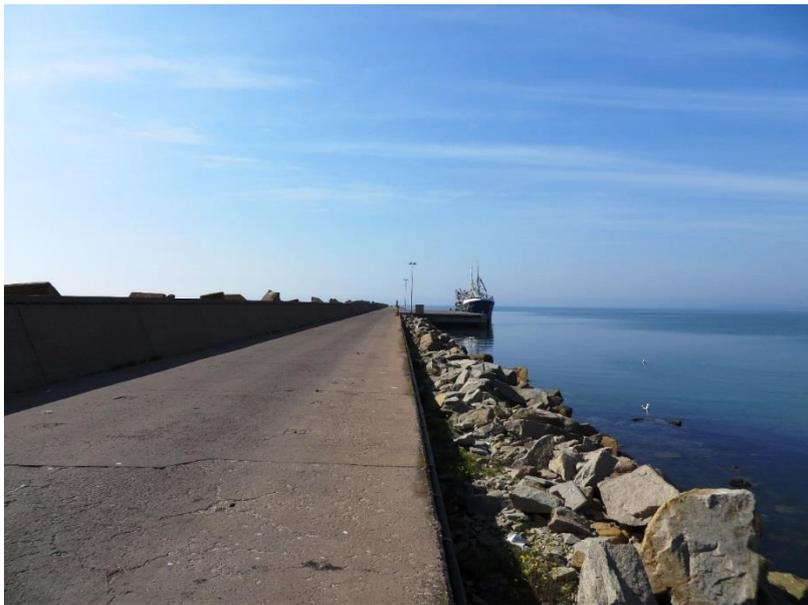
In general, the main breakwater is in good condition (including the concrete structural elements, concrete causeway/deck, concrete crest wall and the outer armour units). However, beyond the 'Coastal Quay' there is evidence that the concrete deck has deteriorated somewhat and may, at some stage, require remedial works – primarily patch repairs. This could be attributed to higher exposure of the deeper section to waves and potential overtopping.

Figure 2: St Helena Bay Harbour main breakwater (eastern face)

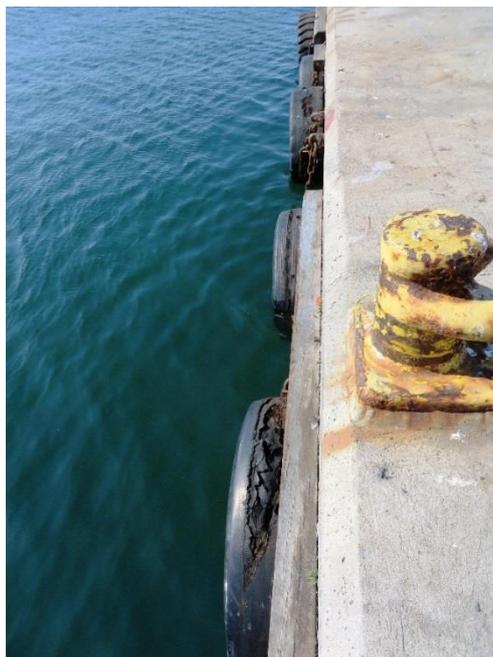
The fendering system, comprising tyres, chain supports and fastening, requires a general service. Approximately 8 tyre fenders need to be replaced. The bollards along the jetty require cleaning and repainting.

Figure 7: Damaged tyre fenders along Jetty 1

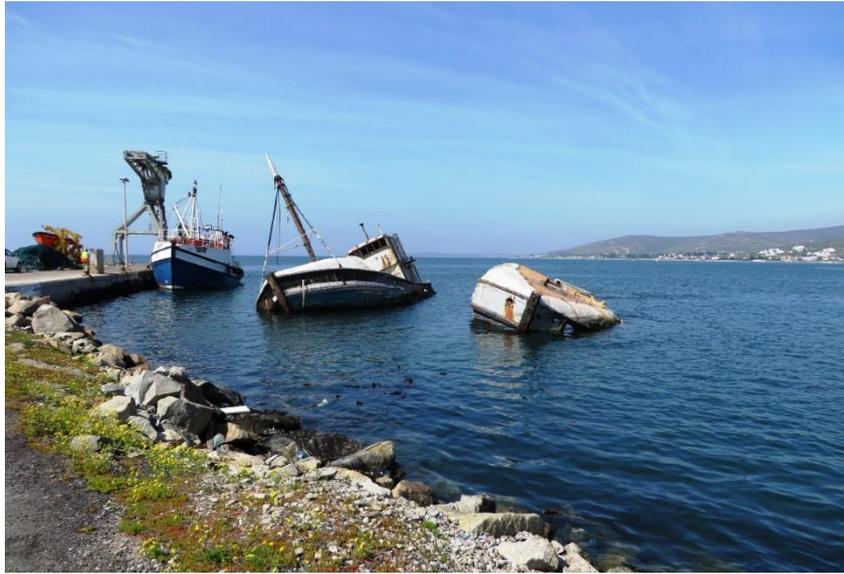
Figure 8: Sunken vessels alongside Jetty 2

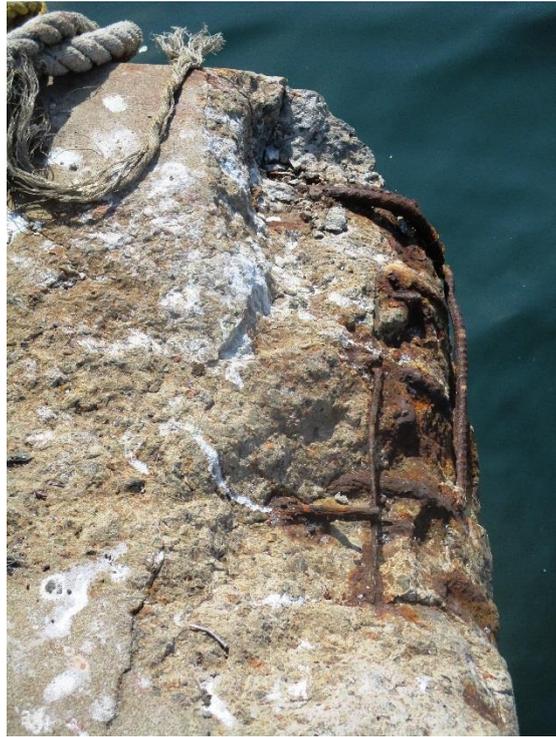
The concrete jetty structure is generally in good condition. It was noted that at the head of the jetty, along the slipway face, the corner has been damaged, presumably by impact from vessels entering the slipway, and requires repair.

Figure 9: Exposed reinforcement at NE corner of Jetty 2

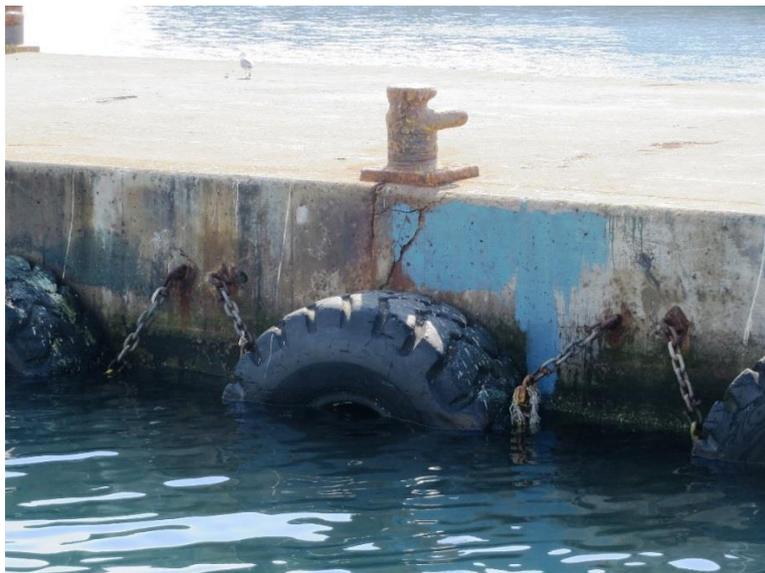
The concrete jetty structure is generally in good condition. However, it was noted that there is a crack below one of the bollards near the head of the jetty, which will require repair. A general service of the tyre fenders, chain supports and fastening is required. The bollards along the jetty require cleaning and repainting.

Figure 11: Crack below steel bollard on Jetty 3

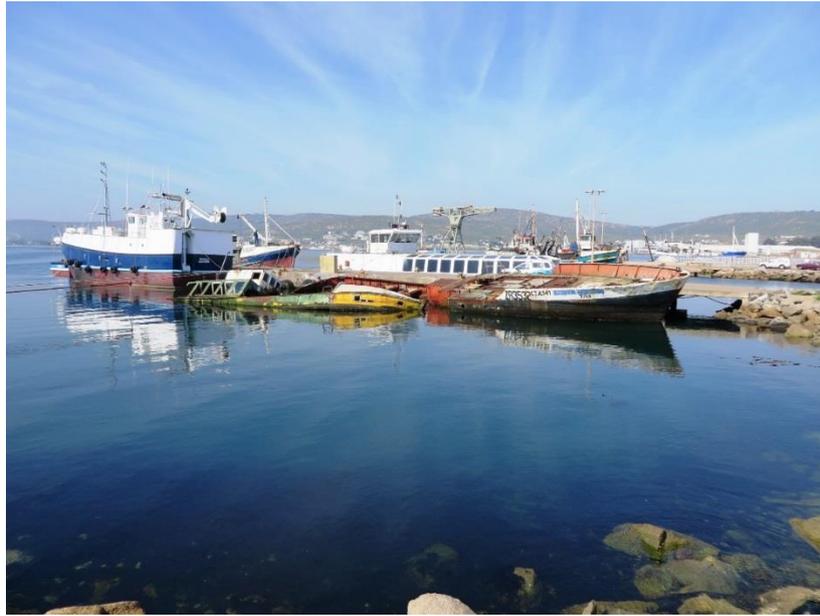
Figure 12: Sunken vessels alongside Jetty 4

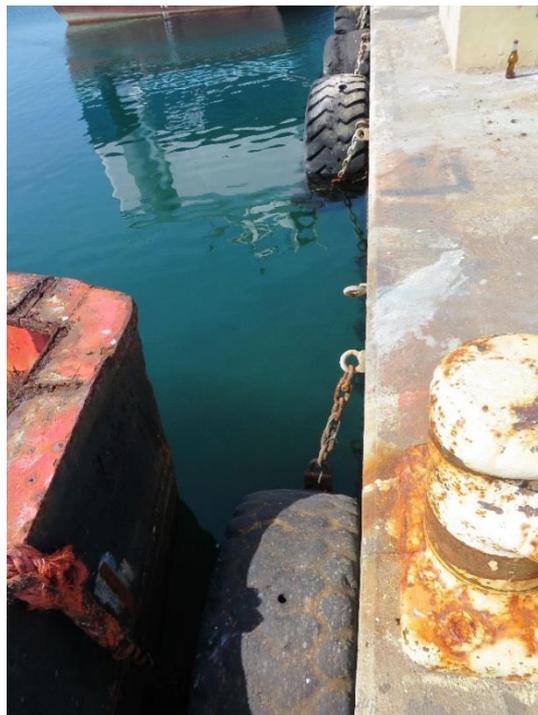
The concrete jetty structure is generally in good condition. However, there are approximately 3 tyre fenders missing along the northern face of the jetty and one fender needs to be replaced on the eastern face. Apart from replacement of the missing and damaged fenders a general service of the tyre fenders, chain supports and fastenings is required. The bollards along the jetty require cleaning and repainting.

Figure 13: Missing tyre fender at Jetty 4

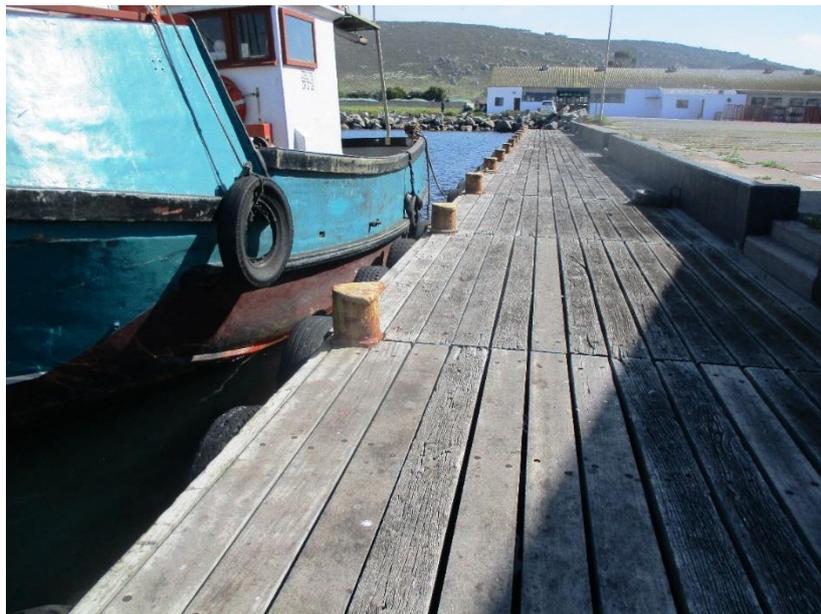
Timber Quay 1 shows evidence of deterioration of the timber deck with the majority of the deck panels needing replacement. The condition of the supporting reinforced concrete piles are still to be ascertained as it requires an inspection by divers.

Figure 15: Degraded wooden deck and rusted bollards at Timber Quay 1

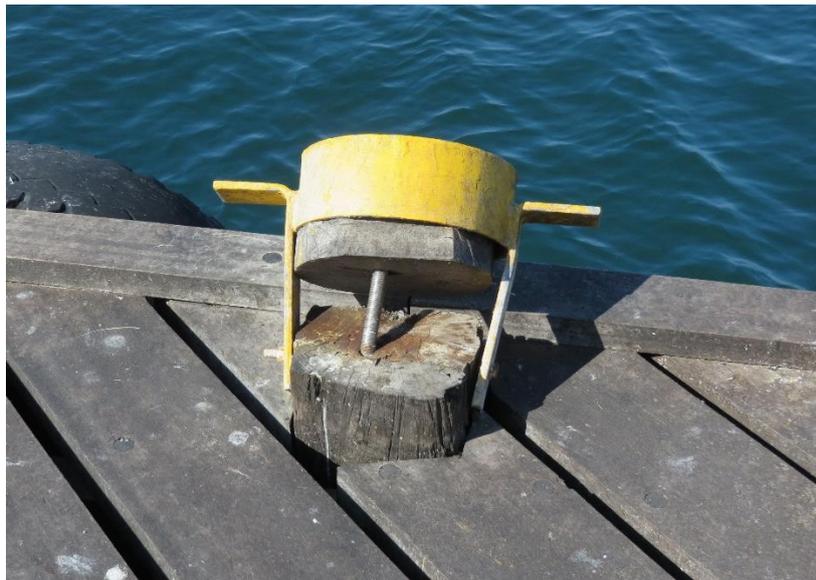
Timber Quay 2 has recently been refurbished and is in good condition. It was noted that two tyre fenders are missing whilst one of the bollards requires repair. Apart from the repair needs, the bollards along the jetty require cleaning and repainting.

Figure 17: Damaged bollard

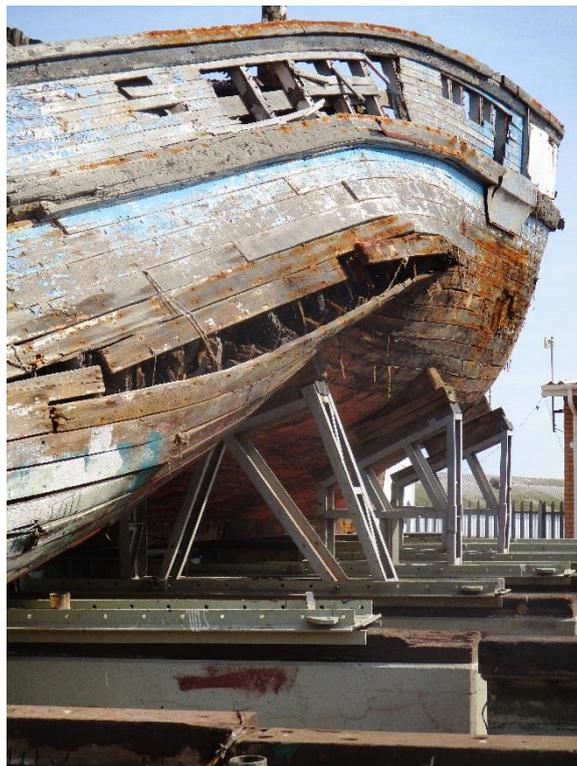
The main repair slipway is located between Jetties 2 and 3. The slipway layup area has capacity to accommodate 4 vessels at a time. However, the presence of an abandoned wreck, which has been lying at the SE repair bay for approximately 13 years (according to the harbour staff), has reduced this capacity to 3. The existing cradle/lift is said to work adequately with no issues raised or identified pertaining to the rail system. However, the use of divers to investigate the portion of the rail below the low water mark is recommended.

Figure 22: Wrecked vessel on the SE repair bay

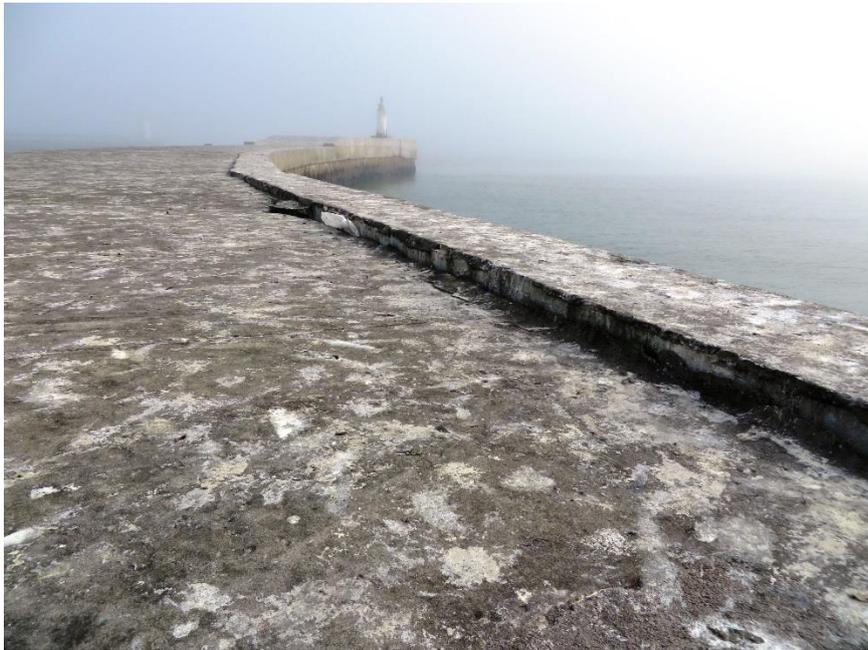
Along the eastern breakwater, which was constructed in the late 1960's / early 1970's, there is evidence that the concrete sheet pile wall sections have separated at certain locations. This has resulted in significant loss of sand fill from the breakwater. In turn, this has led to the surface bed concrete slabs settling and severe distress is now evident in many places. Cracking and spalling of

**Figure 26: Eastern breakwater and evidence of concrete deck settlement**

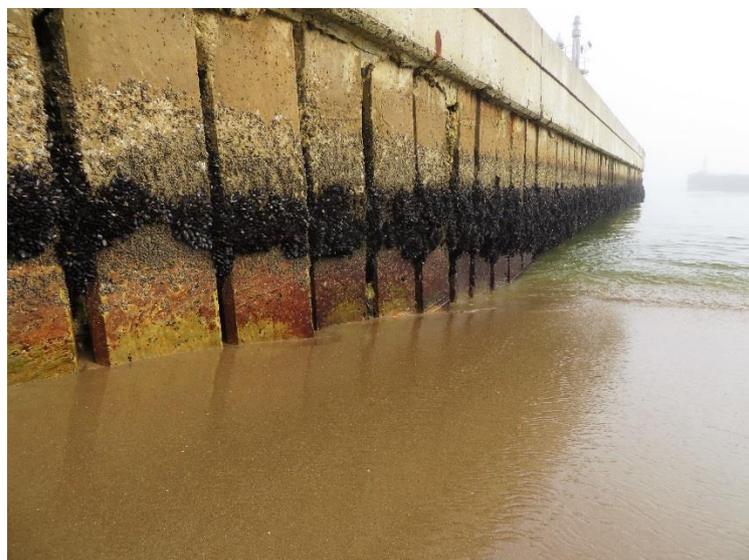
Figure 29: Separated and misaligned sheet pile walls

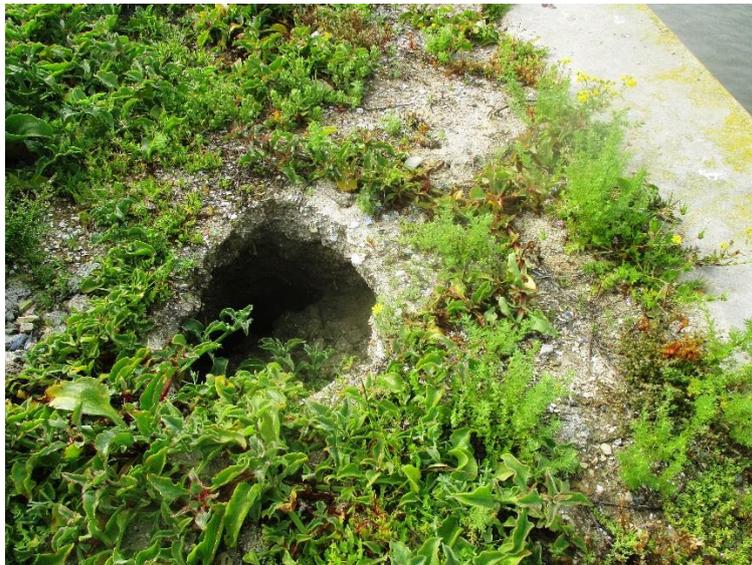
The middle training wall, which extends from the middle breakwater and along the Berg River to the Laaiplek Harbour boat launch ramp, was also constructed with the use of concrete sheet piles. At certain sections along the wall the sheet piles have separated, once again resulting in sand fill being lost from behind the wall. As a result, sinkholes/cavities have formed behind the training wall. In an attempt to remediate this, evidence suggests that ground anchors were installed to tie back the walls and concrete was placed behind the walls to fill in the gaps in the sheet pile wall. In some areas it is apparent that sand fill is still being lost.

Figure 31: Sink hole alongside middle training wall

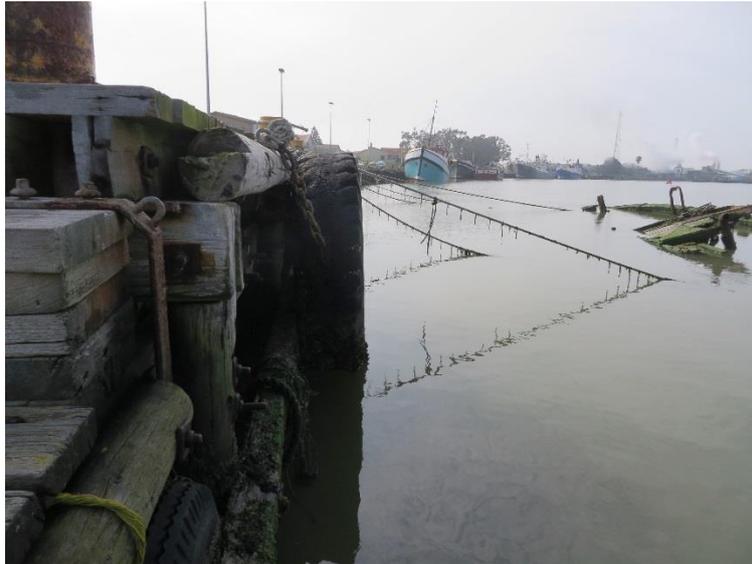
Figure 36: Tyre fender and sunken vessel at the western end of the quay

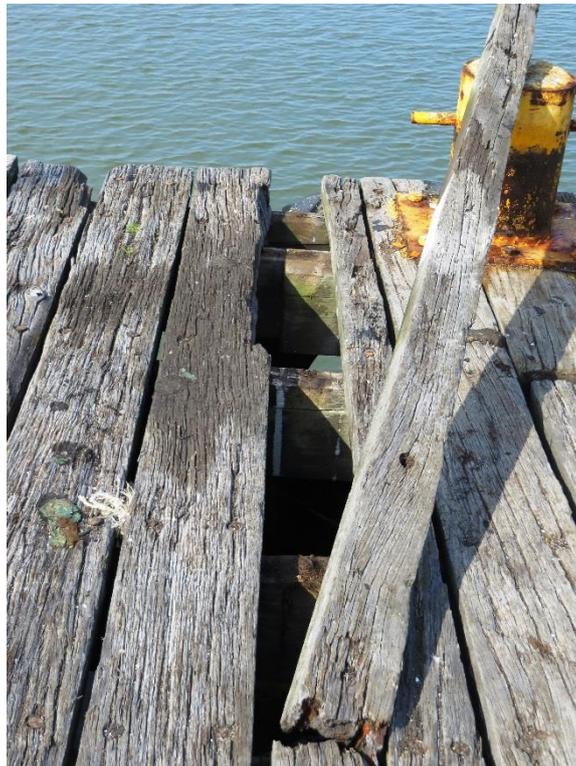
The entire timber deck is in a relatively poor condition, as may be expected due to the minimal maintenance done on it since its construction in the 1960's/70's. A number of the timber deck panels are loose and rotten. The piling will require further investigation by divers to determine the condition of these elements.

Figure 37: Broken timber deck panel on the quay

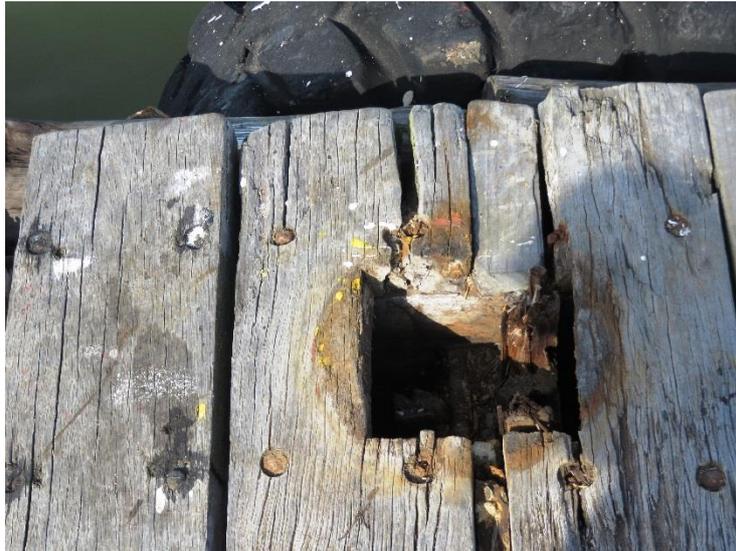
Figure 38: Missing bollard on timber quay

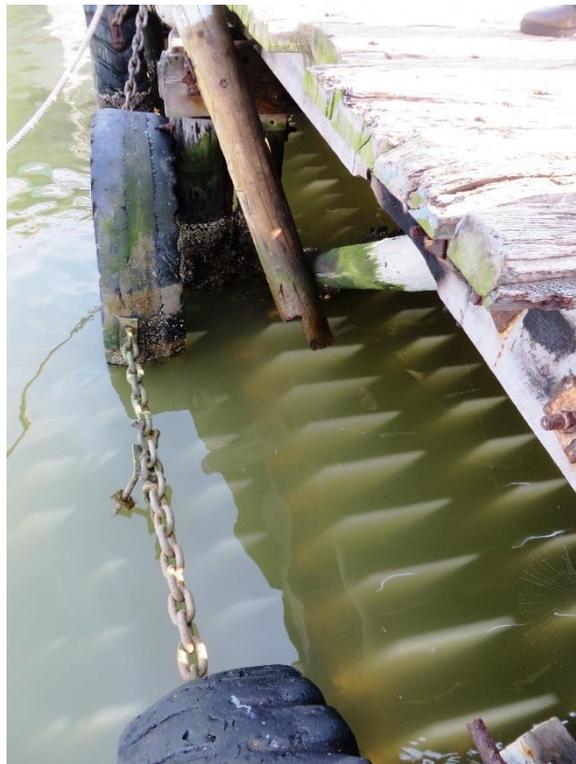
Currently the majority of the tyre fenders along the quay require replacement and/or significant maintenance. In the order of 65 to 75% of the fenders require replacement. As for the rest, a general service of the tyre fenders, chain supports and fastening is required. All the bollards require cleaning and painting whilst roughly 10 to 15% require replacement.

Figure 39: Damaged fender support on timber quay

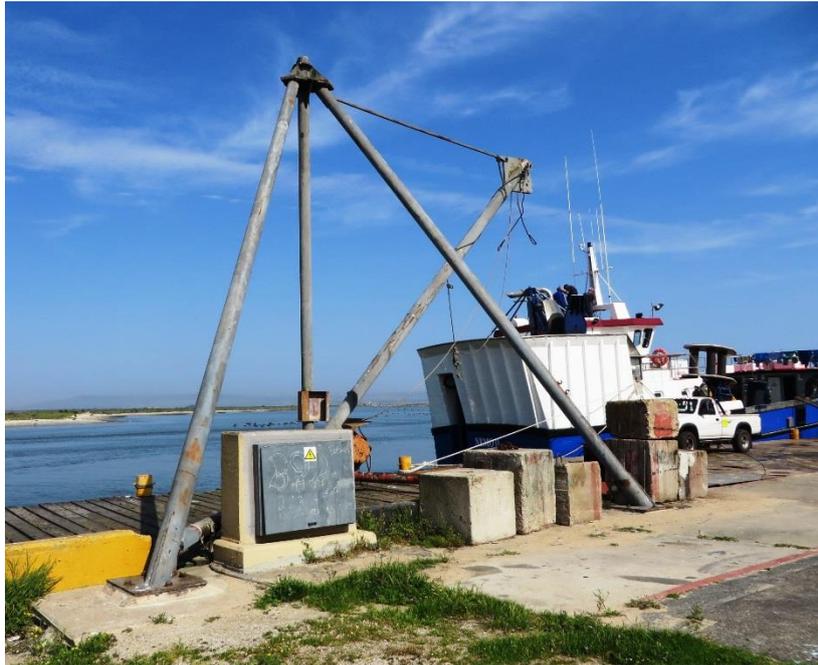
Laaiplek Harbour has a fixed shear-leg crane at the eastern end of the quay. Currently, it is out of order and in poor condition, most likely requiring replacement. Alongside the crane is a makeshift loading area constructed out of steel plates placed on top of the timber deck. It was raised that a better arrangement would be beneficial, possibly formalising this setup with a concrete deck and loading/unloading area.

**Figure 40: Broken shear-leg crane on eastern end of timber quay**

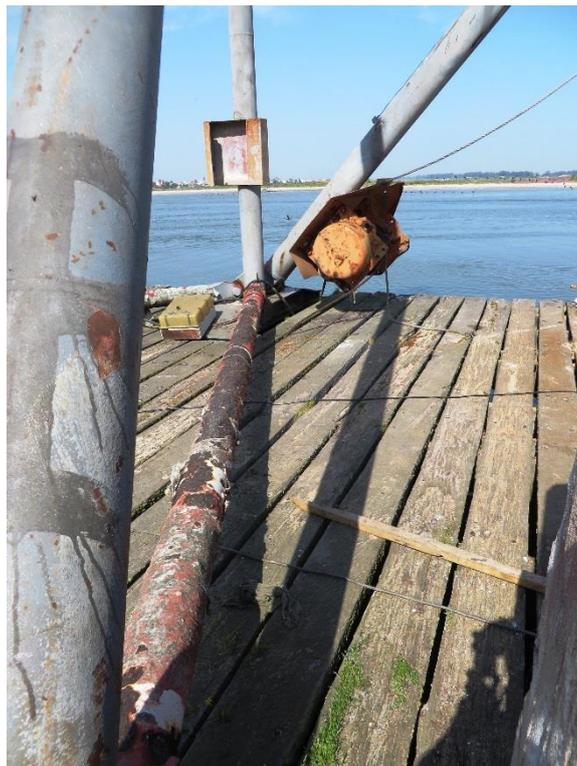
**Figure 41: Rusted crane support and broken winch system**

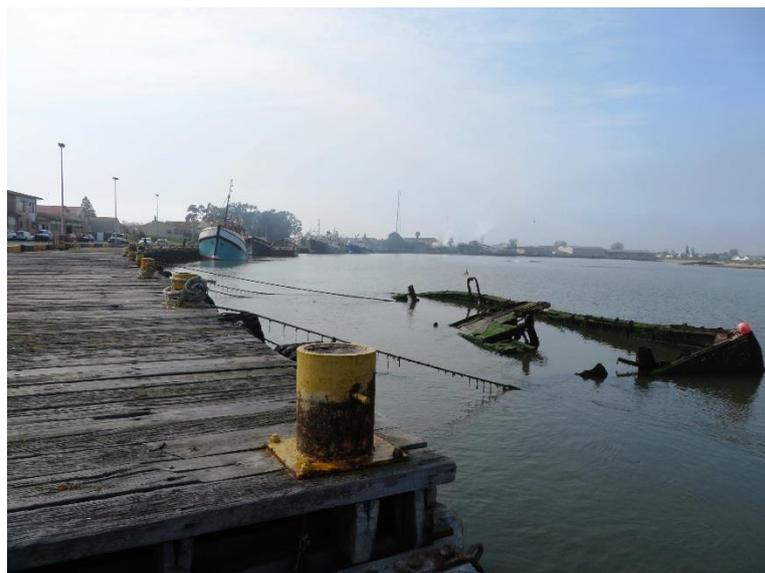
There are two sunken vessels along the timber quay, one at either end of the quay. It is unknown whether the contents of the vessel tanks have been emptied or not.

Figure 43: Sunken vessel at the western end of the timber quay

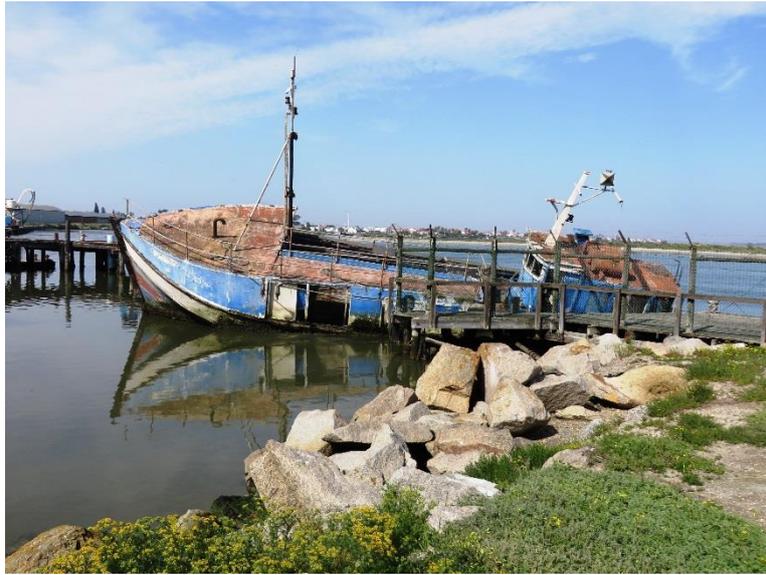
Figure 44: Sunken vessel at the eastern end of the quay

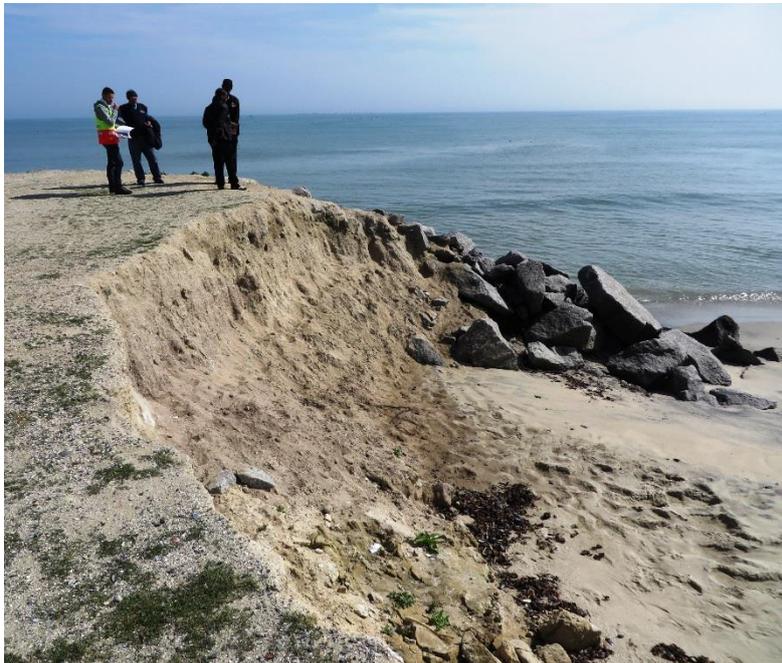
Within the harbour limits, on the Hangbos side, there is significant evidence of coastal erosion at the eastern end of the rock revetment. According to the harbour officials the coastal erosion has been exaggerated over the last 2 years.

Figure 45: Coastal erosion adjacent to the rock revetment

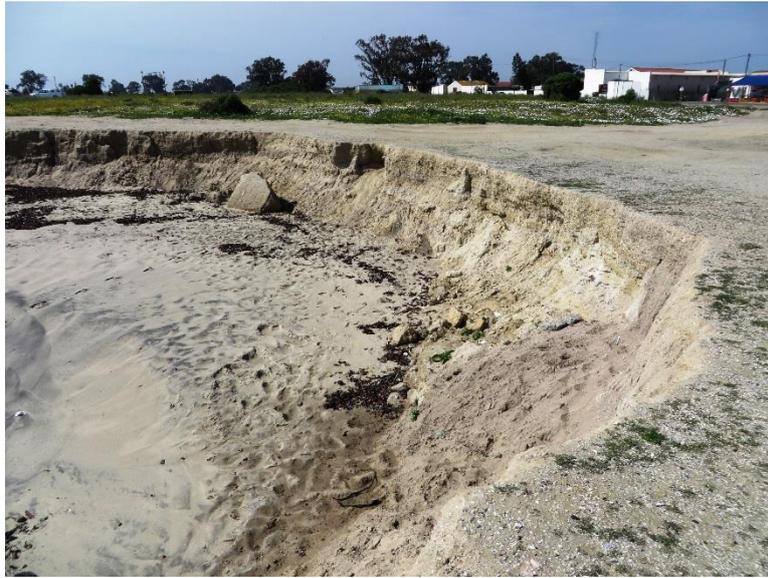
Figure 46: Eroded area behind the rock revetment

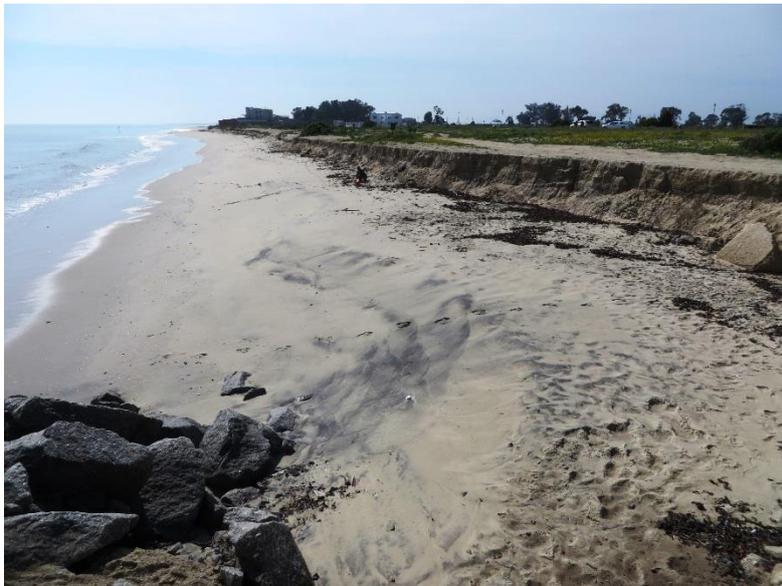
Figure 47: Beach being impacted and eroded downstream of the revetment

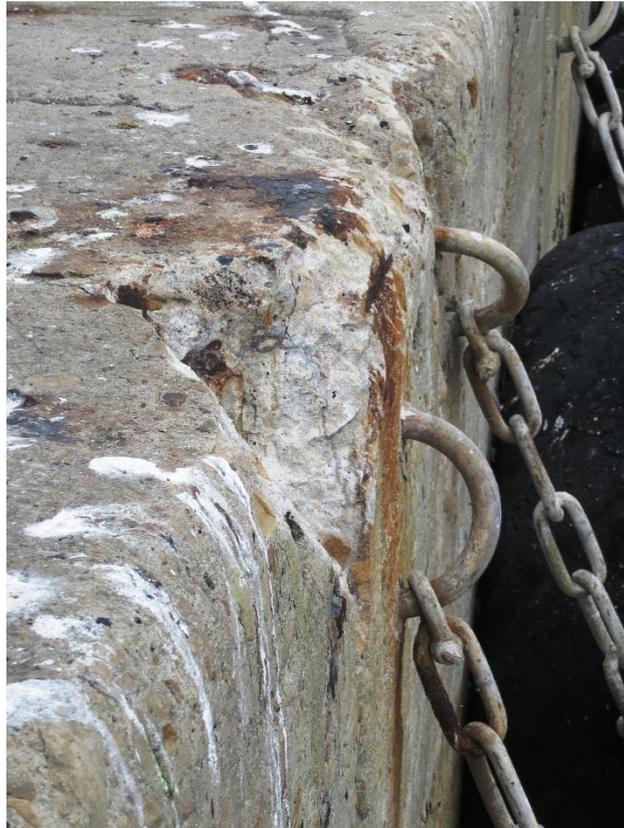
Figure 55: General wear and tear of the coping on the main quay

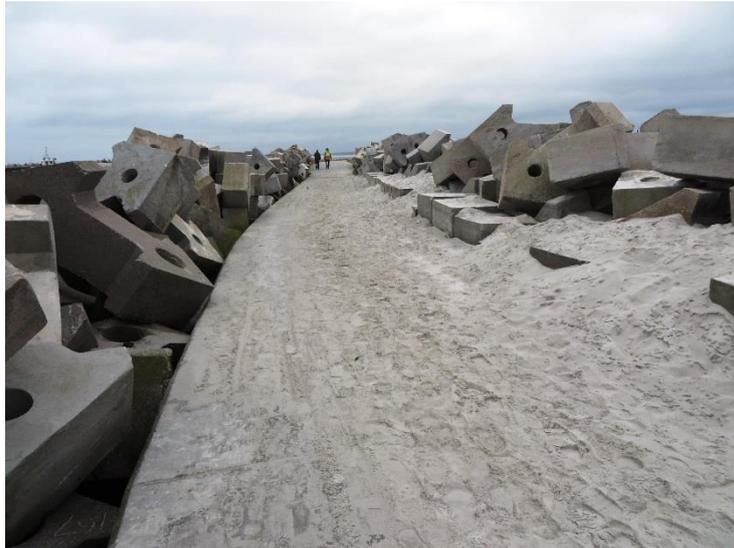
The eastern breakwater structure is in good condition with the navigation aid at the head of the breakwater being fully functional. It was noted that there is a large amount of windblown sand which has accumulated alongside as well as on the breakwater structure, due to north / north-easterly winds.

Figure 61: Windblown sand accumulated on the eastern breakwater

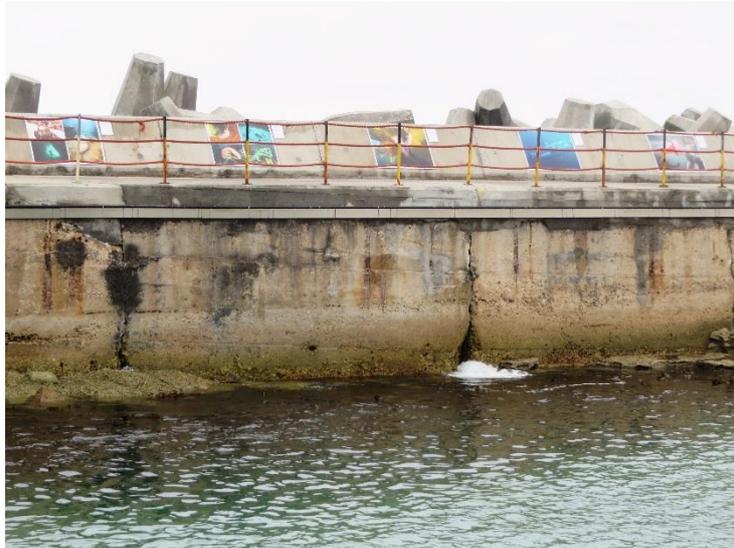
Of major concern is the evidence of water penetrating through the breakwater structure into the harbour basin. This is apparent at a number of the structure's joints (between interlocking breakwater gravity structures) where the grout membrane has been damaged or completely removed. Over the years the wave action has widened the joints by eroding the concrete structure. This has created a passage through which water and sediment can penetrate the breakwater and enter into the harbour basin.

Figure 63: Water penetrating through a crack in the southern breakwater

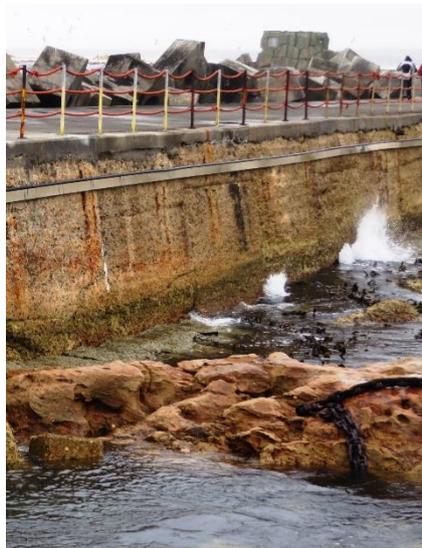
Figure 64: Evidence of water penetrating through the southern breakwater structure

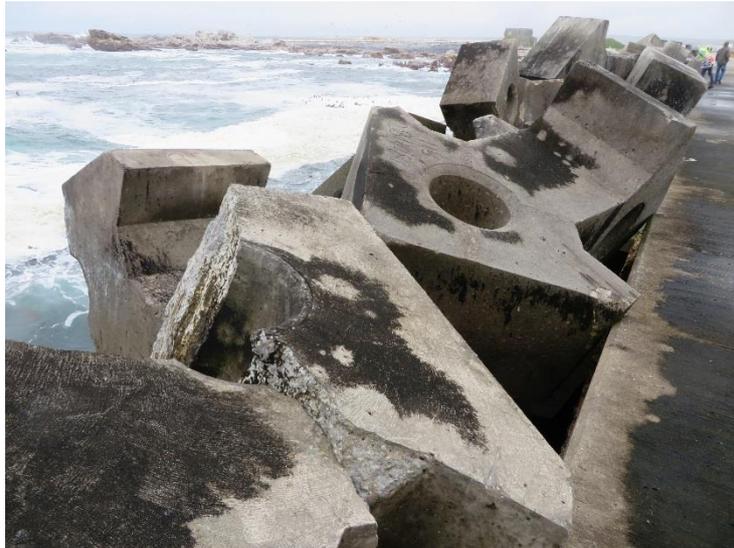
The southern breakwater experiences regular overtopping, especially during high tide and significant swell conditions. This is evident by the pooling of water at certain locations on the concrete deck and degradation of the concrete surface. There is also numerous examples of broken concrete armour units which suggests that the units used may be too small.

Figure 65: Broken concrete armour units along the southern breakwater

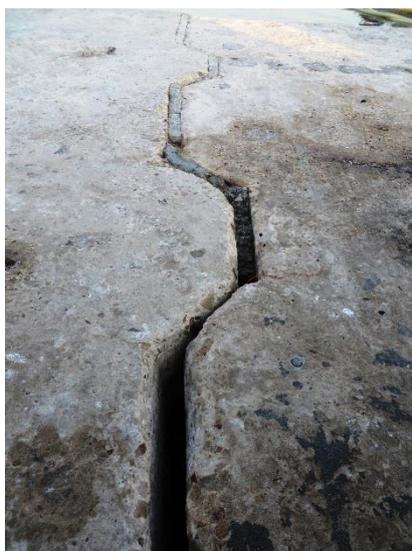
Figure 69: Evidence of previous grouting repairs in the western breakwater joints

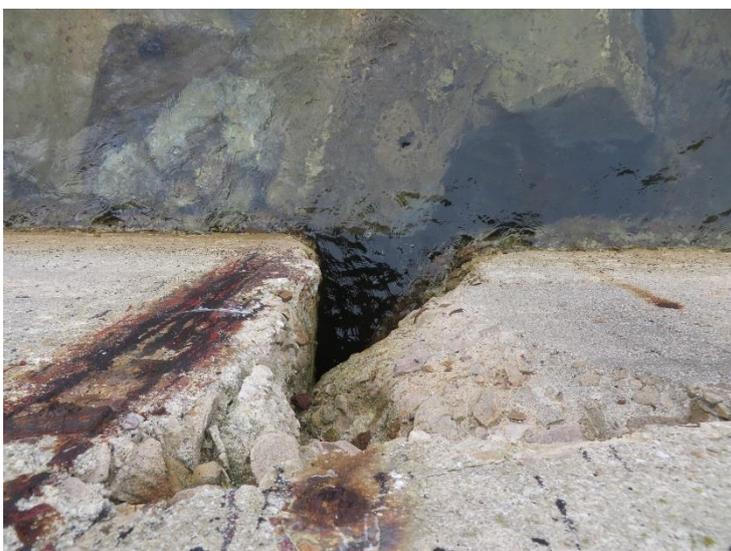
Figure 70: Water penetrating through crack in western breakwater structure  
(looking down the inner face of the breakwater towards the water)

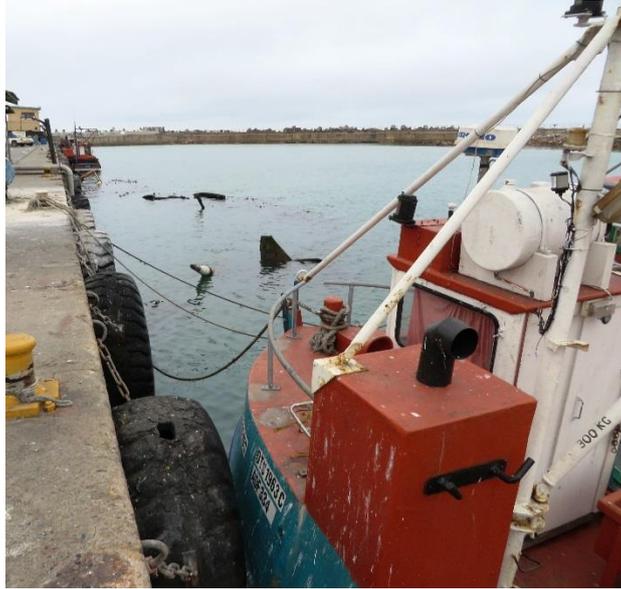
Currently, there are two sunken vessels located along main quay with one of these vessels having broken into two parts. It is currently unknown if the vessels still contain any diesel or other possible contaminants in their tanks.

Figure 78: Two sunken vessels along main quay

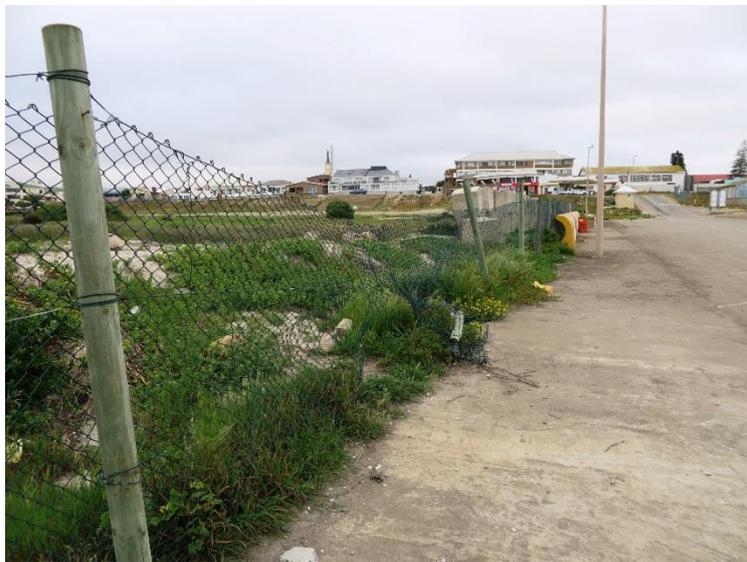
Figure 80: Damaged perimeter fence along the parking area behind Snoek Quay

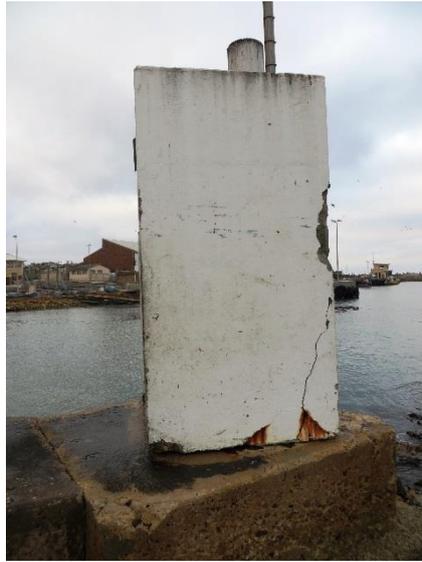
- The navigation aid, also referred to as the “Lighthouse” structure at the southern end of Snoek Quay has been displaced off its plinth foundation. It is significantly damaged and requires repairs.
- Revetment – the revetment in front of Isabella’s Restaurant (between main and secondary quay) requires repairs. It is evident that, although rubble is being dumped on this revetment, there is continued erosion of the slope, which will lead to the undermining of the adjacent roadway. This will significantly hamper access to main quay and create a safety hazard.

**Figure 81: Damaged navigation aid (a.k.a. Lighthouse)**

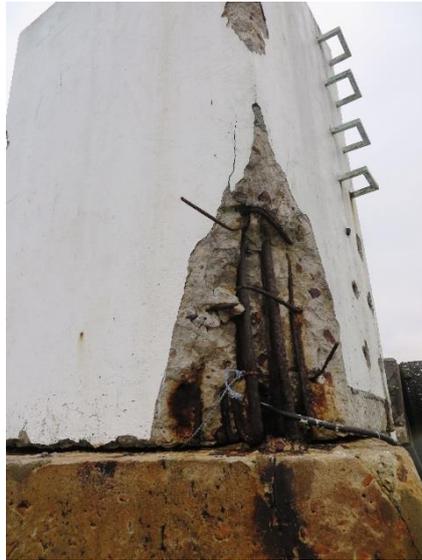
**Figure 82: Exposed reinforcement of navigation aid support structure**

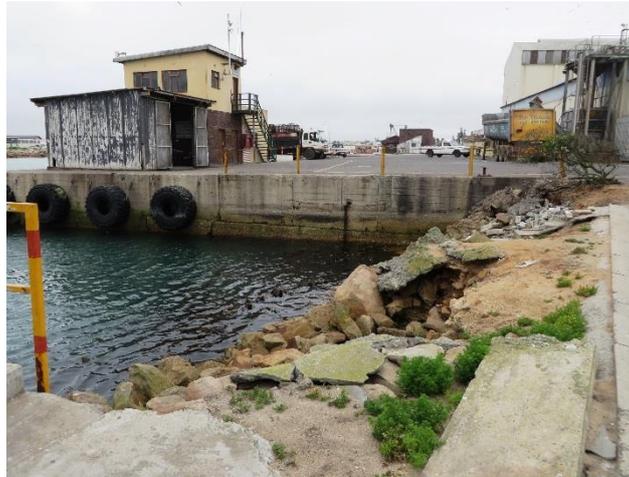
Figure 84: Evidence of the rubble revetment deteriorating
