RESTORATION OF BILLIARD ROOM AT 258 WAKESLEIGH ROAD BELLAIR

REPORT ON STRUCTURAL DEFECTS AND RECOMMENDATIONS FOR REMEDIAL WORK

JOB TITLE
RESTORATION OF EXISTING RESIDENCE AND
OUTBUILDINGS - 258 WAKESLEIGH ROAD BELLAR
BILIARD ROOM - MAIN ROOF TIMBERS LAYOUT
& CONDITION OF TIMBERS

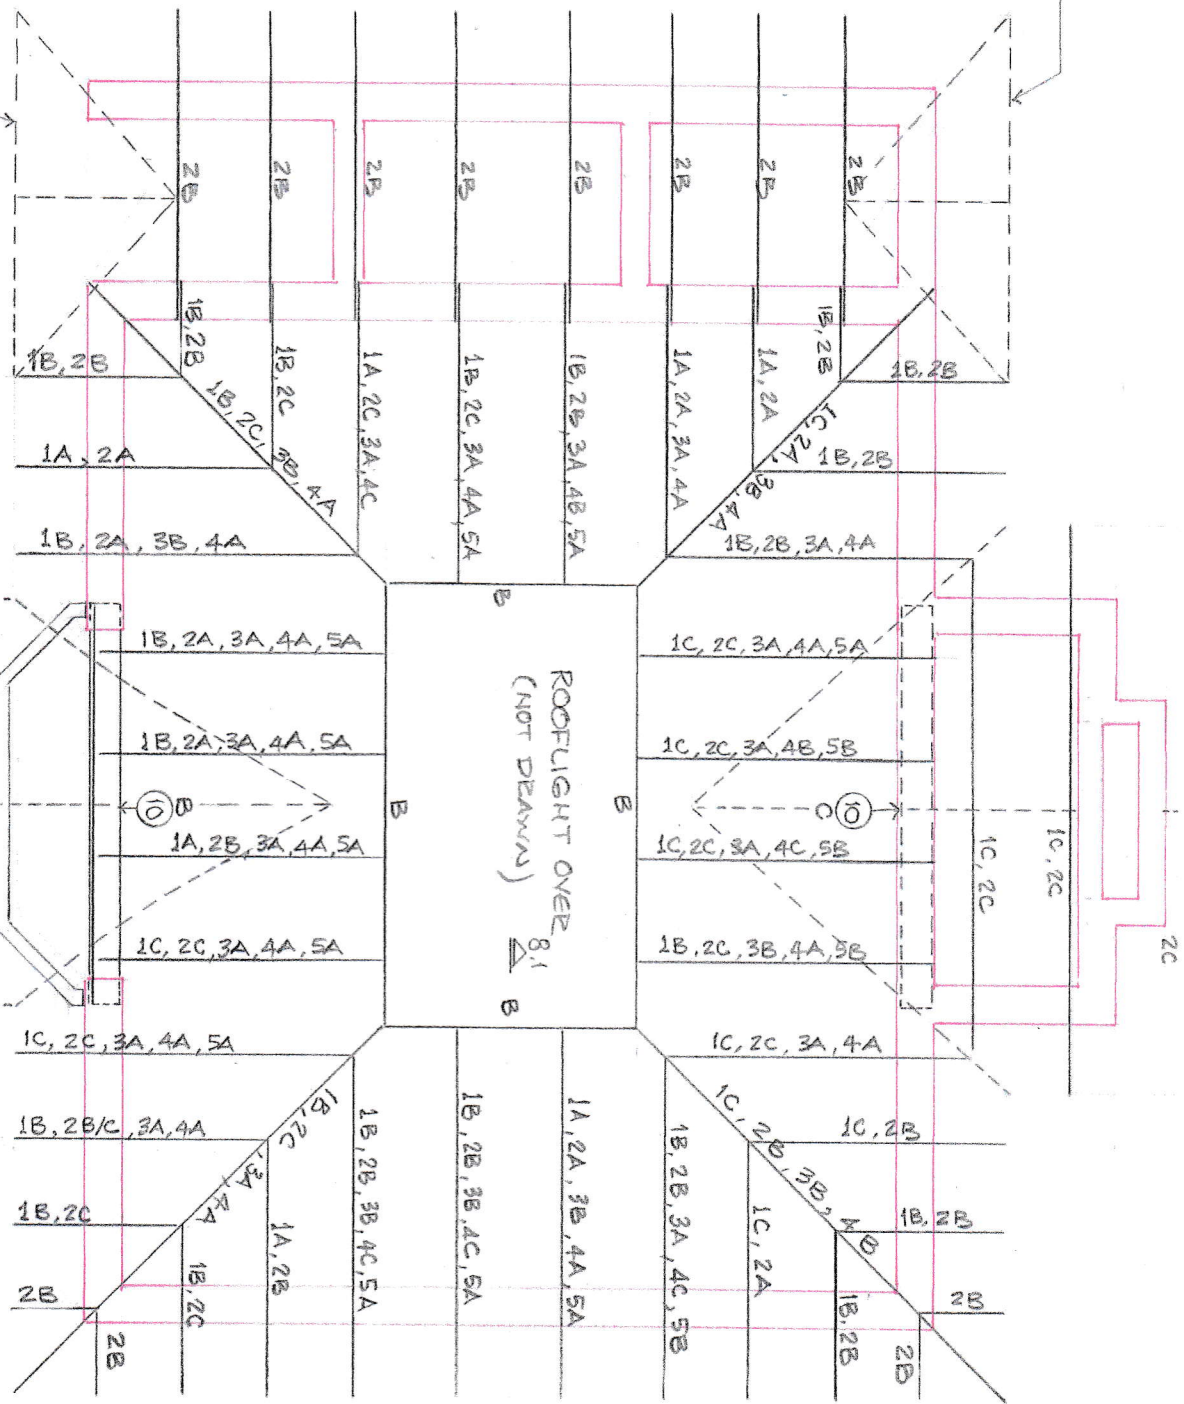
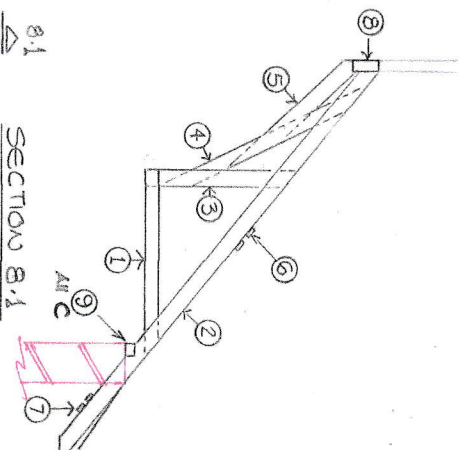
8.1
SECTION 8.1
MEMBER SIZES:-

A high percentage of the roof timbers have been damaged by a combination of termite/borer infestation and wet and dry rot . The roof was opened up in 2014/2015 in preparation for restoration of the then damaged timbers but was never effectively protected once the restoration project was abandoned . As a result the roof and ceilings have been open to the weather the condition of many of the timbers and ceilings has deteriorated significantly since 2014/2015. The uncoated steel mesh reinforcing to the plastered ceilings and bulkheads has also corroded and failed in many areas resulting in the collapse of the majority of the ceilings and bulkheads .

CANOPY ROOF.
ALL TIMBERS
CONDITION B.

CANOPY ROOF, ALL
TIMBERS CONDITION B.

- ① 150 x 75
- ② 150 x 75
- ③ 150 x 75
- ④ 108 x 75
- ⑤ 150 x 50 (SHAPED)
- ⑥ 75 x 32 SHINGLE BATTENS AT 150 W/C + MOSTLY A.
- ⑦ 50 x 20 EAVES CLOSURE BATTENS AT 75 W/C. 50% B, 50% C
- ⑧ 225 x 75 ROOFLIGHT RING BEAM, CONDITION B.
- ⑨ 108 x 75 WALL PLATES, ALL C
- ⑩ 220 D x 310 W TIMBER BEAMS

CONDITION OF TIMBERS
A = PERIPHERAL DAMAGE - REUSABLE
B = LOSS OF STRUCTURAL CAPACITY TO BE INVESTIGATED
C = SEVERE BORE/TERMINAL DAMAGE. REPLACE.

TIMBER FRAMED BAY WINDOW
SUPPORTS DORMER ROOF & TIMBER/EXPANDED METAL/PLASTER GABLE.

DORMER ROOF.
50% TIMBERS CONDITION B,
50% TIMBERS CONDITION C

A new system of supporting steel beams and stabilizing bracing is to be introduced into the roof , the former before the damaged timbers , as identified in schedule RR/8 , are progressively replaced . The new steel beams and bracings are detailed on drawings SS/BR1 , SS/BR2 and SS/BR3 . Before the steelwork is introduced , and to facilitate the erection of same , the entire floor area of the main roof , bay window and fireplace alcove is to be scaffold with a working platform at a level of +- 1200 mm below the level of the underside of the ceiling rafters . The scaffold platform is to step up to nominally 1000mm below the bulkheads encasing the roof timbers passing east /west through the roof light area . THE EXISTING GUMPOLE SUPPORT SYSTEM IS TO REMAIN IN PLACE . The gumpole props are to be progressively wedged up during the jacking of the steel beams so that the north /south timber support beams to the rooflight east/west bulkheads through the rooflight zone remain fully supportive of the rooflight and bulkheads .

The damaged roof timbers and wallplates are to be progressively replaced (see wallplate detail on RR/9) after the steel beam support jacks have been concreted in .The contractor is to agree a method and sequence for the replacement of damaged timbers with the Engineer before replacement commences (complete 5 member rafter assemblies from opposite sides of the roof light are to be extracted from the roof and each is to be used as a pattern for the replacement timbers to the opposing pair of 5 member assemblies) . The replacement timbers are to be treated Oregon Pine of a size and shape to match the existing . The joint types are to match the existing and where possible the existing bolts are to be extracted , de-rusted and reused provided there is no significant loss of cross section due to corrosion .

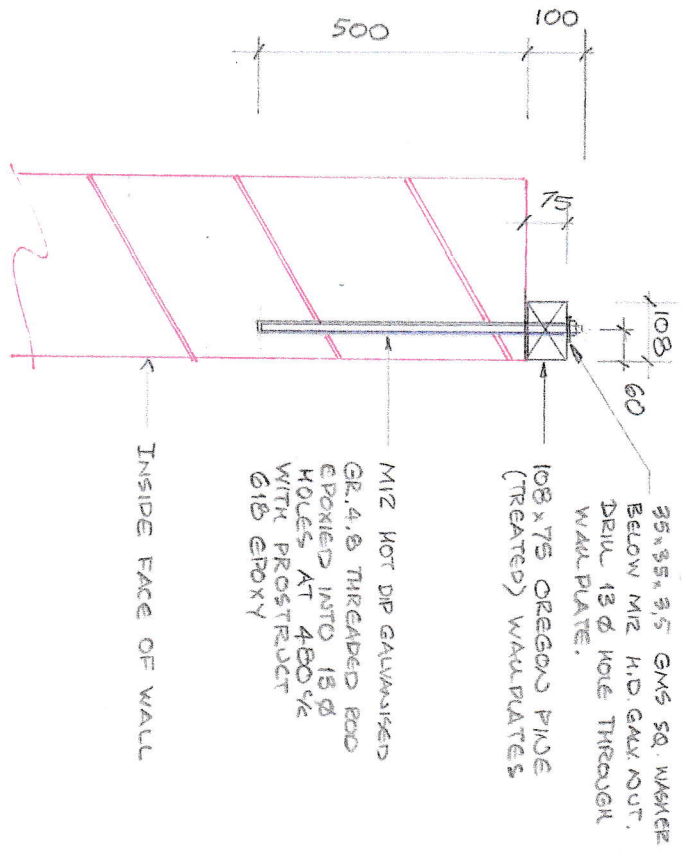
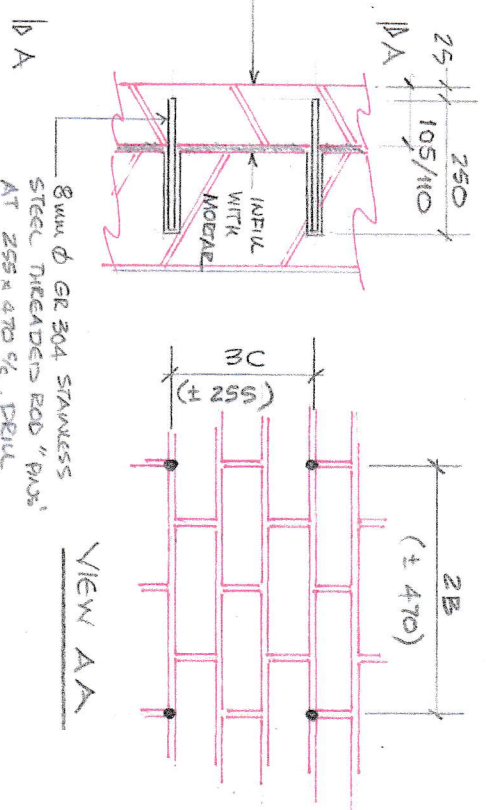
REPLACEMENT OF "FACE" BRICKS

There is evidence widespread rising damp in the walls . The damp has resulted in the deterioration of the bricks and the crumbling/raveling of the face of the bricks . This deterioration of the face is probably the reason for the east wall having been plastered up to the bay window cill level at some time since the building was originally constructed . Many areas of the roof above the walls have been open to the weather for 8 years and rainwater wetting of the brickwork has contributed to its deterioration .

The damp induced deterioration of the face of at least 70% of the external brickwork requires the affected outer 110 skin of brickwork to be removed and replaced with matching bricks . The replacement bricks skin is to be pinned to the balance of the wall according to the detail given on schedule RR/9 . Consideration should be given to removing the external plaster previously applied to the east elevation (north and south of the bay window) and replacing the outer skin of brickwork as referred to above .

NEW "FACE" BRICKS
 TO REPLACE EXISTING
 THAT HAVE CRUMBLED/
 WEATHERED, PATTERNS
 & JOINTING TO MATCH
 EXISTING.
 CLASS II CEMENT/LIME
 MORTAR
