Lindsay Napier architect

LANapier PrArch PGDip MIA P.O.Box 474 Hillcrest 3650
email :lanapier@mindscope.co.za tel 083 6608521

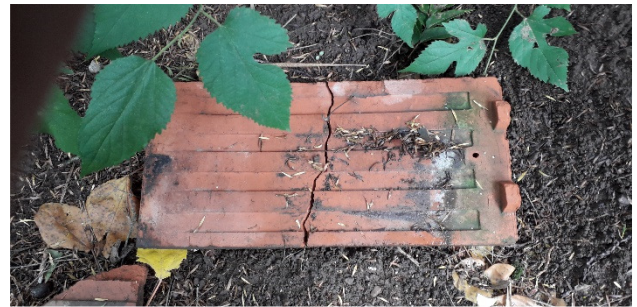
Tiles are to be cleaned and reused, new/ reclaimed matching tiles are available from www.Billmark.co.za. Remove all roof tiles systematically, taking care to cover exposed roof each day. Remove and replace all battens with new 38x38 treated SAPine at approx.150mm centres to match existing. Lichen to be removed from the clay tile by hand, no high-pressure cleaning is allowed. Re-lay tiles, notched over new battens on top of new "Durafoil" , or equal approved insulating underlay.

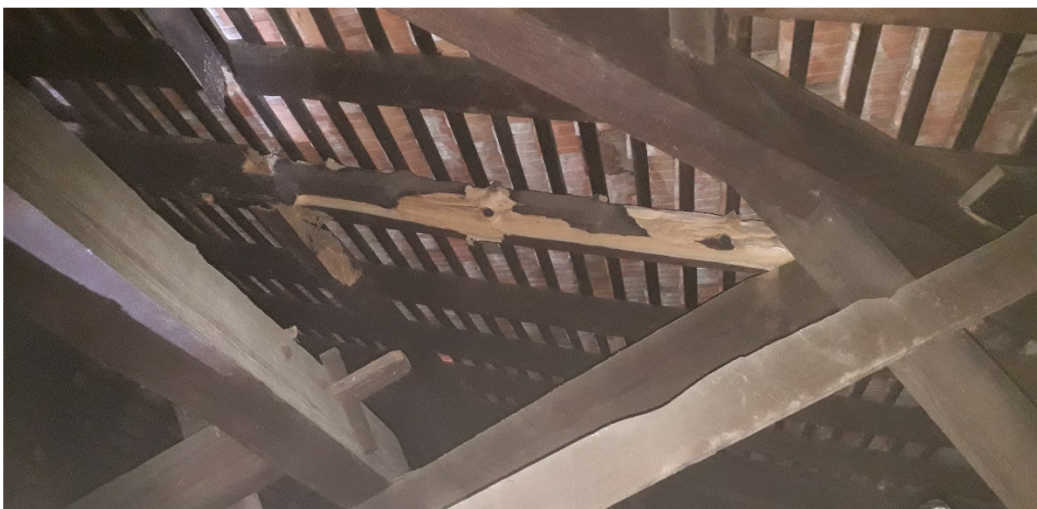
Damaged rafters in the library roof space
