Lindsay Napier architect

22 November 2022

STORM DAMAGE REPAIR AND RESTORATION OF RUSSEL HIGH SCHOOL PIETERMARITZBURG, KZN

149 Hoosen Hafejee St and 130 Boom street.

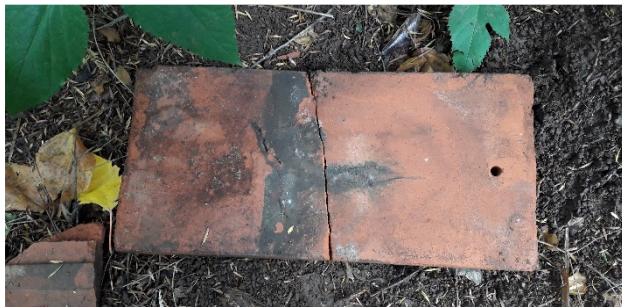
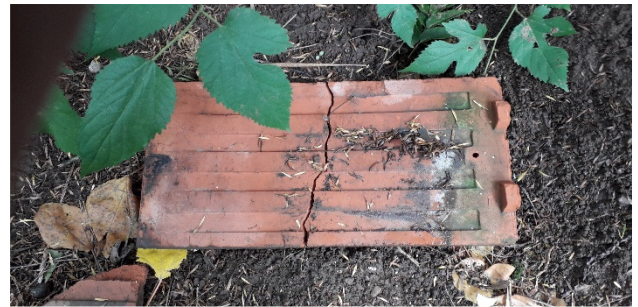
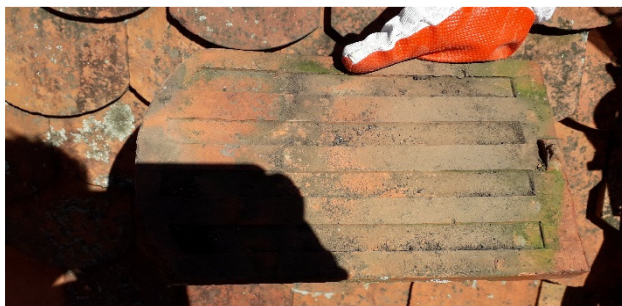
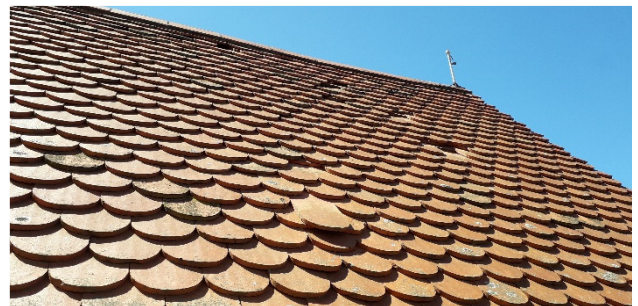
130 BOOM STREET

Existing Broseley round-nose roof tiles occur in two sizes :

Half-round end tile : 360x174mm

Flat curve end-tile : 345x170mm,

Tiles are to be cleaned and reused, new/ reclaimed matching tiles are available from www.Billmark.co.za. Remove all roof tiles systematically, taking care to cover exposed roof each day. Remove and replace all battens with new 38x38 treated SAPine at approx.150mm centres to match existing. Lichen to be removed from the clay tile by hand, no high-pressure cleaning is allowed. Re-lay tiles, notched over new battens on top of new "Durafoil" , or equal approved insulating underlay.

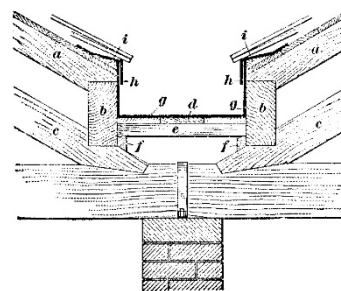
FIG. 68

All repairs are to be made in accordance with the traditional methods of timber construction shown in the typical details below, but with new treated timber. Box gutter conditions at Russell High School are "Side wall gutter" (fig 68 below) and "Central box gutter" (fig 72).

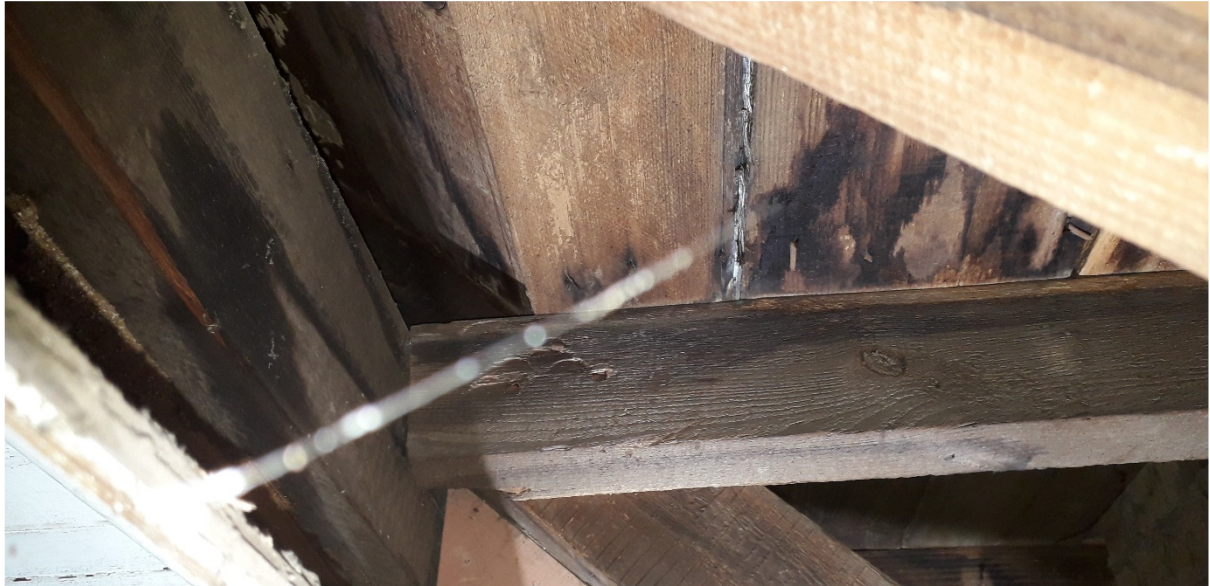
Underside of box gutter above the library

Existing Galvanised Mild Steel linings to box gutters, valleys and flashings are to be lifted and original lead linings to be inspected. The condition of the lead is to be assessed. New lead linings are recommended to replace damaged lead and GMS linings. The timber frames of the box gutters are to be inspected and all rotten timber replaced with treated timber to match existing.

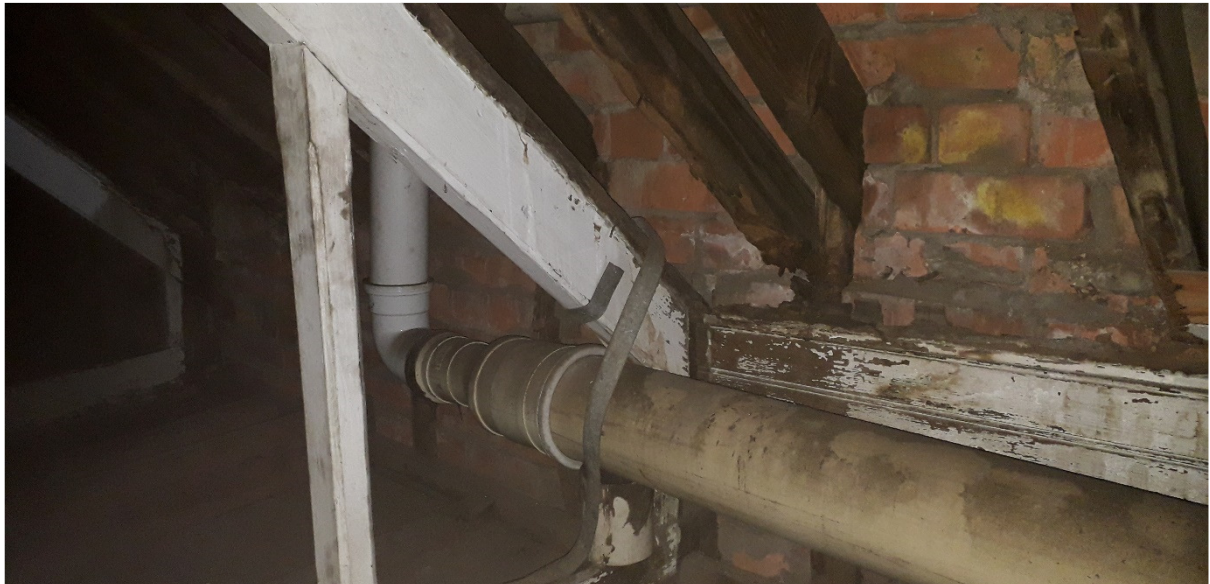
RW pipes in the roof above the library

Replace damaged sections of downpipes to match existing as directed by architect, existing cast iron header boxes and holder bats to be inspected for leaks and sturdiness. Existing inadequate PVC junctions to be replaced with aluminium downpipes sized to match the existing cast-iron downpipes, rubber seals to be used between cast-iron and aluminium. Refer to proposed storm water management system for recommendations for the problem of flooding at ground level. New additional down pipes may be necessary. Downpipes concealed in internal ducts are to be exposed and thoroughly inspected before recommendations are made. Check all down pipes, rain water heads and connections for leaks. Connections to be sealed by specialist.

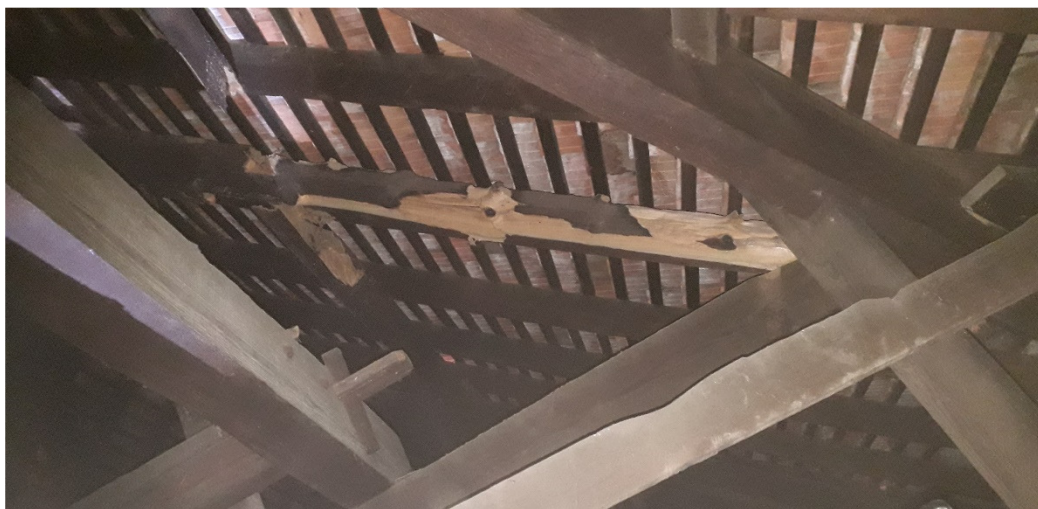
Damaged rafters in the library roof space

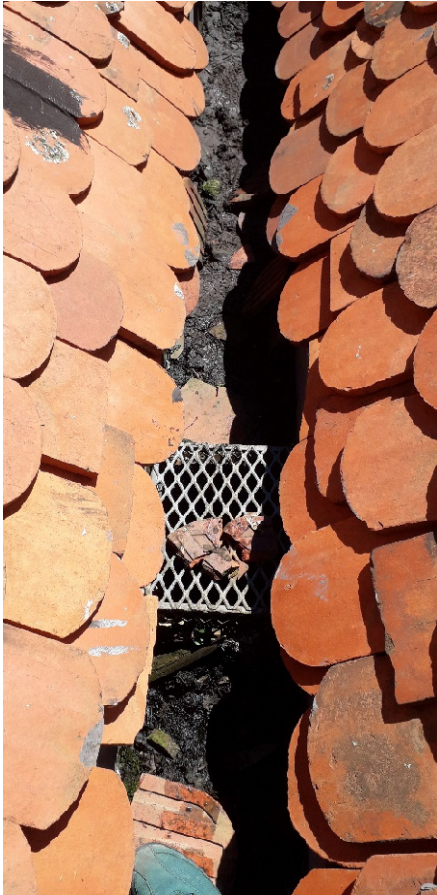
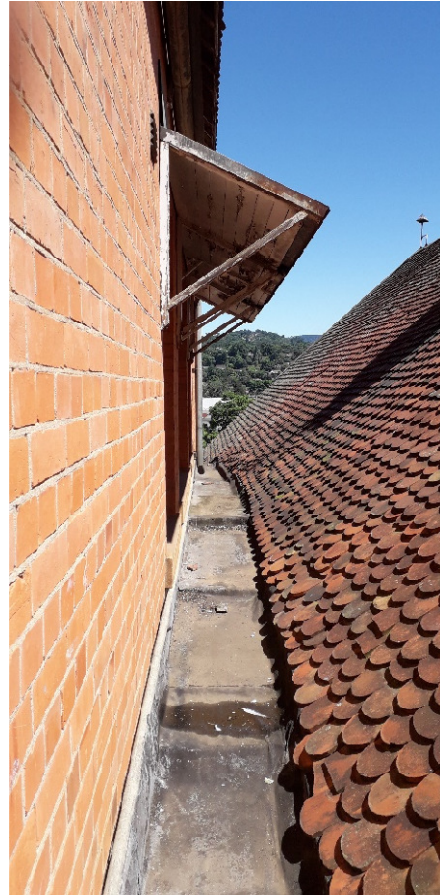
RHS central box gutter and channel above the library
