2012-01-30 RIM REC FAC: OBSERVATIONS AT ALPHA 1.

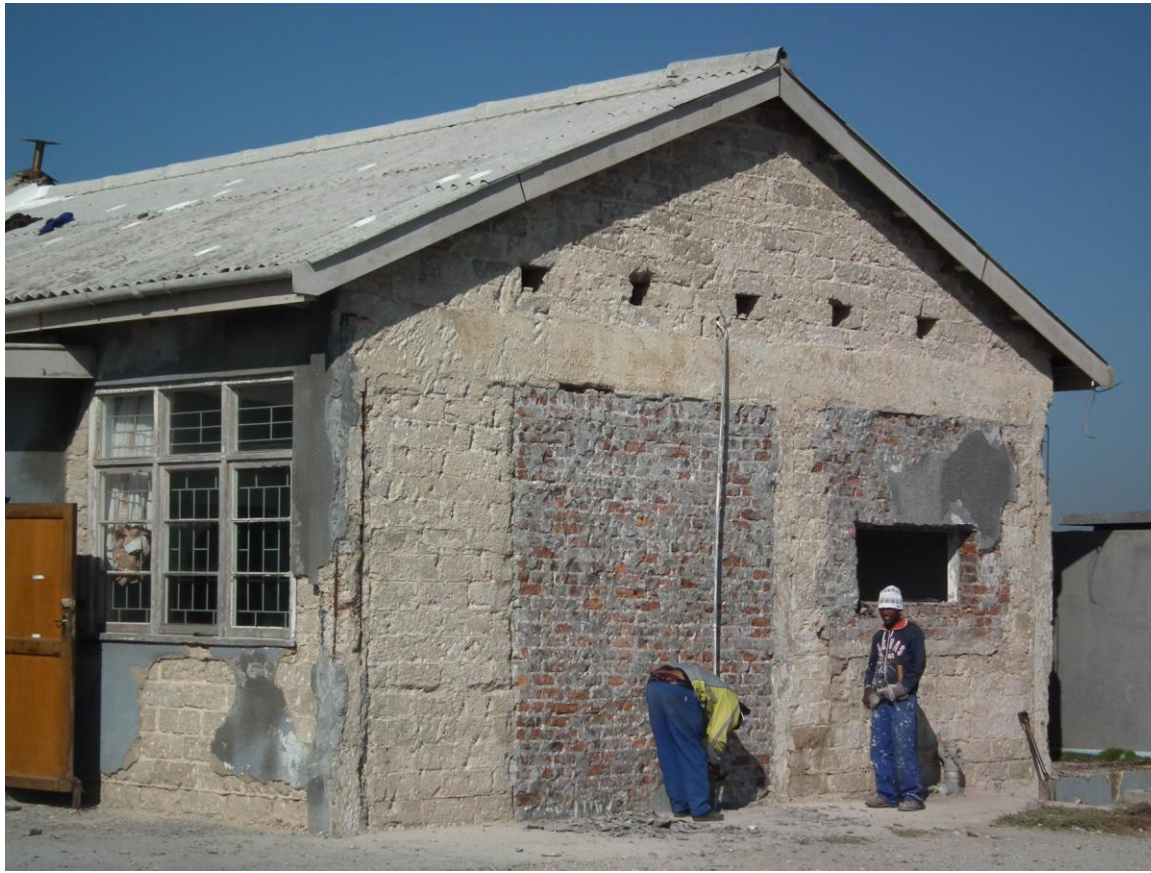
Fig.1.

In July 2011 Alpha one was in an advanced stage of being refurbished under a permit from SAHRA issued in November 2010. With the stripping of the plaster certain bricked up features from the original construction were clearly visible.

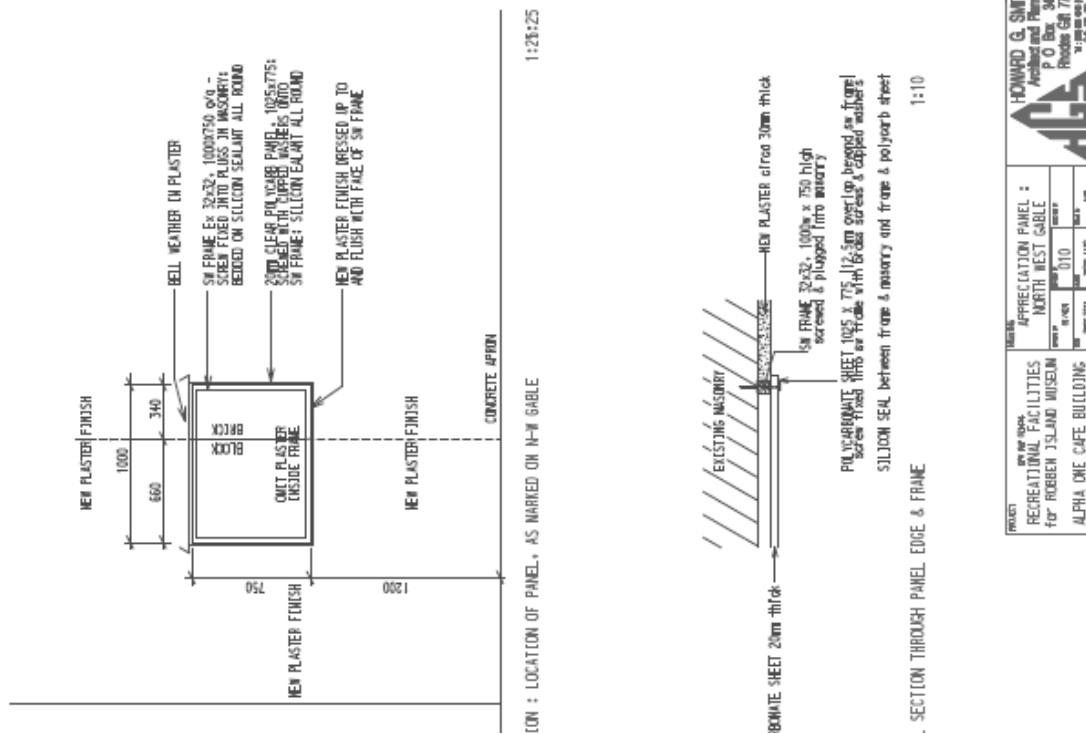
Fig.2.

It was decided to allow for the interpretation of the different building styles by placing a polycarbonate panel at the SW edge. A drawing was made by Howard Smith. [fig.2.]

Observations made on 30 January 2012 shows that the proposal by Howard Smith deviated considerably from the actual installation of the panel.

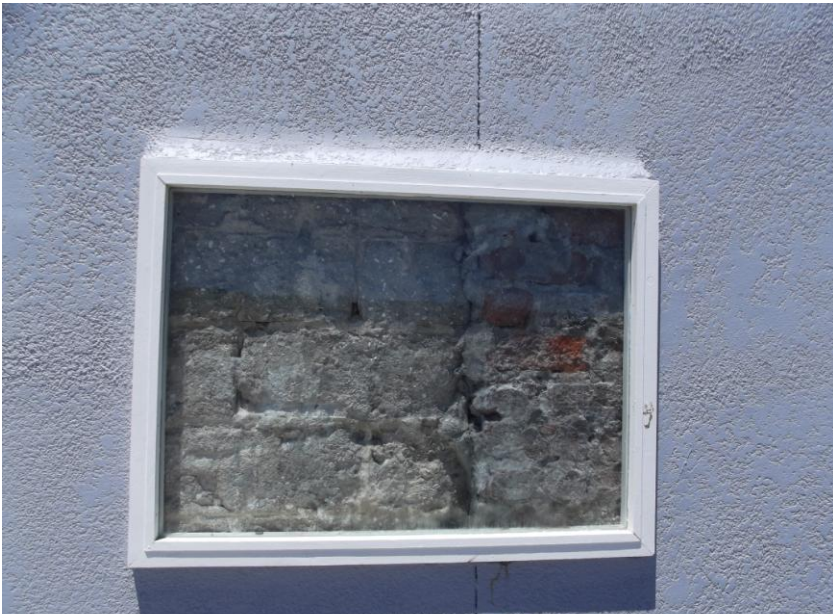
Fig.3.

The present polycarbonate and wooden framework is inconsistent with the above principle. The frame is sealed on all four sides.

Moisture from the brickwork is and will be retained behind the sealed framework.

The build up of moisture will lead to accelerated deterioration in the fabric which has been protected by plaster for more than 70 years.

Image of interpretation panel.

Alterations must be made to the framework to allow for the evaporation of any build up of moisture. Holes drilled into the polycarbonate in appropriate places may alleviate this build up.

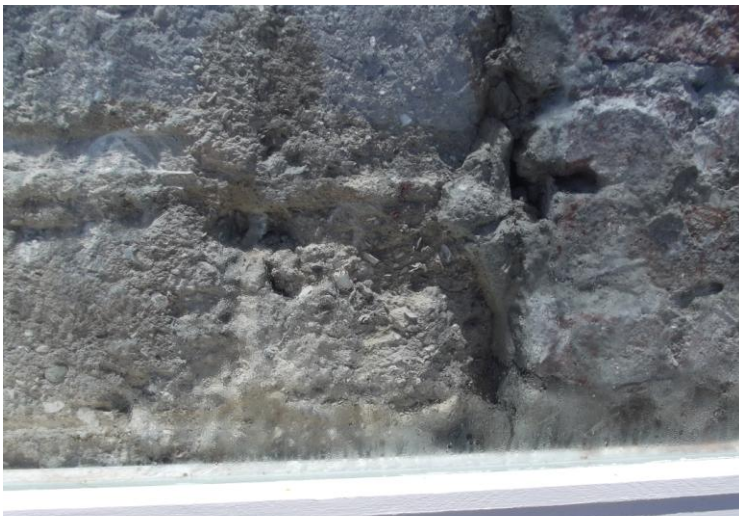
Fig.4. Image showing moisture build up.

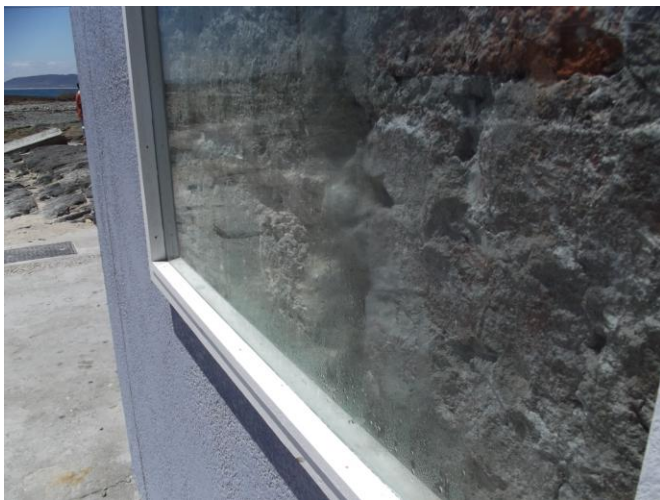
Fig.5. Image showing moisture build up.
