16 BROWNS ROAD / 8 ALBERT ROAD RESTORATION AND STATUS QUO REPORT

2.3 ARCHITECTURAL ASSESSEMENT OF CONDITIONS OF PROPERTY

Inspected in November 2007 and September 2013.

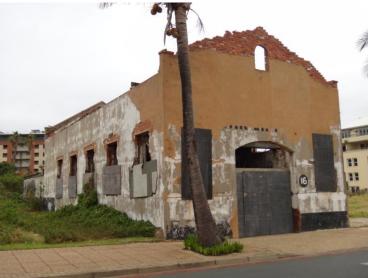
2013

The building was constructed in six bays with nibs on the interior of the building. The walls were 345 mm thick below ties above the windows and doors and 230 brickwork above that. The gable on the north façade disintegrated three years ago and has been re-built albeit that the gable is incomplete. The opposite gable on the south façade is leaning out by 20 to 30 centimetres. This gable will also need to be re-built.

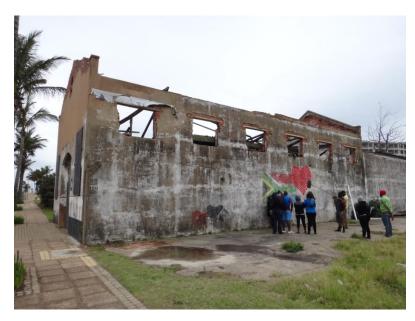
2013

This structure is extremely frail. The building is constructed of 345 mm brickwork at ground floor and 230 mm brickwork above the mezzanine ties. The gable on the west façade has already disintegrated and been rebuilt while the opposite gable on the south façade is leaning out by 20-30 cms. Both the gables will need to be rebuilt.

The simple gable to the west façade is to be completed while the gable to the east is to be rebuilt.

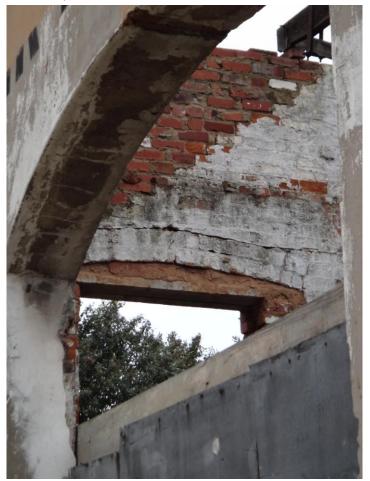
2013

The original door facing Browns Road was replaced with a roller shutter door. This has been removed and the opening is boarded up. This will be replaced with a glazed timber door.

No windows exist but they were probably sliding sash windows. New lintols have been added which do not recognise that the windows had bowed arches. The windows are to be re-instated on both north and south elevations. Doors are to be introduced in the window positions on the ground floor as the building will relate to the courtyard.

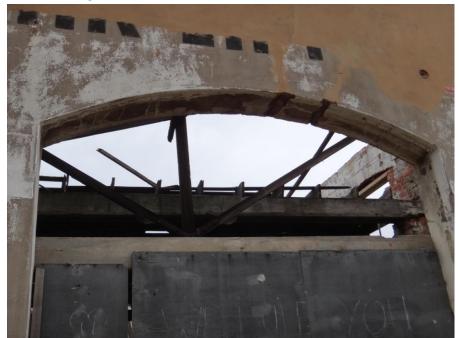
2013

There are no ceilings in the building. The exposed bolted king post trusses have collapsed and are lying on the mezzanine floor. They are an important characteristic of the building and are to be reconstructed.

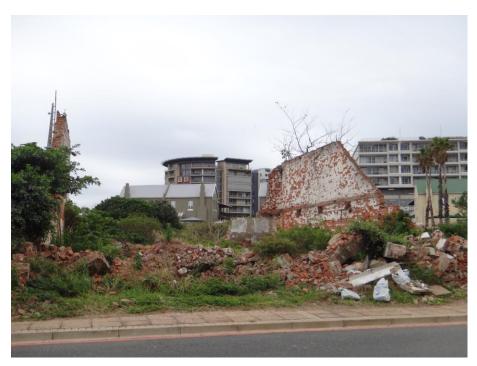
2013

In 2007, this building was substantially intact. The building had timber posts supporting a mezzanine floor and was roofed with corrugated sheeting on king post timber trusses. There was a fig tree growing along the east facing wall. In 2009 a decision was made to convert the building into 21 units. The fig tree was removed (it had damaged the structural stability of the wall). An opening was made in the north facing wall for the piling rig to access the interior of the building. The development did not go ahead. A portion of the east facing wall collapsed, followed by a portion of the west facing wall, the north façade and finally the south facing façade. The new development will use the piles for support. The crumbling brickwork will be retained as a ruin with a concrete edge to the brickwork. A contemporary building will be built inside the ruin.
