**Request for permit permission to replace the metal clad wooden urns at the Evangelical Lutheran Church complex, Strand Street (erf9245) with fiberglass replicas.**

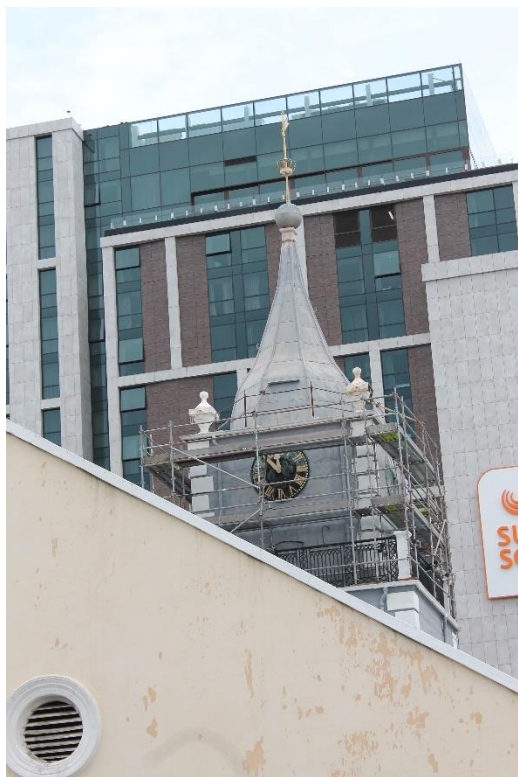
*Two of the urns on the upper level of the clock tower*

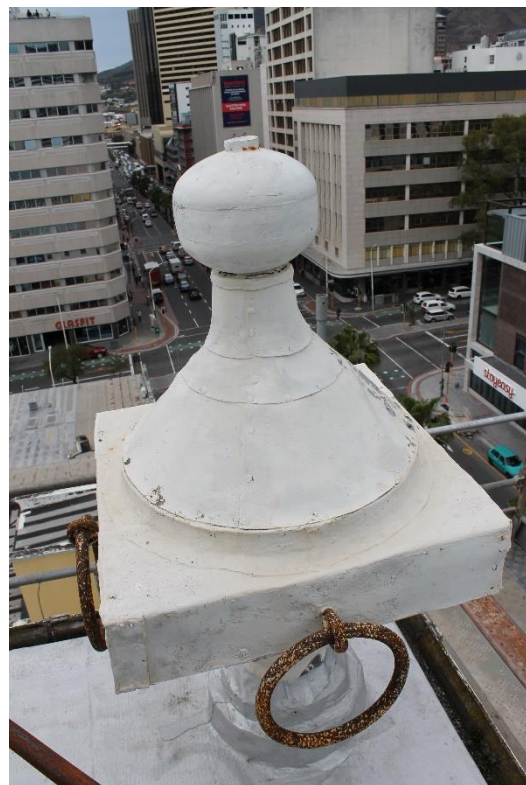
*The one remaining complete urn*

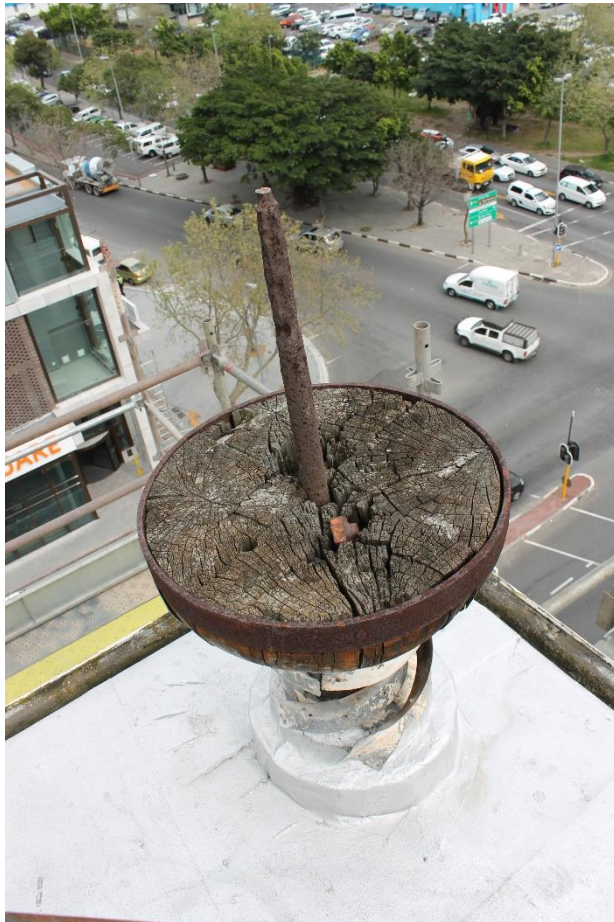
*The first urn which has lost the top half and is showing serious rot in the remaining bottom half.*

The ELC has contacted a number of heritage restorers and all have stated that it would be possible to repair only one of the urns as the others are so badly damaged that they would require total replacement with the possibility of using some of the remaining parts to refurbish the one remaining urn that is in sound condition. The cost of making exact

The ELC in discussion with our heritage consultant, Stuart Hermansen, then investigated the possibility of having fiberglass replicas made using the one remaining urn as the template. This process is feasible and provides the following advantages:

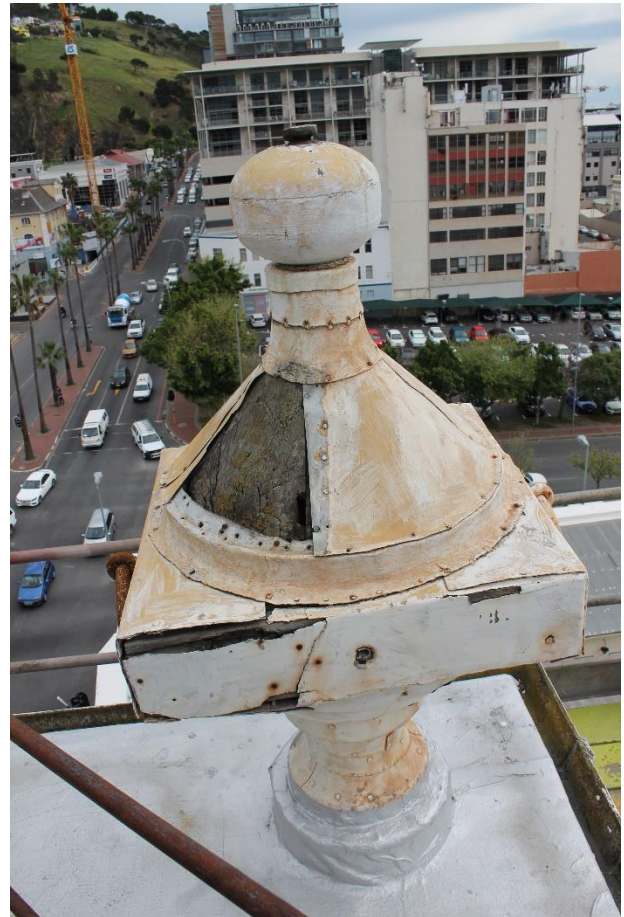
*The third urn showing loss of metal cladding and serious rot in the top and centre section with the additional loss of one of the cast iron rings from the side.*
