Conditional Assessment for Buildings on Robben Island

Outline Description of Material Testing Required

November 2018

OSMOND LANGE ARCHITECTS
+ PLANNERS

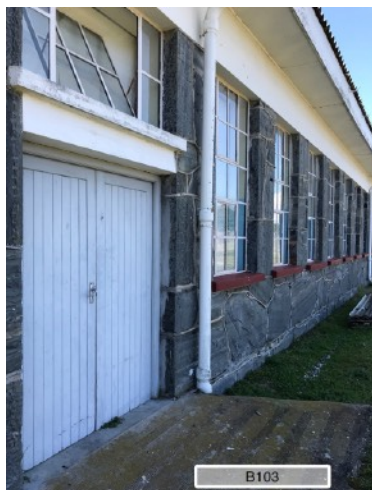
3. lime mortar used in pointing in a west facing wall on Building B103 (Recreation Hall). Cement pointing repairs has been done in places.

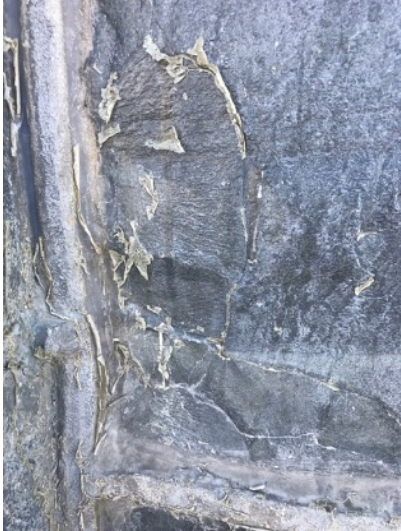
4. Composition of lime mortar used in pointing in a west facing wall at The Kramat. Picture shows silicon over repairs to the pointing in cement.

Generally the building is in good condition, only the external west and north facing facades need specific attention. Remove all silicone and cement pointing and replace with lime mortar.

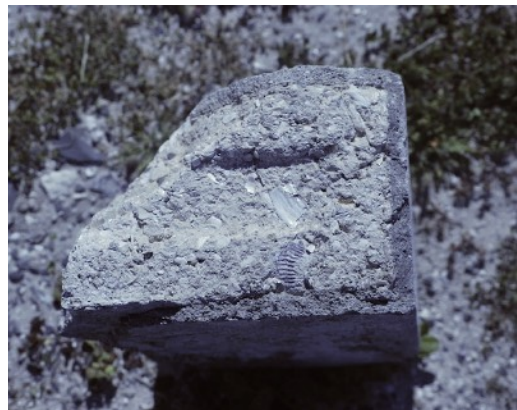
A sample of limestone brick found on Robben Island. A typical example of the quality of brick produced. It appears if the mortar contains cement, which should be analysed to determine the mortar mix for the restoration work.

Where necessary, replace all cementitious material with lime mortar.

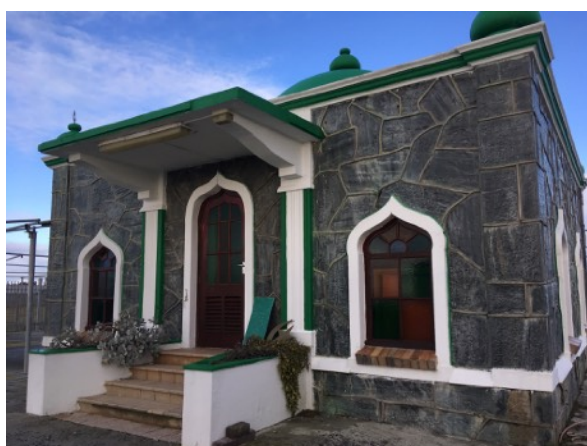
Fig 3. Entrance to the Kramat

The entrance door is half-glazed and the windows are wooden four-paned casements with fanlights. The inside walls are plastered with minor damage from water leakage. Ongoing maintenance is required to prevent further deterioration.

Service and maintain timber doors and windows where necessary.

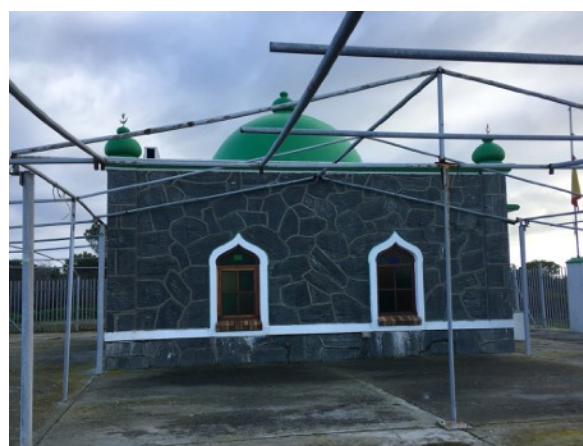
Fig 4. Tent structure next to the Kramat

An informal metal structure has been incrementally erected within the precinct over which tarpaulins are presumably draped to form temporary covered areas during religious ceremonies.

Remove all existing poles for the temporary tent structure and provide new free standing external covered area.

Remove all surface mounted services, including anchor positions of tent structure.

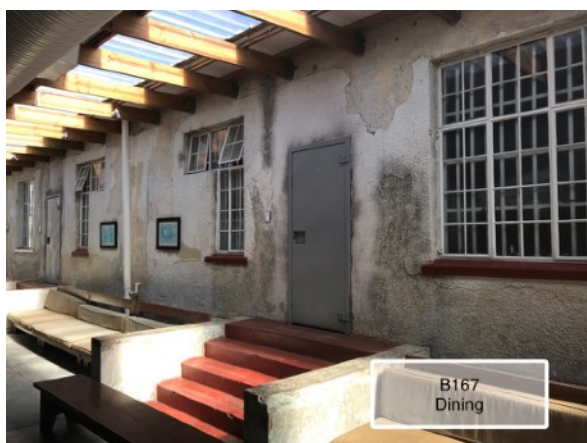
The cause of the black mould, which is quite prevalent in the dining area, needs to be investigated. It is likely that there is inadequate natural ventilation in this space. Surrounding remedial work will be required to prevent this from re-occurring.

Fig 5. Black mould on walls in dining area. Causes need to be established

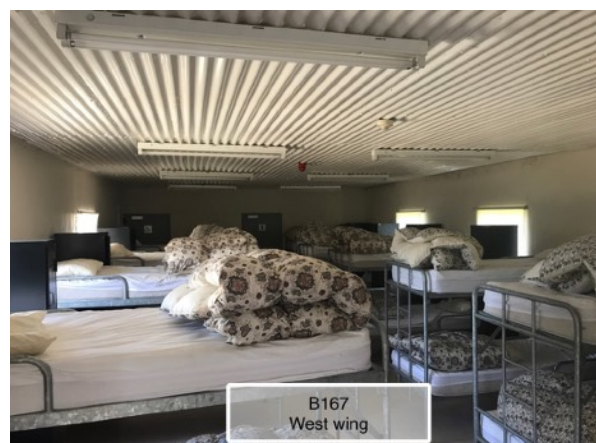
As stated elsewhere, modern paints such as PVA acrylics and enamel paints are not compatible with lime mortars and plasters where wet conditions occur. Moisture can be from wind driven rain, leaking gutters and from leaking water pipes.

Fig 6. Note the flaking paint on the walls close to the concrete ceiling. Most likely caused by excessive moisture generated by children with walls not being able to 'breathe'.

The flaking paint in some of the dormitories is evidence of this, and where this occurs, all paint has to be removed, surfaces checked for any cement repairs, which will also need to be removed. Restore plastered walls using lime plasters to match original lime composition, then render using lime washes and distempers.

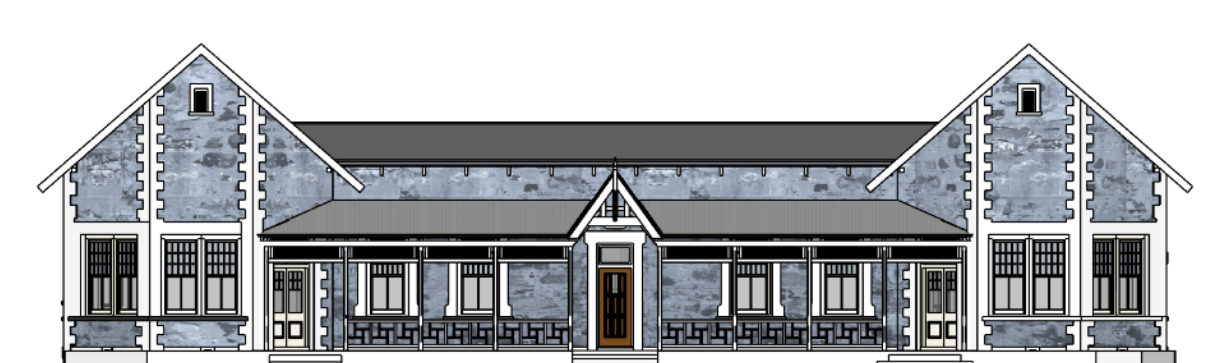
Fig 7. East Elevation of the Pre-Primary School.

Attempts have been made to repair and restore parts of the stone building. We suspect that many parts of the stone walls have been repaired using cement, which is detrimental to the overall fabric.

Full restoration of main school building, possibly to be used as a conference or meeting place or formal teaching facility.
