## Site Management Plan (SMP)

**Robben Island**

*Reference: Irish Graveyard*

# **Draft outline of Site Management Plan**

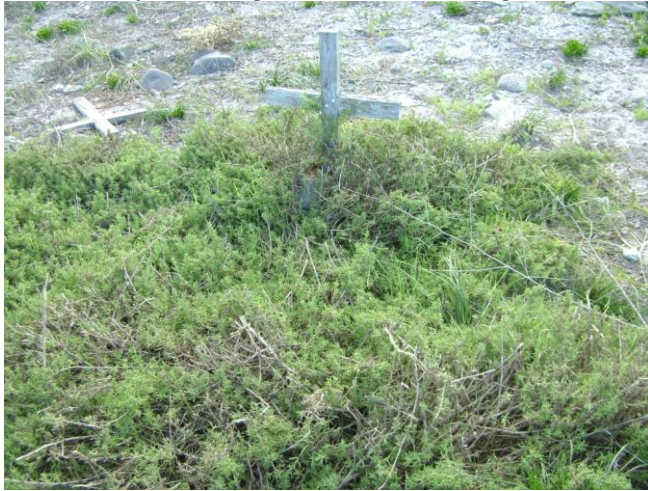
*Problem:* Most of the site itself is infested by vegetation but my focus is more on the Irish Graveyard site. Within the graves themselves its hard to walk as pathways are filled by overgrown vegetation. It is said that there use to be pathways that were build from seashells, which prevented growth of vegetation. Some of the graves are hard to identify as a result of this vegetation. *Solution:* By clearing up pathways would benefit both the site (graves) and the visitors (human). Also building those pathways with seashells would be ideal, as this would be cost effective- using the available resources. People would move more easily between the graves and they would no more step on some graves with in turn would cause damage to the site.

*(a) Infested vegetation within the graves.*

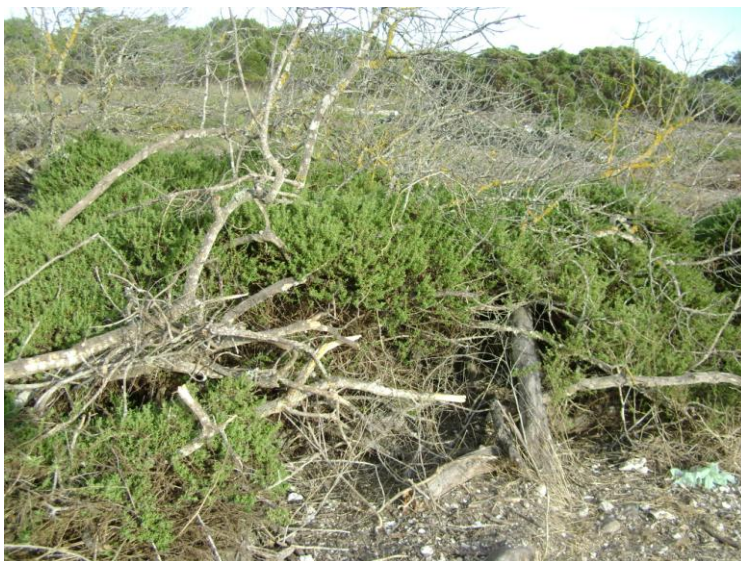
Problem: There is plenty of vegetation outside (exterior) the site too. The falling of branches from trees and logs being blown by gusty winds inside the graveyard could pose a risk. Solution: Both these vegetation should be maintained seasonally, that would be twice a year- just before the hot summer months to prevent wild-fires and just before the rainy winter months to prevent overgrowth. If both of these managerial elements are not practised on these months, vegetation can have devastating impact on the site. Also regular monitoring of the growth of vegetation should be a priority and there should be no logs placed next to the graveyards.

*(a)Vegetation outside (exterior) the site.*

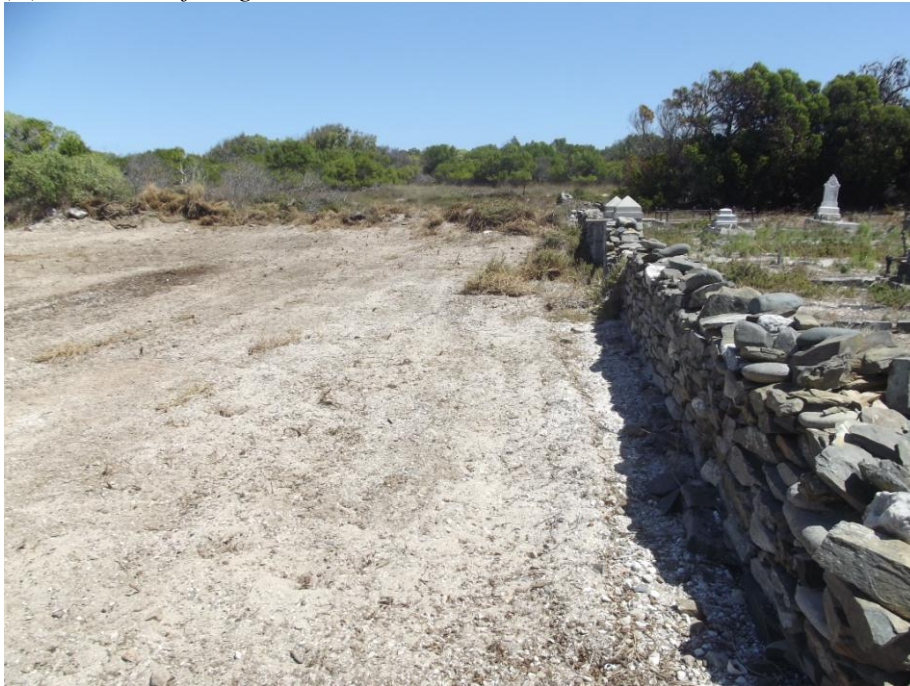
*(a) Removal of vegetation*

If one looks closely just next to the rough stone wall there used to be a one metre path of seashells just outside the stone wall. The Contractor removed vegetation including that path. This can have effect on the walls as erosion can easily occur as there is wont be a strong base, causing the walls to fall weak on the foundation resulting in falling of the stones from the wall (currently this has stated to occur). This is perhaps the major cause for the degradation of the site.

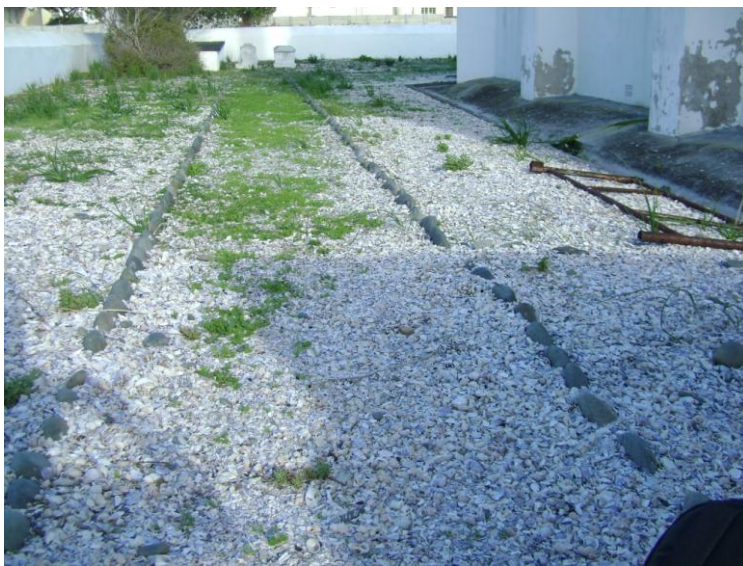
*(a) Seashell Pathways t the Garrison Church.*

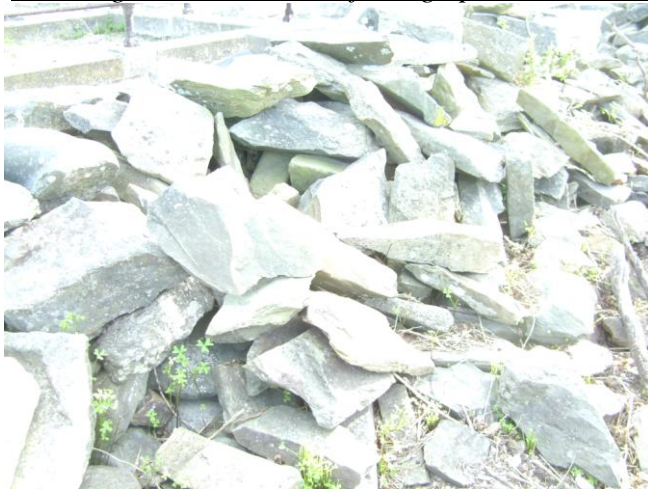
*Problem:* The rough stone walls are starting to fall apart starting from the foundation. Generally the stone wall is not in a good condition at all, evidence of erosion can be seen as some part on the Northern part of the site have completely fallen. The issue is said to have been caused by contractors that were hired to clear up vegetation on the

surrounding of the site. However those contractors could have clipped away the seashell pathways around the graveyard which acted as a supporting foundation to the rough stone walls and it too helped to prevent growth of vegetation, hence there are eroding from the bottom/foundation. If doing a comparison with the seashells that are on the Garrison church, it is evident that seashells do prevent vegetation grown **(Picture below of the Garrison Church)**. As a result some of the stones are falling on top of graves which are close by the stone wall. *Solution:* Have those seashells places in there place again which will help in supporting the foundation of the rough stone walls.

*(b) The rough stone walls are falling apart as a result of weak foundation.*

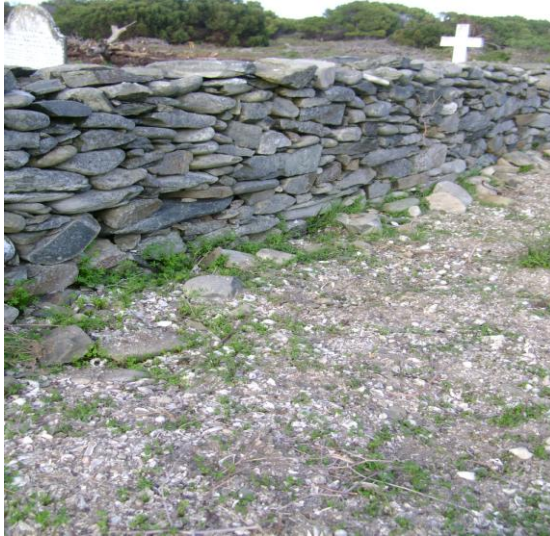
*(c) Rough stone walls still intact, can see the seashells are still in place so the foundation is strong.*

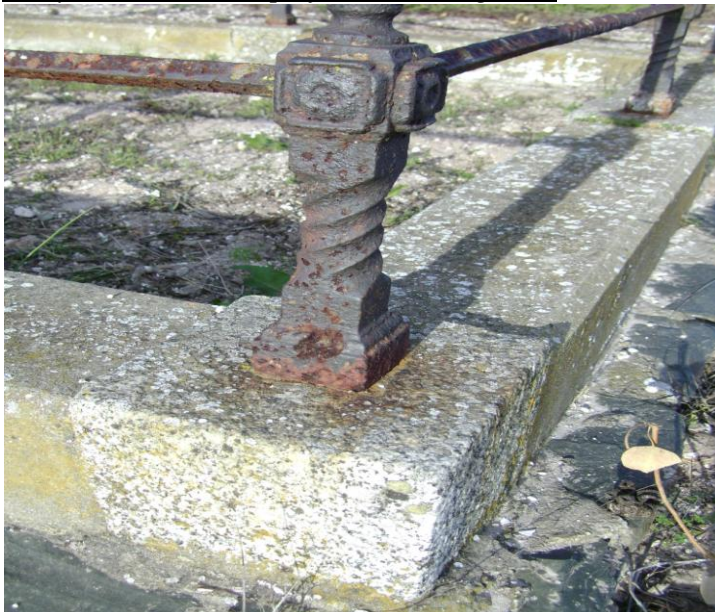
*Problem:* The rusty iron bars on the grave pose a risk to the graves themselves e.g. when they rust on top of the marble stone of limestone they cause them to crack and be weaker, more especially the 1800's graveyards. Also the falling tombstone on top of the grave poses a hazard to the grave itself. Growth of algae which make it hard to read the inscriptions from the tombstone is a risk too.

*(a) Rusty iron bars on top of the marble grave.*

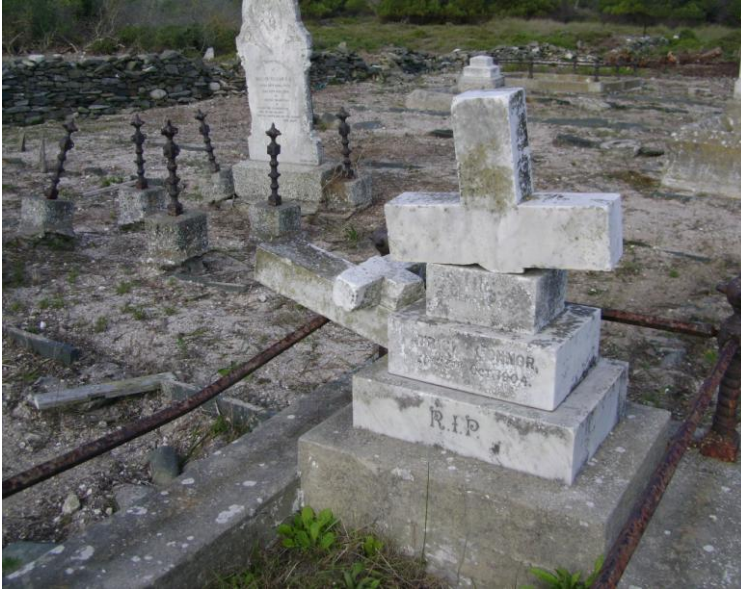
*(b) Slanting of a tombstone on top of a grave... It has been broken.*

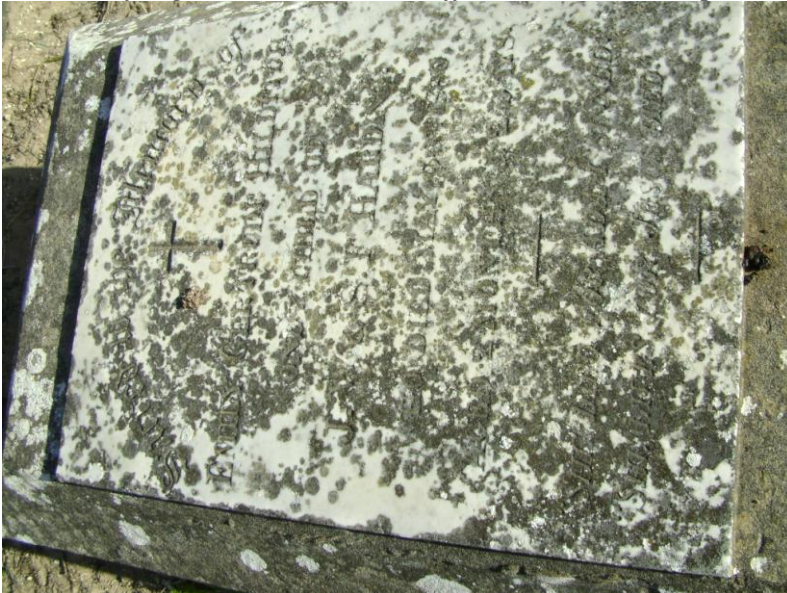
*(c) Growth of algae which makes it difficult to read inscriptions.*

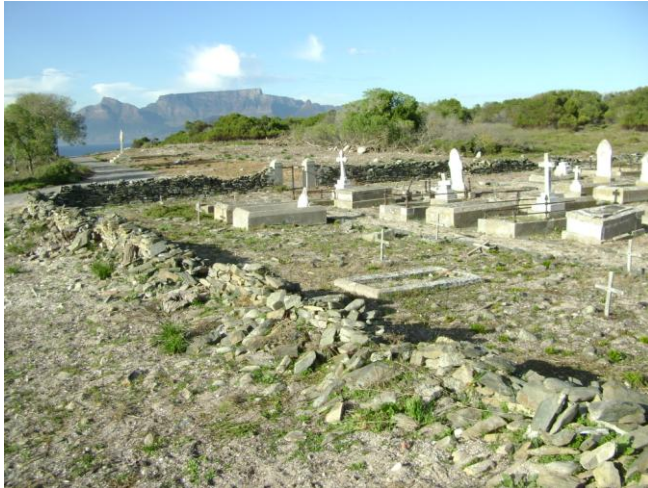
*Problem:* There is no visible signage to inform visitors of the site, though the site has much significance and relates to Robben Island Museum- hence the grave of the lighthouse keeper (David Allen- Died: 10/05/1872) is situated in the Irish graveyard. Also this site is also known as the Staff cemetery as most of the medical staff was buried here. *Solution:* To inform and attract visitors it would be advisable to have signage of the Irish graveyard and perhaps supply some info

(a) *No visible signage at the Irish graveyard.*
