STRUCTURAL ASSESSMENT REPORT

DECEMBER 2022

57 HARVEY STREET, UMKOMAAS

Krishna Govender Family Trust
57 Harvey Street
Umkomaas
4170

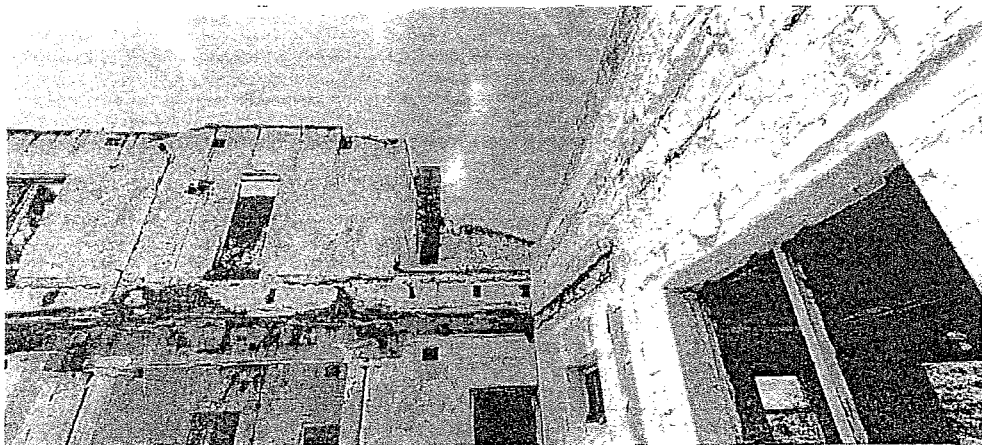
SLIDE 1 : MOISTURE INTRUSION ALONG EXTERNAL ENVELOPE

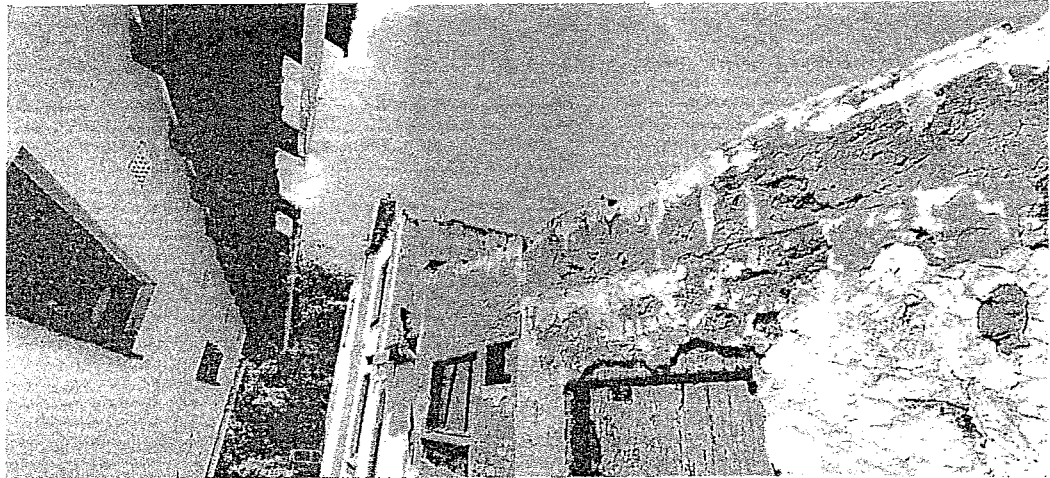
SLIDE 2 : DEBONDED PLASTER ALONG EXTERNAL ENVELOPE

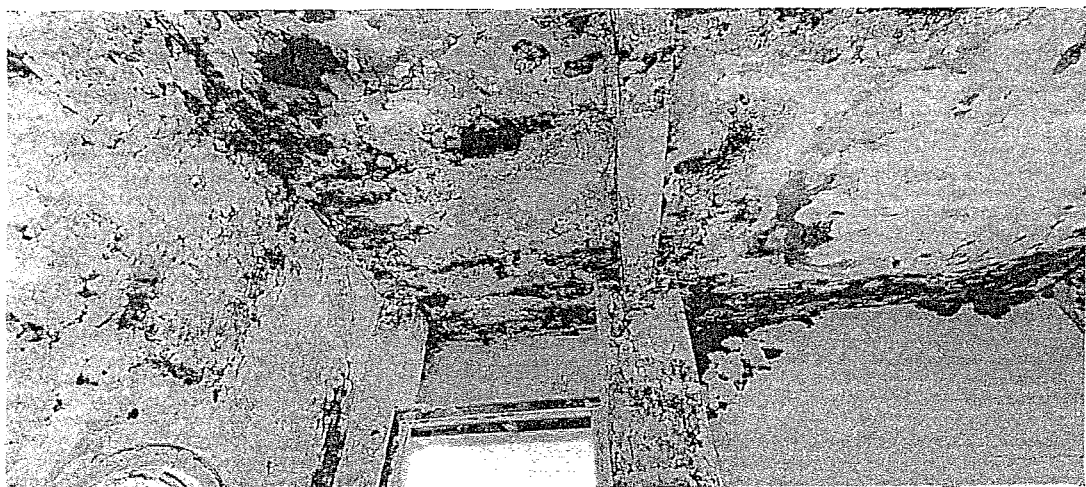
Localized cracks were encountered and noted. In certain instances, these were a result of saturation within the substrate and/or subsurface saturation which can be expected considering the geological profile of the area. Spalling and pitting along the soffits of the entrance slab was noted. For the most part, the walls appear to have been exposed to the elements both internally and externally. Localized signs of material deterioration through moisture intrusion along the mortar joints and plaster was noted with evident signs of material decay. Cracked, open, and debonded mortar joints have allowed increased levels of bulk water from rain accumulation to infiltrate the masonry. The significant distress observed along the internal envelope can be attributed to water flowing down the face of the wall and migration of water within the masonry due to gravity.

SLIDE 3 : SPALLING ALONG SOFFITS AND MOISTURE INDUCED DAMAGE

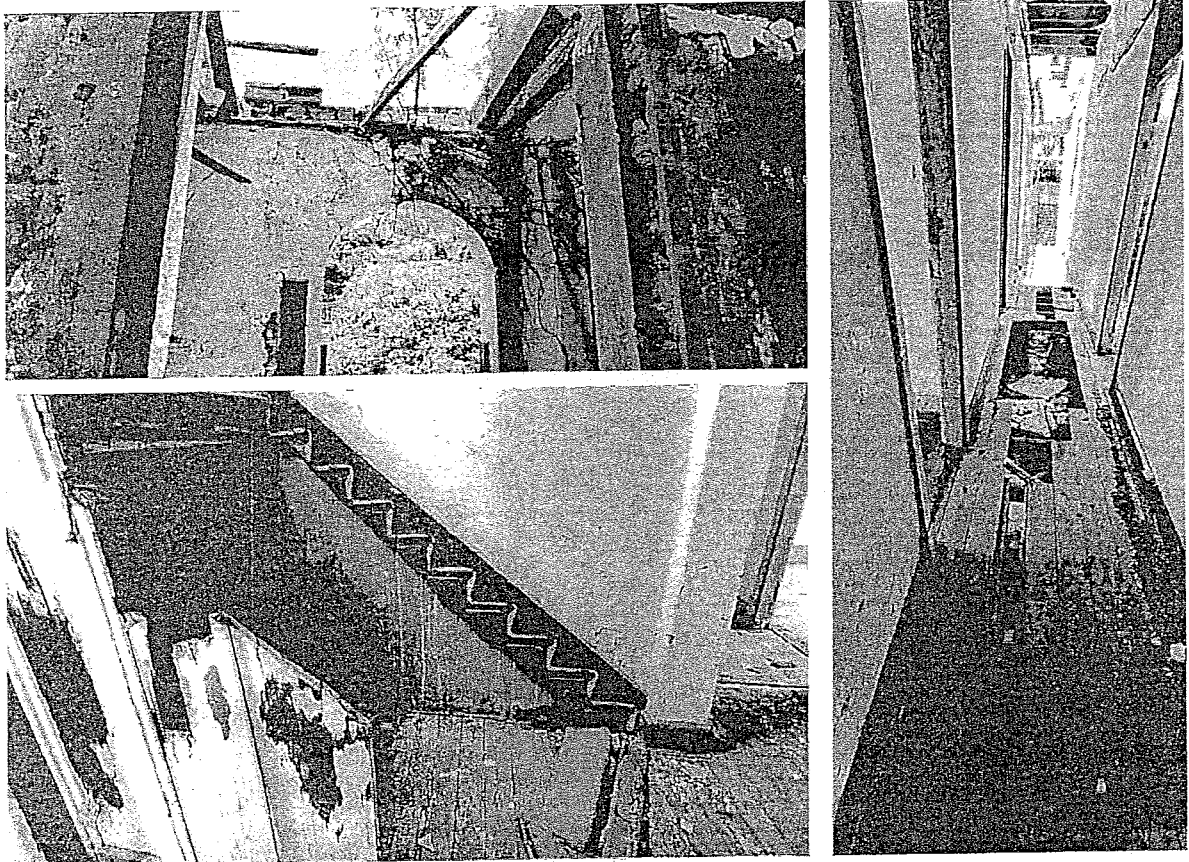
SLIDE 4 TO 6 : DAMAGE TO FLOORS AND WALLS

In certain instances, timber frames appear to be affected by both dry rot which typically occur when the timber becomes too wet with a moisture content of over 20%. In addition, there also appears to be signs of wood borer. This, however, needs to be confirmed by an entomologist. The suspended flooring over the basement has been stripped in most parts. Portions of the remaining timber flooring are in a poor condition.

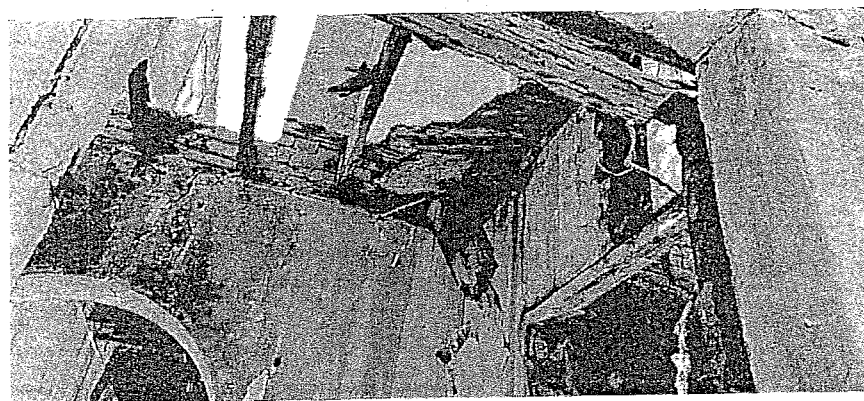
SLIDE 7 : DAMAGED TO ROOF AND INTERNAL ENVELOPE

Firstly. Most of the roof has been stripped. Parts of the roof that remain are not compliant with our current guidelines due to design constraints and material deterioration.

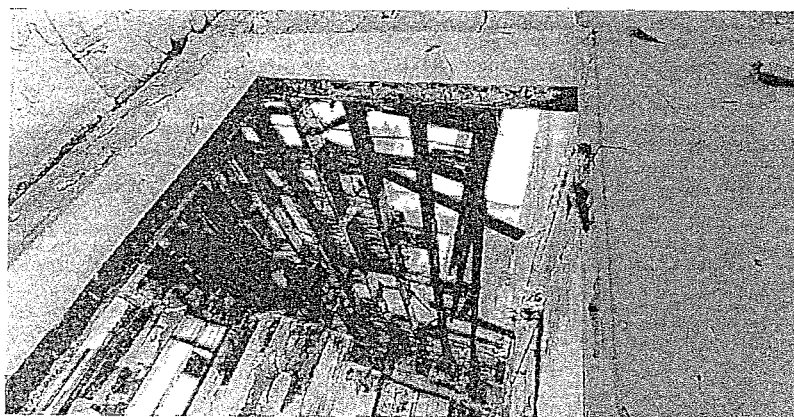
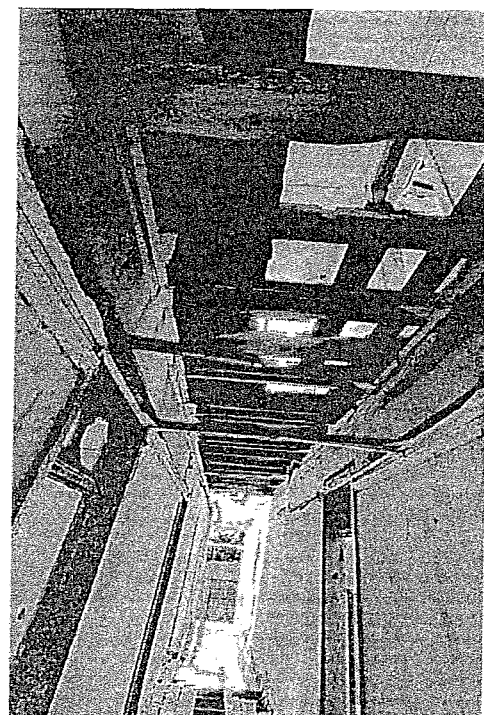
surface, the insides could be eaten away by fungi. The discussion points do not imply that these symptoms are collectively prevalent within the roof assembly. It has been raised as points of concern during our examination. There are evident signs of dry rot and swelling which would suggest that these members will need to be removed and carted off site.

SLIDE 8 & 9 : DAMAGES TO ROOF
