Your Ref: Assessment of existing building on 371 Prince Alfred Street, Pietermaritzburg 3201

ANNEXURE A: PICTORIAL REPORT

Assessment of existing building on 371 Prince Alfred Street, Pietermaritzburg 3201

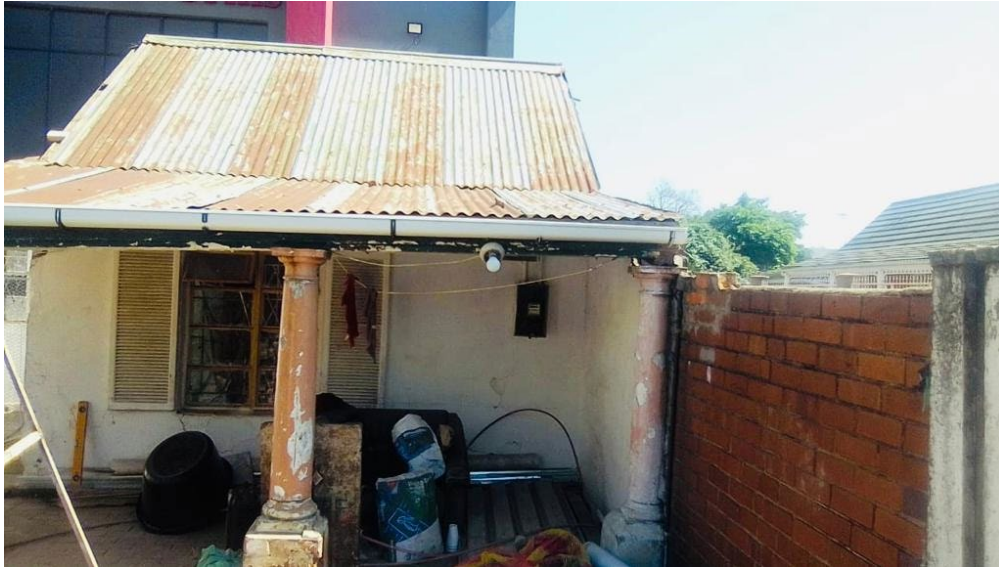
Picture showing the front view of the buildings to be demolished

Based on the above findings, we recommend the owner of the property consider demolishing all the buildings as they are no longer safe for occupations. This matter needs an urgent attention as prolonged intervention may lead to injuries or loss of lives.

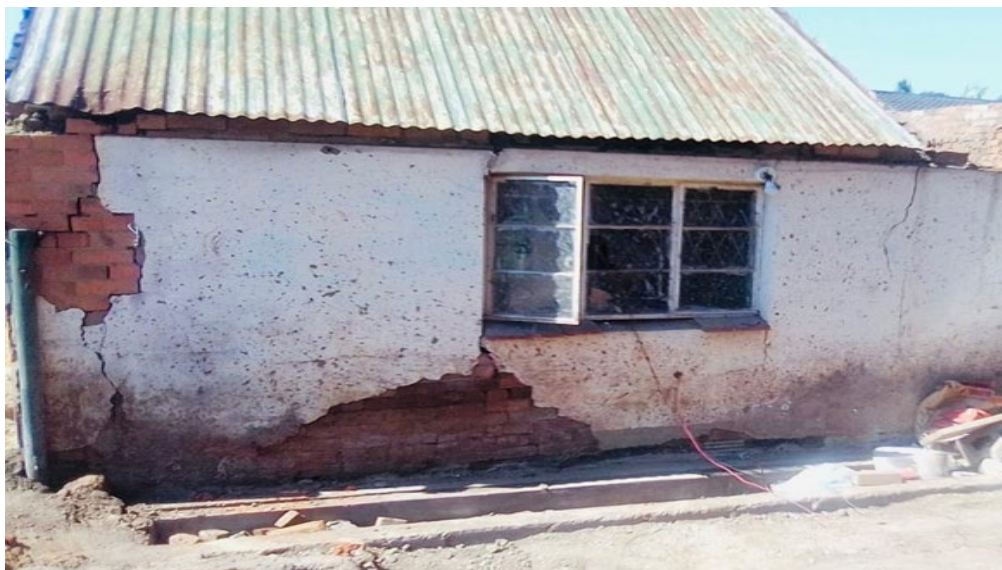
Picture showing the rear view of the buildings to be demolished

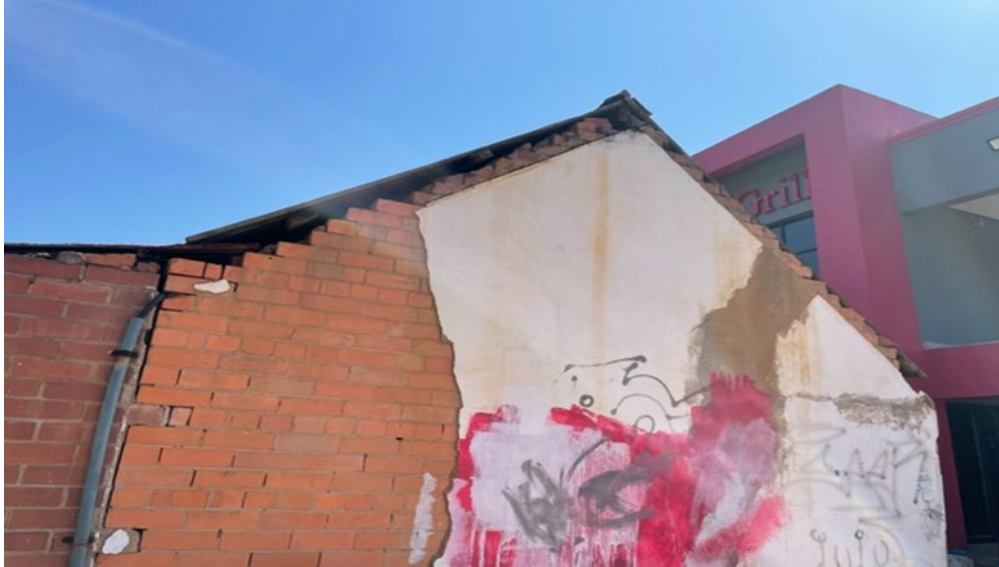
Picture showing the side view of the buildings to be demolished

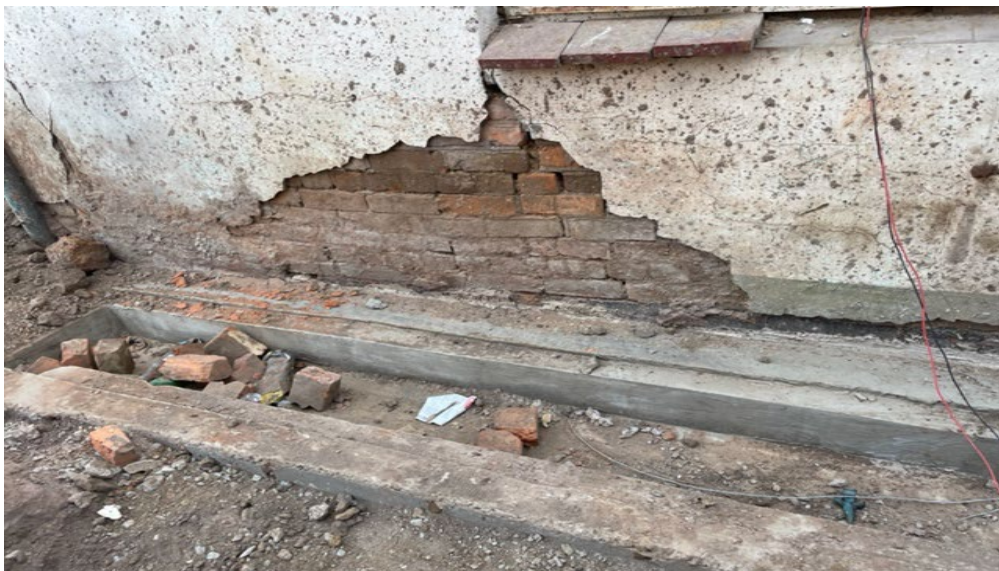
Ground floor walls are the elements of the buildings on site that are used as the load bearing walls to support the roof and other elements of the buildings. The walls of the existing building were no longer on the safe state to support any load imposed to them. From our assessment, we noticed that the walls elements such as bricks were no longer attached to the mortar and in some parts of the buildings the bricks were falling off on their own.

Picture showing the conditions of the walls of the buildings to be demolished

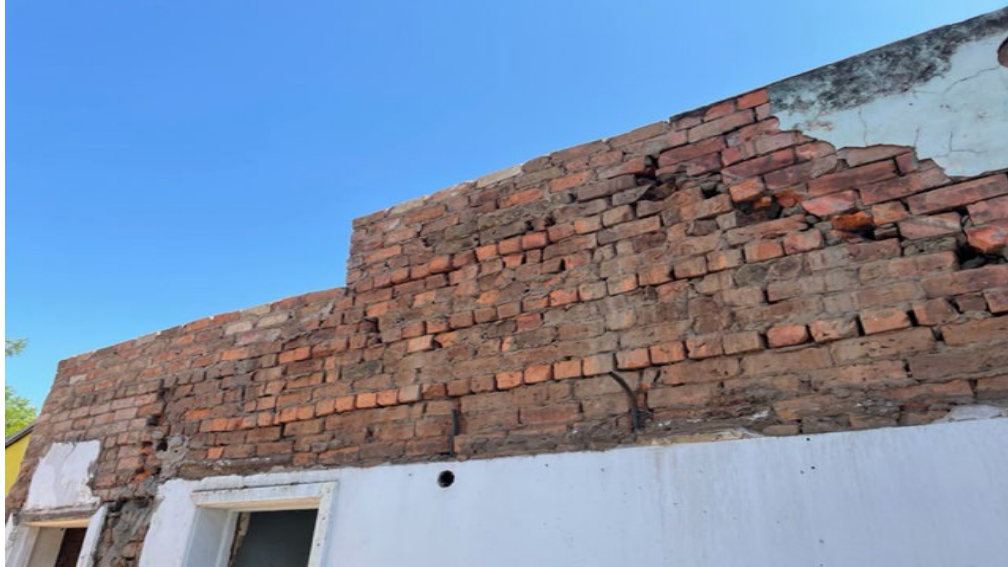
Picture showing the conditions of the beam filling for the building to be demolished

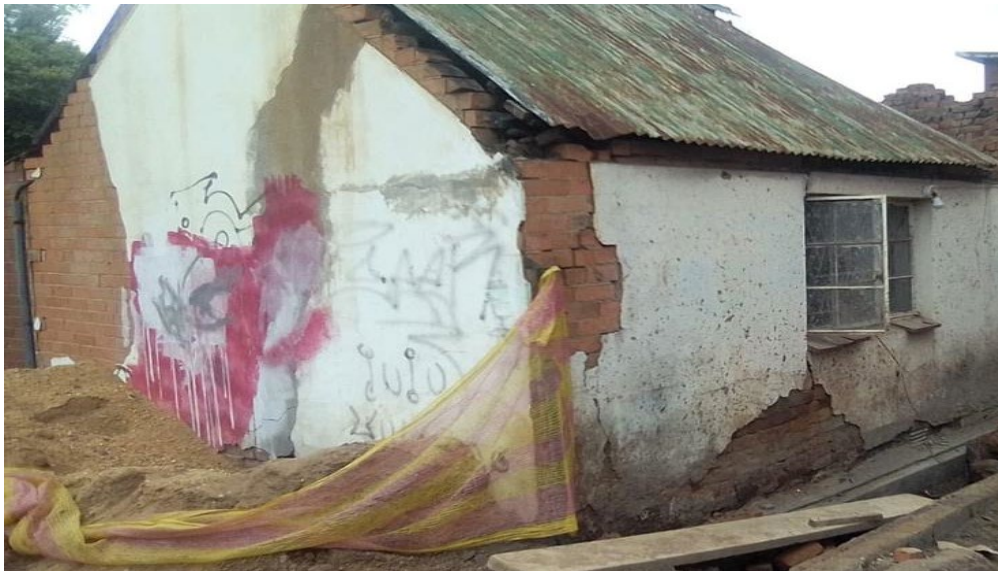
The roof of the buildings on this property revealed that the building were not properly maintained and the roof elements were in need of being replaced. The timber elements supporting the roof

sheeting were severely damaged (rotten). This may result in a collapse of the roof and cause damage to the property or people residing on site.

Picture showing the conditions of the roof for the building to be demolished
