Rim Restoration Work

Sample Images & Paint Specs

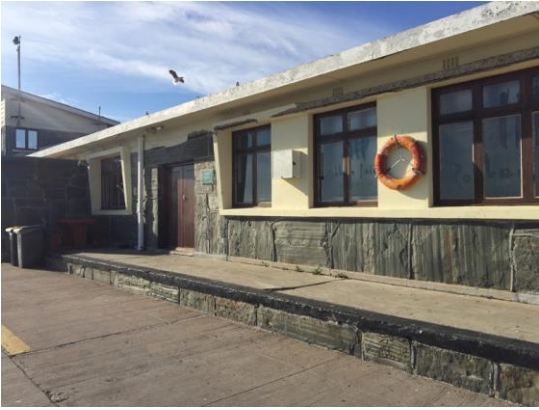
Repair & repainting of Walls.

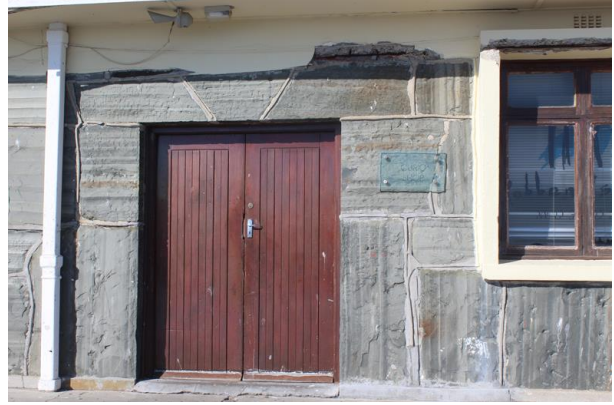
Lintels to be repaired & woodwork revarnished.

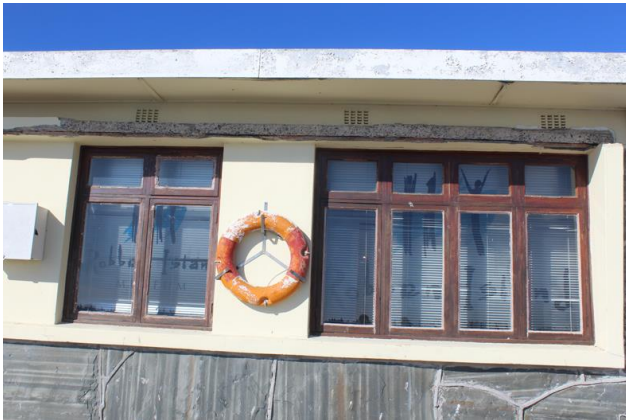
Sand, prime & repaint fascia boards.

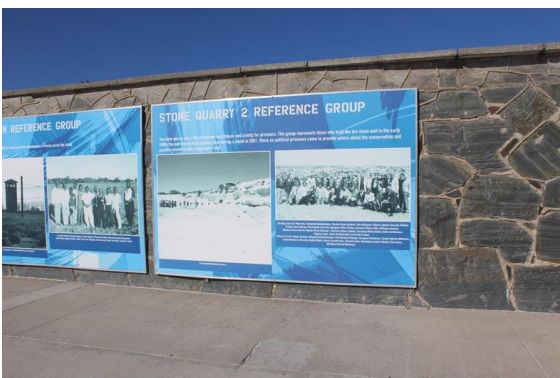
Billboards to be removed.

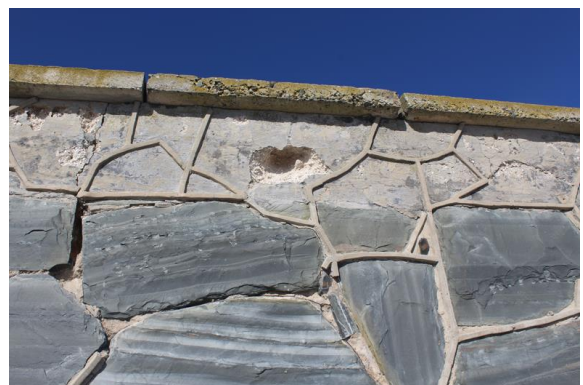
Pointing to be restored & holes in wall to be repaired with matching aggregate to the actual wall finish.

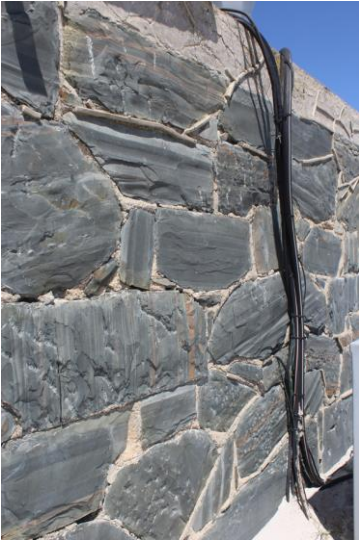
Electrical wiring to be housed in electrical conduit

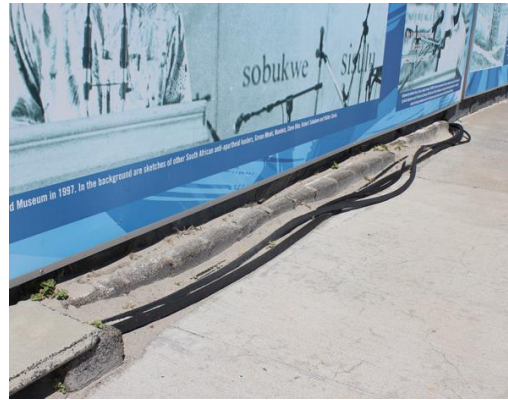
missing concrete slabs covering wiring to be replaced.

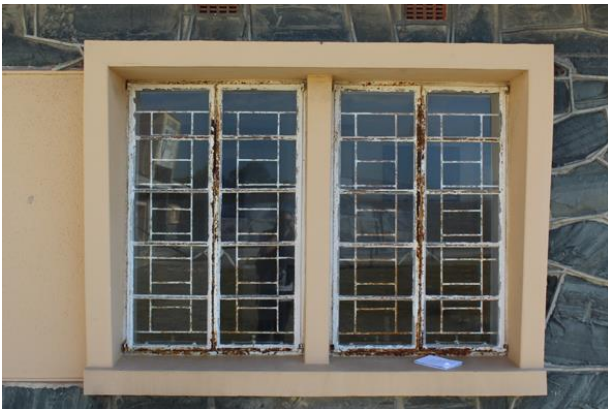
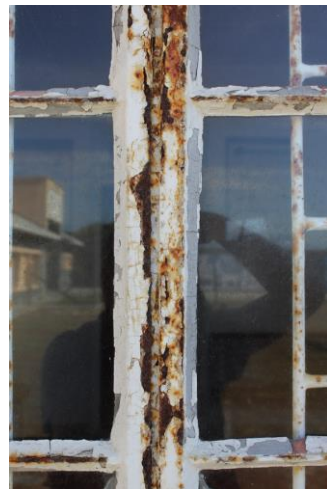
Visitors Centre Windows

Windows show different levels of deterioration. One would require sandblasting for deep rust removal prior to finishing.

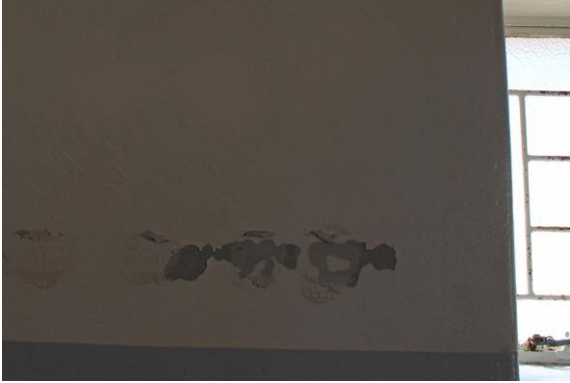
*Flaking paint to be scrape & sanded down.
The wall filled, primed & overpainted.*

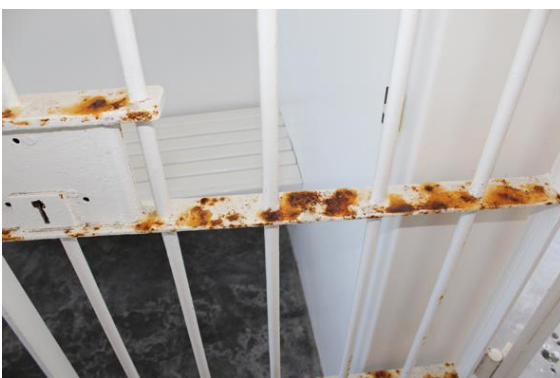
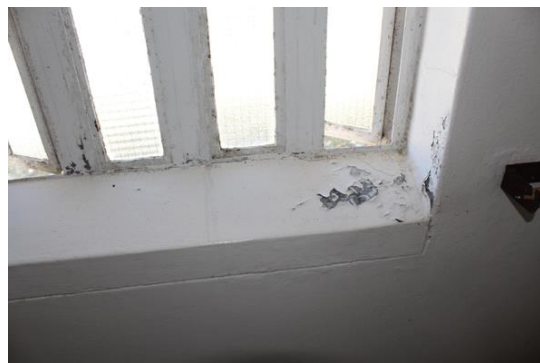
Visitor Centre Cells

Cell doors to be sanded and/or ground down to remove rust, next primed and overpainted, cell interior walls to be restored as described in the supporting document.

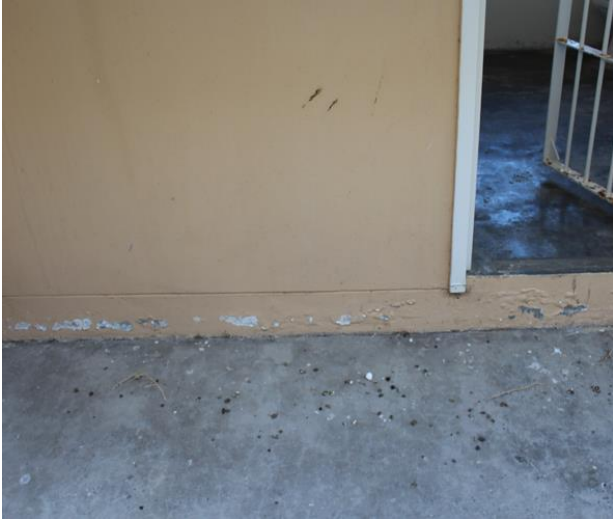
Cell exterior walls to be sanded, filled, primed and overpainted.

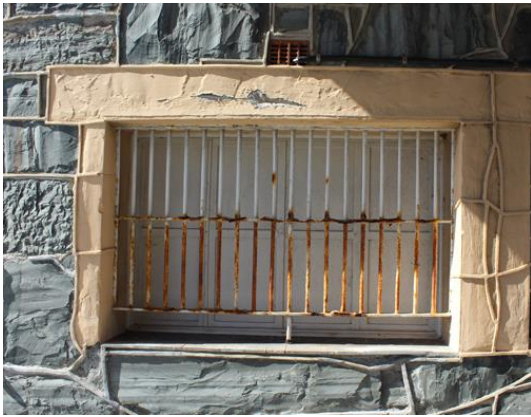
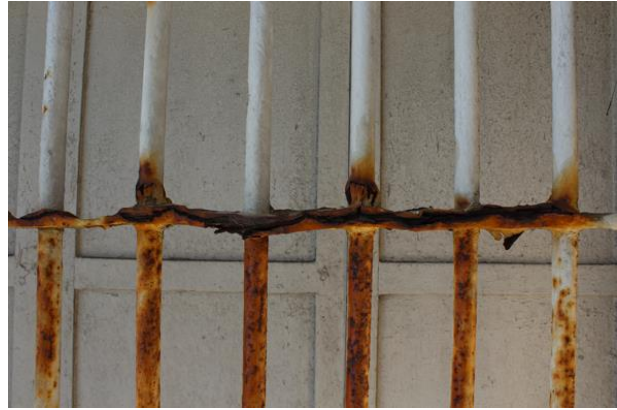
Dankie Hek 1 bars to be sanded/ ground down, rust removed, primed and over painted. Sections of the cross bars are badly rusted and would need to be ground off and replaced.

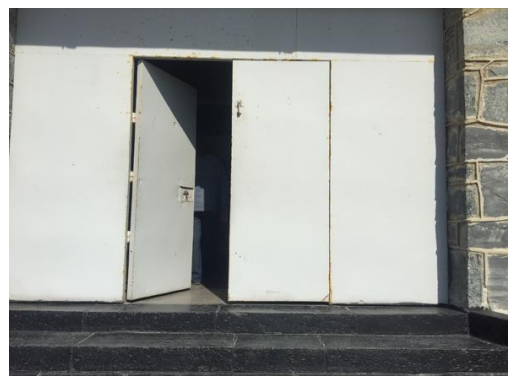
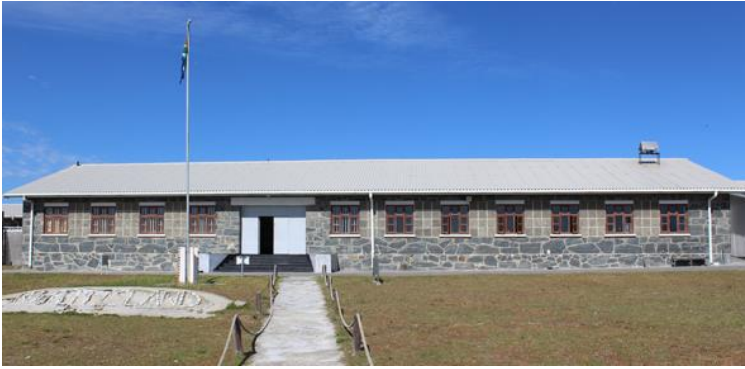
MSP Exterior

The areas showing deterioration are the painted and varnished areas. The materials and method of restoration are described in the supporting document.

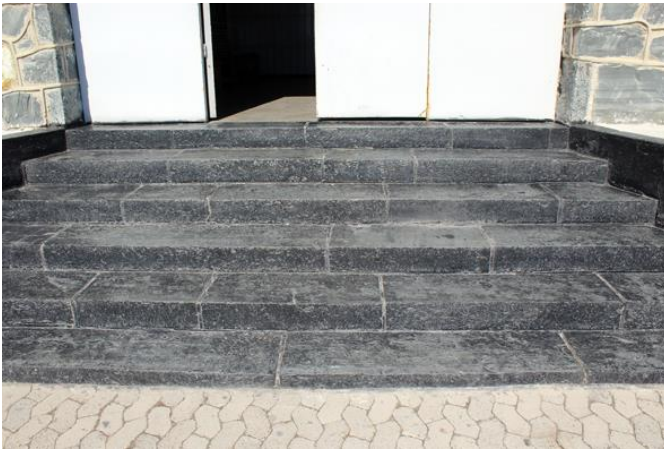
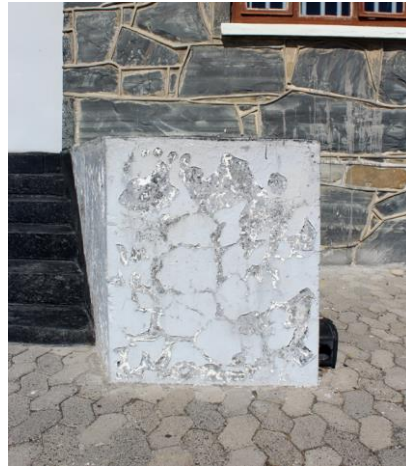
Step paint worn down and needs to be repainted. Step surrounds to be sanded down, primed and over-coated with enamel paint.

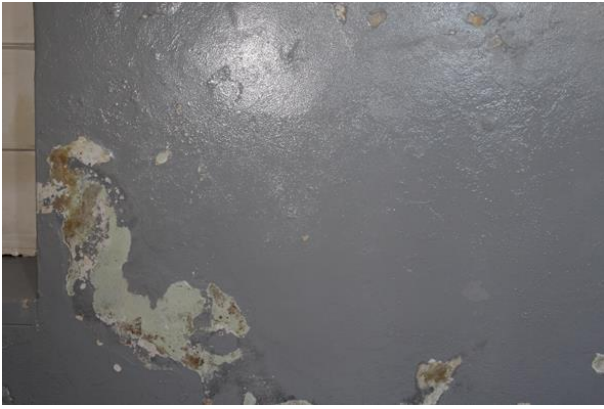
MSP Spine Corridor Walls, flaking paint.

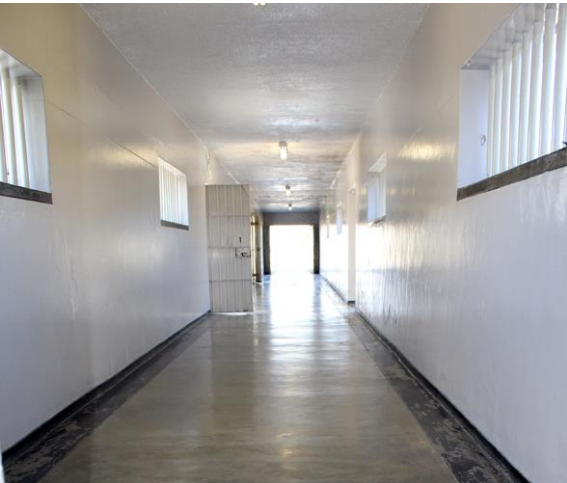
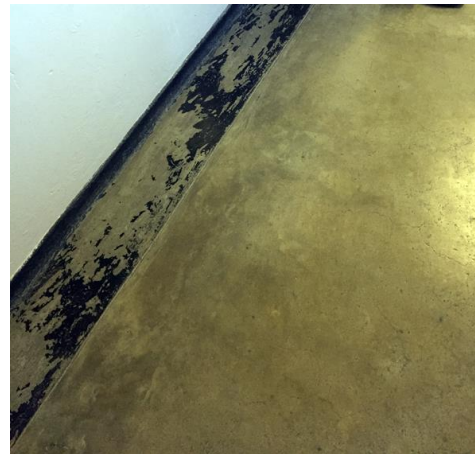
Spine Corridor floor

The floor paint edging is worn and needs to be repainted. The old paint needs to be sanded down prior to painting. The floor will be degreased and sanded down and resealed with an epoxy resin sealant.

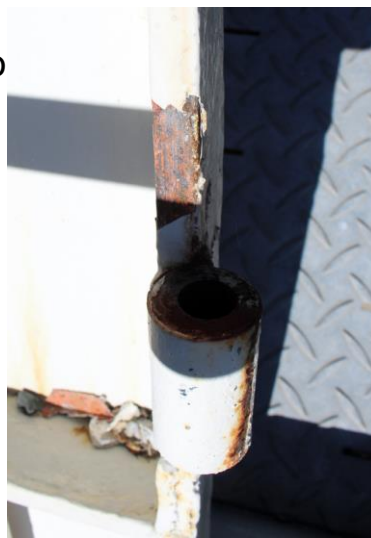
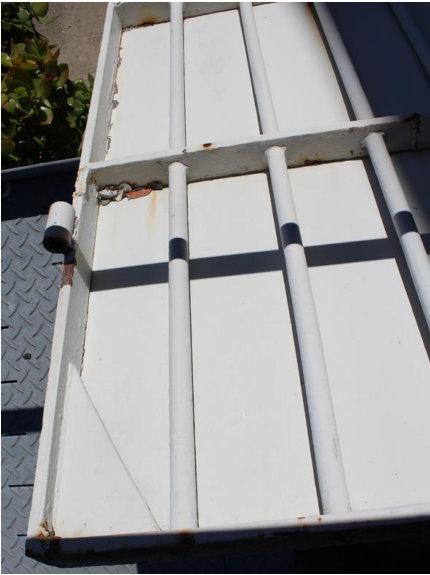
Spine Corridor Door (Leading to Hospital Yard)

The door is lying in the Hospital yard. The bullet hinge is broken and needs to be welded, the rust removed, the door primed & painted.

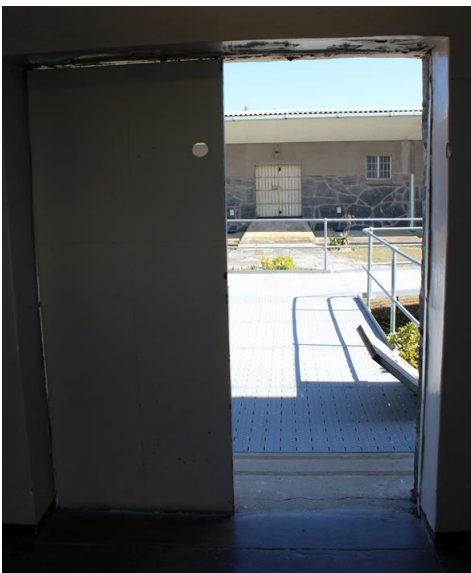
Spine Corridor Door (Leading to B Block Yard)

Door to be refitted after repair

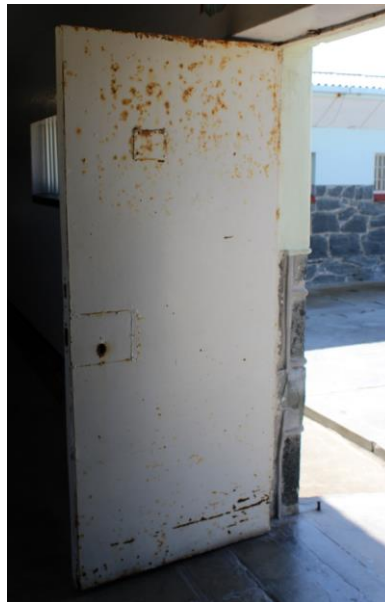
B Block Yard door needs to be sanded, primed and painted

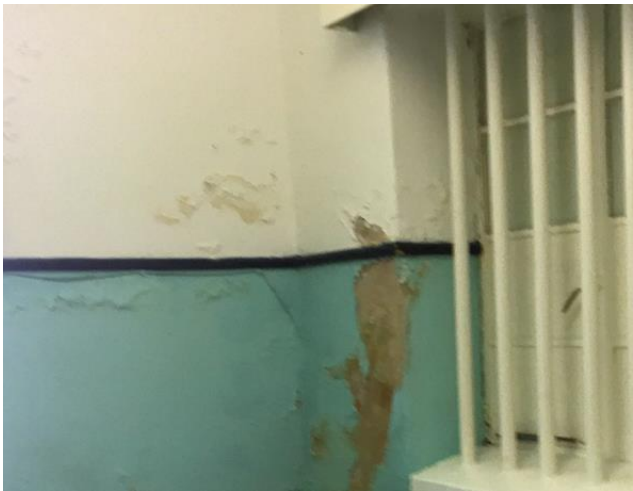
Study Room

Study room Flaking paint

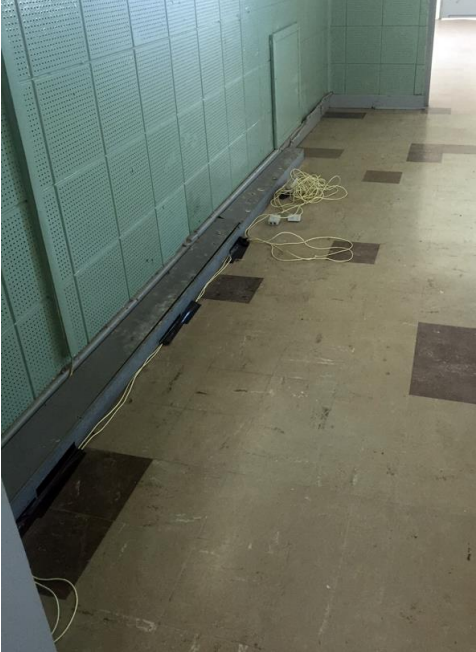
Censorship Room

Censor Room in good condition. Wires need to be housed in conduits & room cleaned.

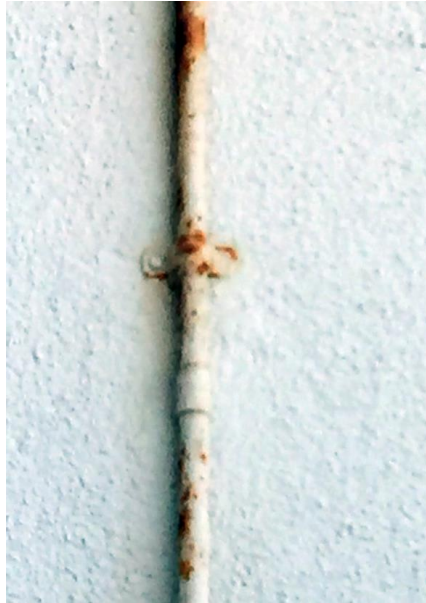
Rusted conduit pipes to be sanded down, primed & repainted.

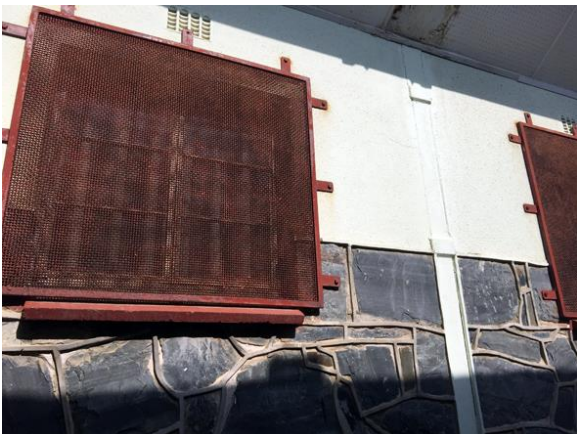
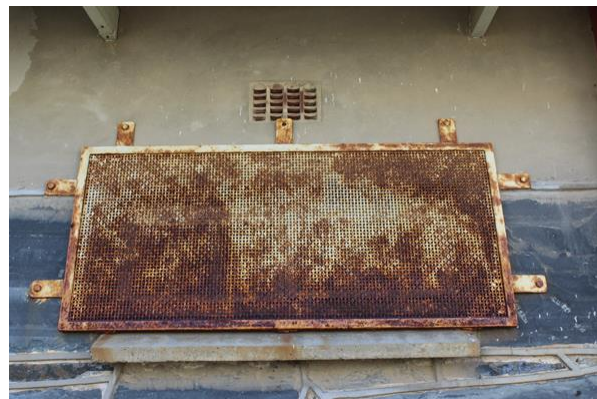
C Section

Grates to be sandblasted for rust removal. The grates to be primed with anti rust primer and finished in enamel topcoats.

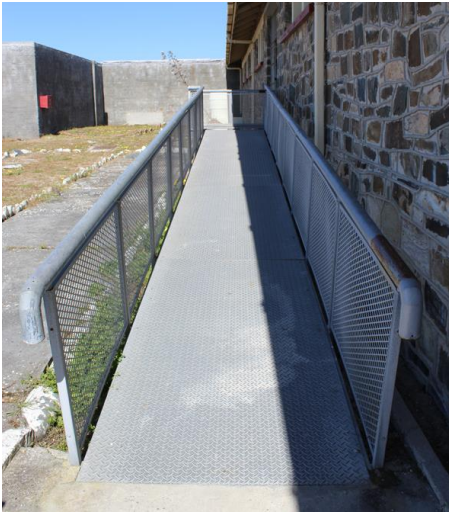
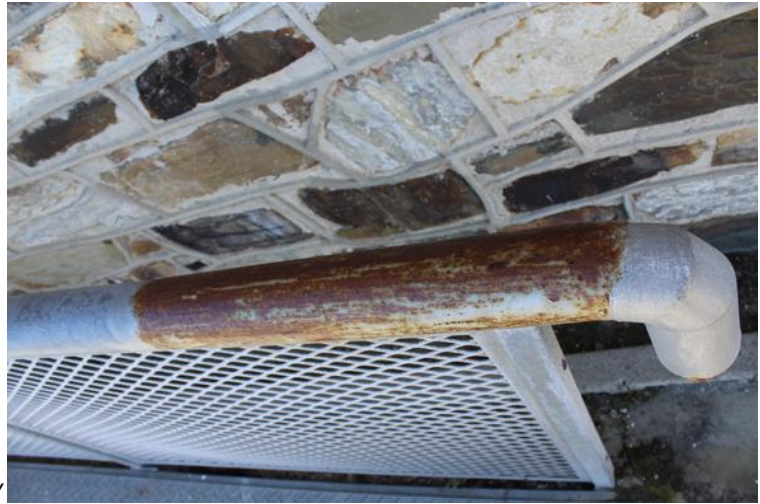
D Section Ramp

The galvanised

ed rail is in good condition except for two areas of the rails that show some rusting. The rusted areas will be ground away and the metal treated with cold galvanising paint.

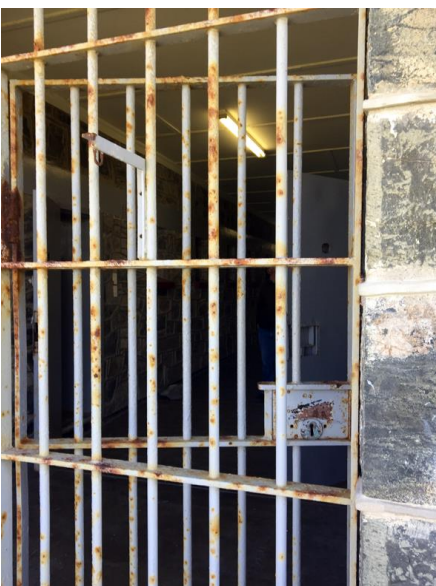
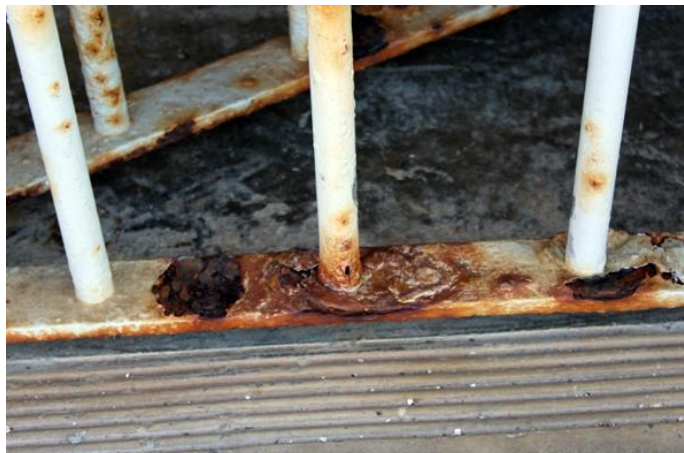
Bars to be sanded to remove rust, Bars to be primed with anti rust primer and finished in enamel topcoats.
